Urban Forest  
Management Plan

Stewart Indian School

Prepared by  
John Christopherson  
Forest Protection Specialist  
Nevada Division of Forestry

2001

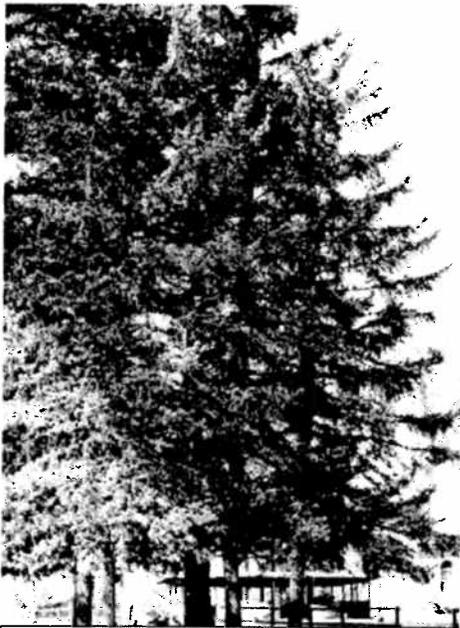
Figure 1. Topped Spruce

the spruces (tree # 6) has been topped (see Figure 1). Removal of the topped tree will reduce competition and eliminate any future problems associated with the topping cut. Branches in the adjacent cottonwood (tree #8) that hang over the spruce should be pruned off.

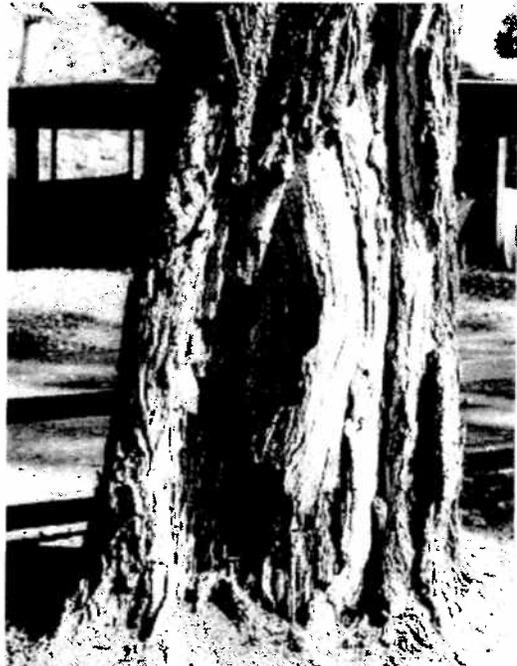
Figure 3. Basal decay on Cottonwood

The 36" dbh cottonwood located north of the Trading Post (tree #12, Figure 3) has significant trunk decay with inadequate sound wood to make the tree safe. **This tree is hazardous and should be removed.**

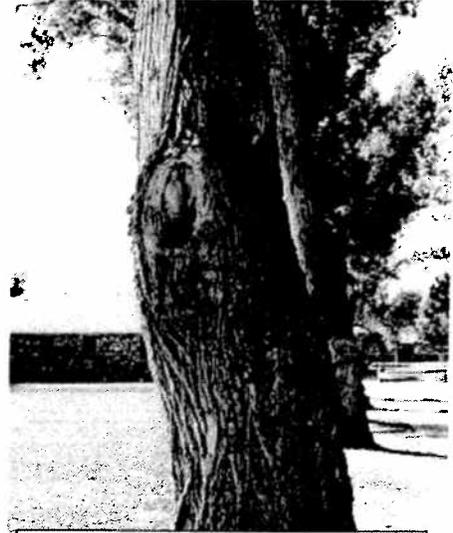
Figure 4. Cottonwood with decay at pruning wounds.

- The cottonwood (tree #13, Figure 4) located south-east of the museum, just north of the sidewalk running along the south side of bldg. 1, has 3-12" diameter pruning wounds along the trunk which are filled with decay. All branches have been topped and the tree is declining. **Consider removing tree**, or watch and plan for the tree's replacement.

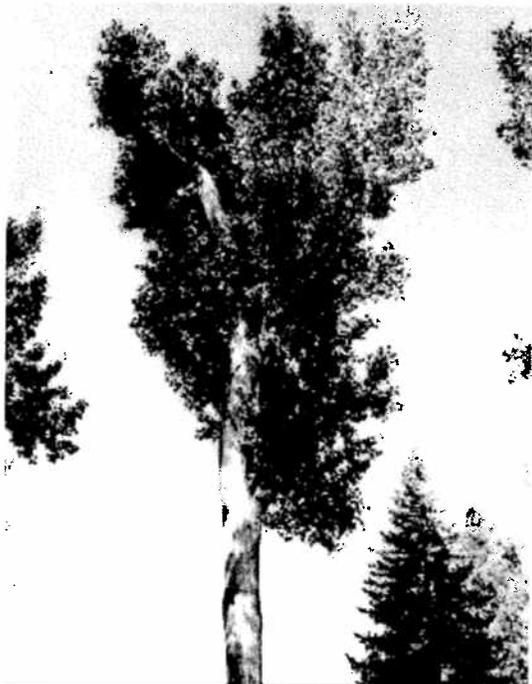
Figure 5. Severely topped Cottonwood

- Tree #14 is on the opposite side of the north-south sidewalk from #13. It is another cottonwood with all its branches stub-cut (Figure 5). The tree has little live crown left and has very low vigor. **This tree should be removed.**

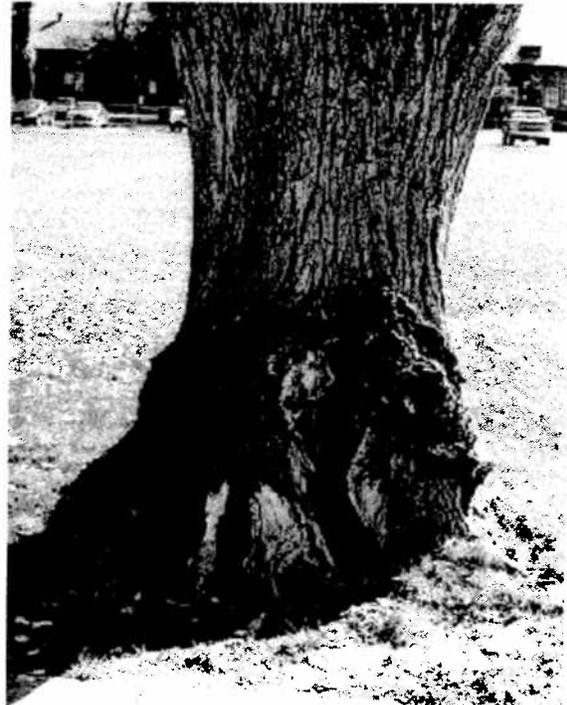
Figure 6. Basal decay on Cottonwood

- Tree #18 is the next to last cottonwood in the row. The tree very likely has significant internal decay from old pruning wounds. Basal decay has caused significant root loss on the windward side of the tree (Figure 6). **This tree is a hazard and should be removed.**

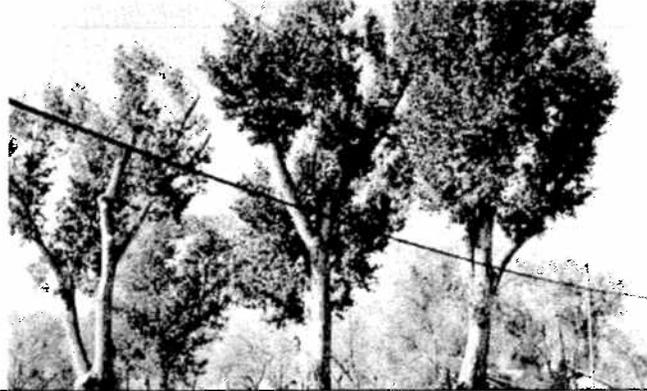
Figure 7. Topped Cottonwoods on Wa-Pai-Shone

Trees 21-23 are all cottonwoods located in the median between Wa-Pai-Shone and the parking lot, immediately west of bldg. 6. The trees have all been severely topped (Figure

7), have little live crown remaining and will likely continue to deteriorate. Rather than continue to prune dead branches as they occur, consideration should be given to removal and replacement. If the trees are retained, they should be given supplemental irrigation throughout the growing season.

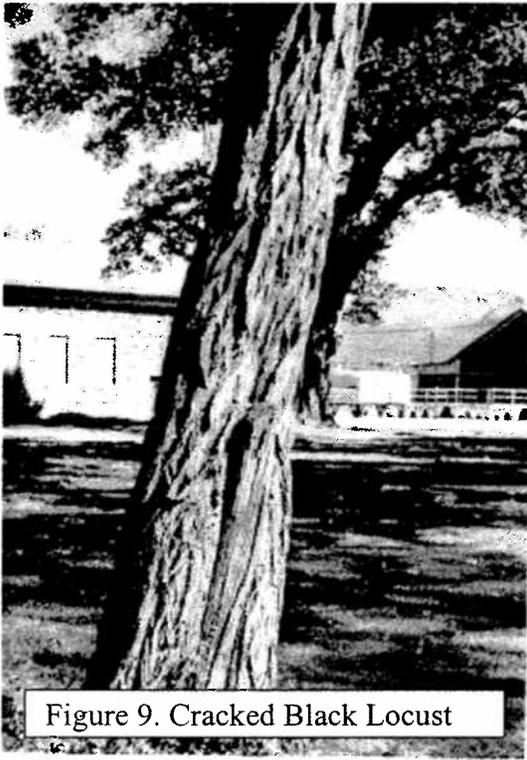
Figure 9. Cracked Black Locust

There is a black locust (tree #4) located on the north side of the entrance to the parking lot between the boiler room and bldg. 160. The tree has significant basal decay which has caused a large crack to develop up the stem (Figure 9). **This tree is a hazard and should be removed.**

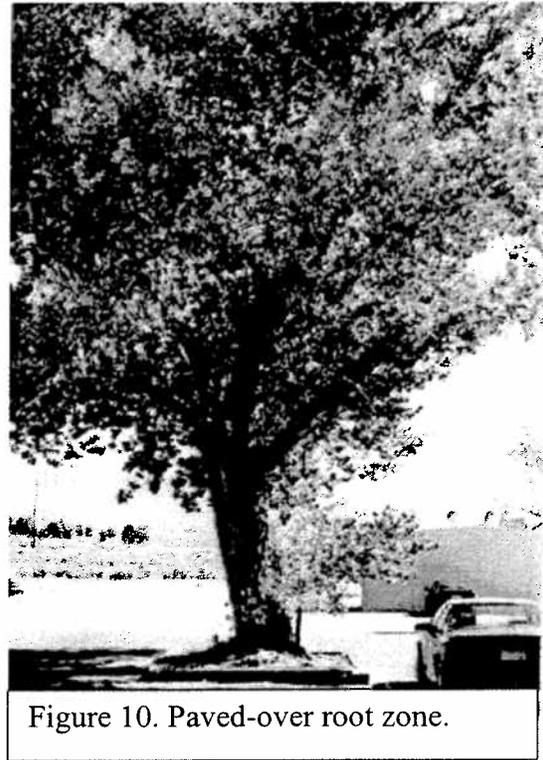
Figure 10. Paved-over root zone.

Trees #5-12, all cottonwoods, have numerous dead branches that should be removed. Tree # 13, located in the parking lot between bldgs. 89 and 90 (Figure 10) is causing significant buckling of the recent paving. The tree is in need of a significant amount of pruning. The recent paving of the lot has likely caused significant harm to the root system of the tree. Watch this tree for signs of declining. **If a decision is made to keep this tree, the pavement should be removed out to a minimum of the trees drip line and a root system inspection should be performed. Alternatively, consideration should be given to removal of this tree.**

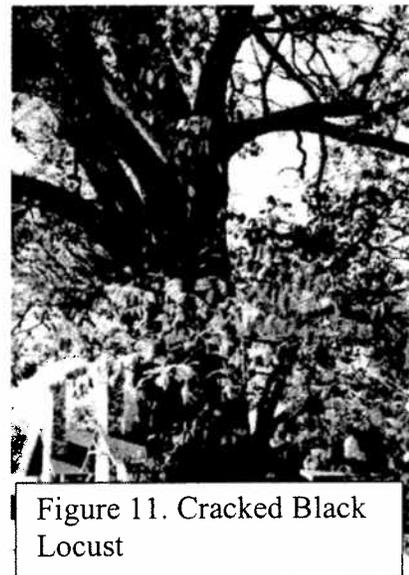
Figure 11. Cracked Black Locust

The black locust in the turf area on the south side of Jacobsen Way (tree #8) is cracked completely through the main stem (Figure 11). **This tree should be removed.**

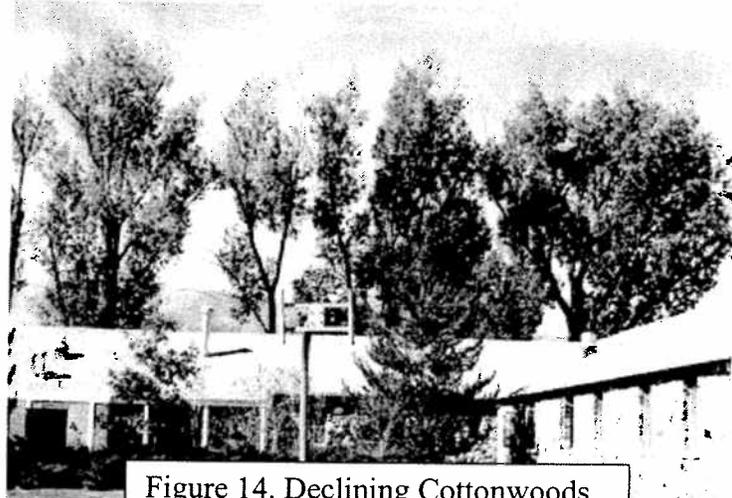
Figure 14. Declining Cottonwoods

Tree #s 18-24, row of cottonwoods along Wa-Pai-Shone Ave. All the trees are in poor condition (Figure 14). Replacement trees should be planted in between the cottonwoods and the larger trees eventually removed. This would help lessen the visual impact of removing several large trees from this area at once.

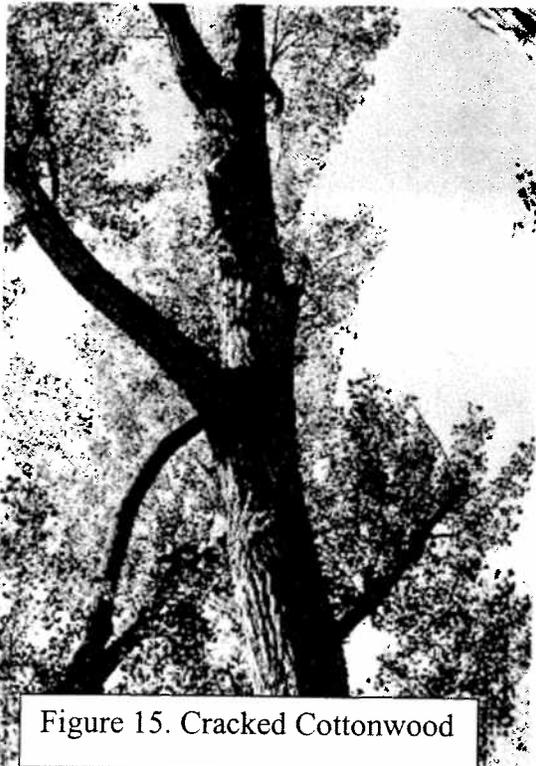
Figure 15. Cracked Cottonwood

Tree #20 has a large hollow in the base and is cracked further up the stem (Figure 15). **This tree should be removed.**

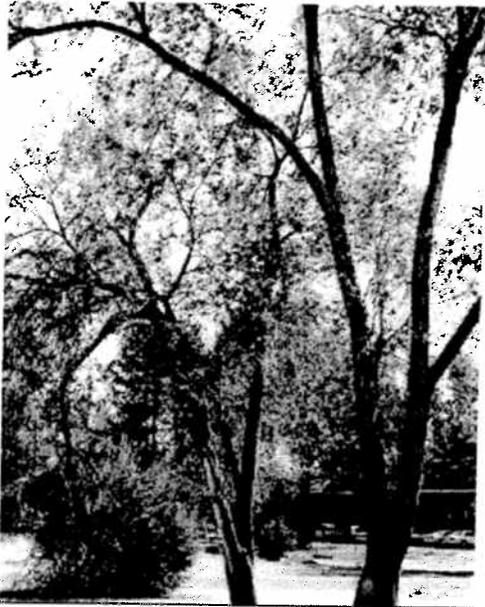
Figure 16. Siberian Elm with co-dominant stems and wounds

Tree #1, a Siberian elm. Tree has codominant stems, one of which is badly wounded. (Figure 16) This tree is in poor condition. **Recommend removal.**

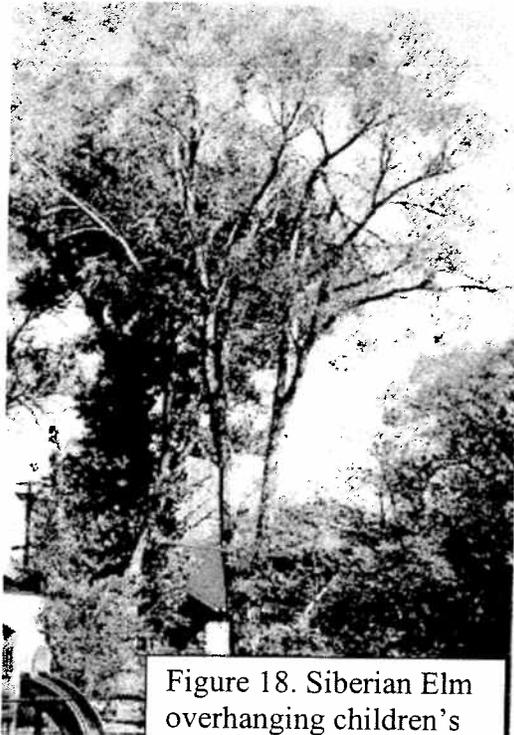
Figure 18. Siberian Elm overhanging children's playground

Tree #28, Siberian elm. Tree overhangs children's playground (Figure 18). There are numerous dead and poorly formed branches creating a hazard to children playing below. **The tree cannot be improved and should be removed.**

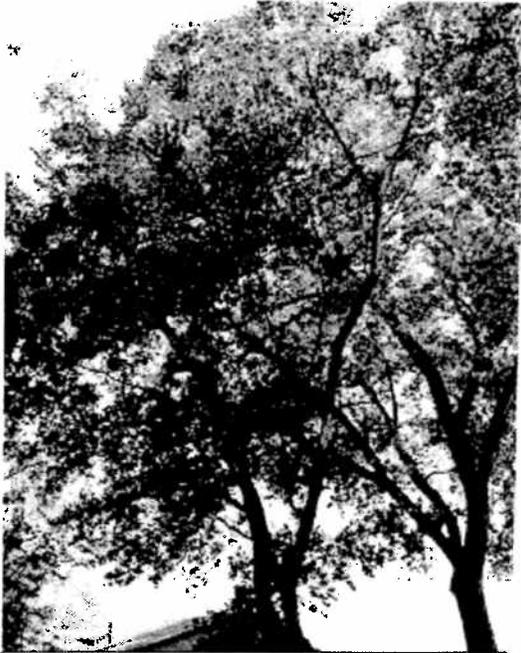
Figure 20. Hazardous branch in Cottonwood

Tree #19, cottonwood. This tree has two scaffold branches, one of them is dead and represents a hazard to the occupants of surrounding structures (Figure 20). Removing this branch would leave insufficient live crown. **Recommend tree be removed.**

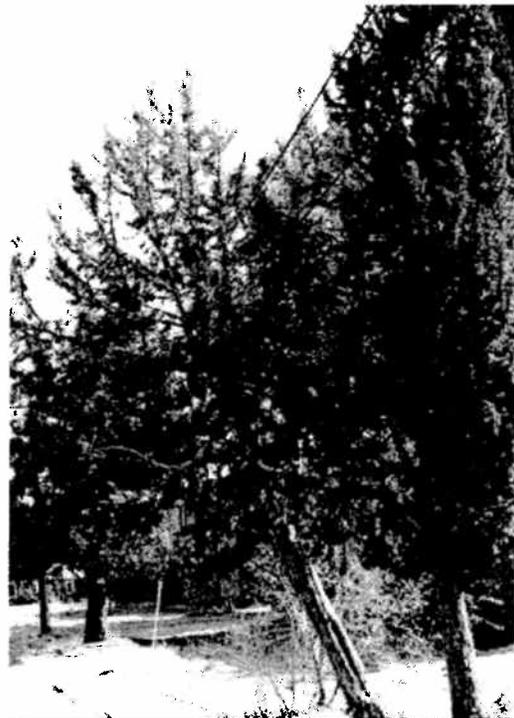
Figure 21. Junipers in powerlines

Tree #3-5, Junipers. Trees located under powerlines (Figure 21). Recommend removal of tree #3 and pruning of branches on #s 4 and 5 where they are interfering with the powerlines. ANSI Standards for safety should be followed (see Appendix A).
