State of Nevada
Department of Wildlife
Winnemucca Office Building
Facility Condition Analysis

WINNEMUCCA OFFICE BUILDING

705 East 4th St.
Winnemucca, Nevada

Site Number: 9909 – Building Number 2433
STATE OF NEVADA PUBLIC WORKS DIVISION
FACILITY CONDITION ANALYSIS

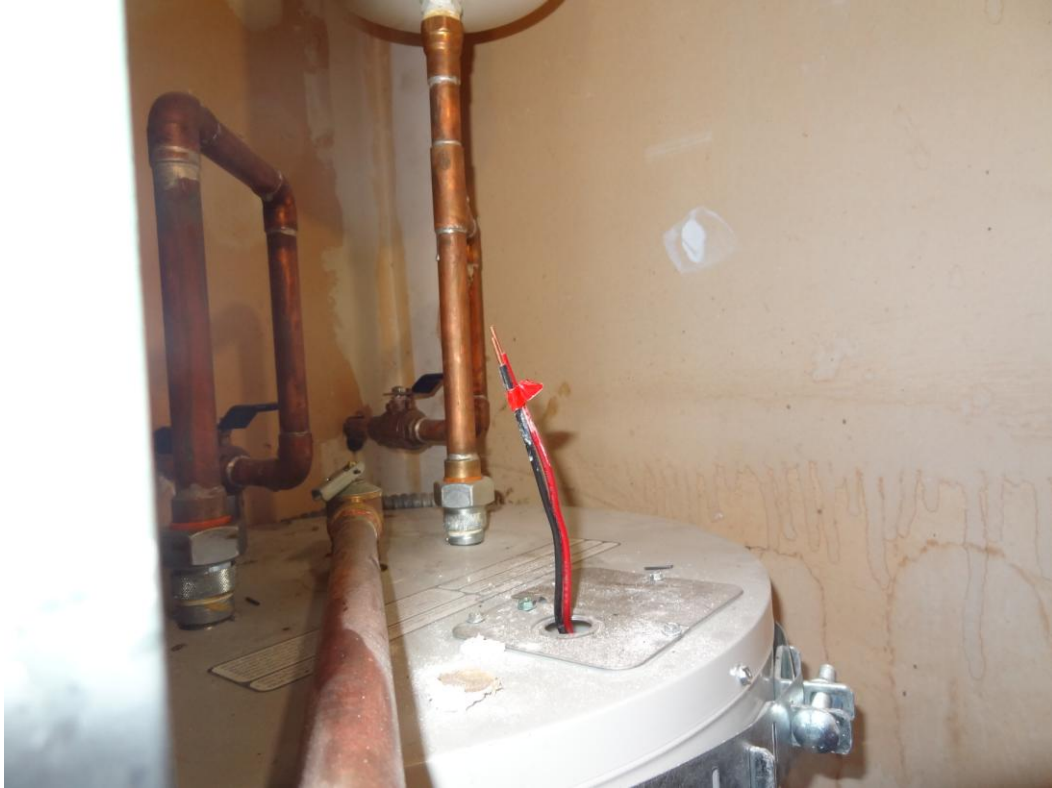
There are two water heaters in the building, one serving the single level portion and one serving the two level portion. The water heater in the single level portion is missing a drain pan, missing seismic straps and the electrical wiring appears to be sub-standard. The new water heater installed in the two level portion of the building is not operational and is missing a drain pan. At the time of the survey, the electrical wiring was not connected to the breaker box. This water heater provides hot water to the entire two level portion of the building and should be repaired before employees are assigned to this area. This project would provide for a licensed electrician to properly connect power to the new water heater, repair the electrical wiring for the older water heater and perform testing to ensure that they are fully operational and safe. This project also provides for installing drain pans and seismic bracing.

Winnemucca Office Building – Winnemucca Site – FCA Building #2433
Description: Water Heater electrical not connected.

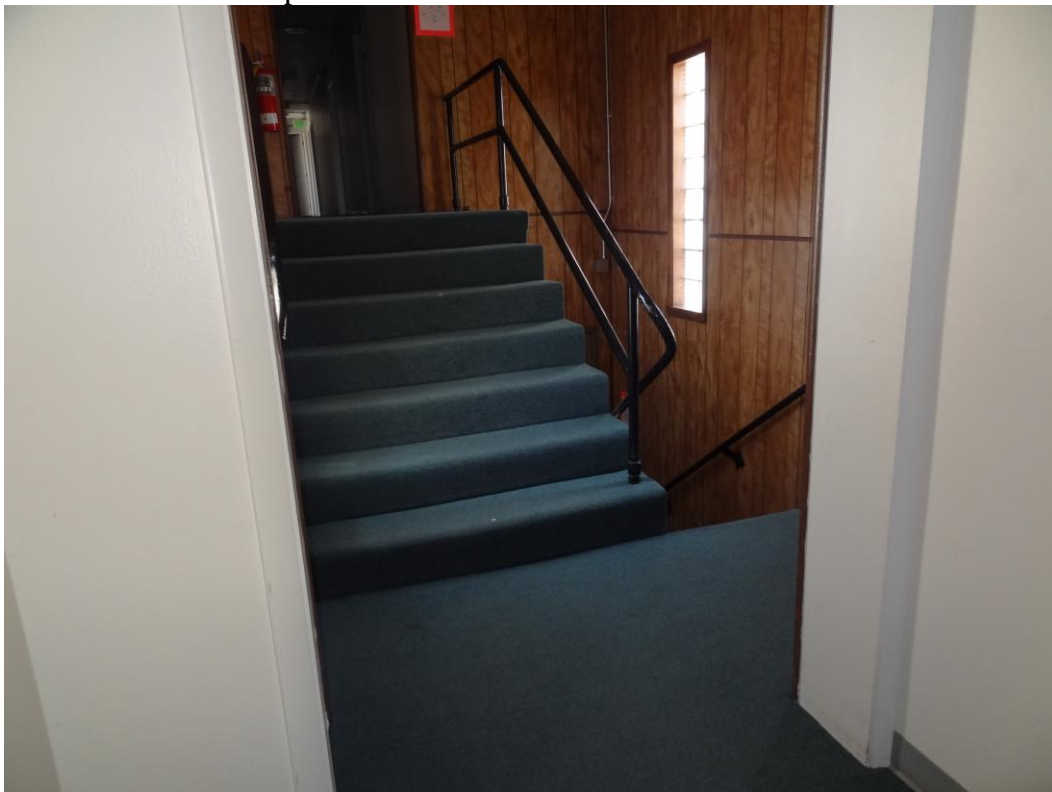
The interior stair handrails from the main floor to the upper and lower floors at the rear of the building are older and do not meet code for safety. The gripping surfaces are incorrect and they are not continuous from the top to bottom landings. This project recommends the installation of handrails on both sides of the stairs, with proper returns, gripping surfaces and supports in accordance with the 2012 IBC Chapter 10, Section 1012. This project or a portion thereof was previously recommended in the FCA report dated 05/11/2011. It has been amended accordingly to reflect conditions observed during the most recent survey date of 09/01/2015.

Winnemucca Office Building – Winnemucca Site – FCA Building #2433
Description: Non-compliant interior handrails.

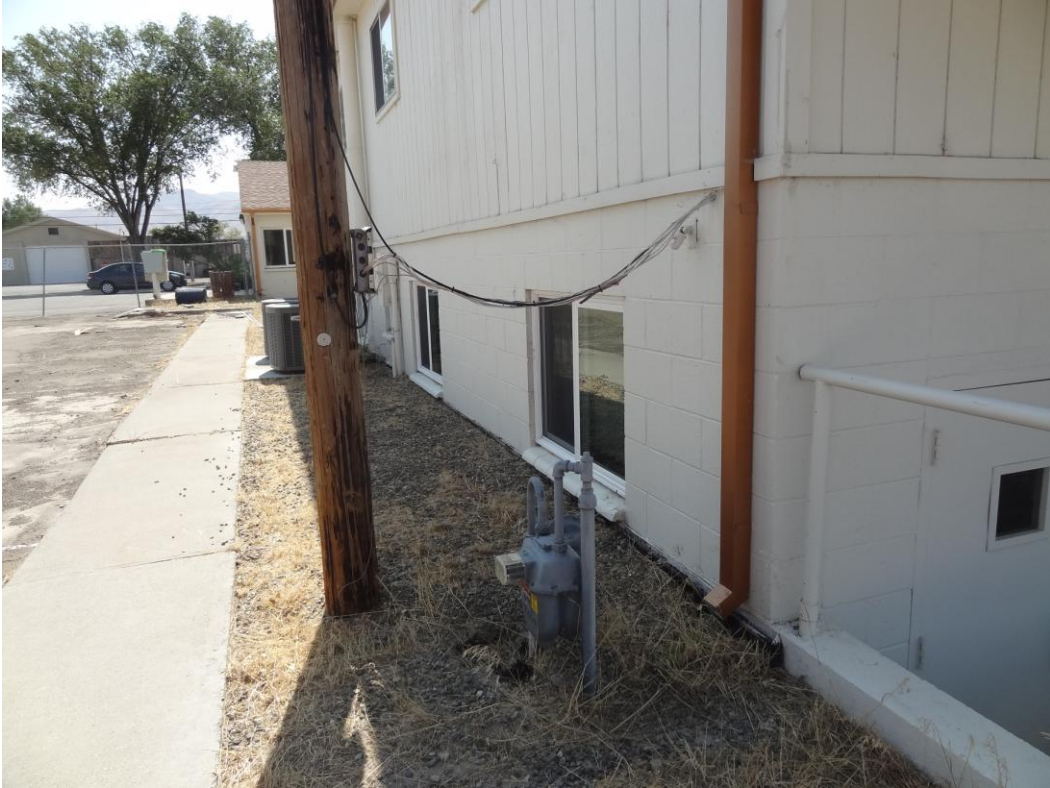
This project would provide for the installation of a seismic gas shut-off valve on the main gas service piping just prior to entering the building in two locations. This estimate is based on the manufacturer Pacific Seismic Products or approved equal, equipped with the optional Model MS remote monitoring switch (to be interfaced with the direct digital control system and/or with an audible alarm). The gas piping immediately adjacent to the seismic gas valve shall be secured to the building utilizing unistrut channel bracing.

The natural gas meter at the rear of the building is not protected from vehicle impact. The meter is close to the parking lot on two sides and is at risk of damage from vehicles. This area is in need of bollards to protect the natural gas lines from damage. This project would provide funding for 4 eight inch diameter bollards to be located in between the gas meter and the parking areas.

Winnemucca Office Building – Winnemucca Site – FCA Building #2433
Description: Gas service missing seismic shut-off and pipe bollards for protection.

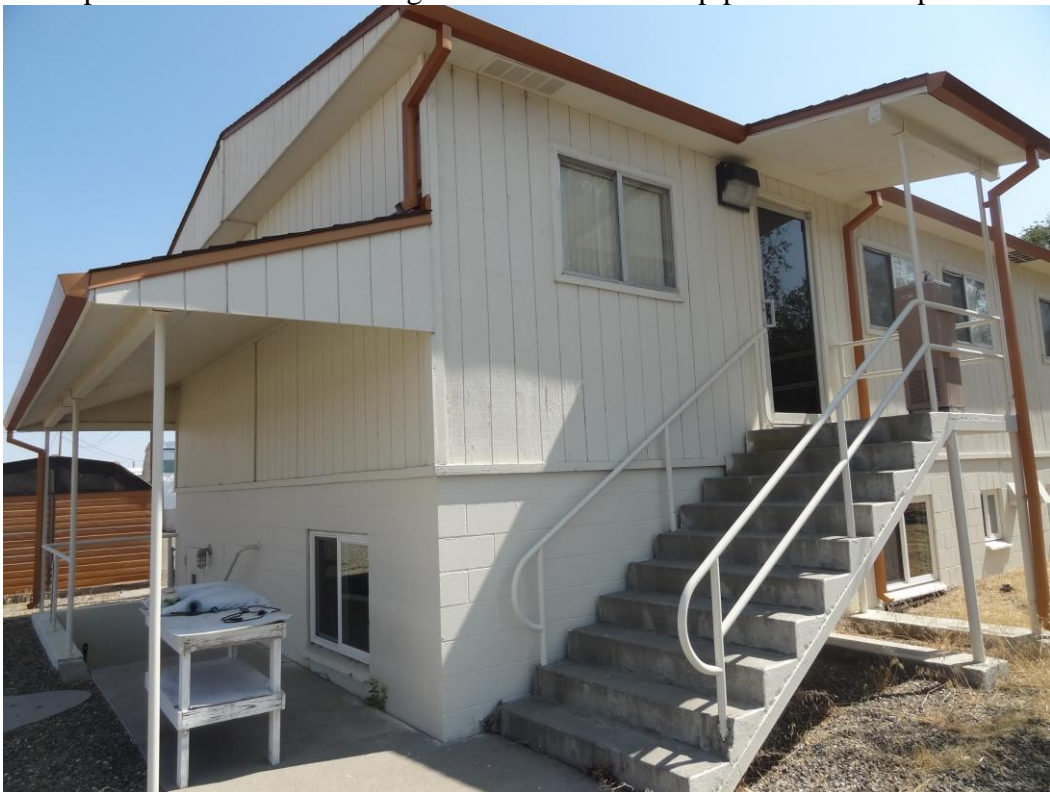
There are two sets of stair handrails at the rear of the building that are older and do not meet code for safety. The gripping surfaces are incorrect, they are not continuous from the top to bottom landings and/ or they are installed on only one side of the stair. This project recommends the installation of handrails in accordance with IBC Section 1012.

Winnemucca Office Building – Winnemucca Site – FCA Building #2433
Description: Non-compliant exterior handrails.

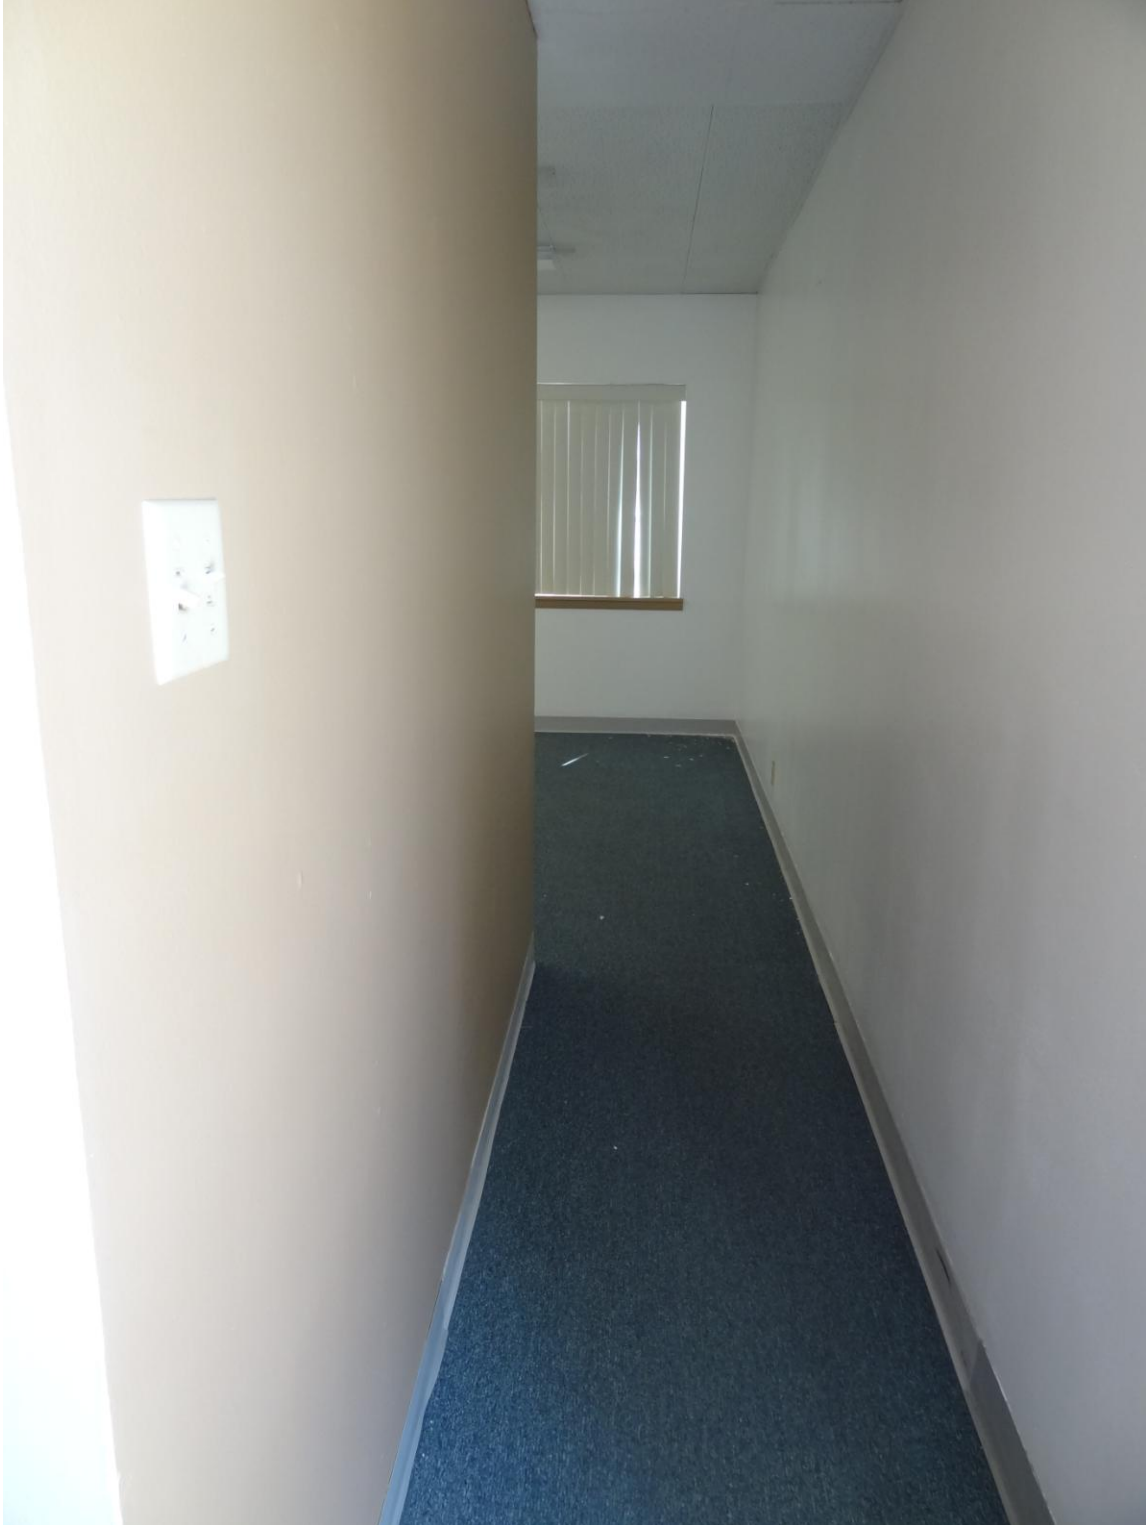
All exit corridors in a building are required to have a clear width of at least 36". The corridor between the conference room and the main hallway is only 34" which is a building code violation. This project would provide for installing an exterior exit door in the conference room to comply with the building code. Alternatively, the corridor could be widened to provide the 36" clear width, but additional costs would be necessary for this alteration. Section 1005.1 and Table 1018.2 of the 2012 IBC were used as a reference for this project.

Winnemucca Office Building – Winnemucca Site – FCA Building #2433
Description: Non-compliant exit corridor from conference room.

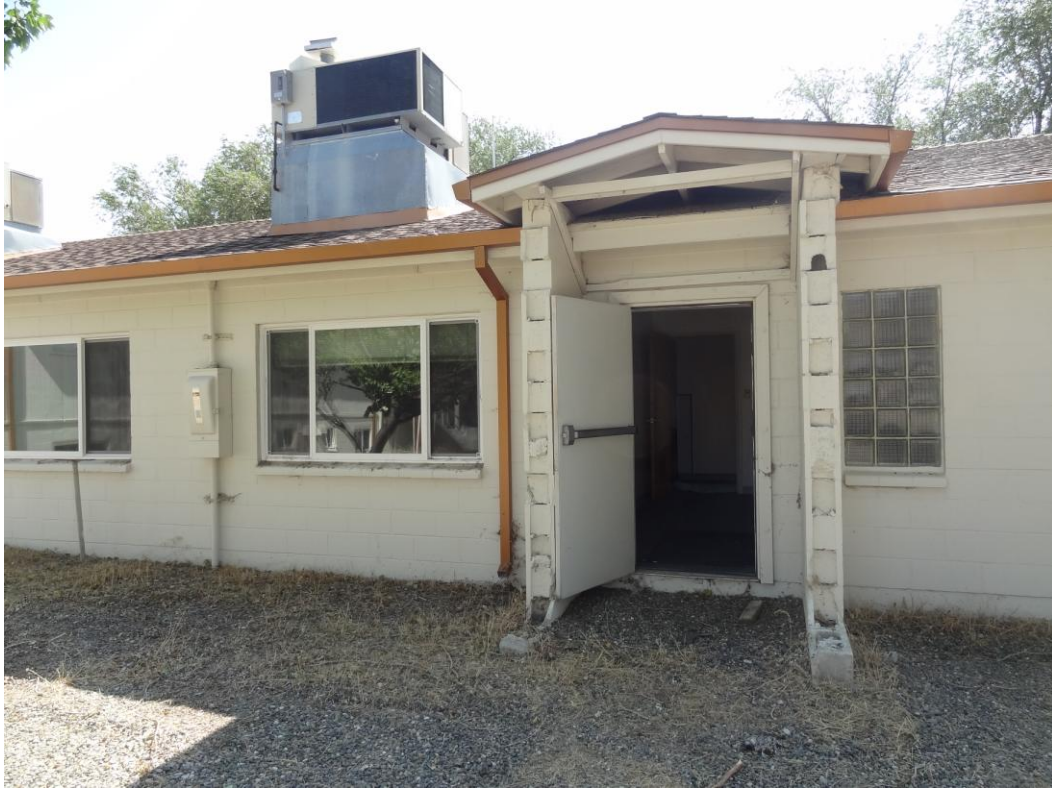
Section 1008.1 of the 2012 IBC describes the requirements for doors including floor elevations and landings. The floor or landing shall be at the same elevation on each side of the door, the exterior landing shall not exceed a 2-percent slope and shall have a length measured in the direction of travel of not less than 44 inches. The landing at the door on the north side of the building does not comply with this code and poses a safety hazard. This project would provide for the installation of a compliant landing for the door.

Winnemucca Office Building – Winnemucca Site – FCA Building #2433
Description: Missing exterior landing.

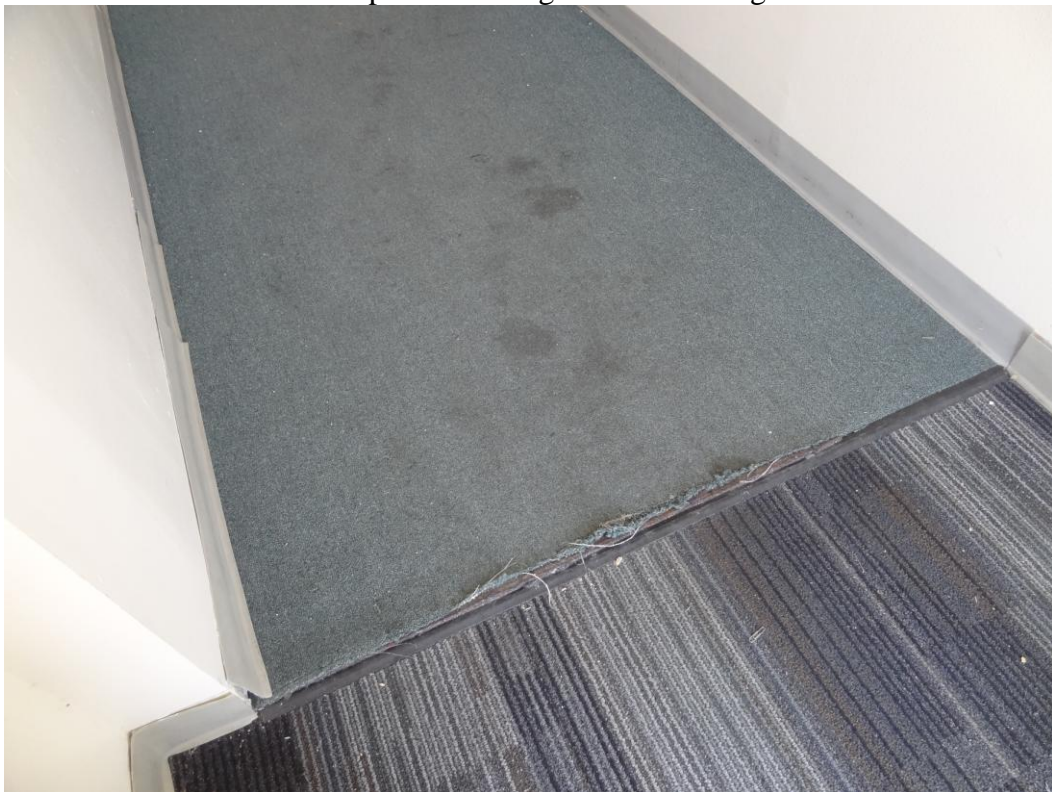
The carpet in the building is showing signs of wear and should be scheduled for replacement. It is recommended that the carpet be replaced with heavy duty commercial grade carpet or Vinyl Composite Tiles (VCT) in the next 2-3 years. Additional costs would be required if there is asbestos in the carpet adhesive.

Winnemucca Office Building – Winnemucca Site – FCA Building #2433
Description: Stained and worn carpet.

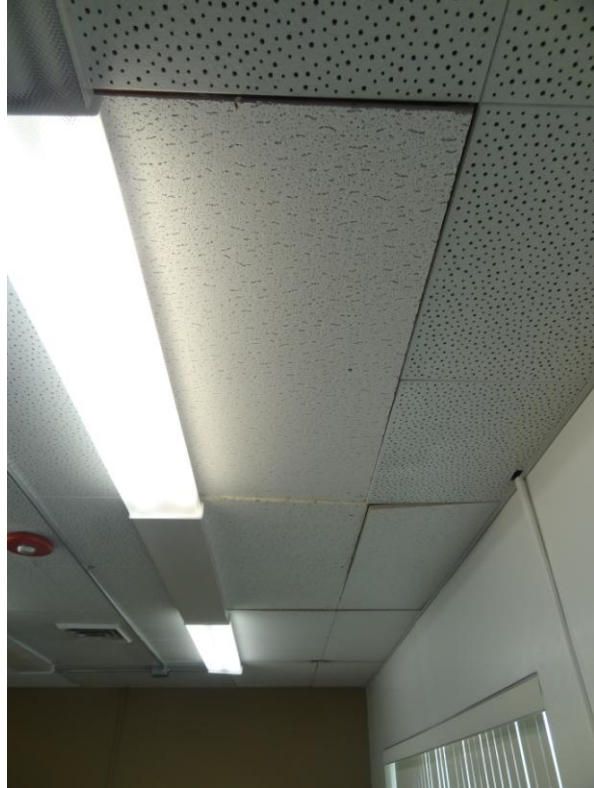
The ceiling in the single story portion of this building is covered with acoustical ceiling tiles. The ceiling tiles are damaged and stained and some are coming loose from the substrate. Many 2x2 tiles have been replaced with ill-fitting 2x4 tiles. This project would provide for the replacement of the ceiling tiles. Removal and disposal of the existing tiles is included in this estimate. Additional costs would be required if there is asbestos in the tiles or adhesive. Additional costs would be required if there is asbestos in the tiles or the insulation above the ceiling.

Winnemucca Office Building – Winnemucca Site – FCA Building #2433
Description: Damaged ceiling tile with mismatched replacement tiles.

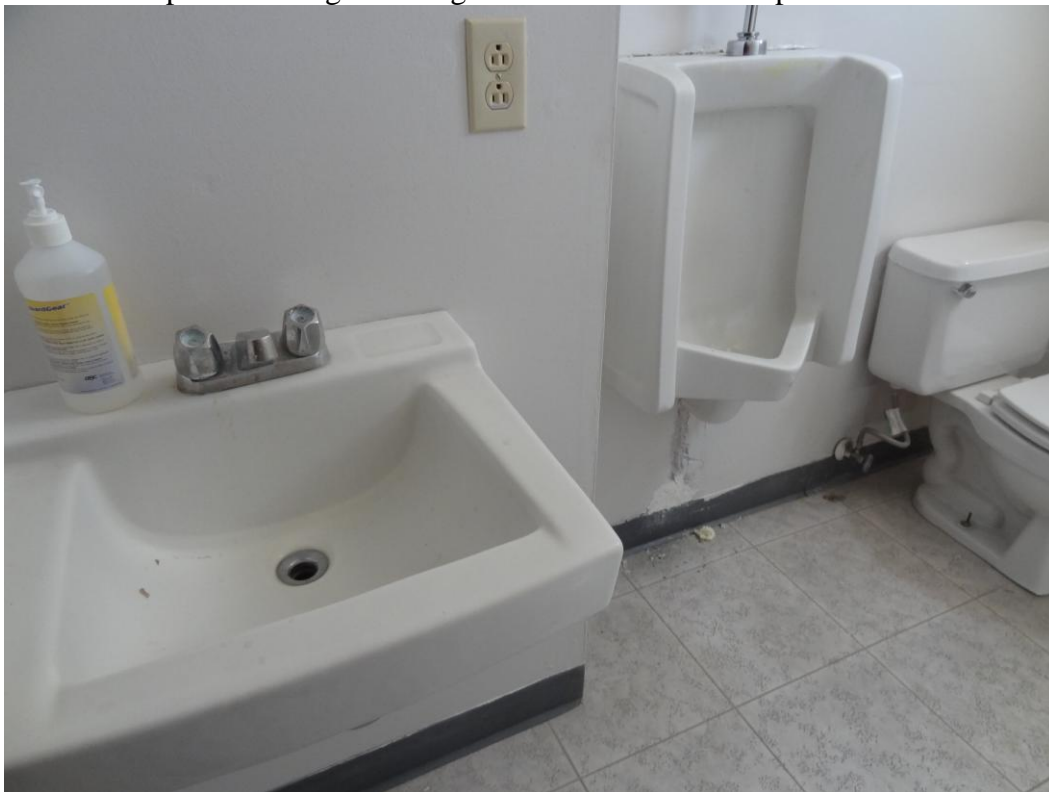
The two restrooms in the first floor of the two level portion are original to the building and in overall poor condition. The finishes, fixtures, cabinets, toilets and exhaust fans are showing signs of wear and deterioration. This project would provide for a complete remodel of the restrooms. The removal and disposal of the existing fixtures and finishes is included in this estimate.

Winnemucca Office Building – Winnemucca Site – FCA Building #2433
Description: Restrooms due for a complete remodel.

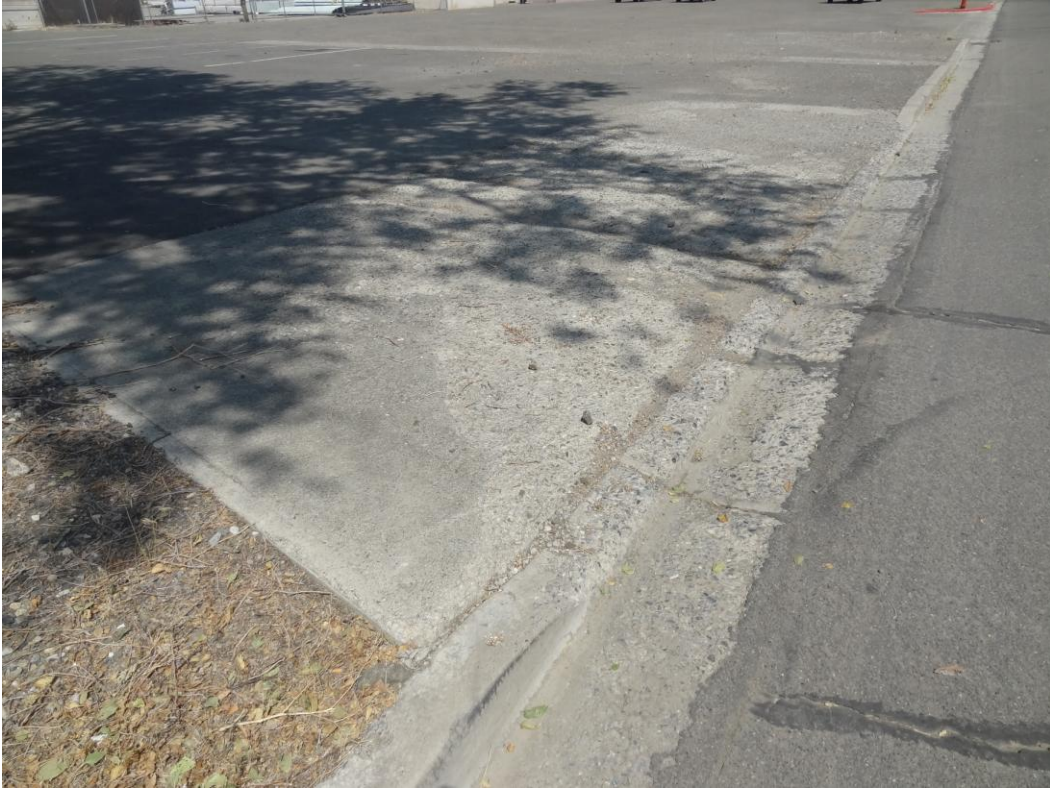
The concrete entrance to the parking lot of the Winnemucca Office Building has extensive cracking and spalling and is due for replacement. This project would provide for the installation of a new concrete slab-on-grade driveway at the entrance to the parking lot. Removal and disposal of the existing concrete is included in this estimate.

Winnemucca Office Building – Winnemucca Site – FCA Building #2433
Description: Deteriorated concrete apron.

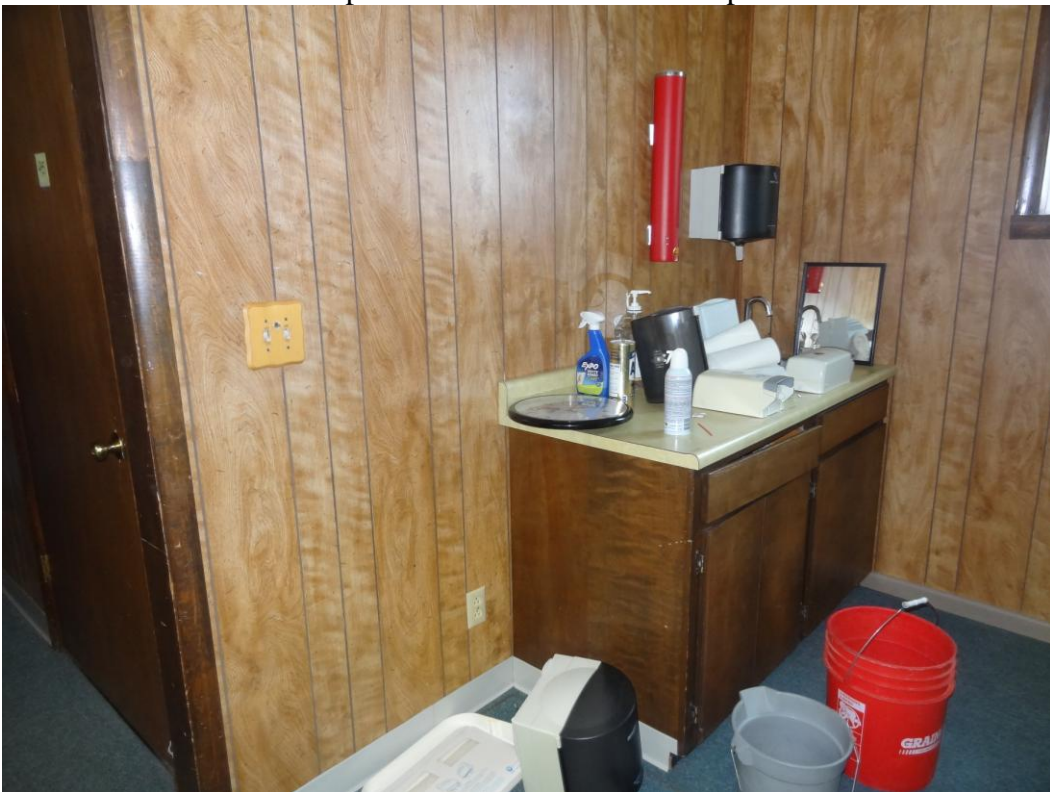
The kitchenette and associated cabinets in the first floor of the two level portion of the building are over 20 years old. The quality of construction and installation were inadequate for the high usage at this facility, and the cabinets and countertop are delaminating and failing. This project recommends the replacement of the existing kitchen counter, cabinets, sink and associated equipment with heavy duty, quality components. The cabinets should be finished inside and outside with a melamine or similar finish which encapsulates the door, frame, and shelving. The countertops should be constructed of a highly durable product, such as stainless steel, over a moisture resistant underlayment to minimize swelling and damage from water exposure. This estimate includes disposal of the existing materials.

Winnemucca Office Building – Winnemucca Site – FCA Building #2433
Description: Kitchenette due for replacement.

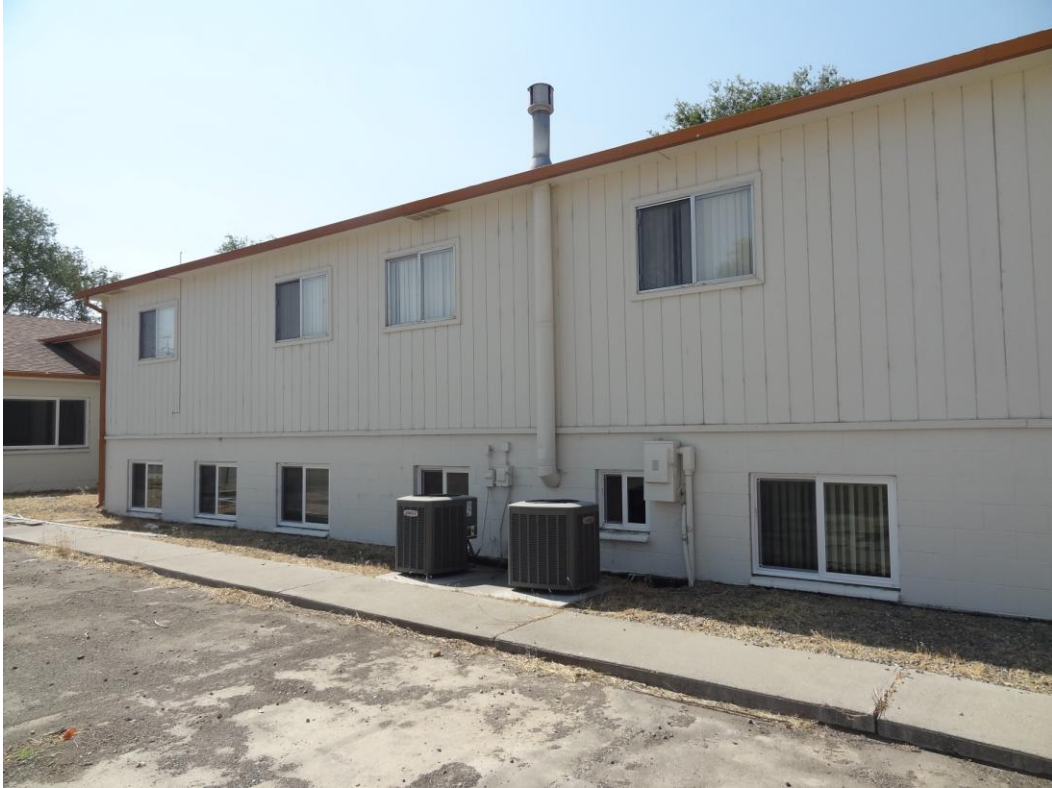
The windows on the second floor of the two level portion are original, single pane construction in metal frames. These older windows are drafty and not energy efficient. This project recommends replacing the windows with dual pane, higher efficiency units. This estimate is for the replacement of 11 units. Removal and disposal of the existing windows is included in this estimate.

Winnemucca Office Building – Winnemucca Site – FCA Building #2433
Description: Second level windows have not been replaced.

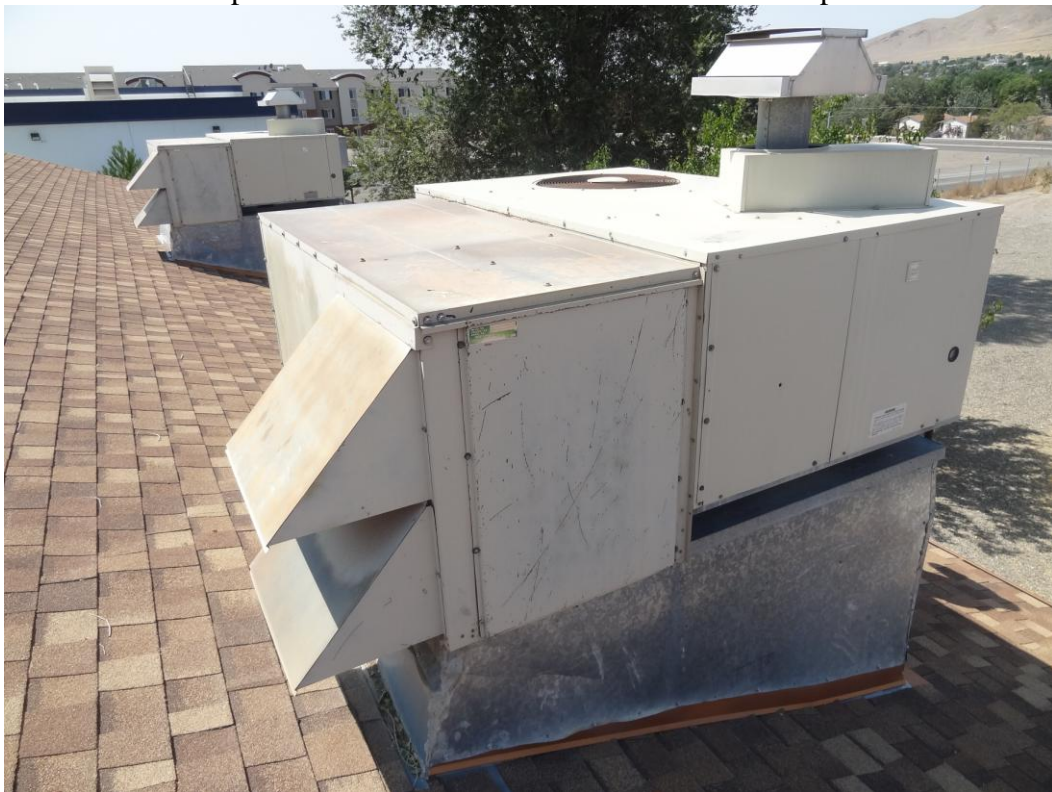
The two HVAC roof top units in the single level portion of the building were installed in 1985. They are not energy efficient and have reached the end of their expected and useful life. This project would provide for installation of two new HVAC packaged units and cleaning of the existing duct work and grilles. This project includes removal and disposal of the existing HVAC units and all required connections to utilities.

Winnemucca Office Building – Winnemucca Site – FCA Building #2433
Description: HVAC rooftop units over 30 years old.
