State of Nevada
Department of Conservation & Natural Resources

WESTERN REGION NDF NURSERY SITE

Site Number: 9795
STATE OF NEVADA PUBLIC WORKS DIVISION
FACILITY CONDITION ANALYSIS

Report distributed in December 2021

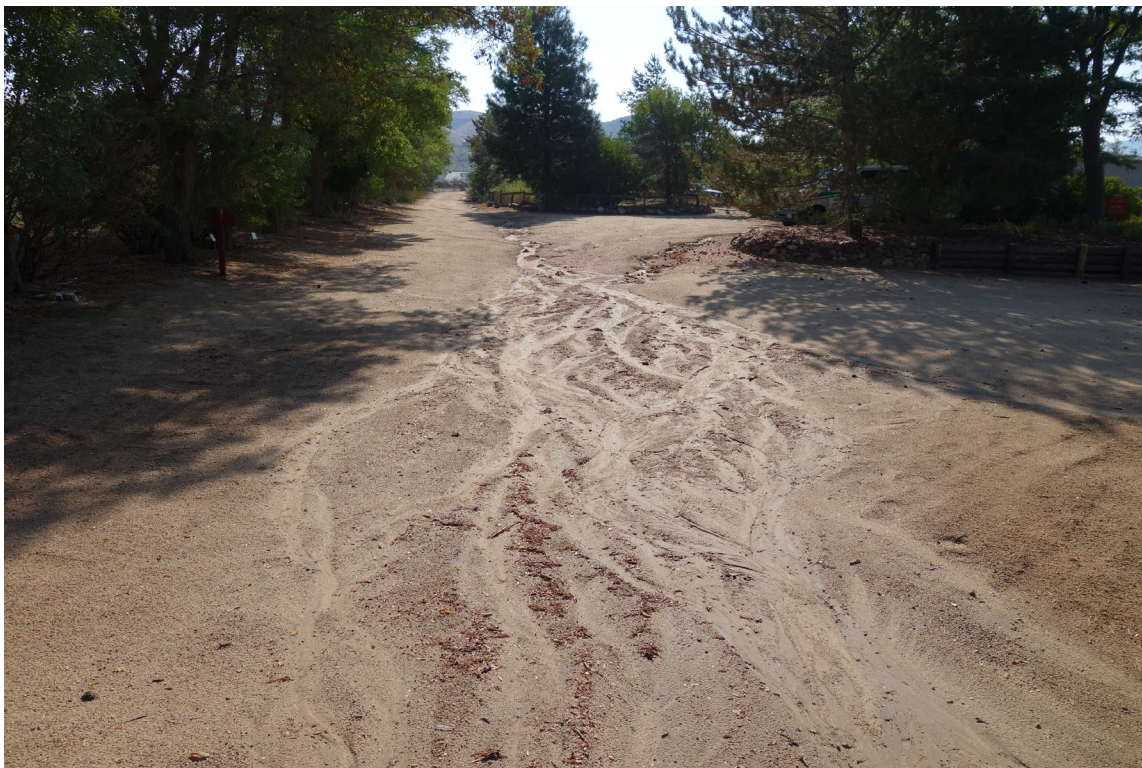
The Nursery site has approximately 40,000 square feet of dirt roads and parking areas and no equipment to maintain them. Precipitation causes erosion to all road and parking areas making it difficult to access the site. This project would fund re-grading the roadways and parking areas on the site and lay down and compact a 6" road base.

Western Region NDF Nursery - Site #9795
Description: Eroded Site Roads Needing Improvements.

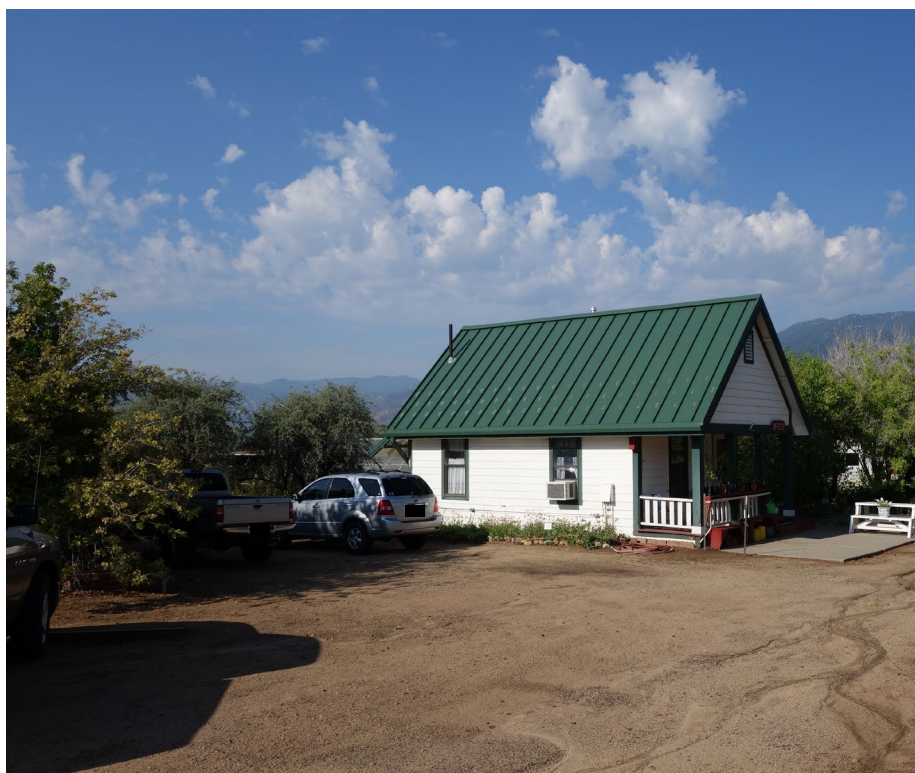
The Americans with Disabilities Act (ADA) provides for accessibility to sites and services for people with physical limitations. A concrete parking area, passenger loading area, sidewalks and ramps are necessary to comply with ADA requirements. The sidewalks and ramps will provide access to the Office, the public restrooms at the Cook House, the Lath Houses and any other area on the site that the public is allowed to go to view and purchase plants. Estimated amount of sidewalk installation & replacement is 1,000 lineal feet. Additionally, this project would provide 400 square feet of concrete van accessible ADA parking, loading space signage. This will require regrading, installing P.C. concrete, striping, signage, railings and any other necessary upgrades. The 2018 IBC, ICC/ANSI A117.1, NRS 338.180 and the most current version of the Americans With Disabilities Act Accessible Guidelines (ADAAG) was used as a reference for this project.

Western Region NDF Nursery - Site #9795
Description: ADA Accessibility Lacking at the Site.

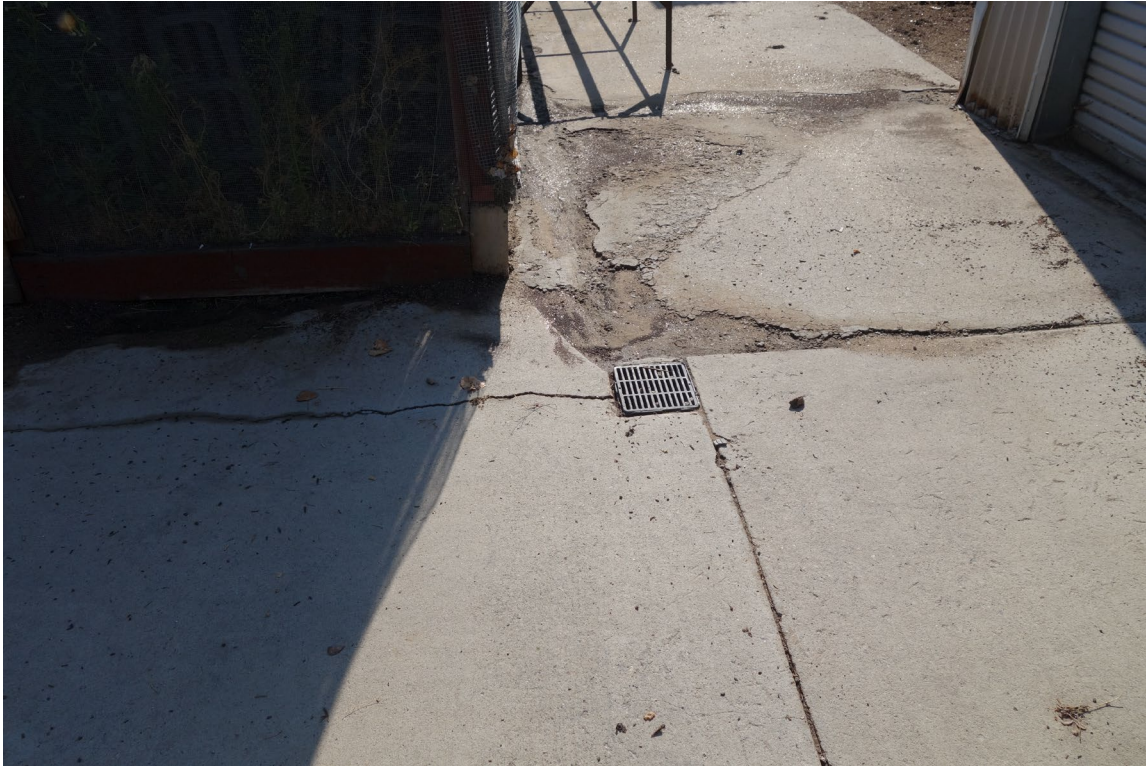
Western Region NDF Nursery - Site #9795

Description: Site Sidewalk Failing and Need for Public Accessible Paths of Travel.

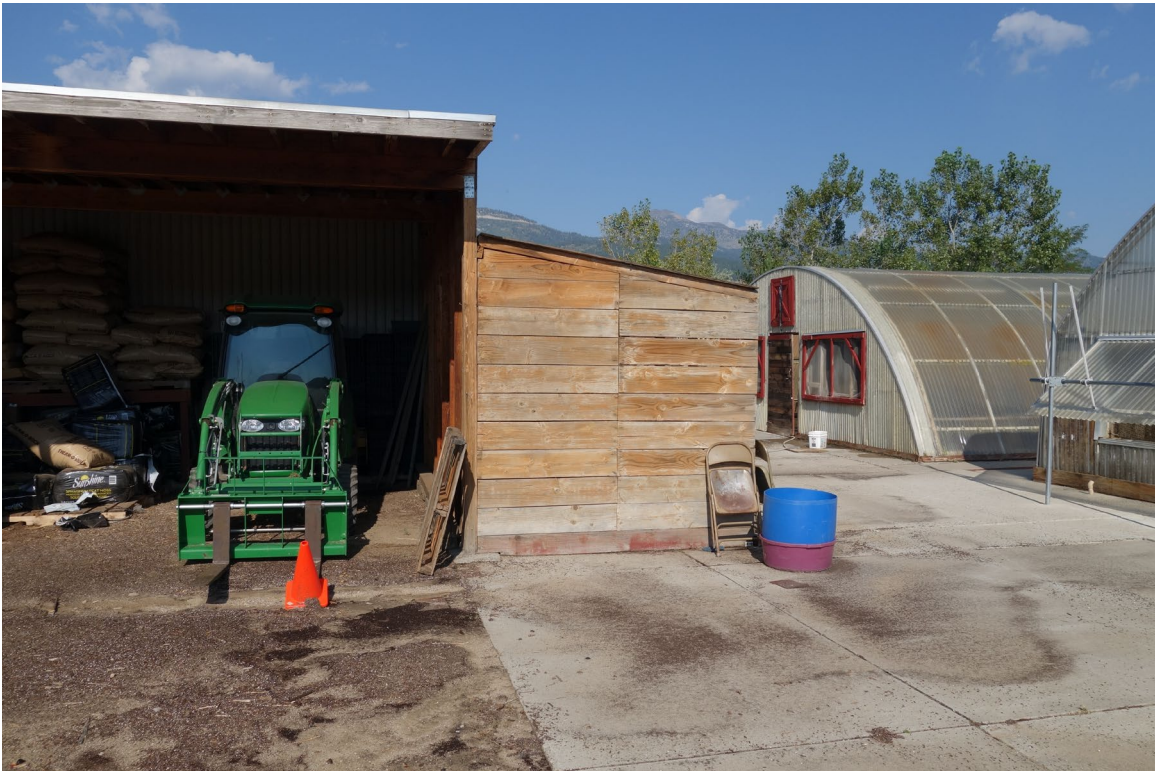
Nursery Planting Building Storage - Building #2345

It is important to maintain the finish, weather resistance and appearance of the building. This project would provide funding to protect the exterior of the building. Included in the cost is sanding, priming and painting and caulking of the flashing, fixtures and all other penetrations. It is recommended that the building be painted in the next 3-4 years and that this project be scheduled on a cyclical basis to maintain the integrity of the structure.

Description: Exterior of the Building.

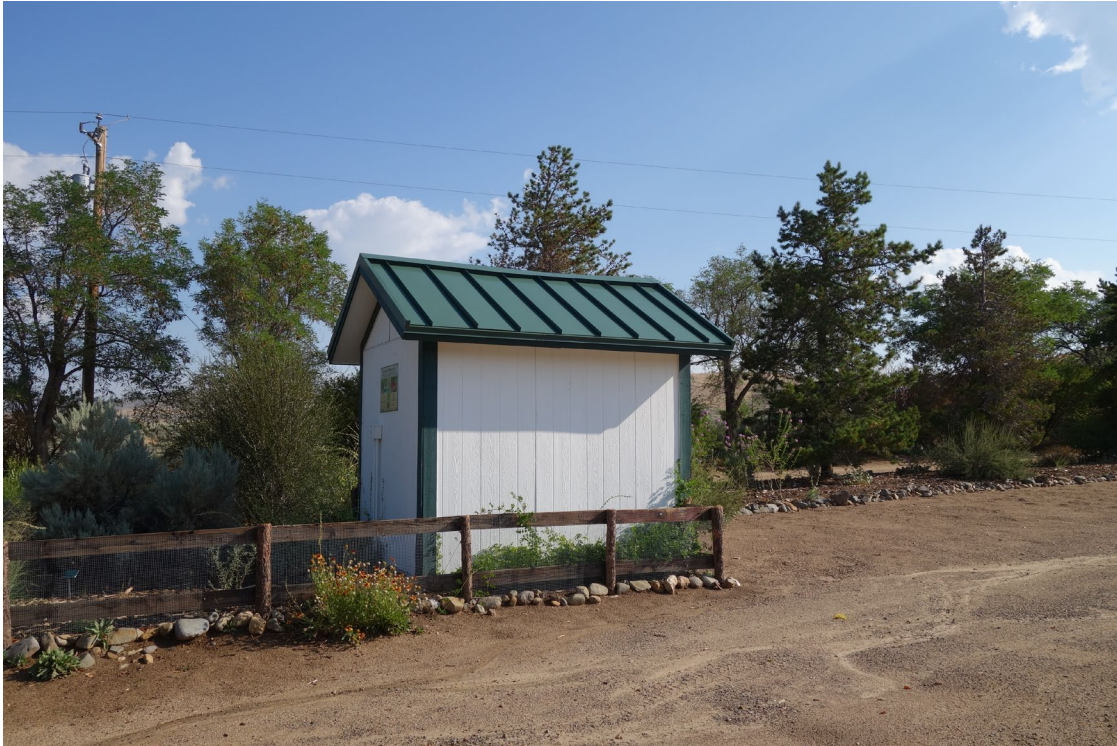
The exterior finishes are in fair condition. It is important to maintain the finish, weather resistance and appearance of the building. This project would provide funding to protect the exterior of the building. Included in the cost is sanding, priming and painting and caulking of the flashing, fixtures and all other penetrations. It is recommended that the building be painted in the next 4 - 6 years and that this project be scheduled on a cyclical basis to maintain the integrity of the structure.

Nursery Pump House - Building #2344
Description: Exterior of the Building.

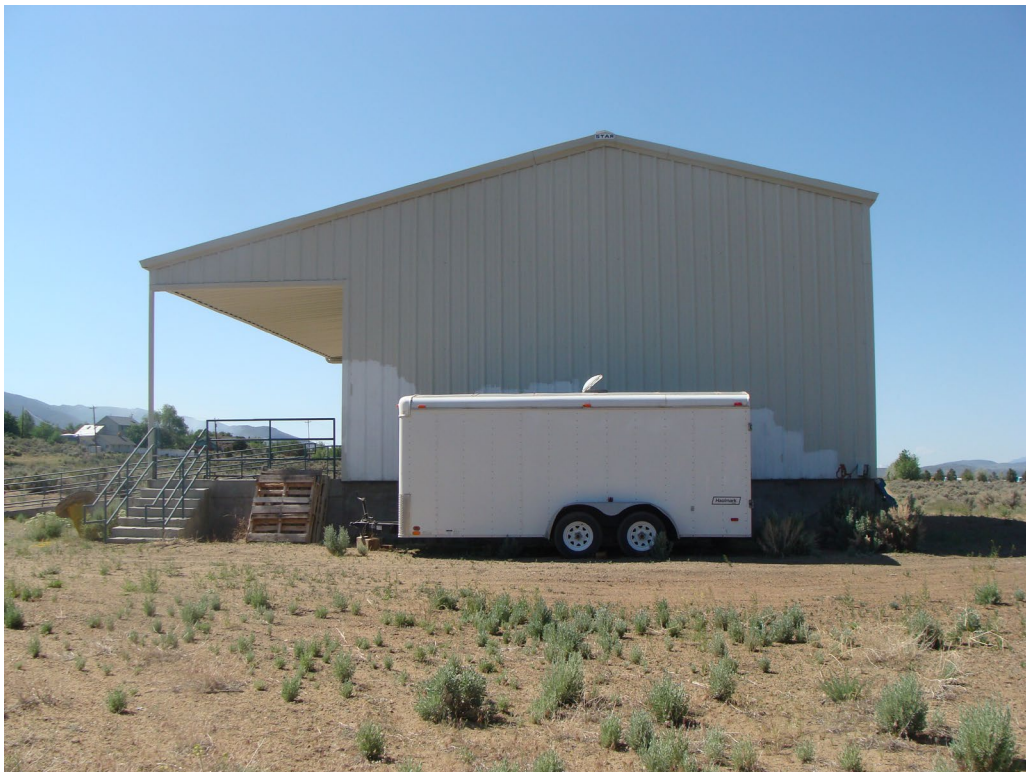
The exterior finishes are in good condition. It is important to maintain the finish, weather resistance and appearance of the building. This project would provide funding to protect the exterior of the building. Included in the cost is priming and painting to repair the graffiti damage and caulking of the flashing, fixtures and all other penetrations. It is recommended that the building be painted in the next 7 - 9 years and that this project be scheduled on a cyclical basis to maintain the integrity of the structure.

Nursery Seed Bank - Building #2343
Description: Exterior of the Building.

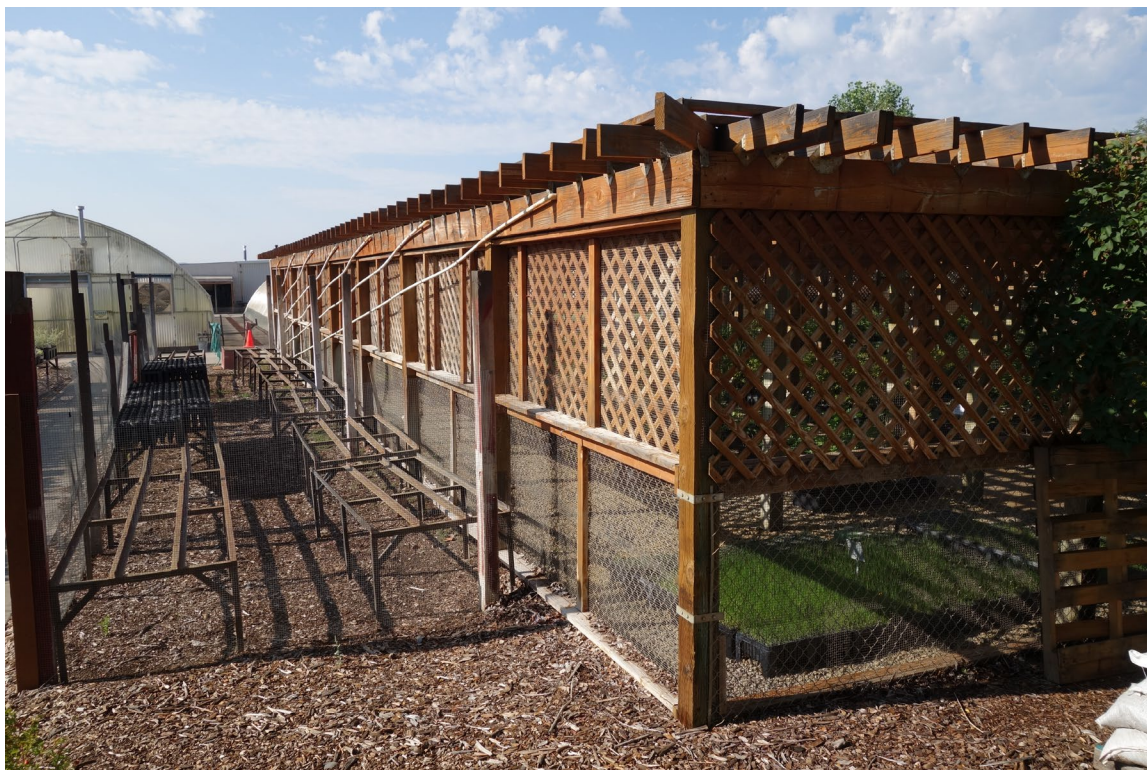
It is important to maintain the finish, weather resistance and appearance of the structure. This project would provide for staining of the structure and it is recommended that this project be scheduled on a cyclical basis to maintain the integrity of the structure.

Nursery Lath House (North) - Building #2341
Description: Exterior of the Structure.

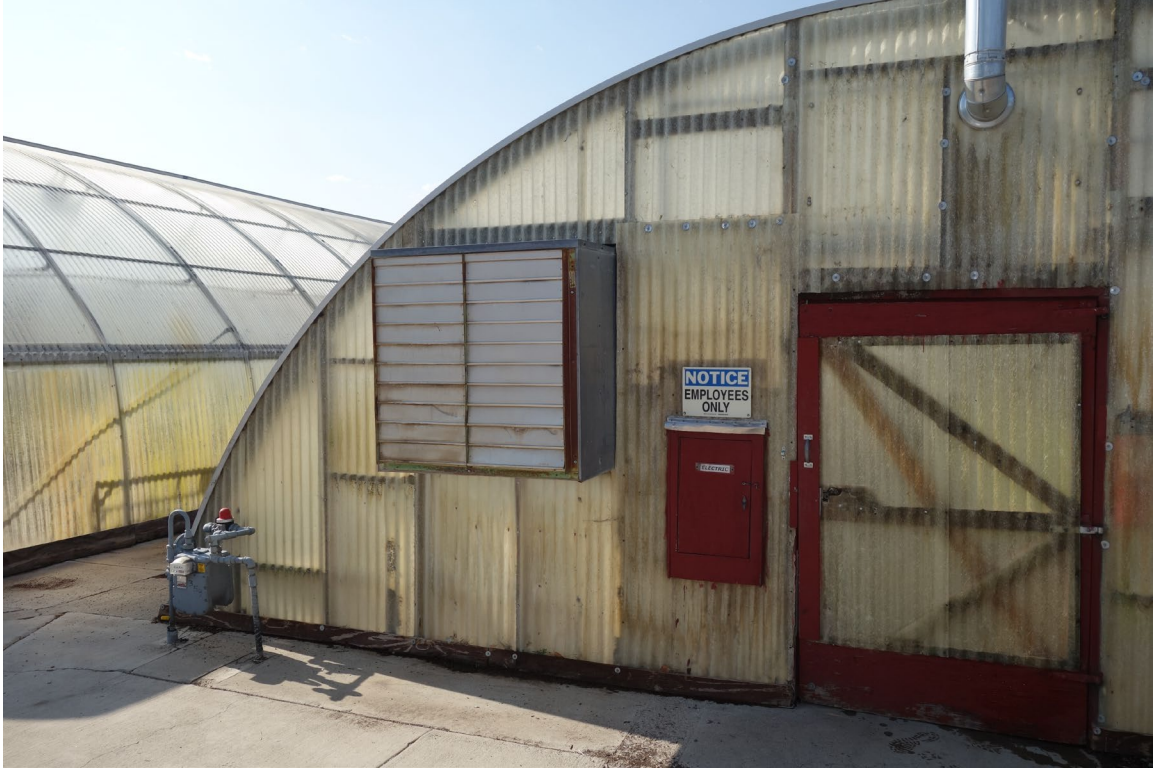
It is important to maintain the finish, weather resistance and appearance of the structure. This project recommends work to protect the exterior building envelope including repairs to the exterior membrane and caulking around, flashing, fixtures, and other penetrations to maintain the building in good, weather tight condition. It is recommended that this project be implemented in the next 4 to 5 years and it is also recommended that this project be scheduled on a cyclical basis to maintain the integrity of the structure.

Nursery Greenhouse #2 (West) - Building #2340
Description: Exterior of the Structure.

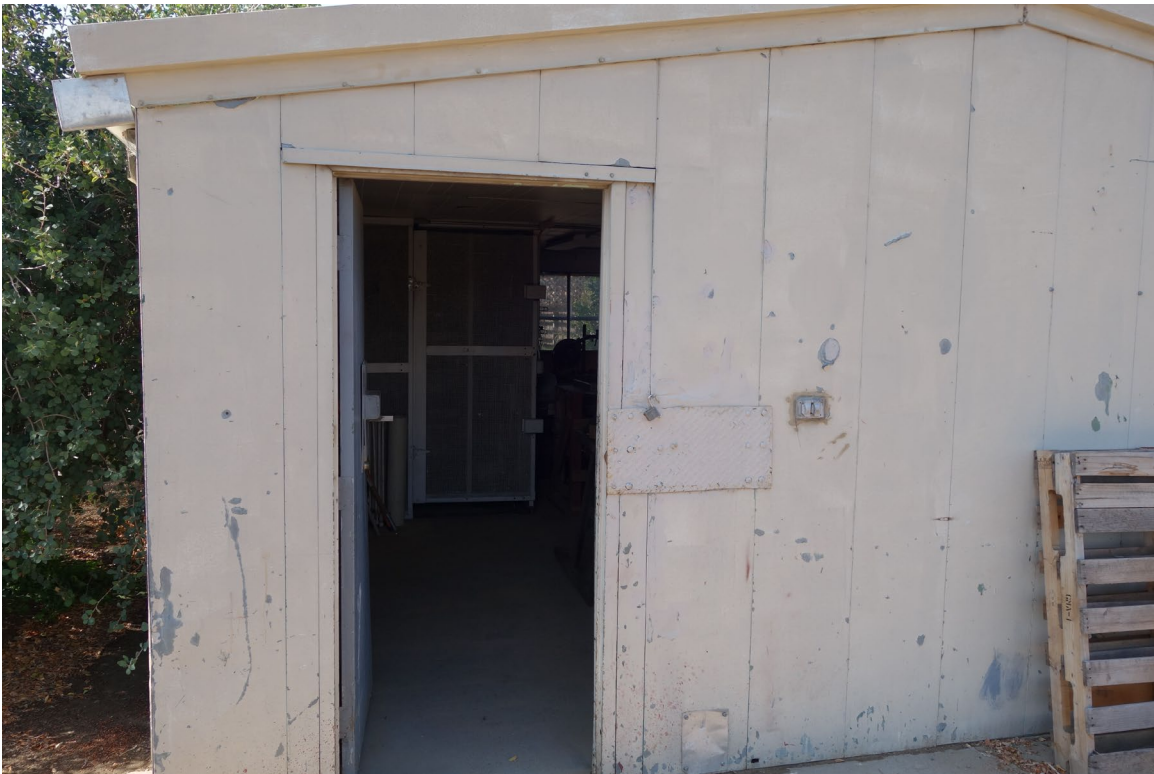
The exterior finishes were in poor condition. It is important to maintain the finish, weather resistance and appearance of the building. This project would provide funding to protect the exterior of the building. Included in the cost is sanding, priming and painting and caulking of the windows, flashing, fixtures and all other penetrations. It is recommended that the building be painted in the next 2 - 3 years and that this project be scheduled on a cyclical basis to maintain the integrity of the structure.

Nursery Shop - Building #0894
Description: Exterior of the Building.

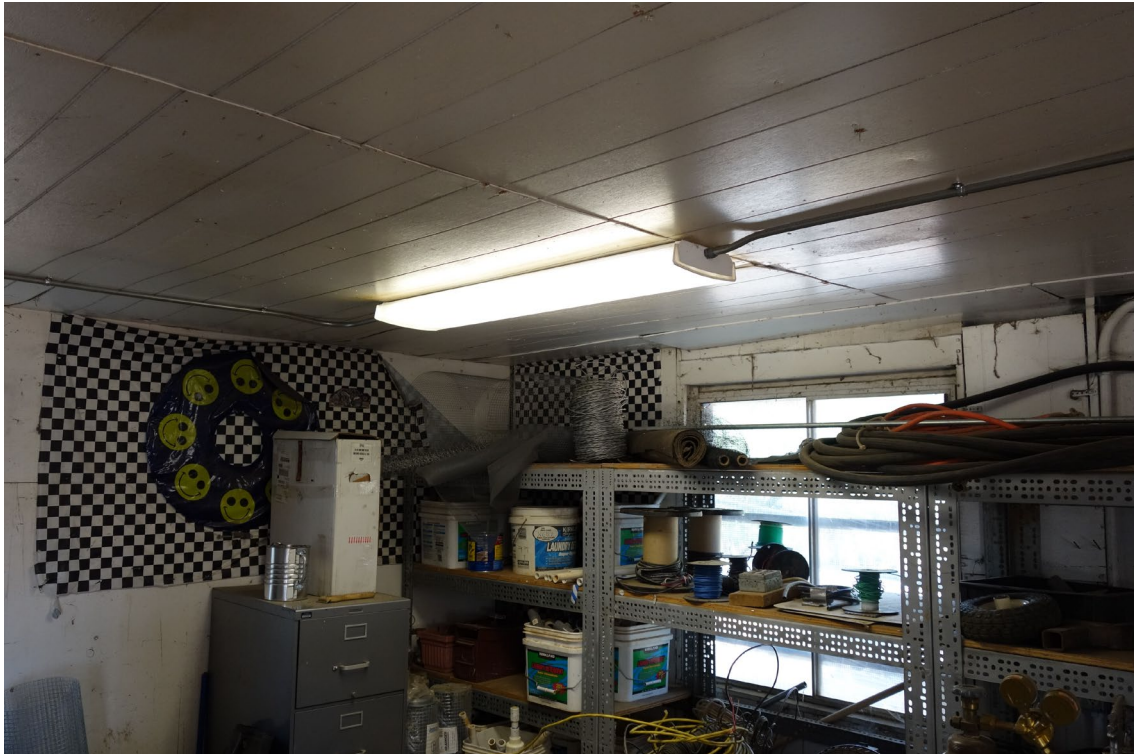
The interior finishes are in poor condition. It is recommended that the interior walls be painted at least once in the next two to four years. Prior to painting, all surfaces should be repaired and prepped. An epoxy-based paint should be utilized in wet areas for durability.

Nursery Shop - Building #0894
Description: Interior of the Building.

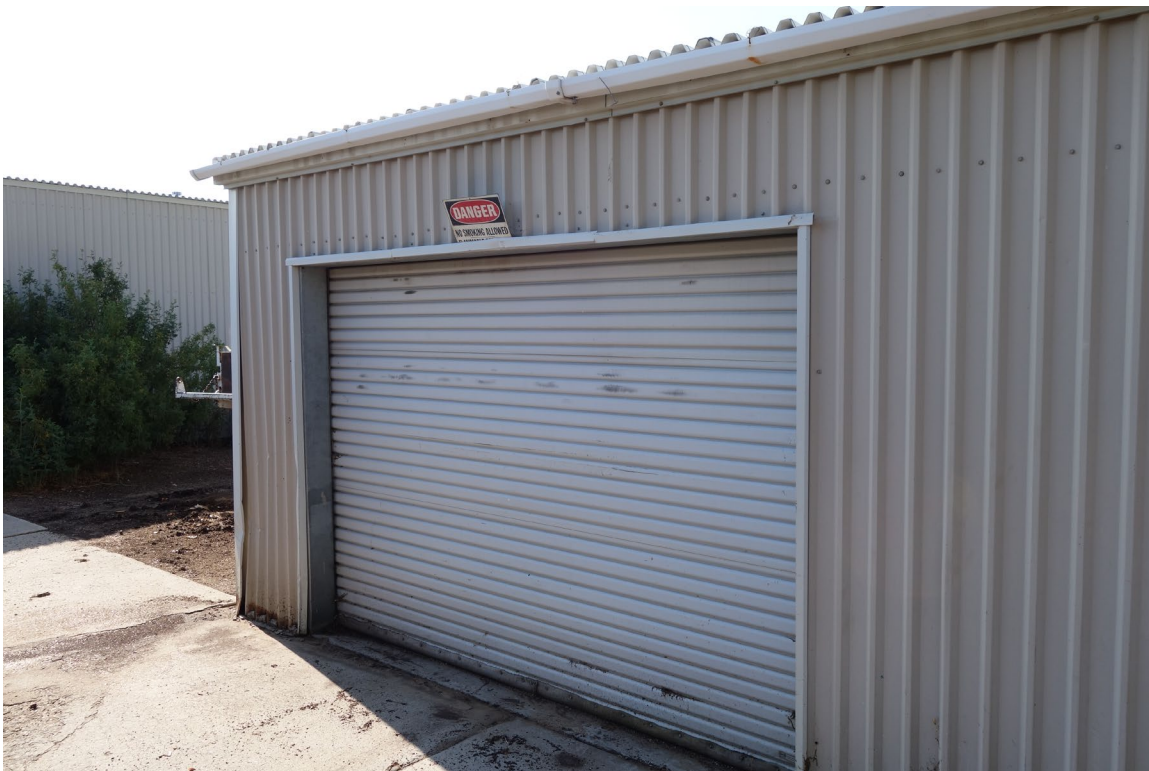
It is important to maintain the finish, weather resistance and appearance of the building. This project would provide funding to protect the exterior of the building. Included in the cost is replacing damaged metal panels, removing dirt around building to below the finish floor elevation and sealing and caulking of the flashing, fixtures and all other penetrations. It is recommended that the building be repaired, caulked and sealed in the next 2-3 years and that this project be scheduled on a cyclical basis to maintain the integrity of the structure.

Nursery Seed / Refrigerator Building - Building #0893
Description: Exterior of the Building.

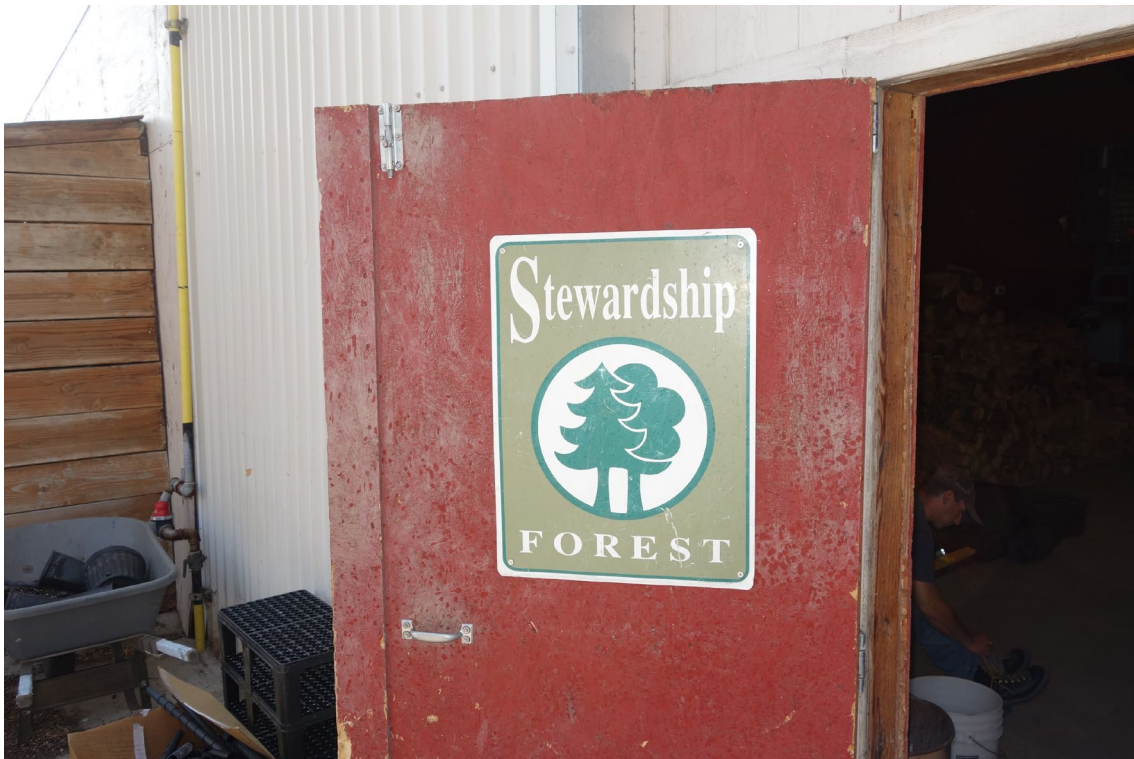
It is important to maintain the finish, weather resistance and appearance of the building. This project would provide funding to protect the exterior of the building. Included in the cost is replacing damaged metal panels, removing dirt around building to below the finish floor elevation and sealing and caulking of the windows, flashing, fixtures and all other penetrations. It is recommended that the building be repaired, caulked and sealed in the next 2-3 years and that this project be scheduled on a cyclical basis to maintain the integrity of the structure.

Nursery Planting Building - Building #0891
Description: Exterior of the Building.

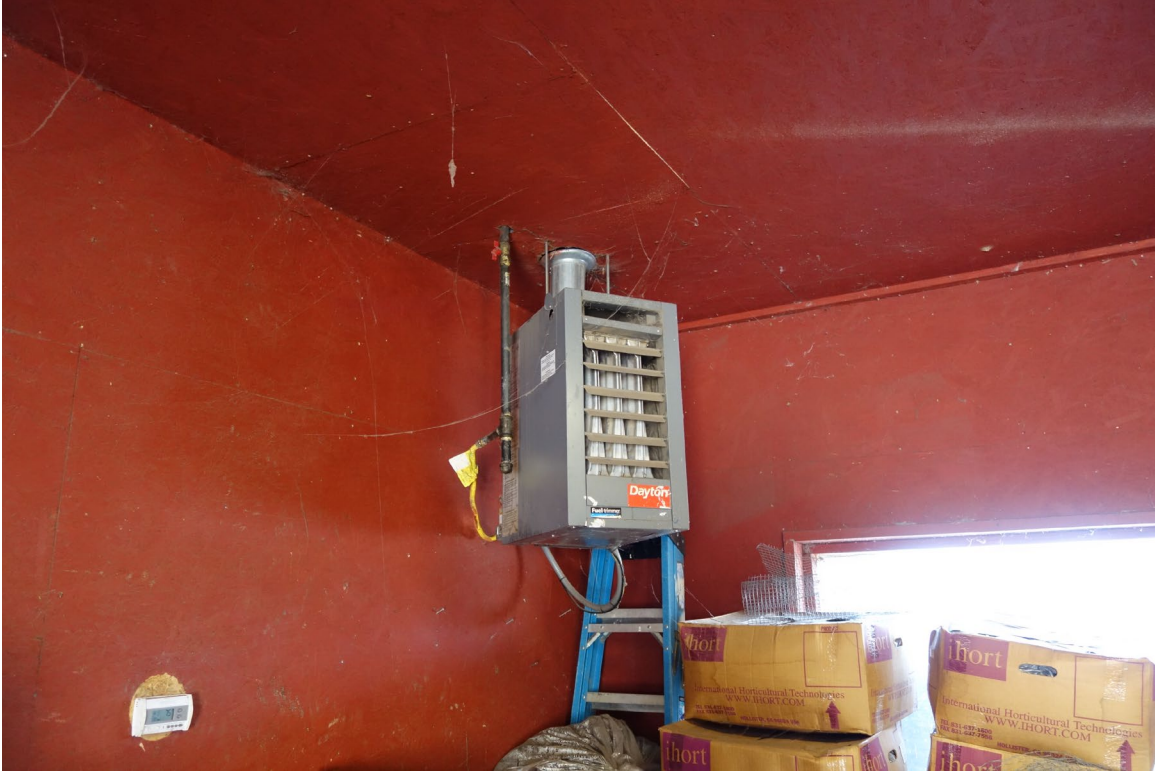
The interior finishes are in fair condition. It is recommended that the interior walls and ceiling be painted at least once in the next two to four years. Prior to painting, all surfaces should be repaired and prepped.

Nursery Planting Building - Building #0891
Description: Interior of the Building.

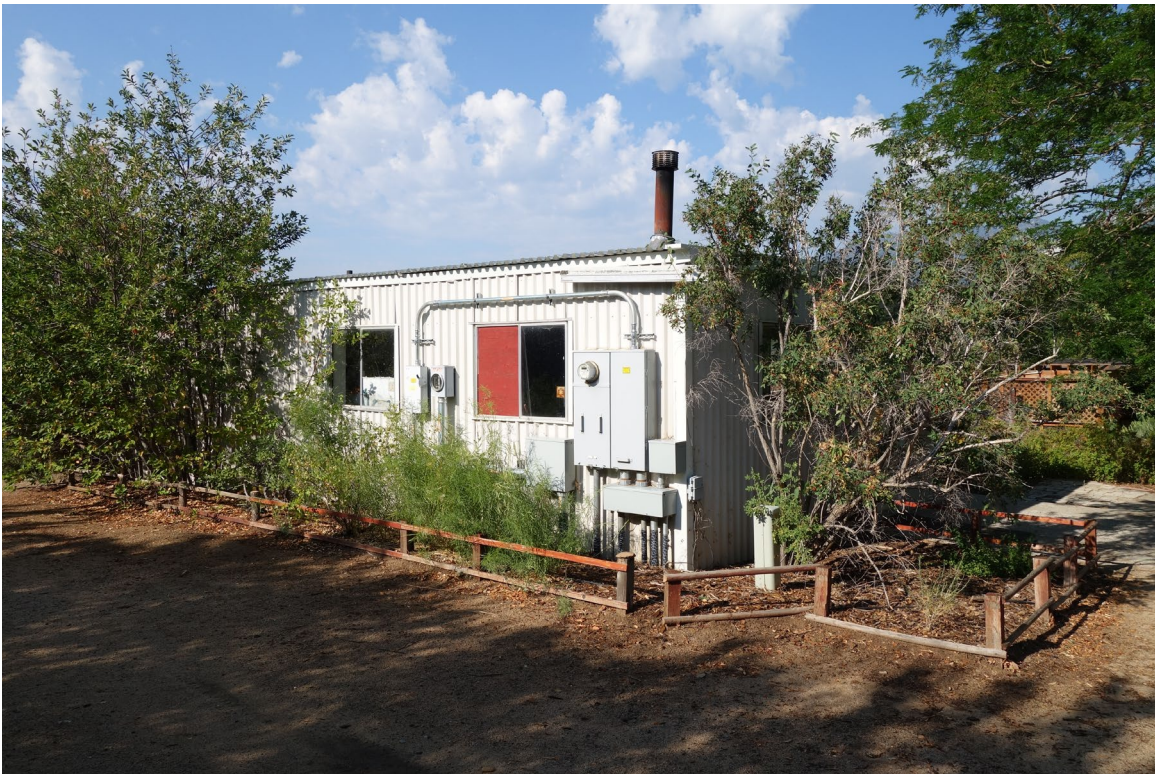
The exterior finishes are in poor condition. It is important to maintain the finish, weather resistance and appearance of the building. This project would provide funding to protect the exterior of the building. Included in the cost is the sealing and caulking of the windows, flashing, fixtures and all other penetrations. It is recommended that the building be caulked and sealed in the next 5-7 years and that this project be scheduled on a cyclical basis to maintain the integrity of the structure.

Nursery Cook House - Building #0890
Description: Exterior of the Building.

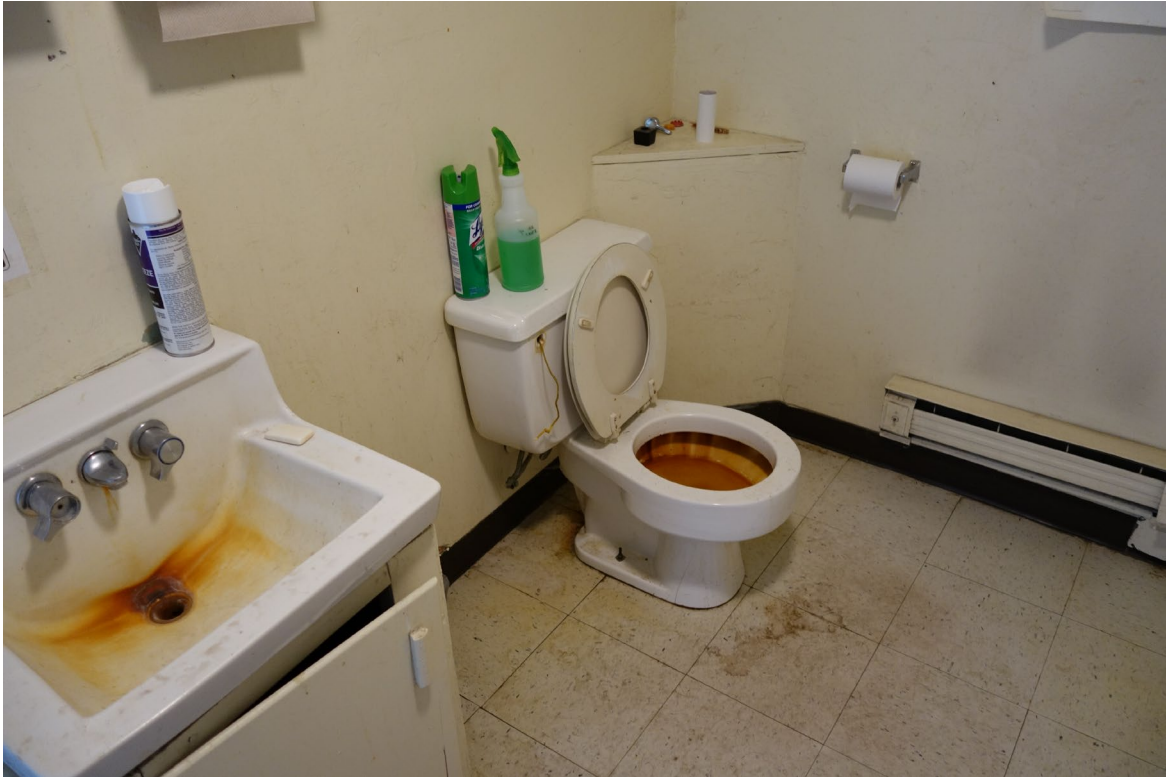
Nursery Cook House - Building #0890
Description: ADA Restrooms / Remodel Upgrade.

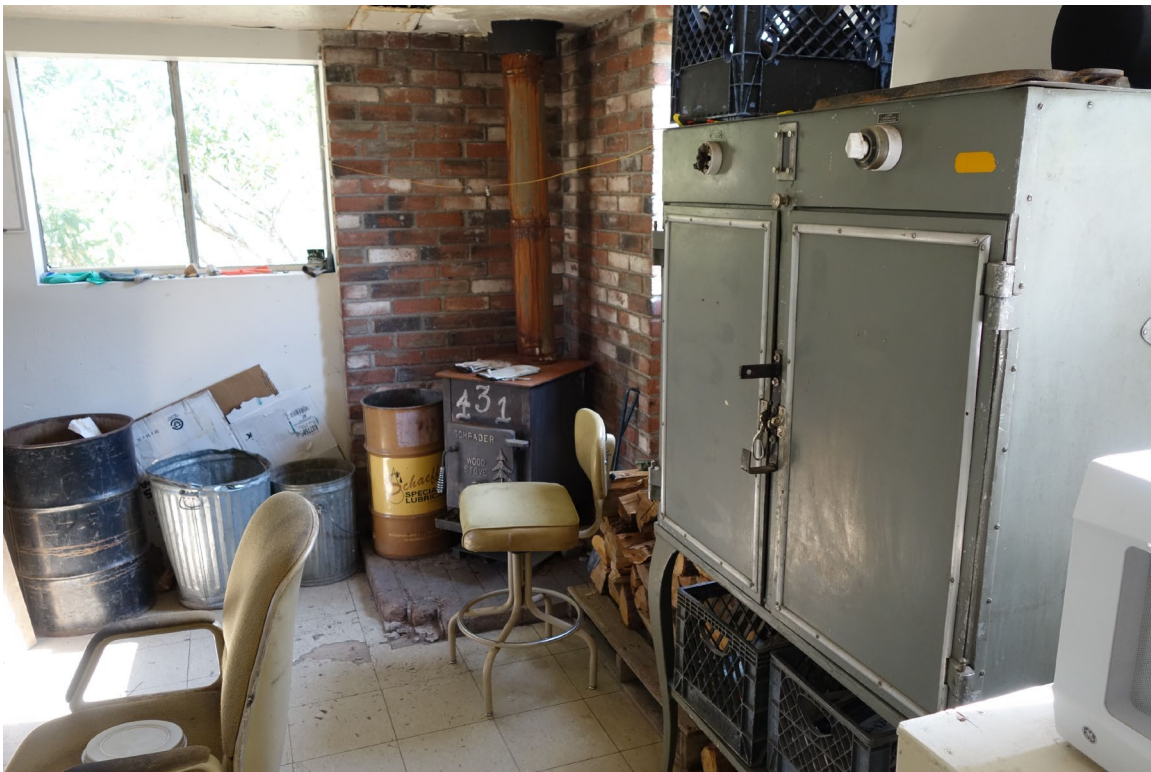
Nursery Cook House - Building #0890
Description: HVAC Upgrade – Replace Heating & Cooling with Central System.

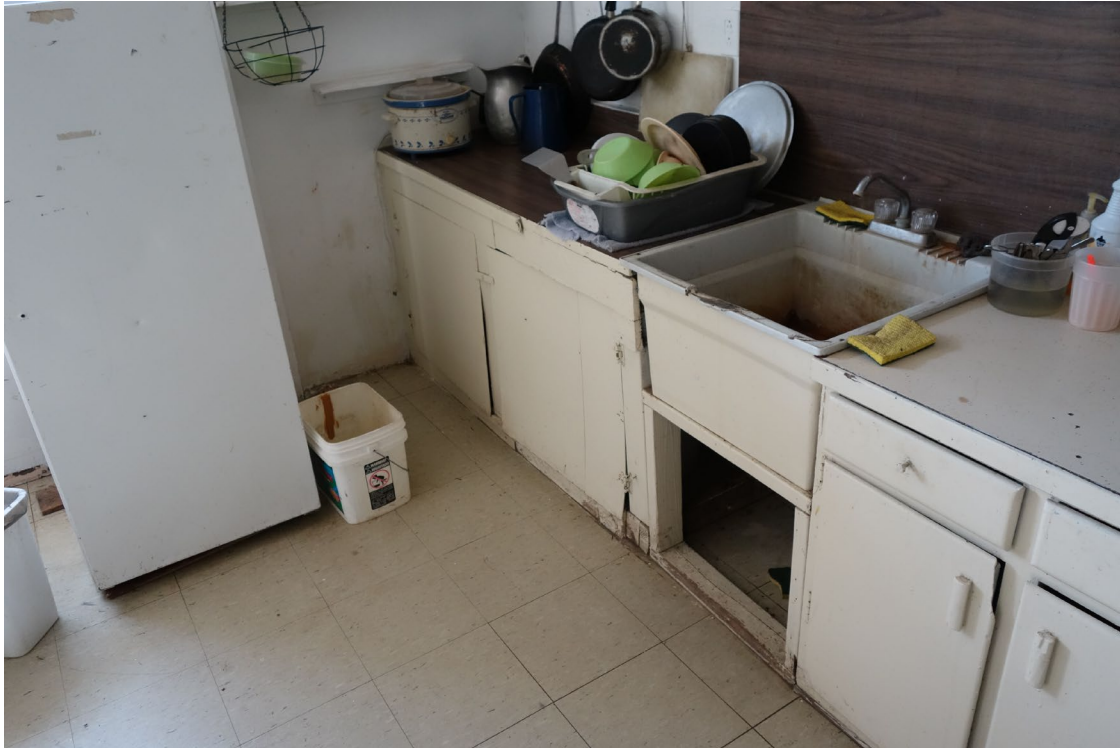
Nursery Cook House - Building #0890
Description: Kitchen Remodel Needed.

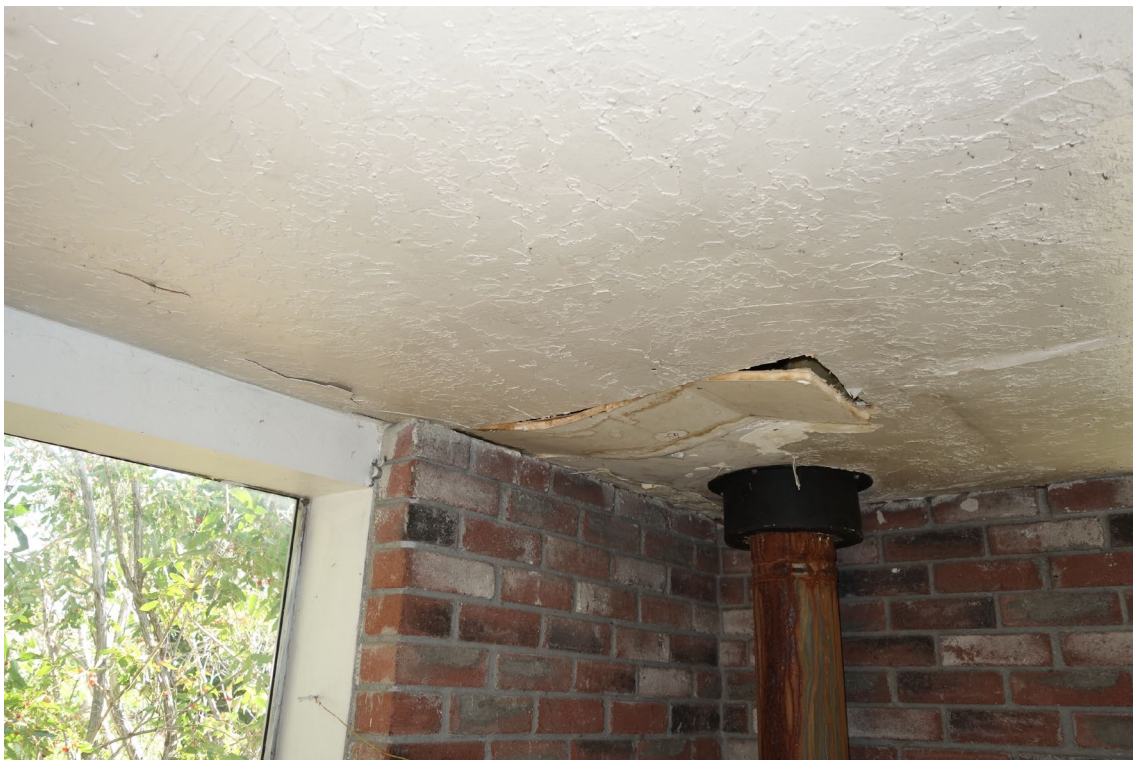
Nursery Cook House - Building #0890
Description: Roof Replacement & Drywall Repairs Needed.

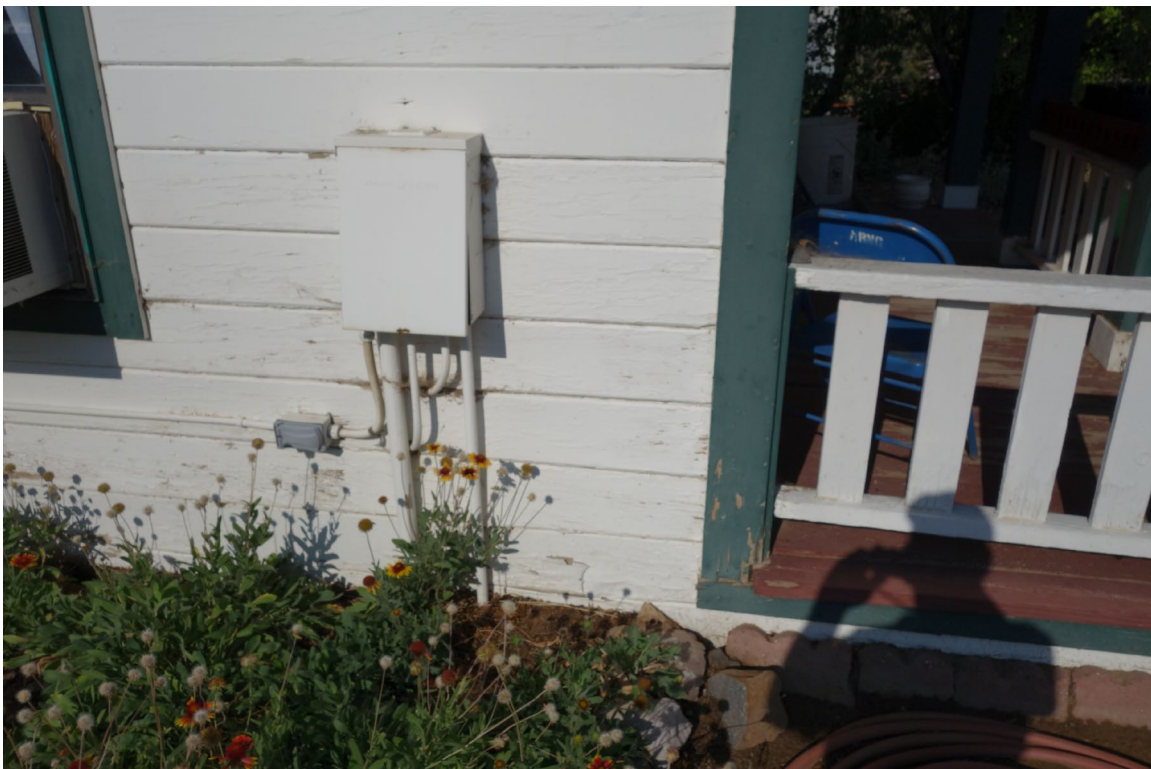
Nursery Office - Building #0889
Description: Exterior Finishes of the Building.
