State of Nevada
Department of Tourism and Cultural Affairs
Division of Museums & History
Facility Condition Analysis

NEVADA STATE MUSEUM, LAS VEGAS

Site Number: 9817
STATE OF NEVADA PUBLIC WORKS DIVISION
FACILITY CONDITION ANALYSIS

NEVADA STATE MUSEUM, LAS VEGAS BUILDING REPORT

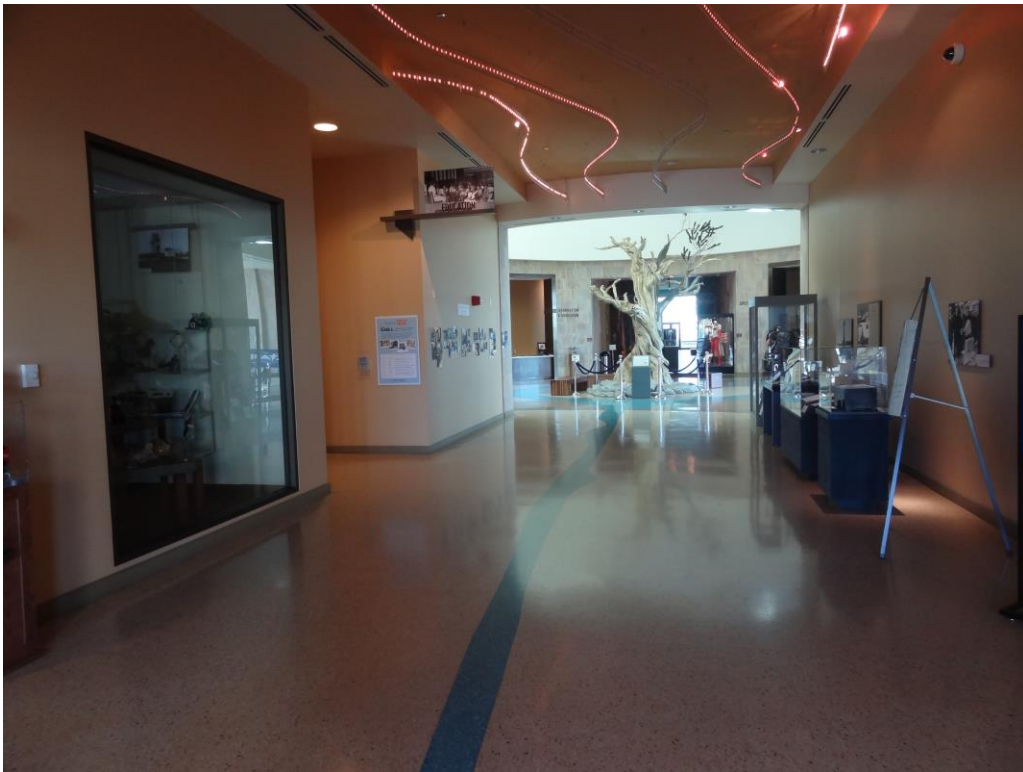
Nevada State Museum, LV - Building #2811
Description: Interior finishes.

It is recommended to paint the interior walls and ceilings at least once in the next 4-5 years and that this project be scheduled on a cyclical basis to maintain the integrity of the structure. Prior to painting, all surfaces should be repaired and prepped. An epoxy-based paint should be utilized in wet areas for durability.

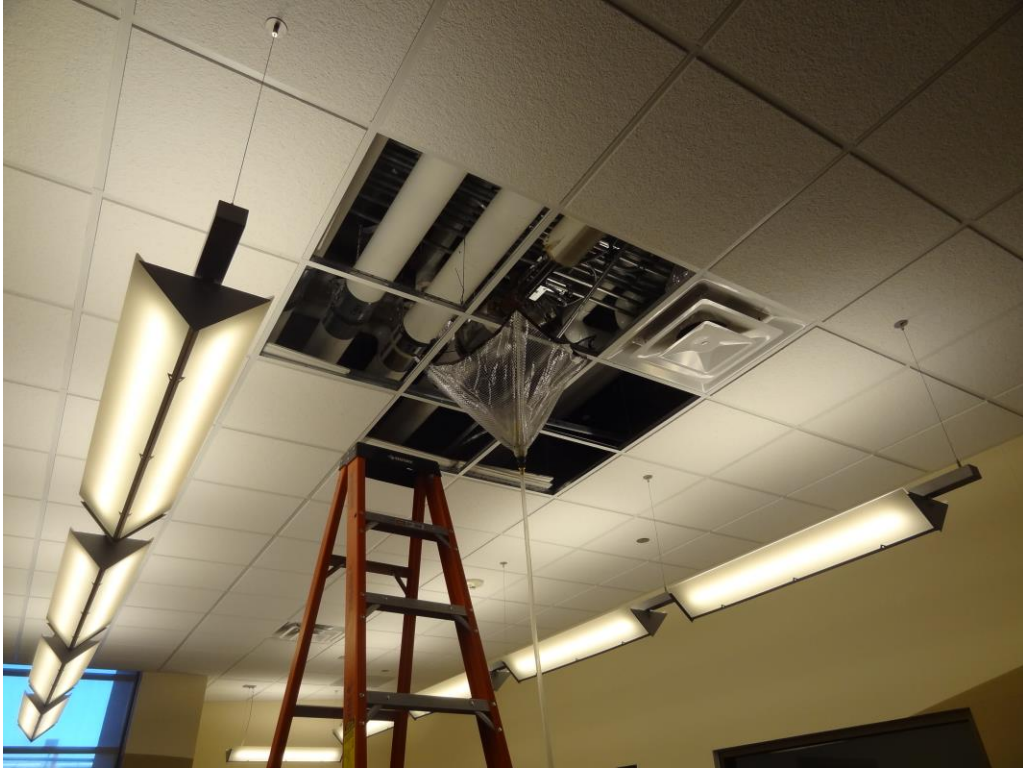
There are no isolation valves for the building's water lines. The main water line that serves the 78,145 sf building on the site is in need of 25 isolation valves. This will allow the maintenance staff to conduct repairs and maintenance to the plumbing without shutting down the entire building. More importantly, a leak in the building can be shut down quickly minimizing damage in an emergency. This estimate provides for 2-1/2" ball valves to be installed in individual rooms throughout the building.

Nevada State Museum, LV - Building #2811
Description: Isolation valve installation needed.

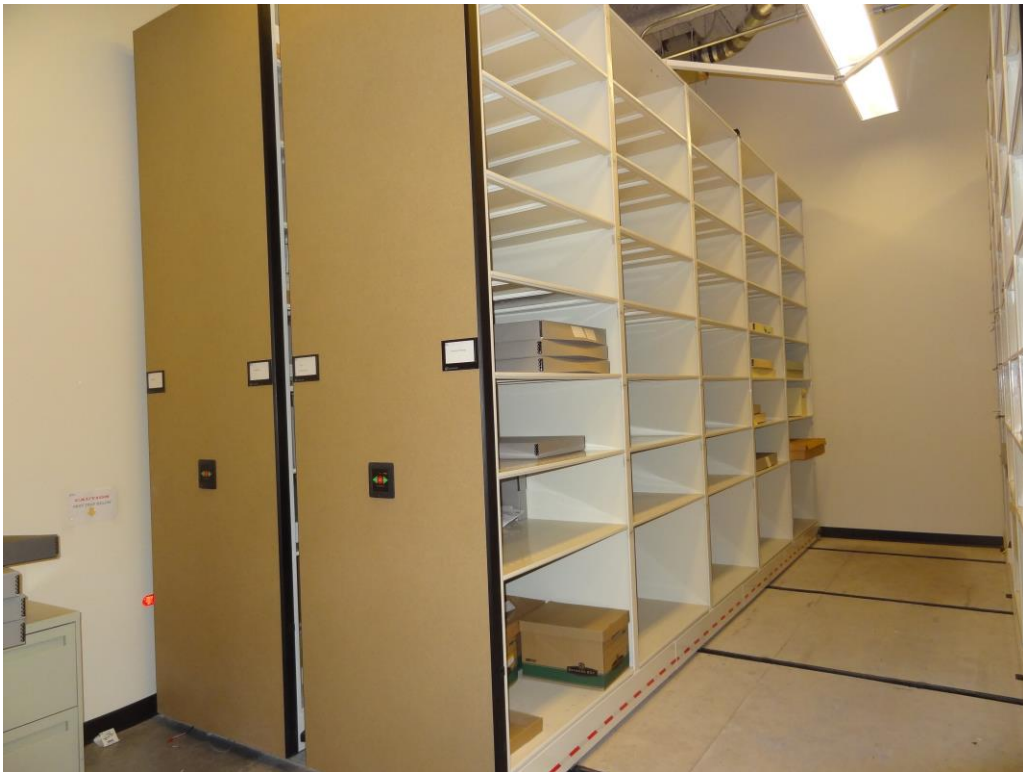
The high density storage system in the building is malfunctioning. The photo eyes and security switches are not operating properly, which is a safety concern. It is recommended that a licensed contractor repair the malfunctioning safety devices.

Nevada State Museum, LV - Building #2811
Description: High density storage repairs needed.

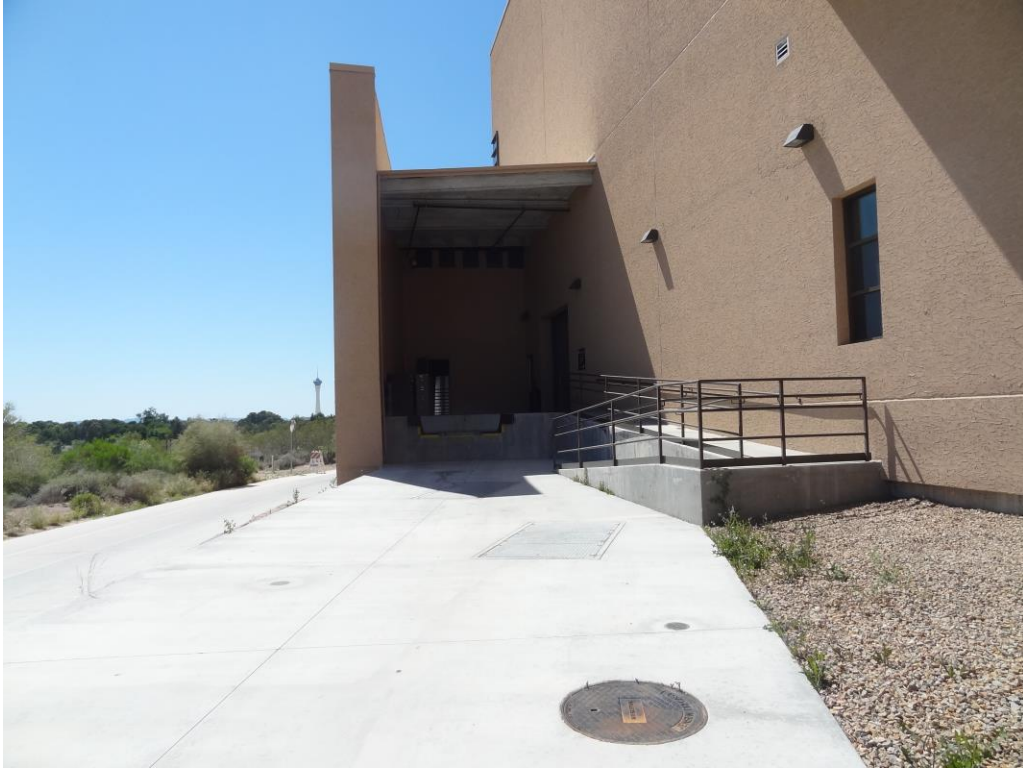
The existing loading dock does not have safety rails on the dock platform nor along the approach ramp, which has a sharp drop on one side of several feet down. There have been several near-miss accidents, where dock users have nearly fallen off the platform due to lack of rails. In addition, the approach ramp to the dock platform has a very sharp angle and is very narrow, which makes it difficult and dangerous to move loading vehicles or equipment from the approach ramp to the platform. This project would provide for the removal of the ramp and the installation of a wider, better angle ramp and for the installation of safety rails per IBC 2012.

Nevada State Museum, LV - Building #2811
Description: Loading dock upgrades needed.

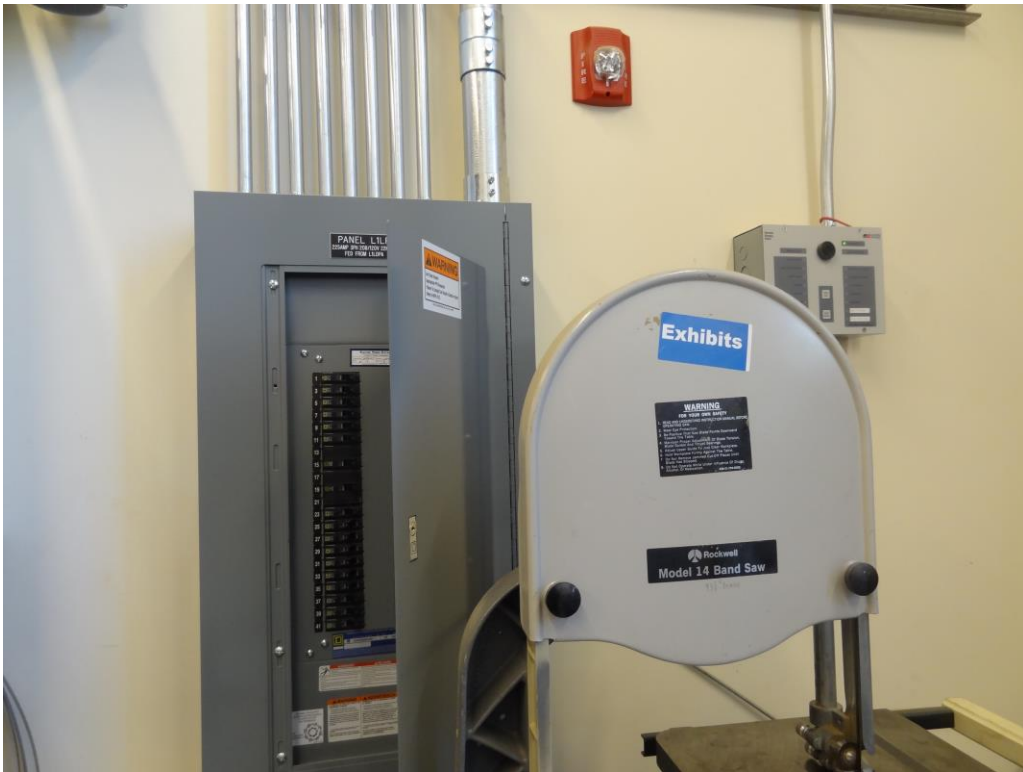
There are electrical panels in the building which do not have proper clear floor space around them. The 2012 IFC Section 605.3 states, a working space of not less than 30 inches in width, 36 inches in depth and 78 inches in height shall be provided in front of electrical service equipment. Where the electrical service equipment is wider than 30 inches, the working space shall not be less than the width of the equipment. No storage of any materials shall be located within the designated working space. This project would provide funding to relocate the items blocking the electrical panels.

Nevada State Museum, LV - Building #2811
Description: Provide clearance at electrical panels.

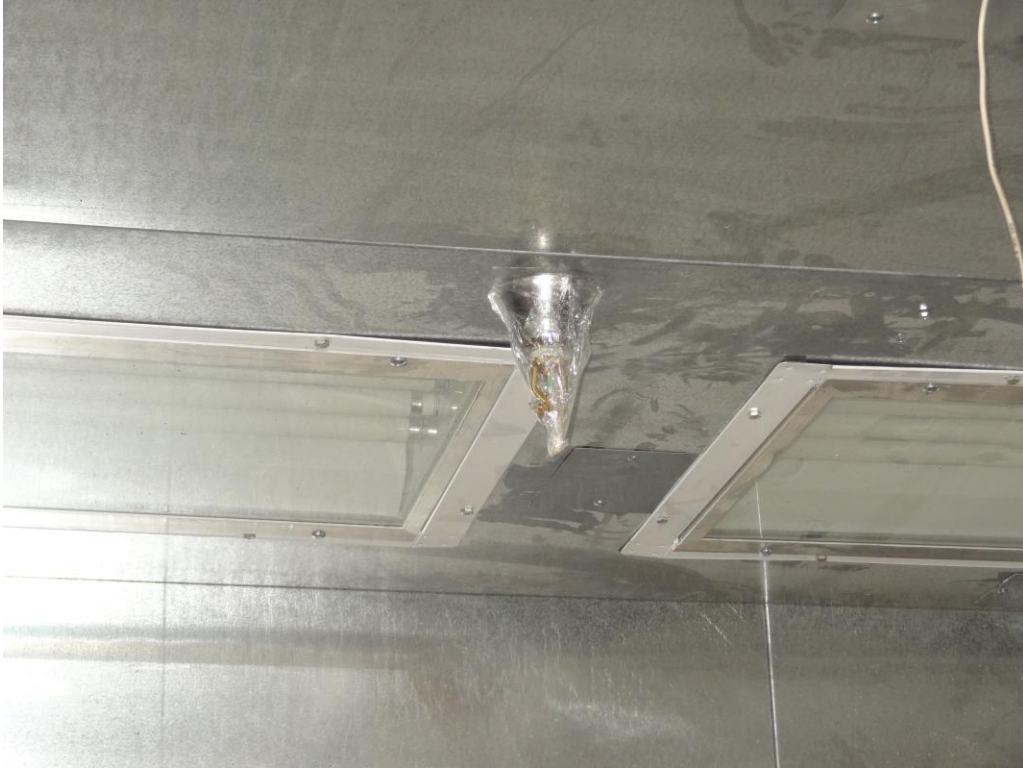
Staff at the Nevada State Museum indicated, during the time of the survey, when the spray booth is in use paint overspray is landing on the fire suppression sprinkler head. They have been written up by the State Fire Marshal's Office for having paint on a fire suppression sprinkler head. Per NFPA 33 Chapter 7 Section 7.2 states, Each spray area shall be provided with mechanical ventilation that is capable of confining and removing vapors and mists to a safe location and is capable of confining and controlling combustible residues, dusts, and deposits. Section 7.2.3 Mechanical ventilation shall be kept in operation at all times while spray operations are being conducted and for a sufficient time thereafter to allow the vapors from drying coated objects or material and residues to be exhausted. It is recommended to have a Mechanical Engineer determine the proper Cubic Feet per Minute (CFM) needed to remove all paint vapors and install exhaust venting to meet the requirements. Per NFPA 33 Chapter 9 Section 9.4.1 The automatic sprinkler system shall be a wet pipe system, a dry pipe system, a pre action system, or an open-head deluge system, whichever is most appropriate for the portion of the spray operation being protected. This project would provide for removing the plastic from the fire suppression sprinkler head and installing the exhaust venting in order to remove the paint overspray from the booth.

Nevada State Museum, LV - Building #2811
Description: Fire suppression/ mechanical upgrade needed.

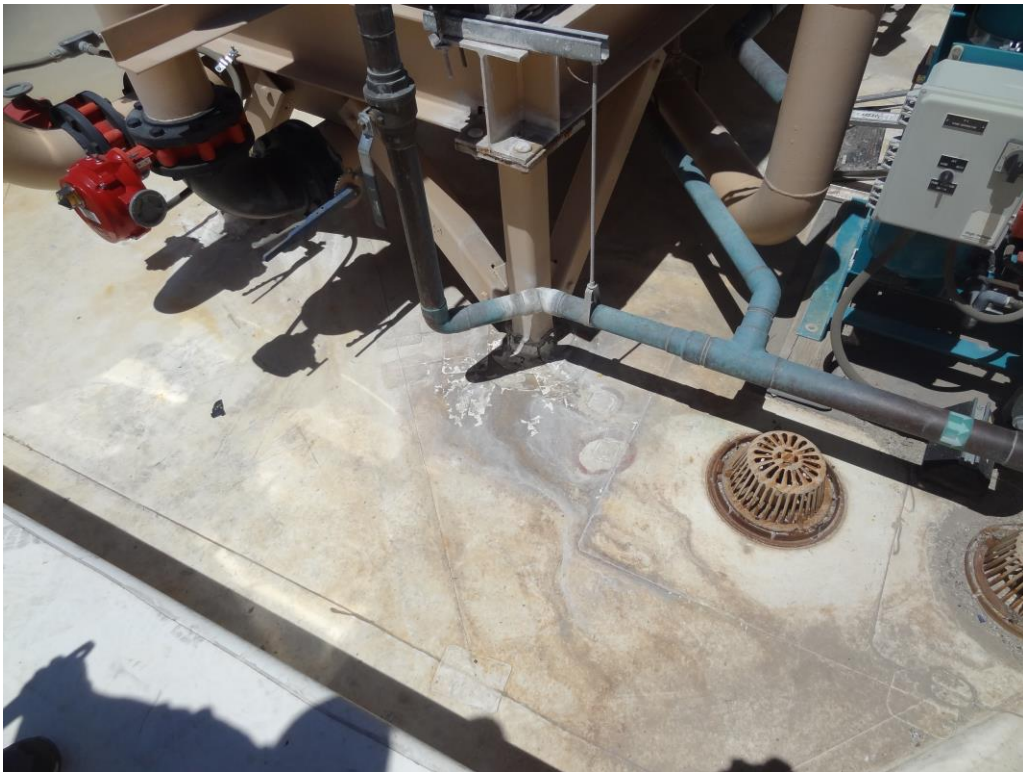
The cooling towers are leaking water onto the single-ply membrane roofing system. The single-ply membrane roofing system is starting to lose the top layer and is showing some of the second layer (scrims). This project would provide funding to repair the cooling tower's leaks, and have the single-ply membrane patched where needed.

Nevada State Museum, LV - Building #2811
Description: Roof repairs needed.
