State of Nevada  
Department of Agriculture  
Elko Agriculture Regional Office  
Facility Condition Analysis

# ELKO AGRICULTURE REGIONAL OFFICE

**STATE OF NEVADA PUBLIC WORKS DIVISION  
FACILITY CONDITION ANALYSIS**

Survey Date: 7/22/2014

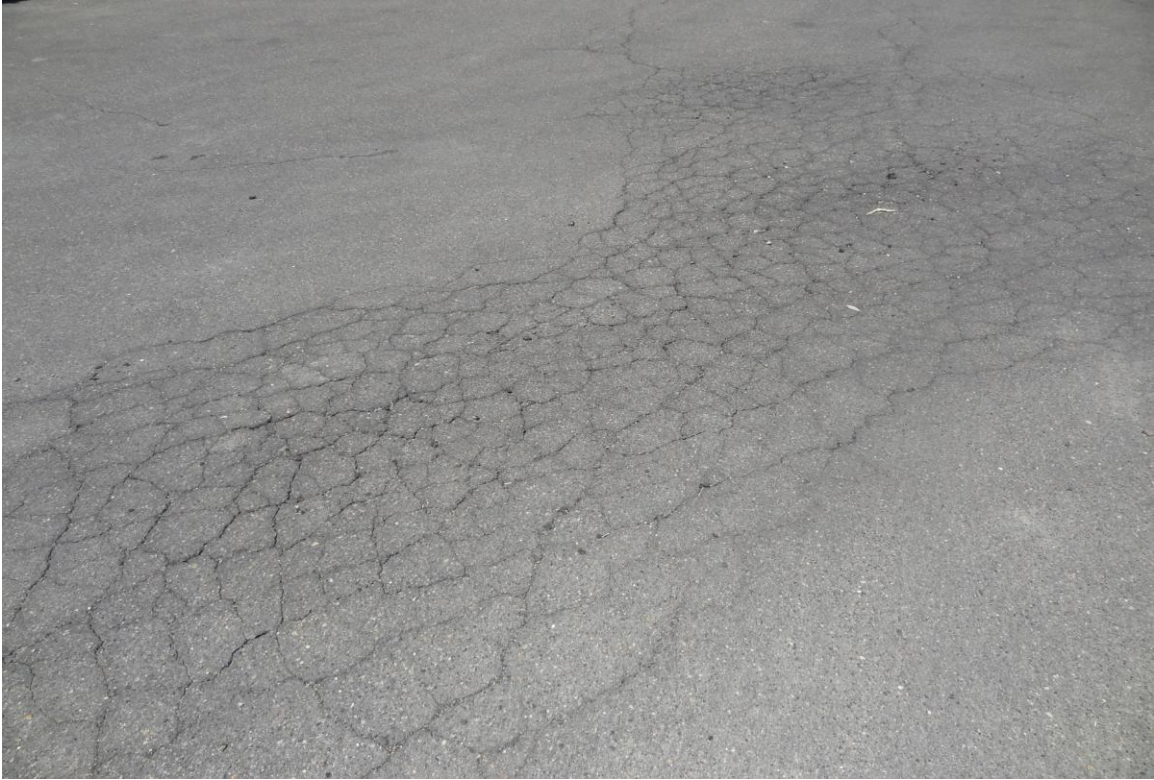
The existing AC paving on site is due for crack filling, sealing and re-striping. There are also some areas that are alligating and in need of removal and replacement. This project would provide for a crack fill and slurry seal as well as repair of damaged AC paving. Striping including ADA accessible parking and loading zones is included in this estimate. This project should be scheduled every 4-5 years based on environmental conditions.

Elko Agriculture Office Site – FCA Site #9822  
Description: AC paving in need of maintenance.

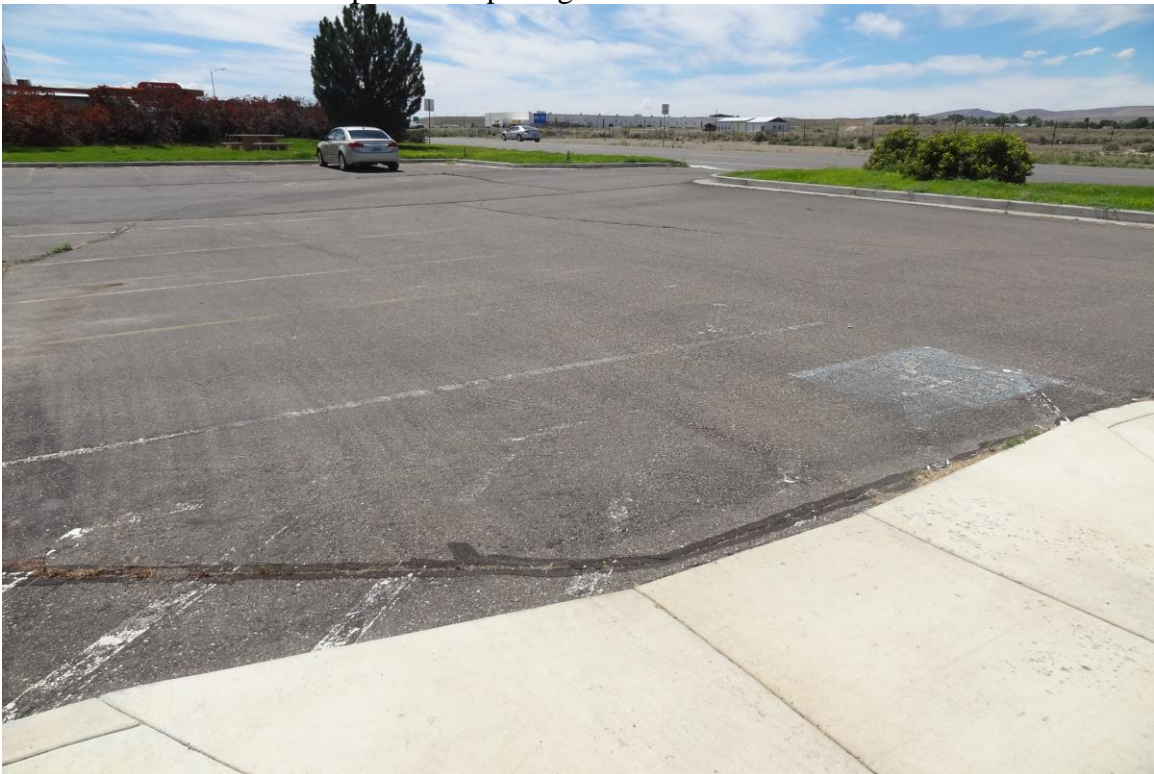
Elko Agriculture Office Site – FCA Site #9822  
Description: ADA accessible parking area in need of striping.

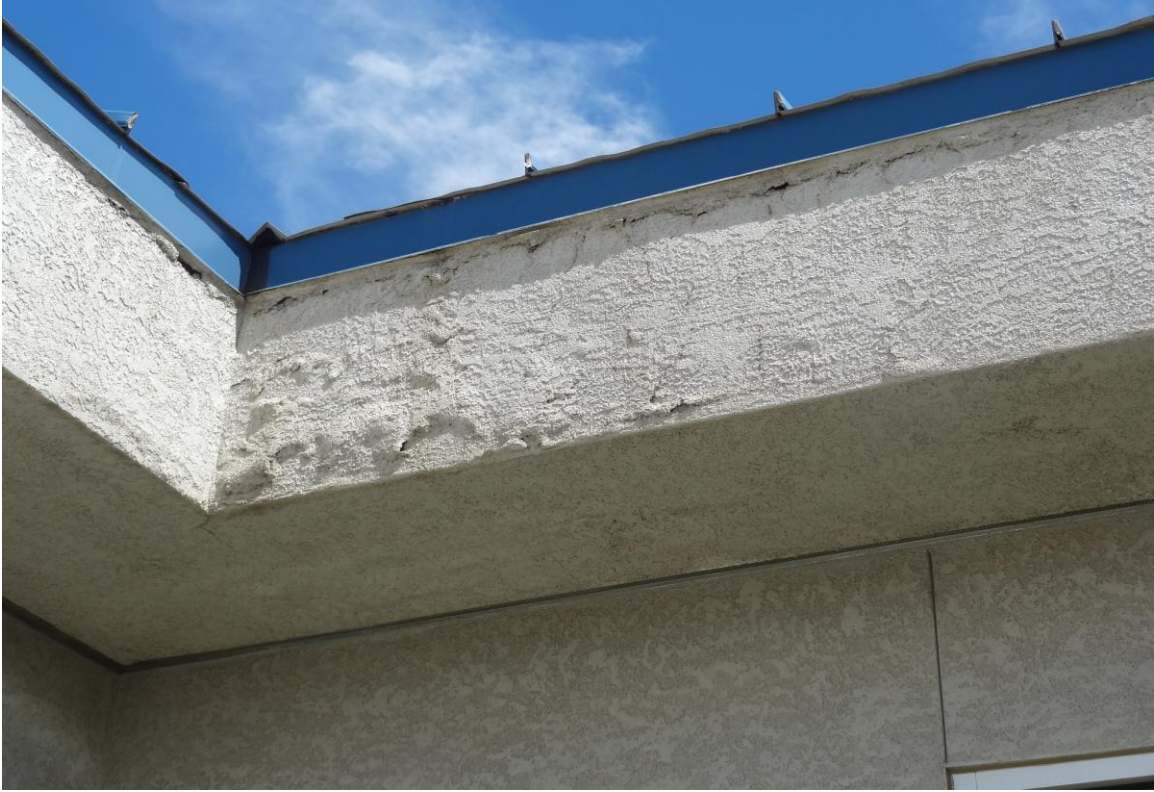
Elko Agriculture Regional Office – FCA Building #2558  
Description: Stucco damage to the north side of the fascia.

It is important to maintain the finish, weather resistance and appearance of the building. This project would provide funding to protect the exterior of the building excluding the roof. Included in the cost are repairing damaged stucco fascia areas, painting, and caulking of the windows, flashing, fixtures and all other penetrations. It is recommended that the building be painted, sealed and caulked in the next 2-3 years and that this project be scheduled on a cyclical basis to maintain the integrity of the structure. An acrylic paint should be utilized on the stucco areas for durability.

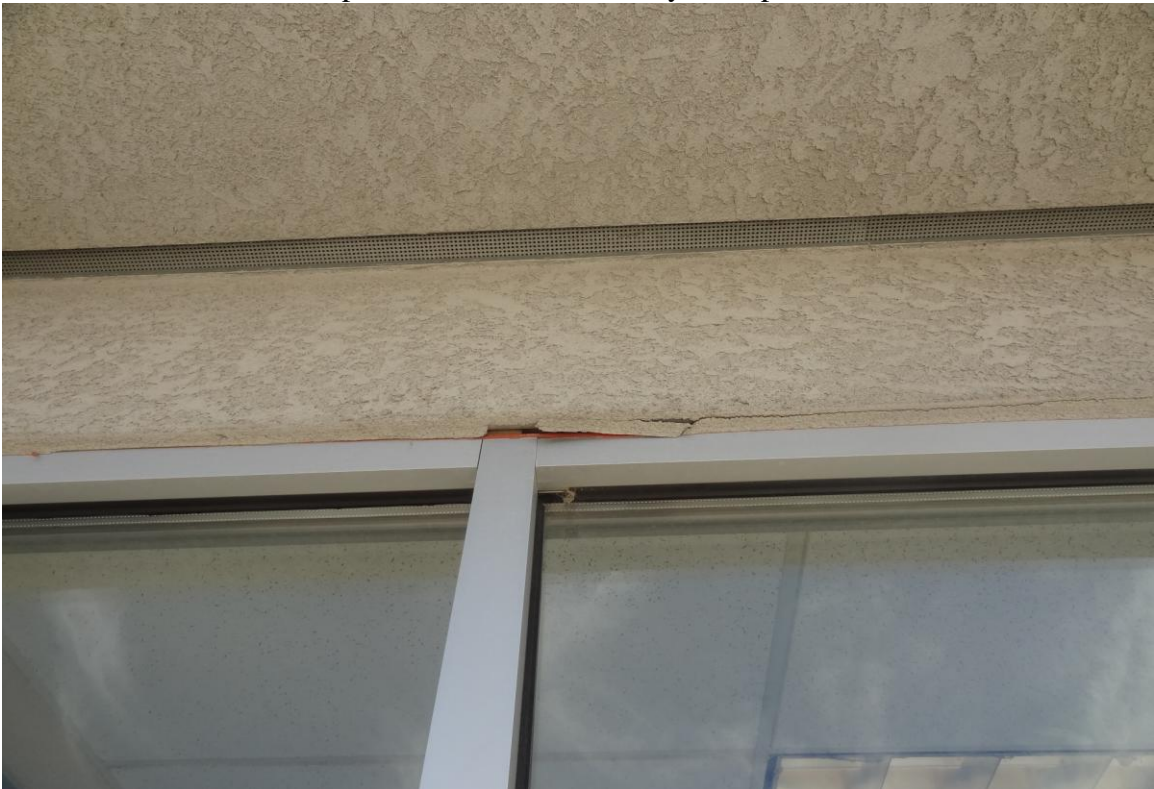
Elko Agriculture Regional Office – FCA Building #2558  
Description: Window in need of caulking.
