State of Nevada
Department of Conservation & Natural Resources
Division of Forestry
Elko Interagency Dispatch Center
Facility Condition Analysis

ELKO INTERAGENCY DISPATCH CENTER

Site Number: 9824
STATE OF NEVADA PUBLIC WORKS DIVISION
FACILITY CONDITION ANALYSIS

Survey Date: 9/19/2013

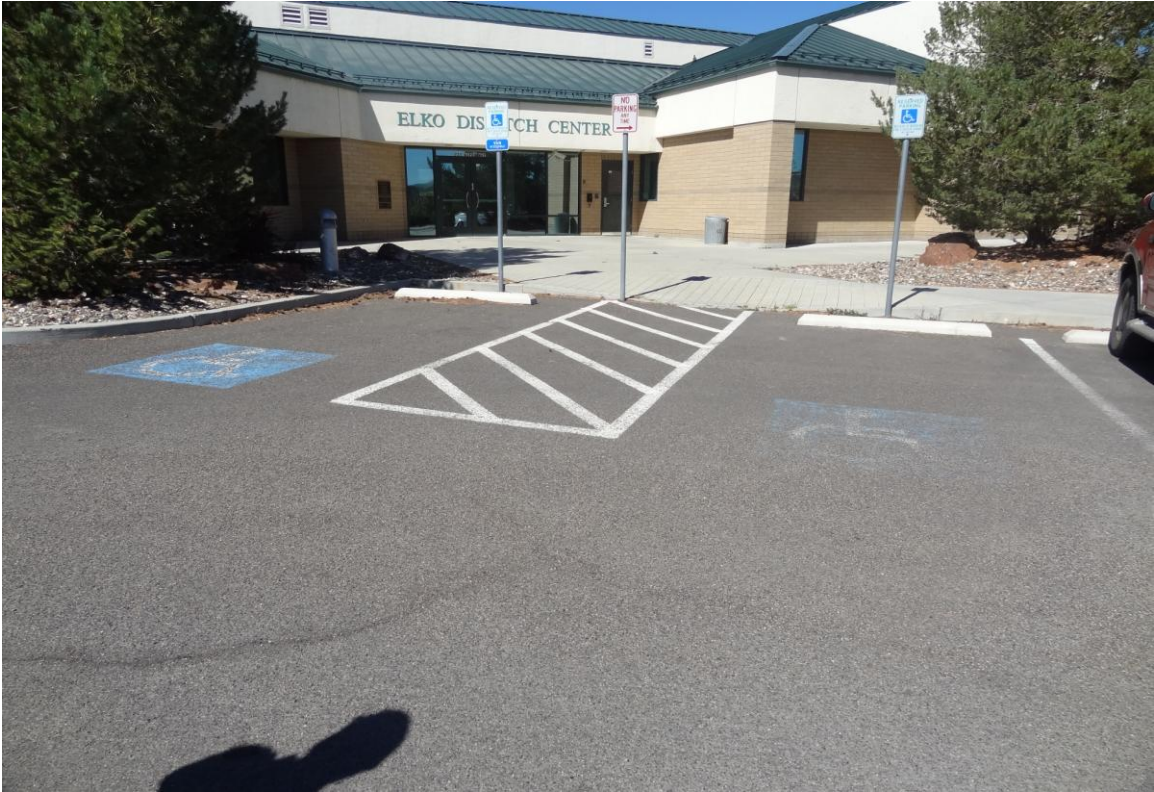
Elko Interagency Dispatch Center Site – FCA Site #9824

Description: ADA accessible parking.

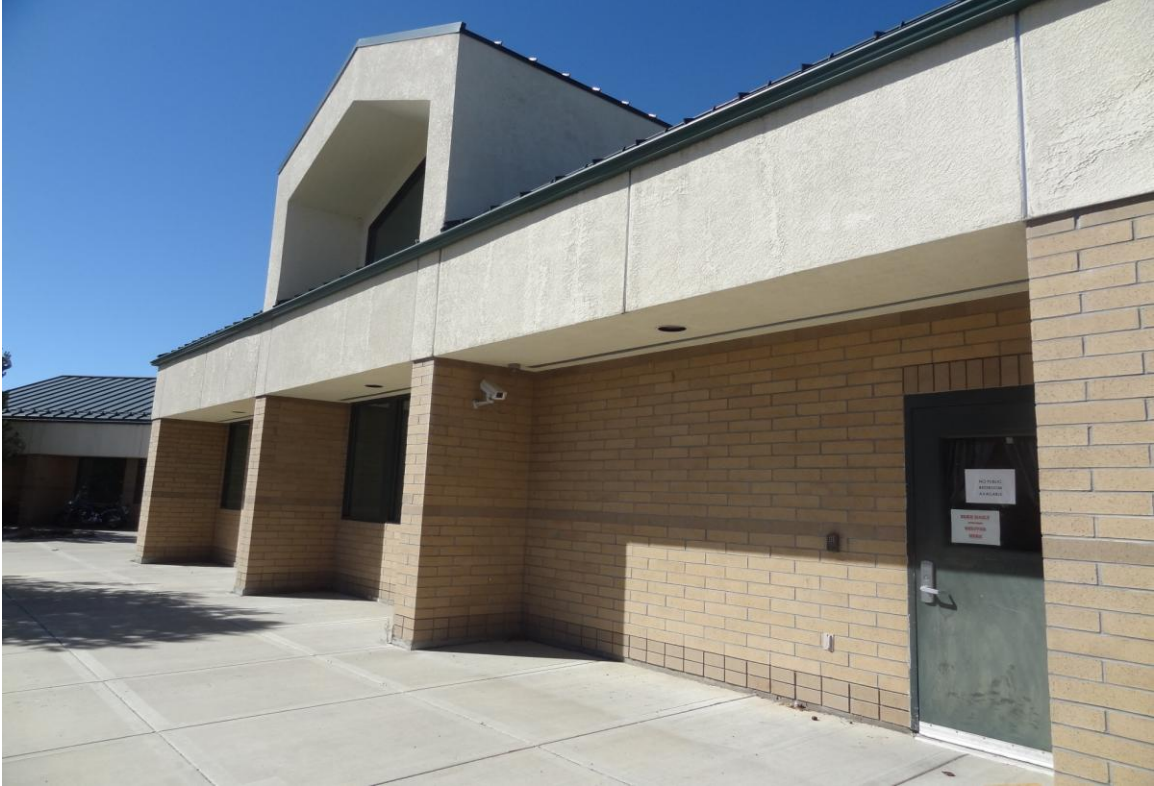
Elko Interagency Dispatch Center – FCA Building #2107

Description: Exterior of the building.

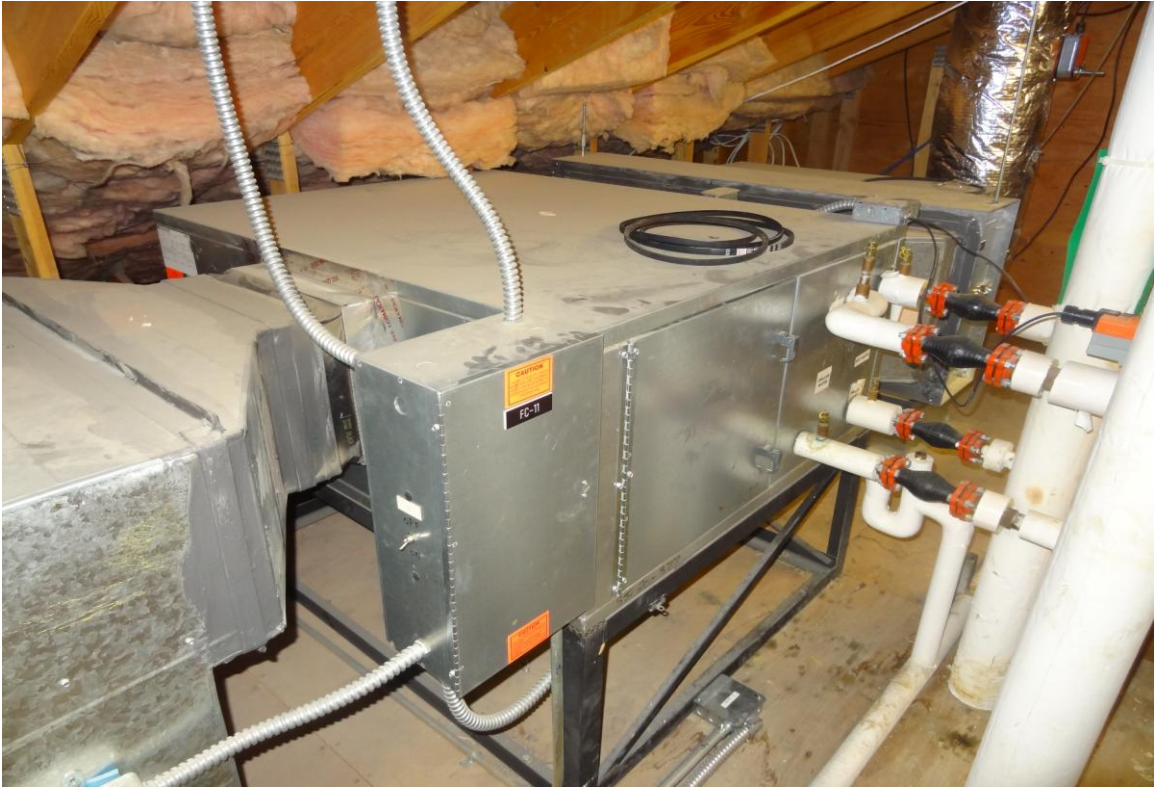
Elko Interagency Dispatch Center – FCA Building #2107
Description: Typical fan coil unit in attic.

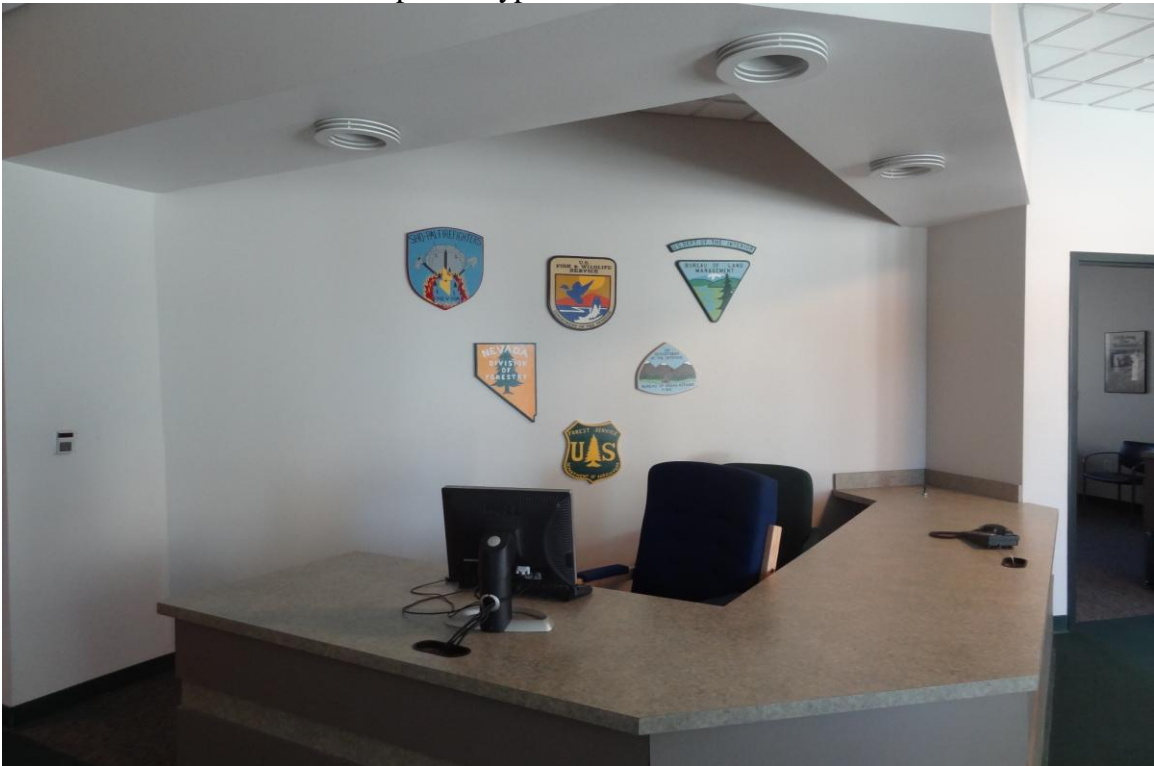
Elko Interagency Dispatch Center – FCA Building #2107
Description: Interior of the lobby area.
