State of Nevada
Department of Wildlife
Ely Wildlife Field Office
Facility Condition Analysis

ELY WILDLIFE FIELD OFFICE

1218 North Alpha Street
Ely, Nevada 89301

Site Number: 9825
STATE OF NEVADA PUBLIC WORKS DIVISION
FACILITY CONDITION ANALYSIS

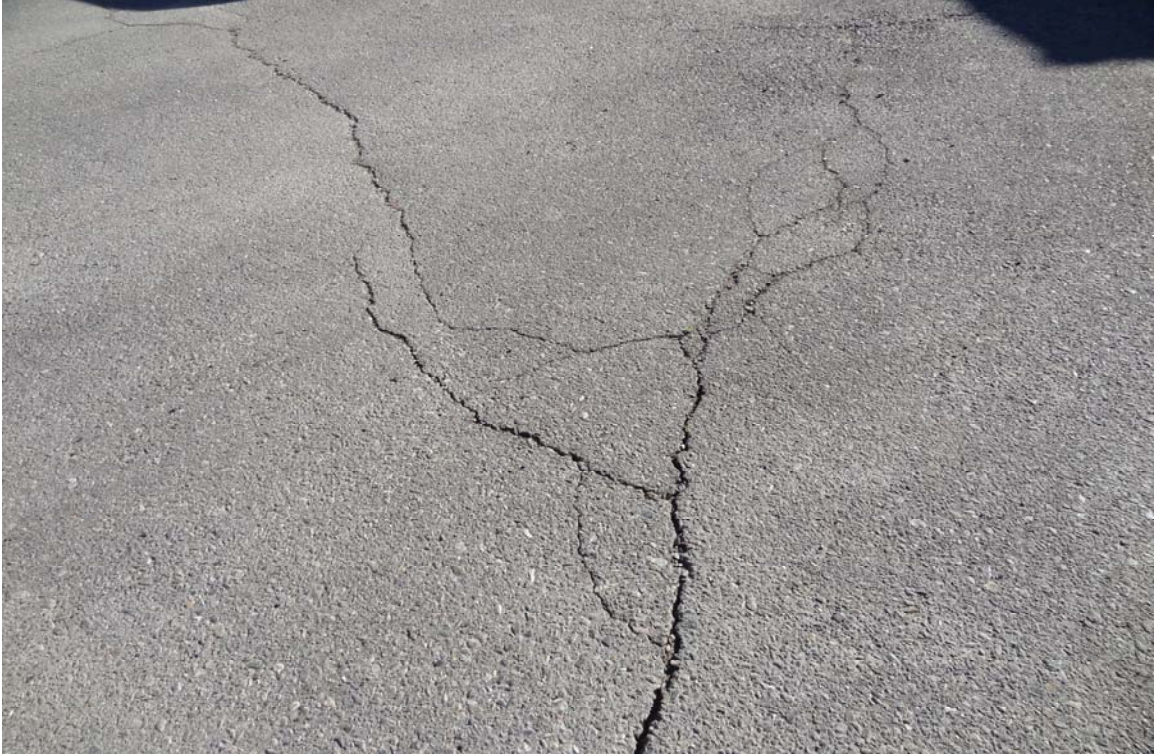
Ely Wildlife Field Office Site - Site #9825
Description: AC Paving in need of crack filling and seal coat.

It is important to maintain the asphalt concrete paving on the site. This project would provide for minor crack filling and sealing of the paving site wide including the access roads and parking lot. Striping is included in this estimate. This project should be scheduled on a 5 year cyclical basis to maintain the integrity of the paving and prevent premature failure. 10,000 square feet of asphalt area was used to generate this estimate.

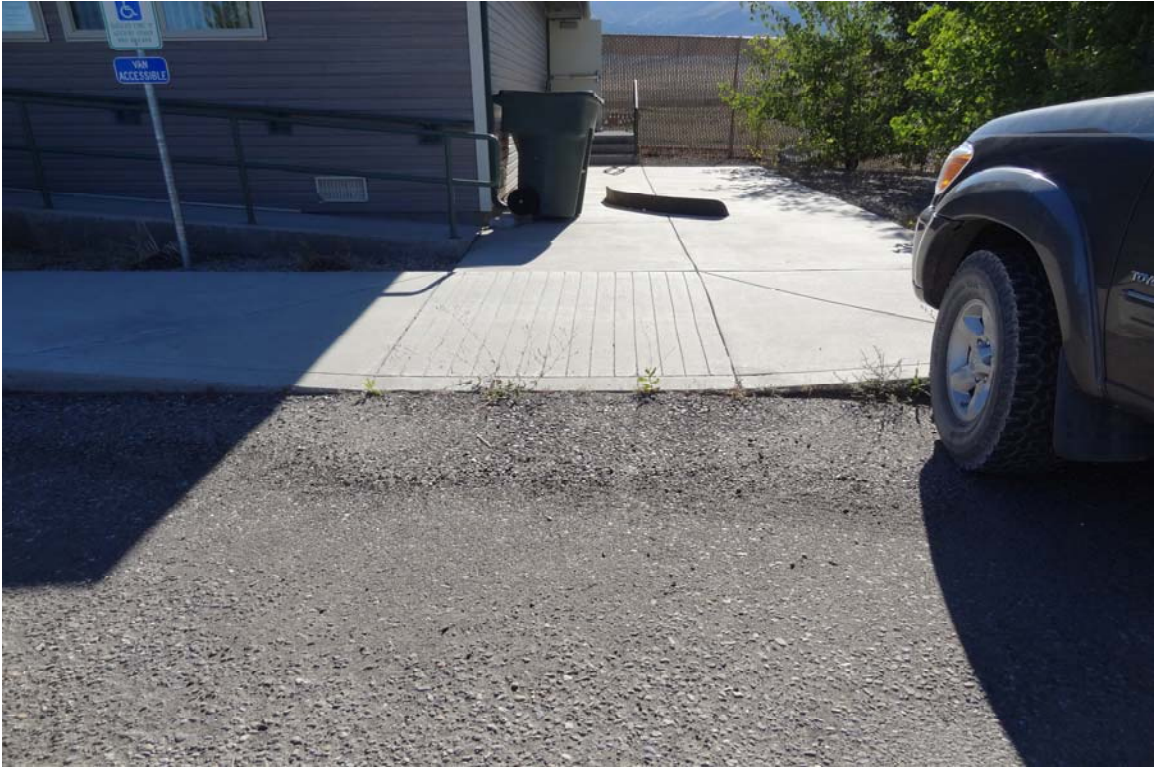
Ely Wildlife Field Office Site - Site #9825
Description: ADA parking area in need of striping.

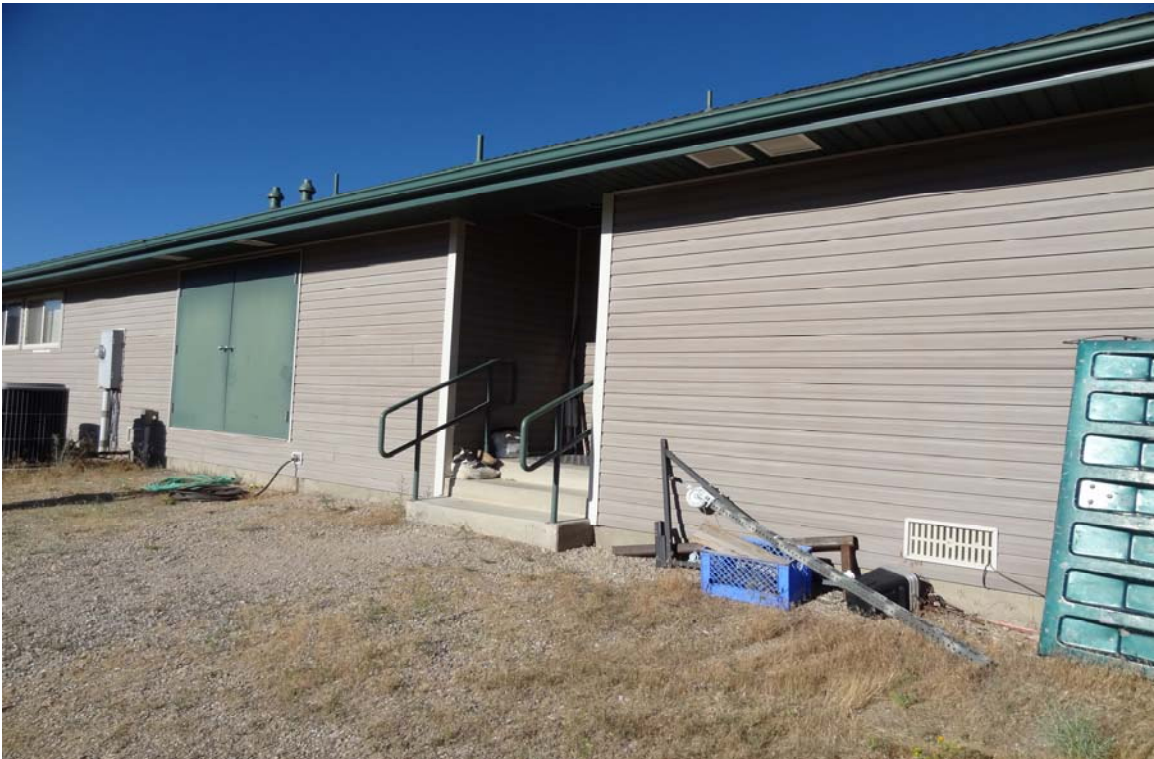
There is an exterior stairway at the rear of the building which does not have a landing. This does not comply with 2006 IBC Section 1008.1 which describes the requirements for landings including that the width of the landing shall not be less than the width of the stairway. This project addresses installing a landing designed to current code.

Ely Wildlife Field Office - Building #2127
Description: East elevation, note landing missing at stairs.

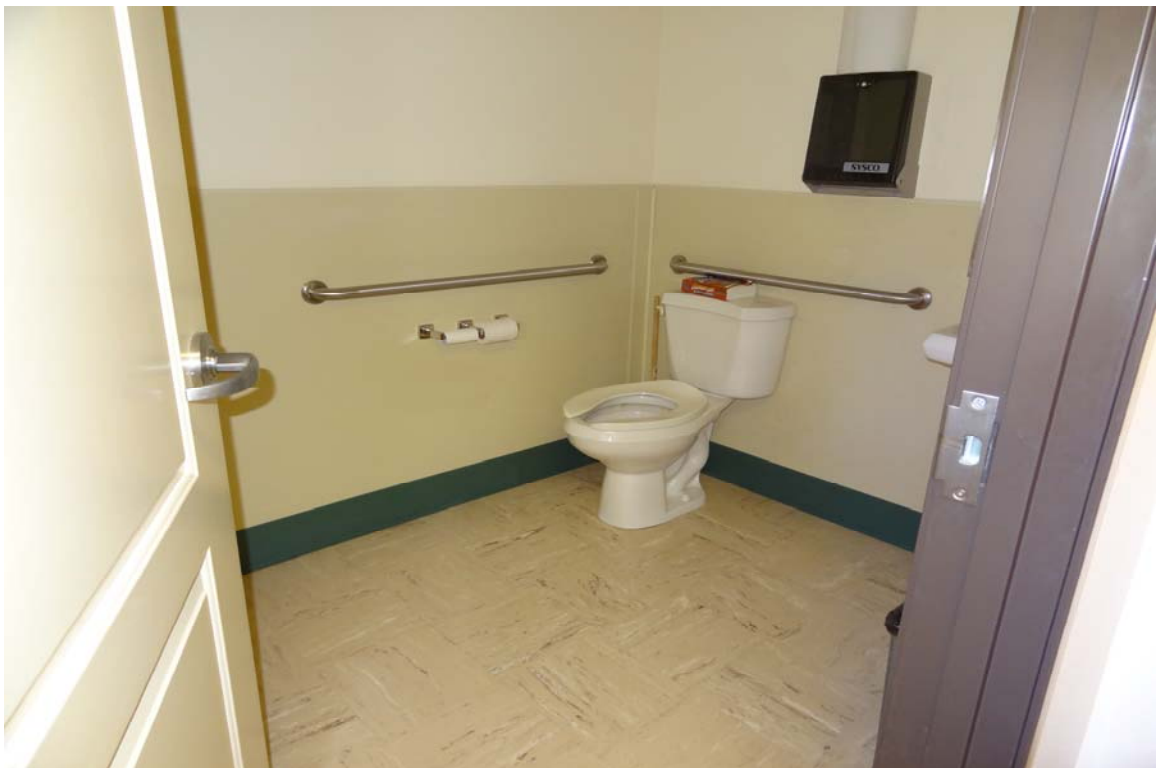
Ely Wildlife Field Office - Building #2127
Description: ADA restroom, note flush handle on wrong side.
