State of Nevada  
Department of Public Safety  
Highway Patrol Division  
Indian Springs NHP Substation  
Facility Condition Analysis

# INDIAN SPRINGS NHP SUBSTATION

851 McFarland  
Indian Springs, Nevada 89018

**Building Number: 2462**  
**STATE OF NEVADA PUBLIC WORKS BOARD**  
**FACILITY CONDITION ANALYSIS**

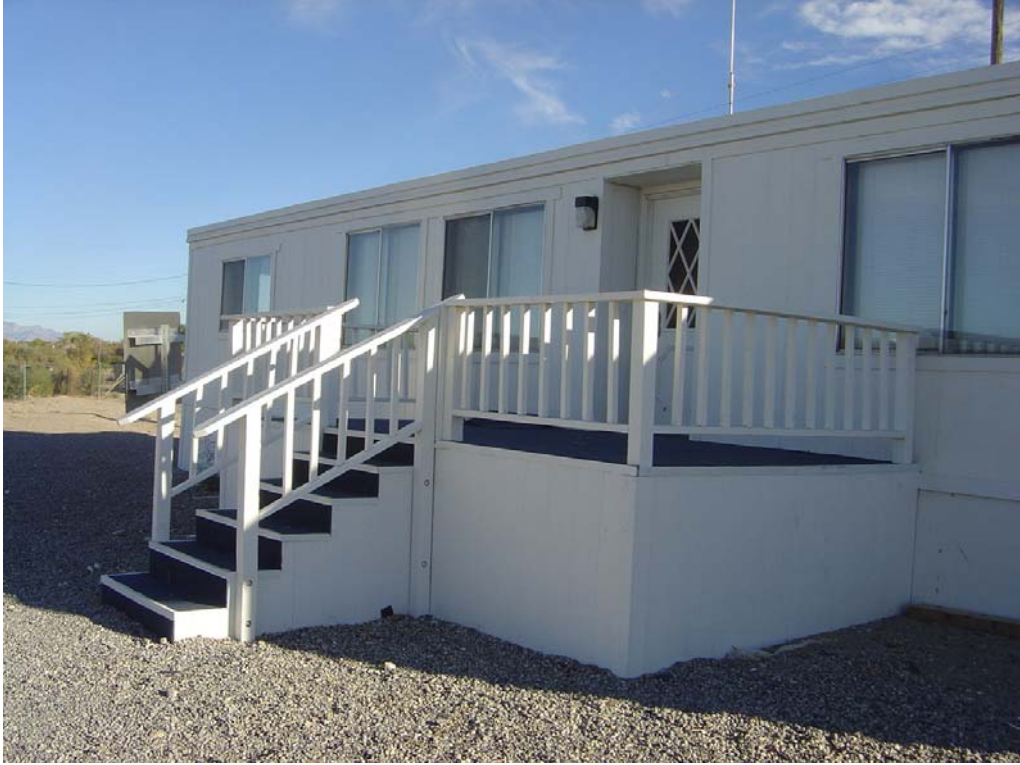
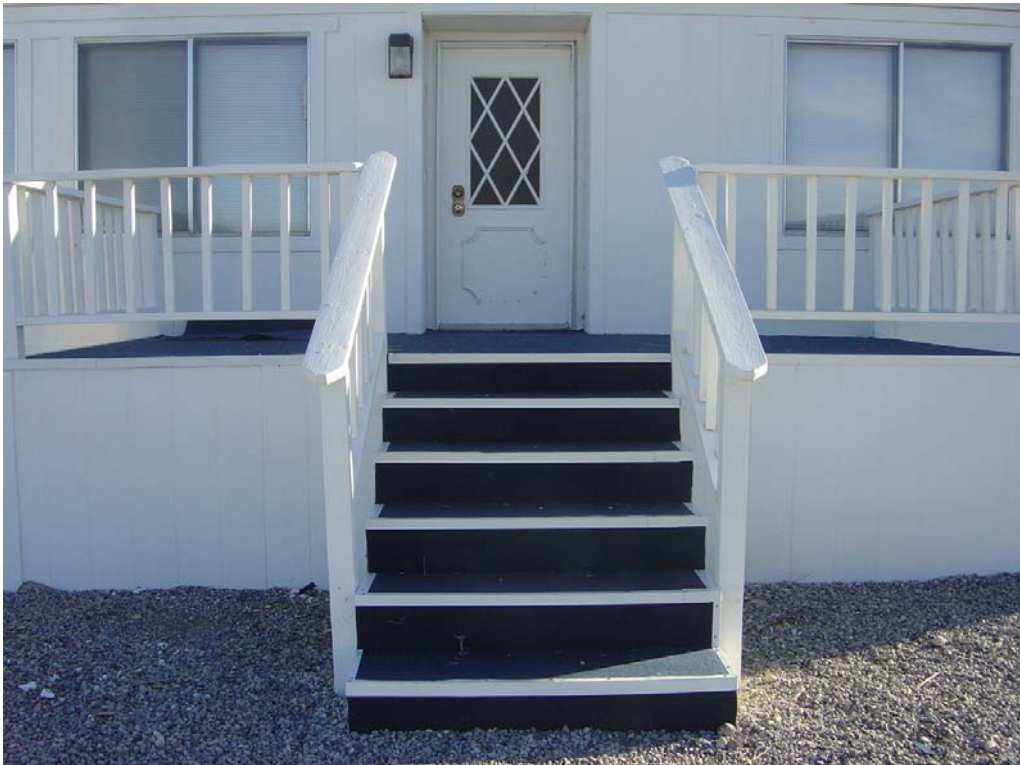
The building has steps leading into the main entrance. The entrance does not meet the requirements for ADA Accessibility ICC/ANSI A117.1-1998 404.2.4.1. The entry door has a threshold and hardware that does not meet the requirements for ADA accessibility, ICC/ANSI A117.1-1998 404.2.5.

Indian Springs NHP Substation - Building #2462  
Description: Entrance into the building.

This project would provide funding for an accessible ramp, including upper and lower landing areas, handrails, curbing, and replacement of the door hardware and threshold to meet the ADA Accessibility Guidelines.

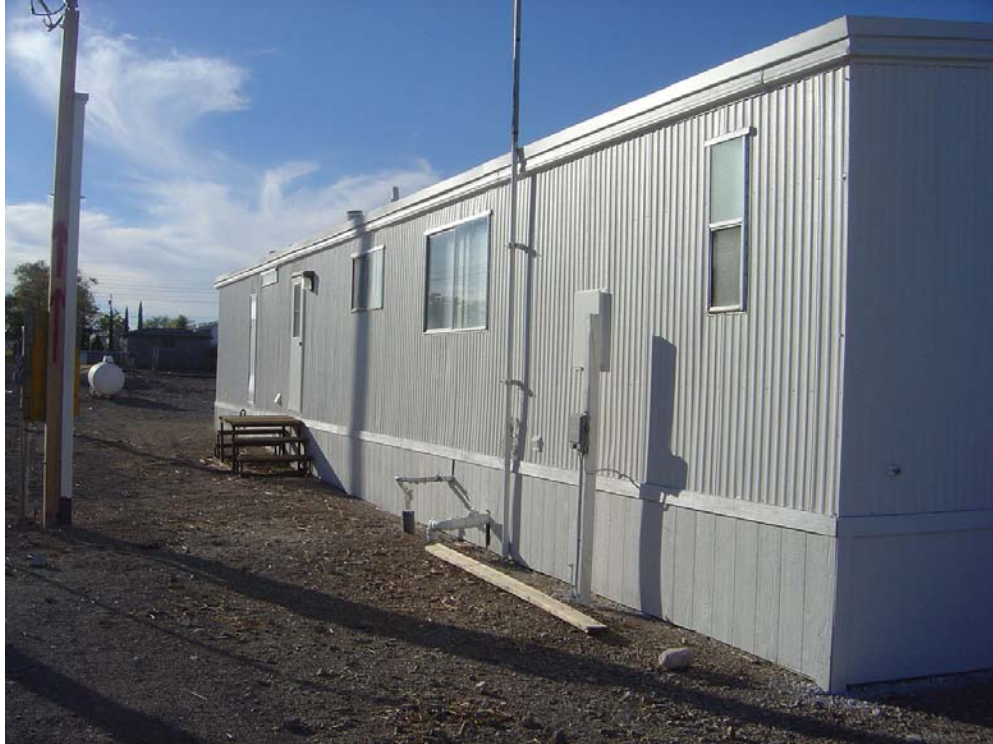
Indian Springs NHP Substation - Building #2462  
Description: Exterior view of the building.

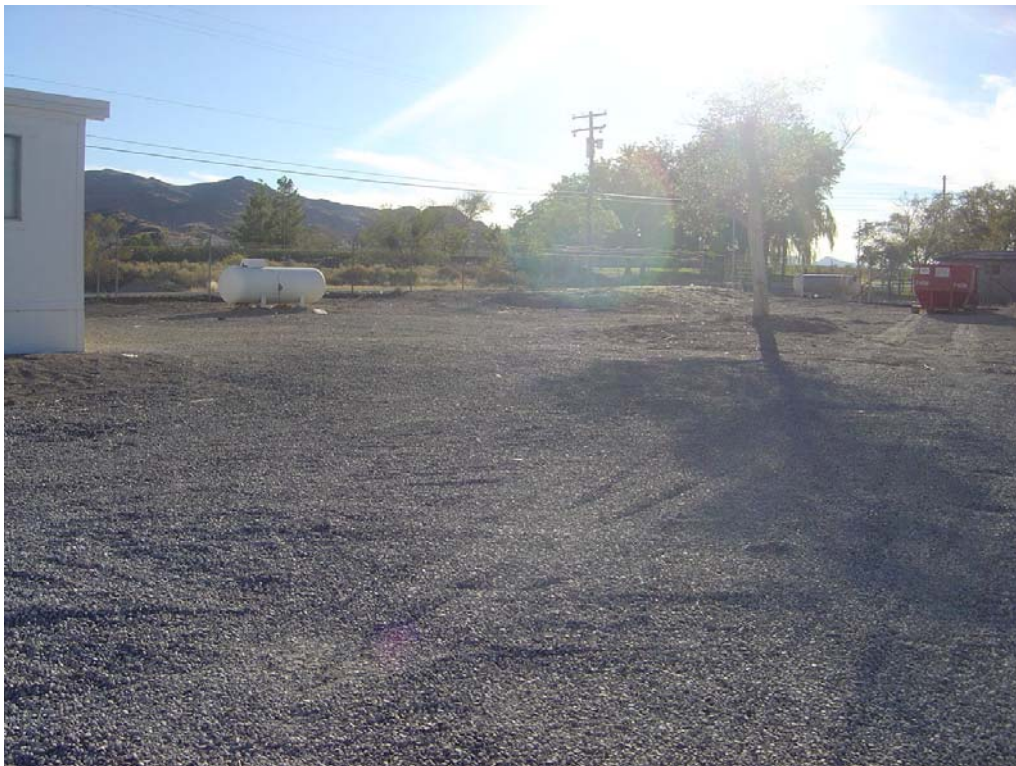
Indian Springs NHP Substation - Building #2462  
Description: Area surrounding the building.

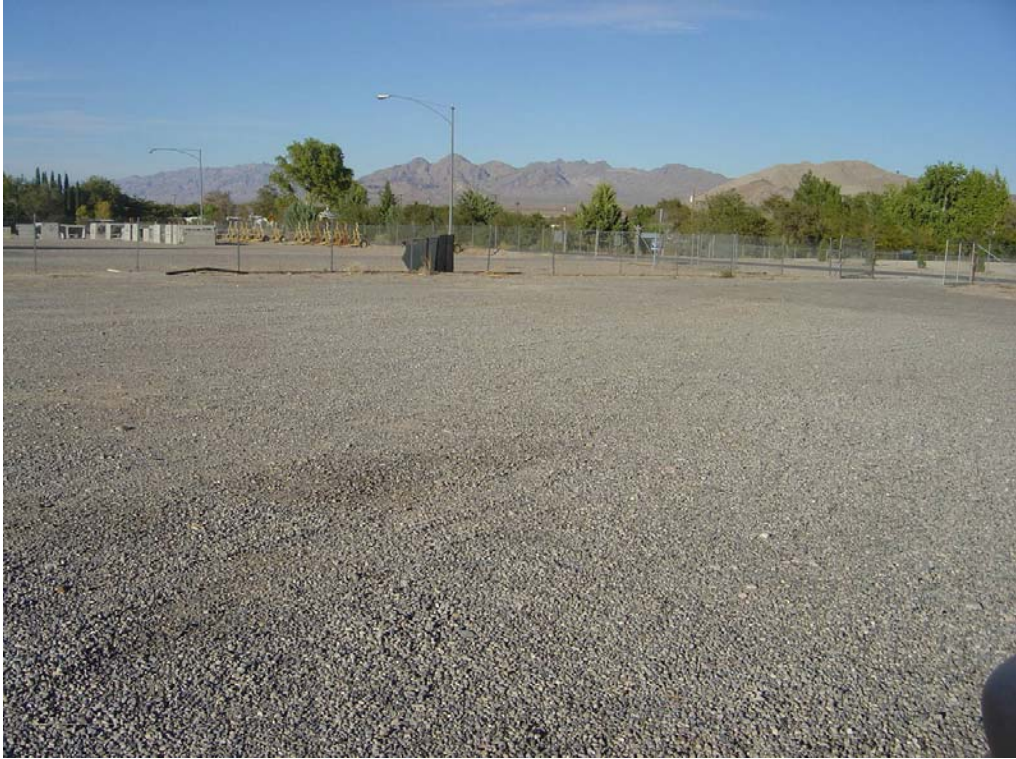
The Americans with Disabilities Act (ADA) provides for accessibility to sites and services for people with physical limitations. A parking area, an adjacent passenger loading area and signage are necessary to comply with ADA requirements.

Indian Springs NHP Substation - Building #2462  
Description: Entrance into gravel parking area.

This project would provide for one parking space, including an adjacent accessible loading zone in the existing gravel parking area. The project includes required soil preparation, an asphalt parking area for one vehicle, signage, striping and marking an accessible route of travel to the building.

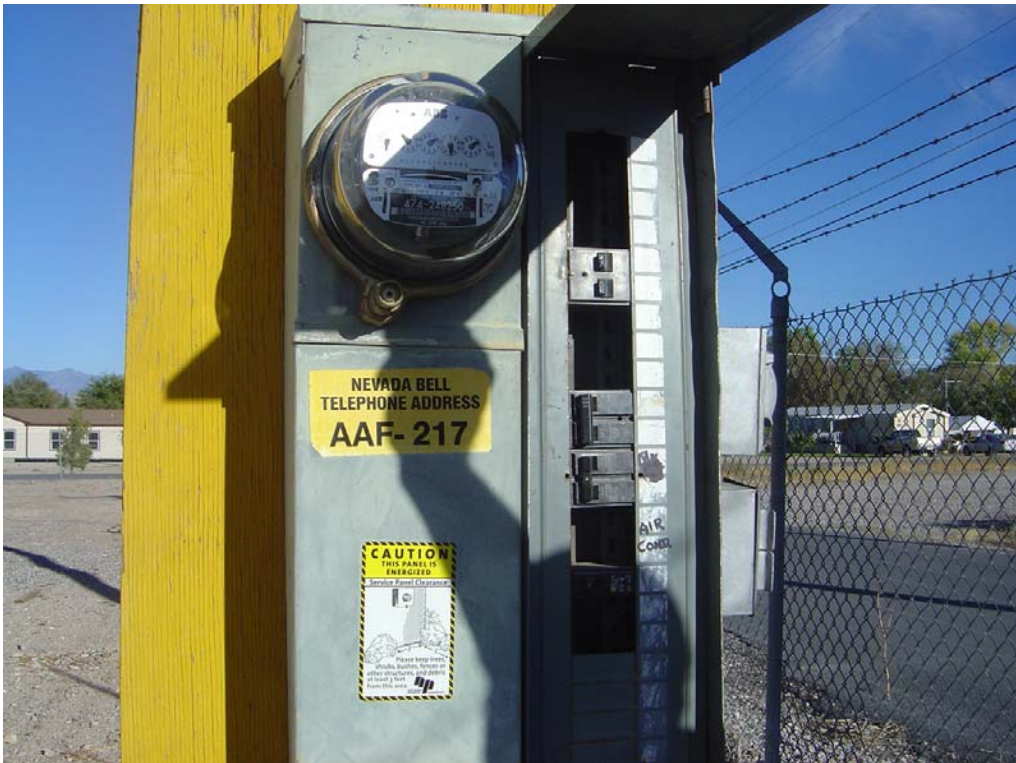
The exterior receptacles are standard duplex receptacles and there are missing safety plugs in the main electrical panel, which is mounted to a telephone pole adjacent to the building. This project would provide funding to install GFIC duplex outlets on the exterior and install safety plugs in the main electrical service including a lock to prevent the public from tampering with the electrical service.

Indian Springs NHP Substation - Building #2462  
Description: Electrical safety covers missing in main panel.
