State of Nevada
Department of Administration
Buildings and Grounds Section
Belrose Office
Facility Condition Analysis

BELROSE OFFICE

620, 628 Belrose Street
Las Vegas, Nevada

**STATE OF NEVADA PUBLIC WORKS DIVISION
FACILITY CONDITION ANALYSIS**

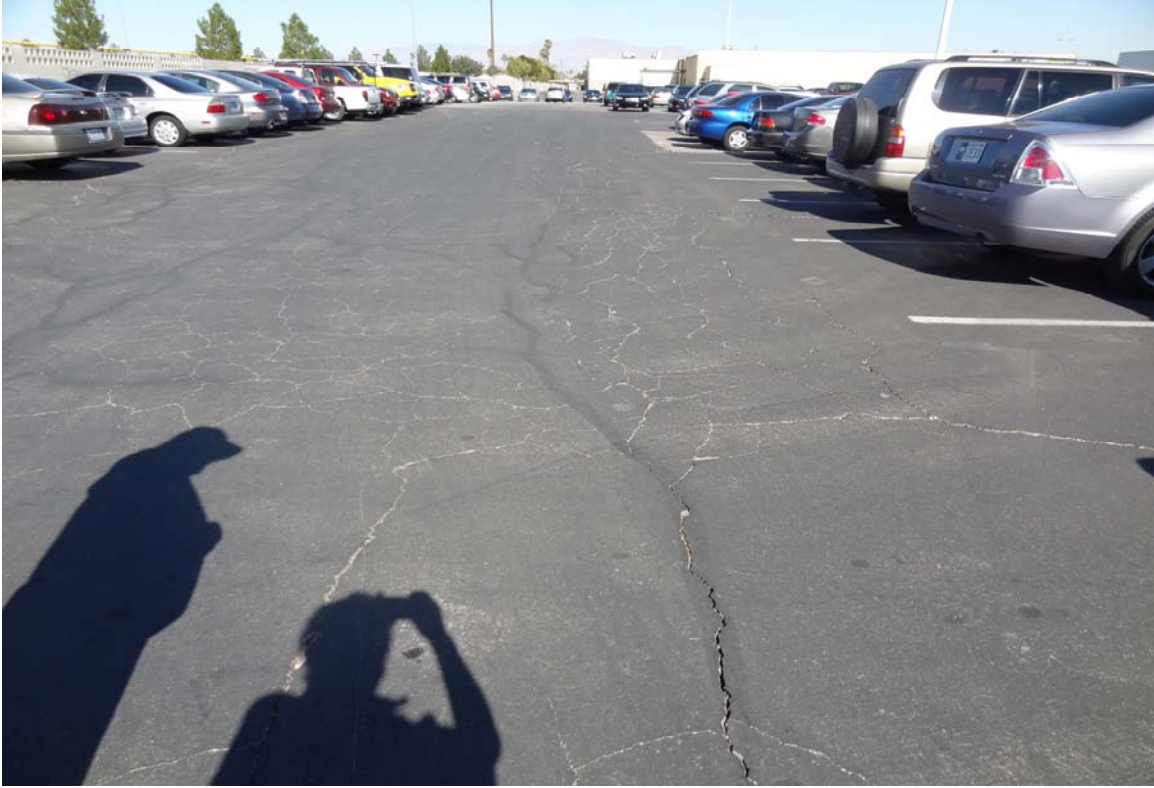
Belrose Office Building Site - Site #9831
Description: Damaged paving in parking area.

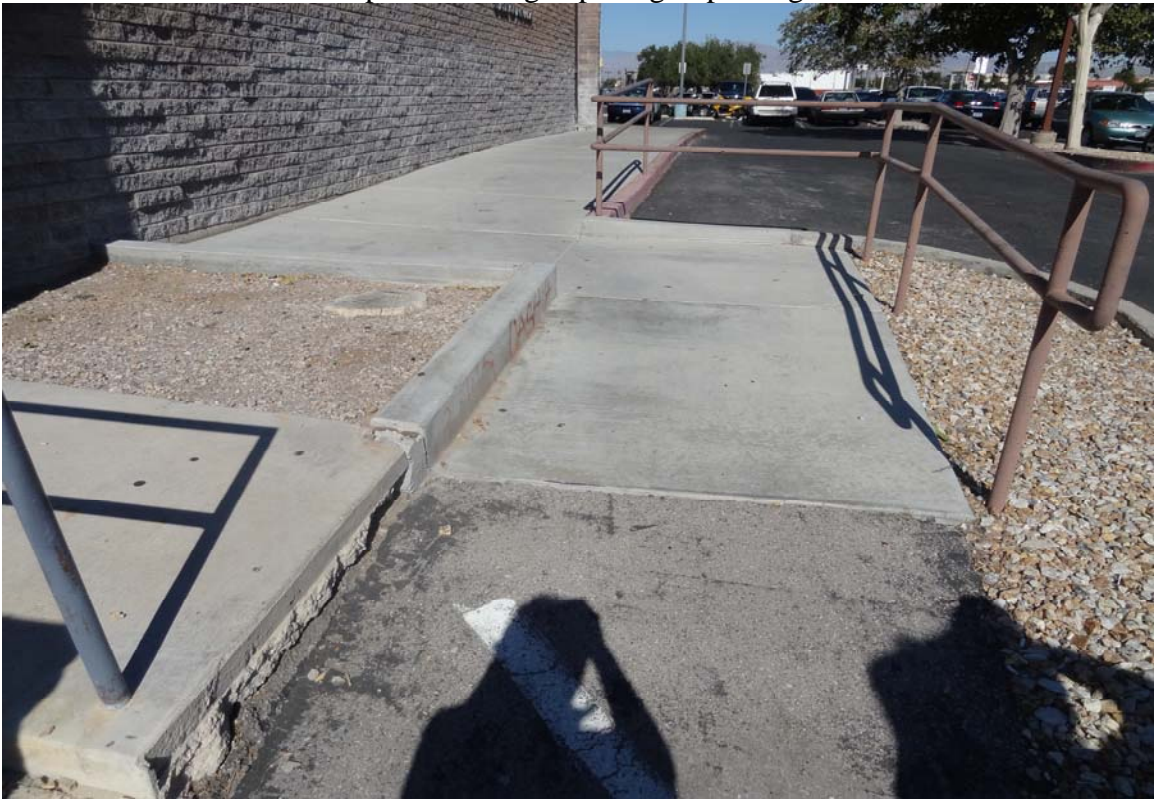
Belrose Office Building Site - Site #9831
Description: Non-ADA compliant route from bus stop to building.

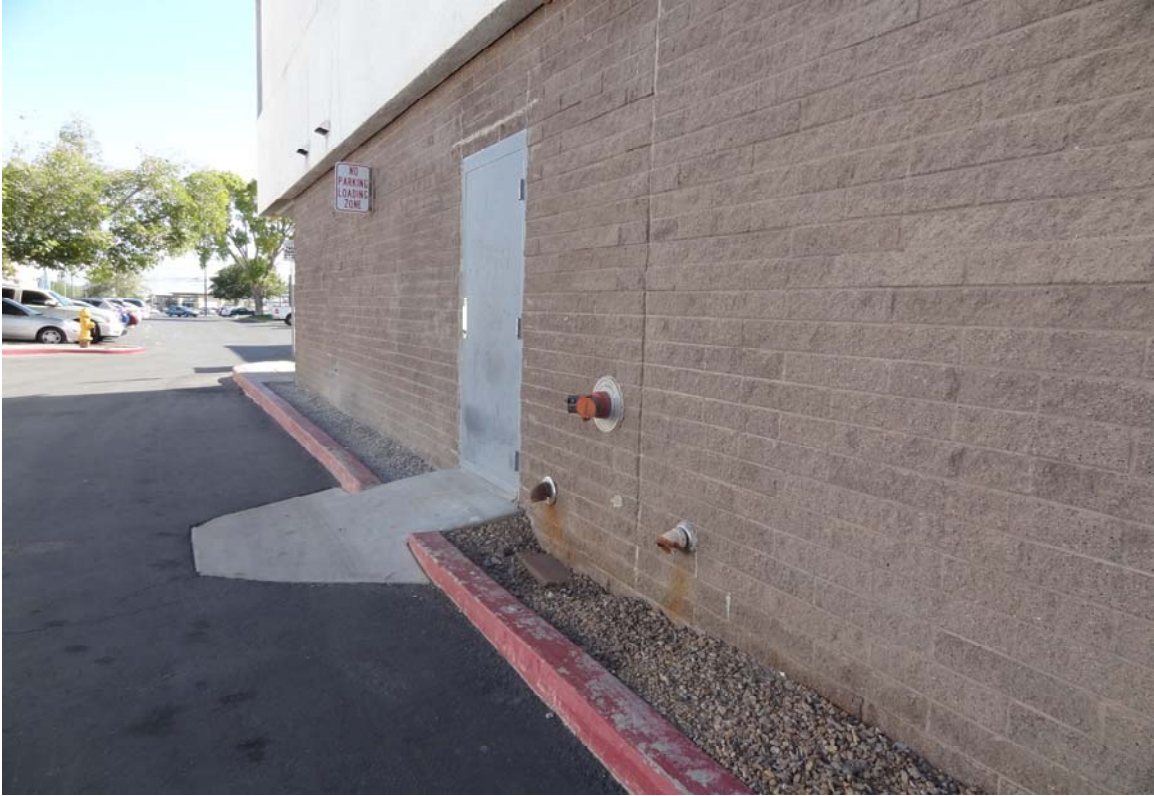
Belrose Office Building Site - Site #9831
Description: Non-code compliant landing at door.

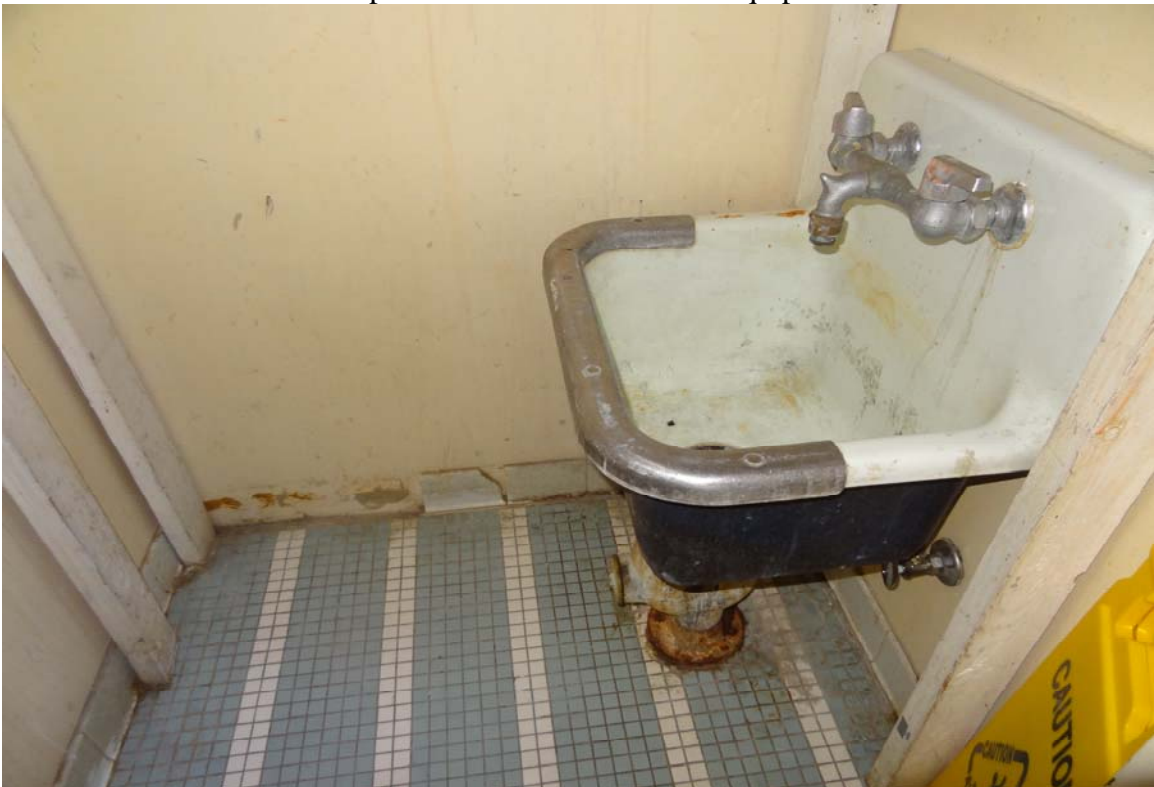
Belrose Office Building - Building #0286
Description: Janitor's closet in need of repairs.

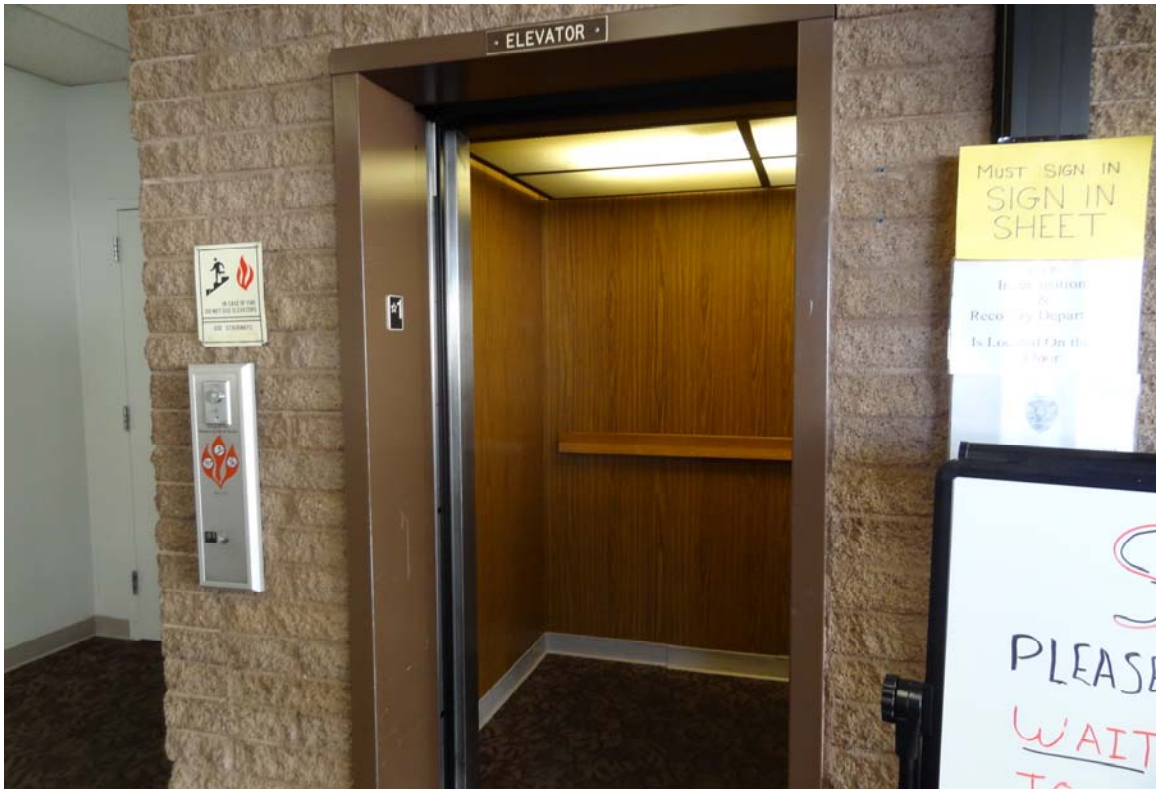
The Department of Rehabilitation has offices on the second floor which are served by an older elevator. The configuration of the elevator and controls does not meet current ADA requirements. Due to the significant number of clients with special needs that the Department serves, a complying elevator should be installed. NRS 338.180, IBC - 2006, ICC/ANSI A117.1 - 2003 and the most current version of the Americans with Disabilities Act Accessibility Guidelines (ADAAG) were used as a reference for this project.

Belrose Office Building - Building #0286
Description: Elevator in need of upgrades.
