DMV EXPRESS OFFICE SITE

4110 Donovan Way
Las Vegas, Nevada 89030

Site Number: 9832
STATE OF NEVADA PUBLIC WORKS DIVISION
FACILITY CONDITION ANALYSIS

Report distributed in November 2021

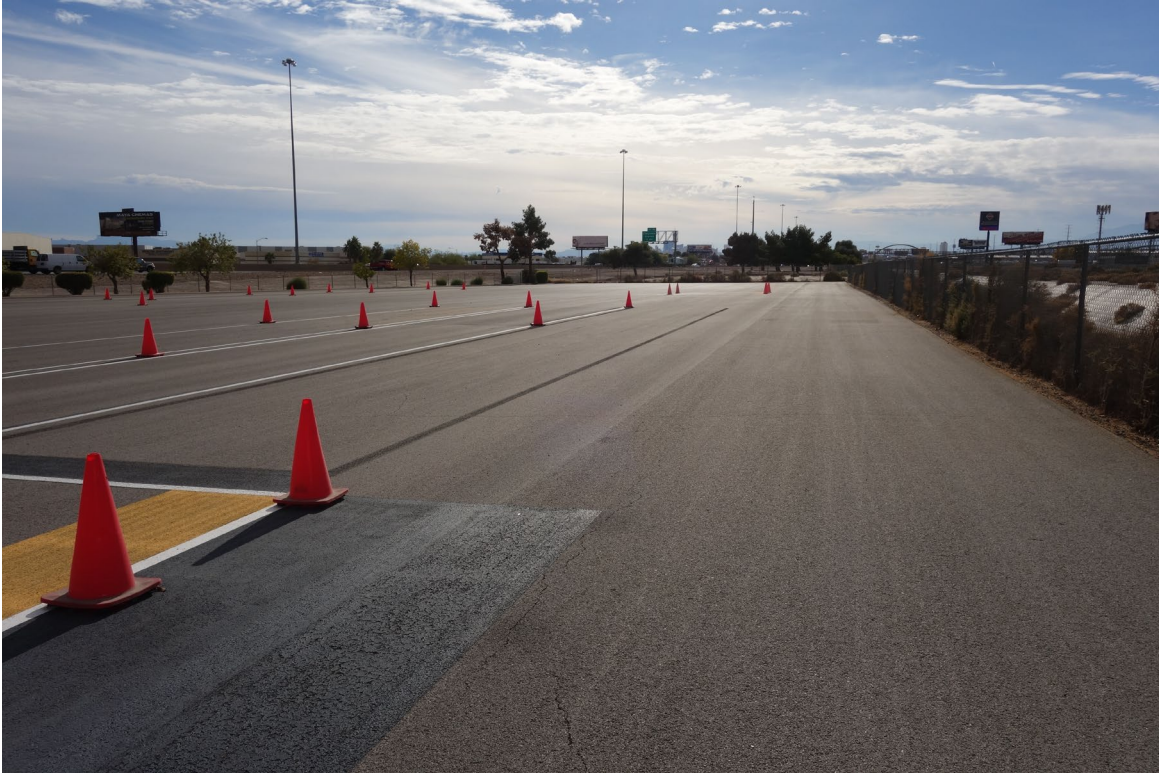
DMV Express Office Site - Site #9832
Description: View South Pavement Area.

It is important to maintain the asphalt concrete paving on the site. This project would provide for minor crack filling and sealing of the paving site wide including access roads, parking areas and the test driving area. Striping is included in this estimate. This project should be scheduled on a 5 year cyclical basis to maintain the integrity of the paving and prevent premature failure. 275,000 square feet of asphalt area was used to generate this estimate. This project should be implemented concurrently with the Concrete Curb Replacement project.

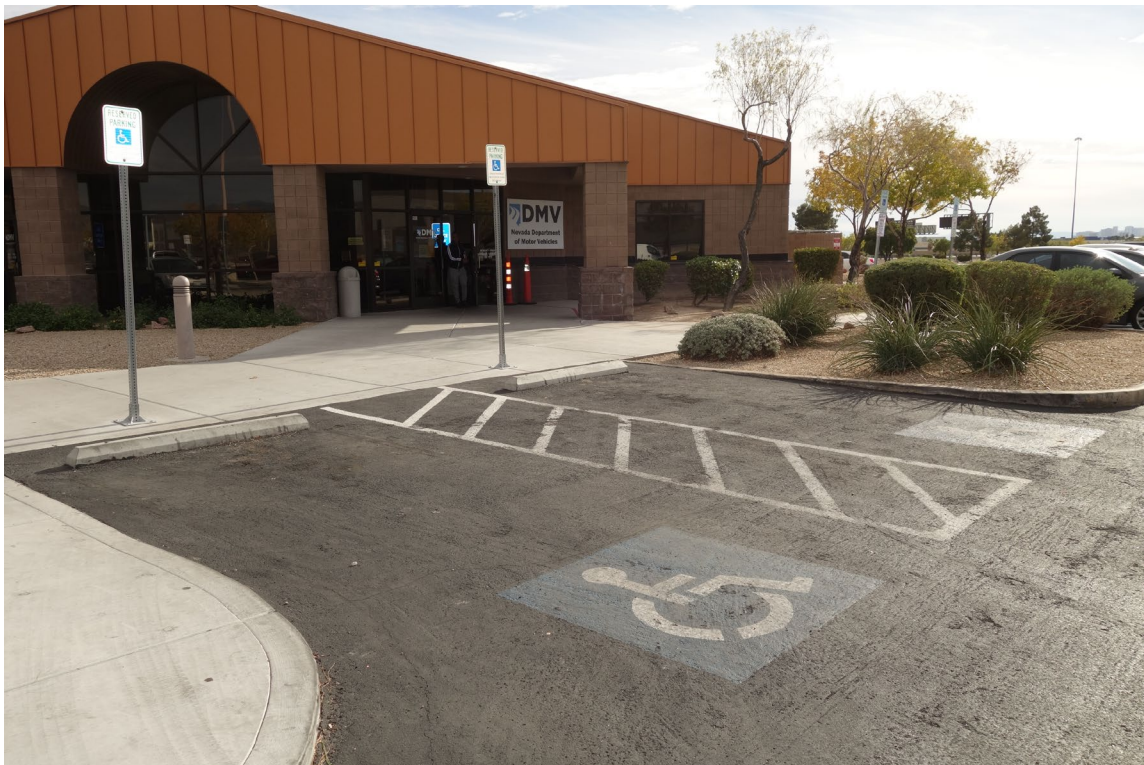
DMV Express Office Site - Site #9832
Description: View of Accessible Parking.

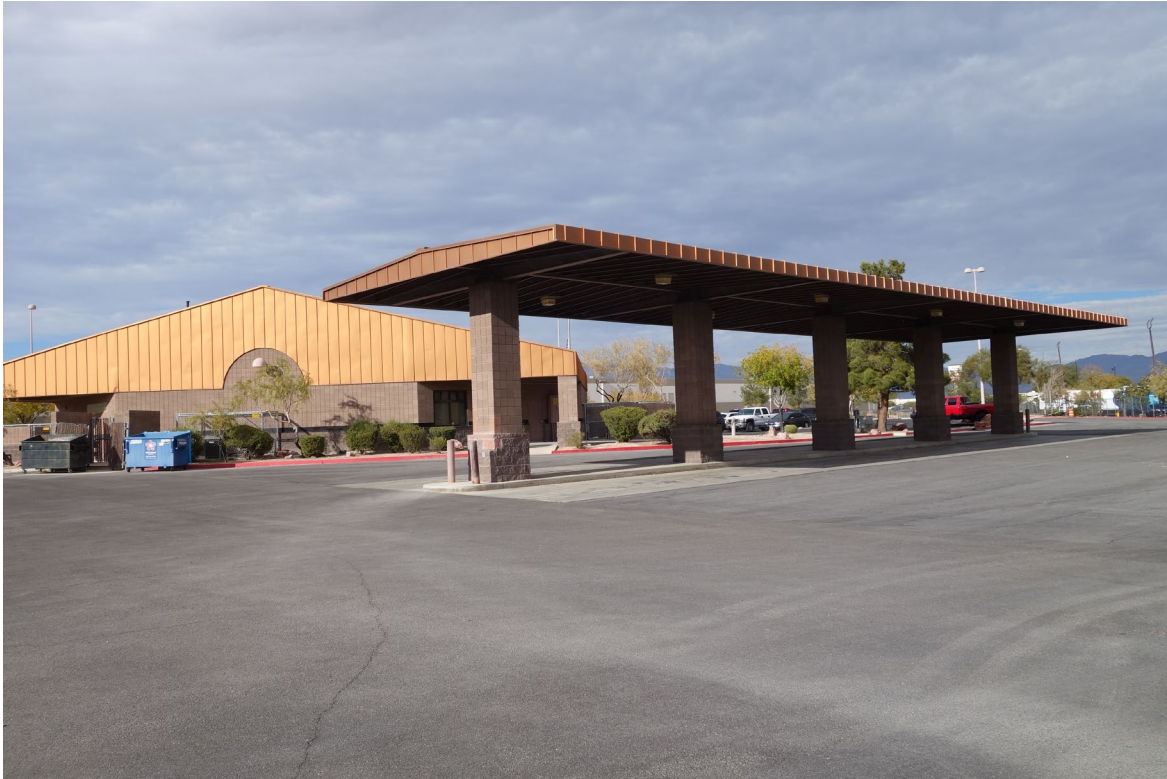
Inspection Station Canopy - Building #3106
Description: Exterior of the Structure.

The exterior finishes were in good condition. It is important to maintain the finish, weather resistance and appearance of the structure. This project would provide funding for repairing, sealing and caulking of the exterior of the structure. Included in the cost is repairing the damaged concrete masonry units (CMU) and sealing and caulking the CMU, flashing, fixtures and all other penetrations. It is recommended that the building be repaired in the next 7 - 9 years and that this project be scheduled on a cyclical basis to maintain the integrity of the structure.

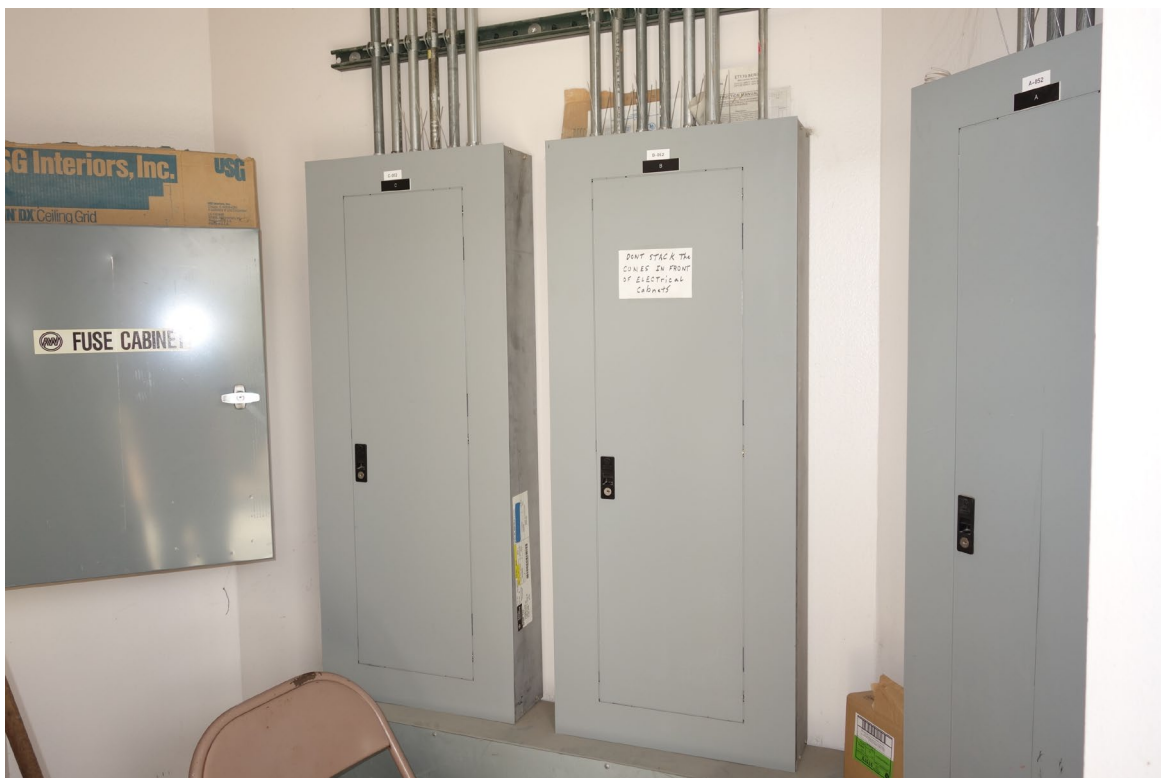
An arc flash and electrical coordination study has not been performed or is more than 5 years since the last coordination study. The latest electrical code requires coordination studies be verified and performed every 5 years and arc flash labeling on all electrical panels to provide the safety requirements for maintenance personnel. This project will perform the required coordination study, evaluation, adjustments and labeling for the building electrical distribution system.

DMV Express Office - Building #0265
Description: Arc Flash Labeling Needed.

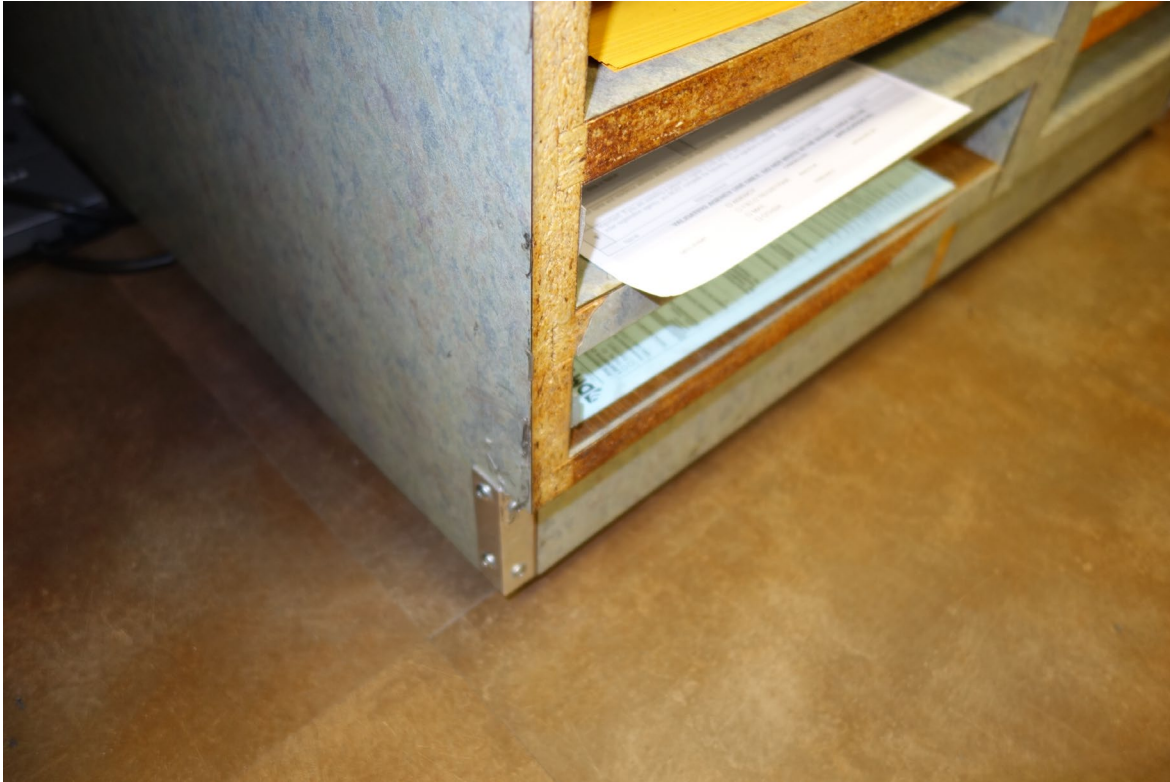
The built-in Customer Service counters and cabinetry are original to the building. The quality of construction and installation was inadequate for the high usage at this facility, and the cabinets and countertops are delaminating and failing. This project recommends the replacement of the existing countertops, cabinets, and associated equipment with heavy duty, quality components. The cabinets should be finished inside and outside with a melamine or similar finish which encapsulates the door, frame, and shelving. ADA compliance according to NRS 338.180, IBC - 2018, ICC/ANSI A117.1 and the most current version of the ADA Standards for Accessible Design should be incorporated into the design such as providing an accessible sink. 50 linear feet of casework was used for this estimate. This estimate includes removal and disposal of the existing materials.

DMV Express Office - Building #0265
Description: Customer Service Counter Replacement Needed.

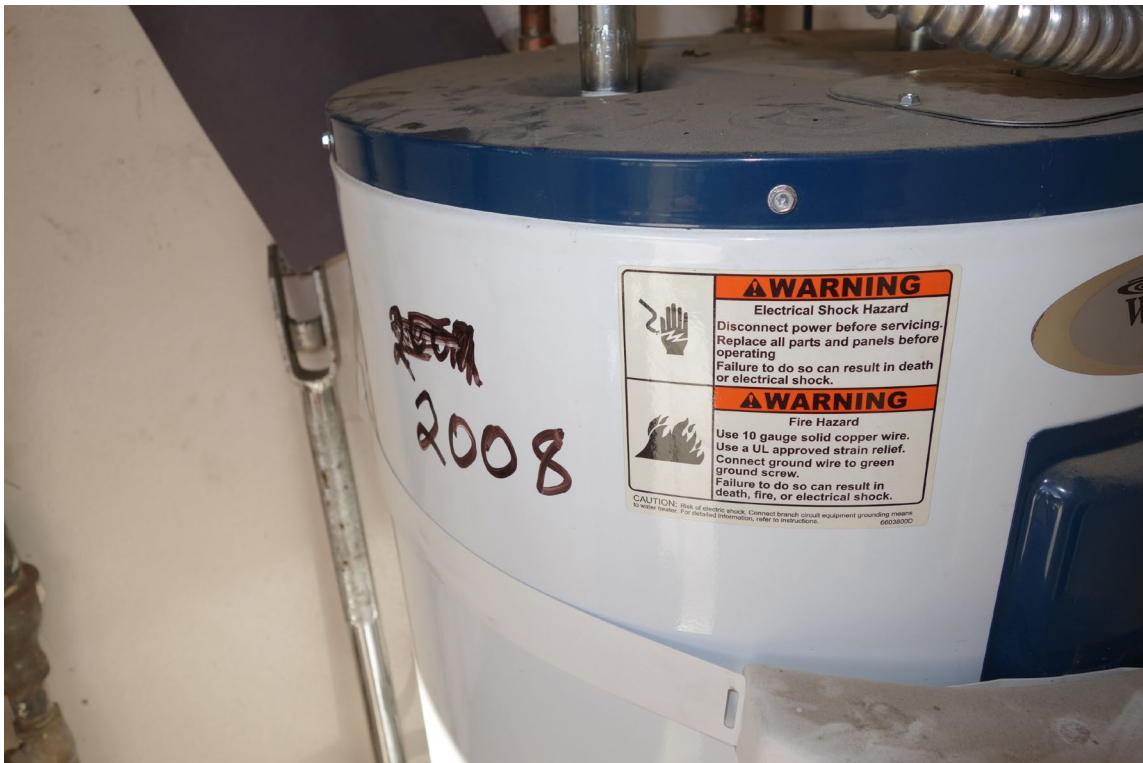
There is a 30 gallon electric water heater in the building. The average life span of a water heater is eight to ten years. With the passage of time and constant use, this unit is showing signs of wear and should be scheduled for replacement in the next 2 - 3 years. It is recommended that a new electric water heater be installed. Removal and disposal of the existing equipment is included in this estimate.

DMV Express Office - Building #0265
Description: Water Heater Replacement Recommended.
