State of Nevada  
Department of Employment, Training & Rehabilitation  
Las Vegas Casual Labor Office  
Facility Condition Analysis

# LAS VEGAS CASUAL LABOR OFFICE

1001 North A Street  
Las Vegas, Nevada 89106

**Site Number: 9833**  
**STATE OF NEVADA PUBLIC WORKS BOARD**  
**FACILITY CONDITION ANALYSIS**

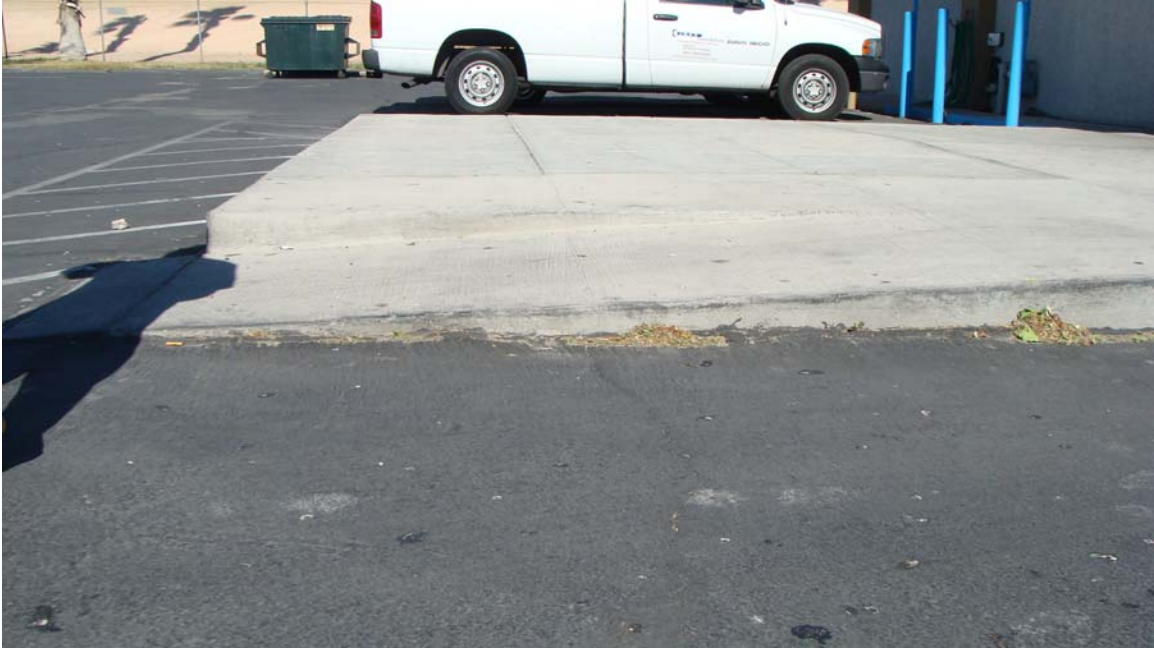
Las Vegas Casual Labor Office Site - Site #9833  
Description: ADA accessible ramp.

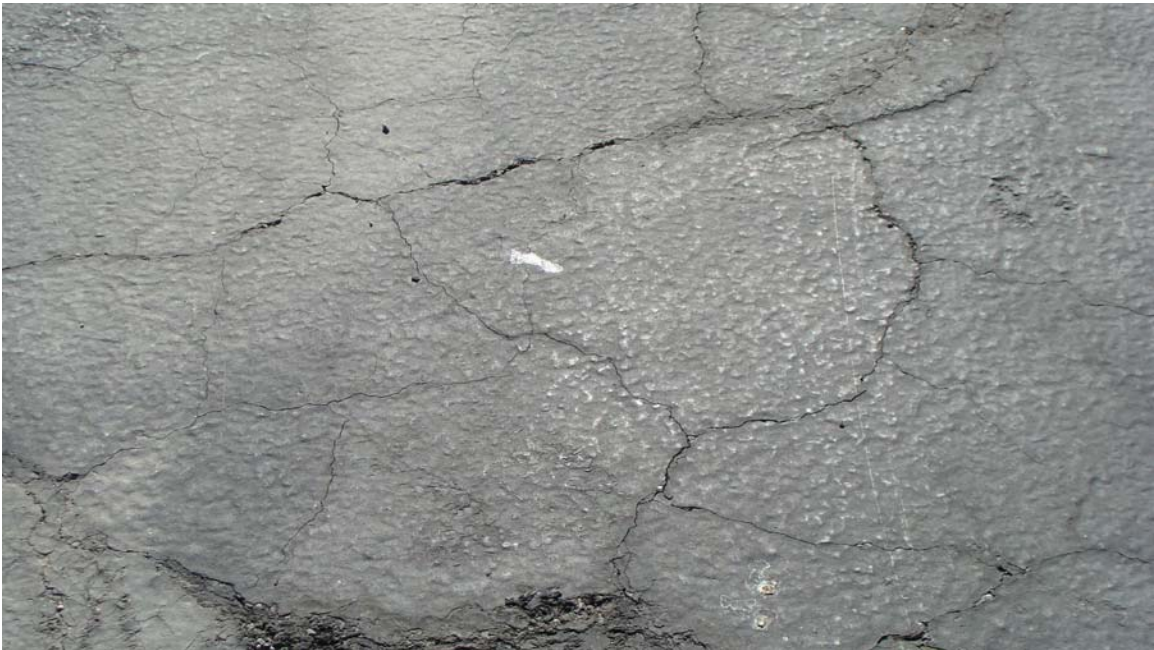
The asphalt parking lots are failing, with significant alligating, settling and general deterioration observed. The settling on the south side has caused drainage problems with standing water in the middle of the parking lot. This project covers the removal and replacement of the existing asphalt for parking and site access. Striping for safety, parking and loading zones is included in this estimate as well as perimeter curbing and parking curbs as needed. 18,000 square feet was used to generate this estimate.

Las Vegas Casual Labor Office Site - Site #9833  
Description: Asphalt paving in need of crack fill and slurry.

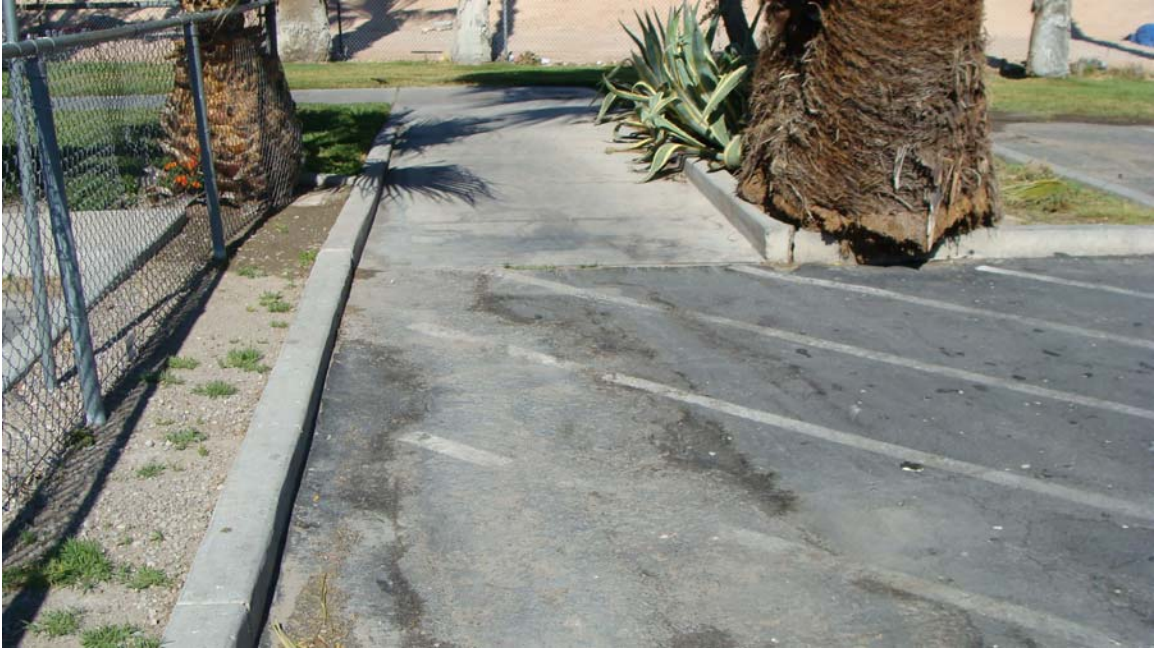
The Las Vegas Casual Labor site is located across the street from the Nevada Department of Transportation's yard on North A Street. It has a paved parking area with ADA accessible parking and route of travel to the office. There are some palm trees, shrubs and irrigated turf areas on the site. The pavement is in poor to fair shape and will be addressed with a proposed project in the site report. Some of the large palm trees are causing damage to sidewalks and curbs. The site is fully fenced and in good shape overall.

Las Vegas Casual Labor Office Site - Site #9833  
Description: Tree causing damage to curb.

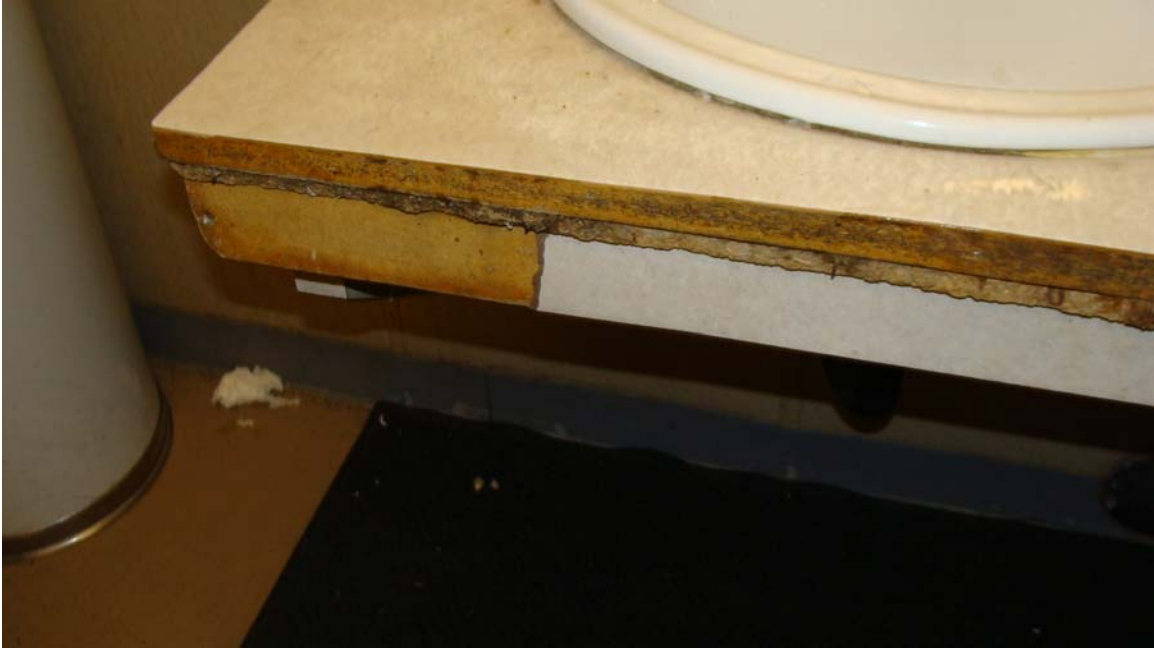
The Men's and Women's designated ADA restrooms in the Job Seeker Room do not meet the Americans with Disabilities Act (ADA) requirements. A complete retrofit is necessary. This project would provide funding for construction of two unisex accessible restrooms. These items may include a new sink, toilet, hardware, mirrors, fixtures, flooring and paint. NRS 338.180, IBC - 2006, ICC/ANSI A117.1 - 2003 and Americans with Disabilities Act Accessibility Guidelines (ADAAG) - 2003 were referenced for this project.

Las Vegas Casual Labor Office Site - Site #9833  
Description: Damaged countertop in day room restroom.

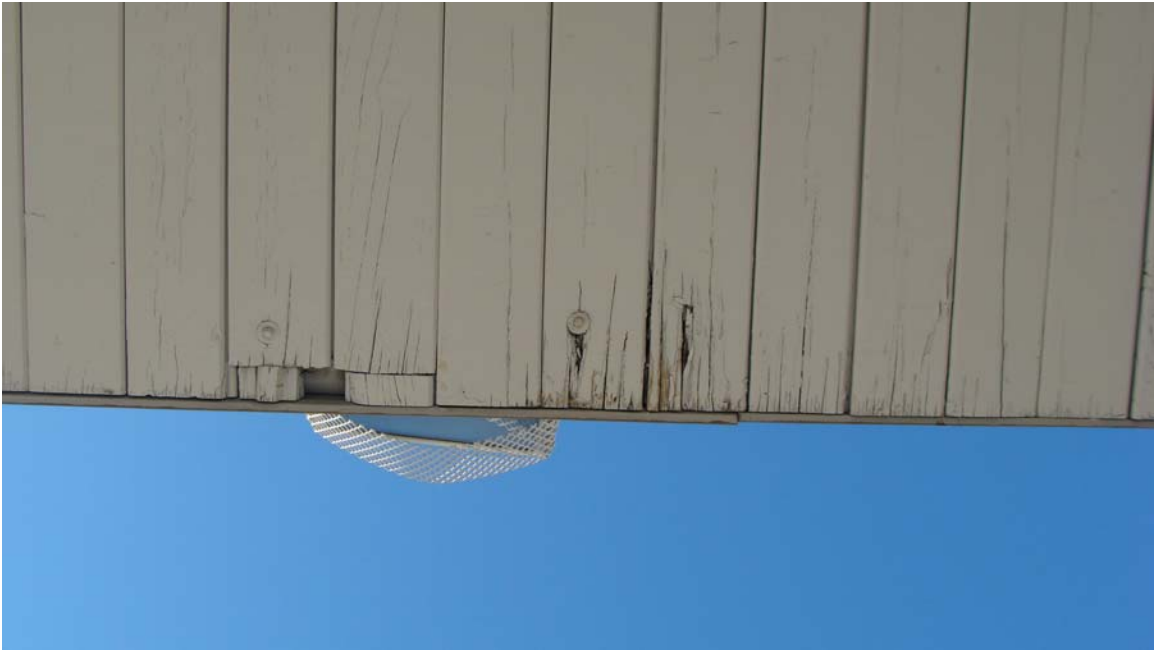
The metal fascia and the soffits around the building are weather beaten, peeling, and are showing signs of considerable wear. This project would provide funding to repair the fascia and soffits. Repairs include: replacing if necessary, sanding, scrapping, priming and painting.

Las Vegas Casual Labor Office Site - Site #9833  
Description: Soffit damage.
