State of Nevada
Department of Cultural Affairs
Division of Museums & History
Nevada State Museum & Historical Society
Facility Condition Analysis

700 Twin Lakes Drive
Las Vegas, Nevada 89107

Site Number: 9834
STATE OF NEVADA PUBLIC WORKS BOARD
FACILITY CONDITION ANALYSIS

Report Printed in April 2010

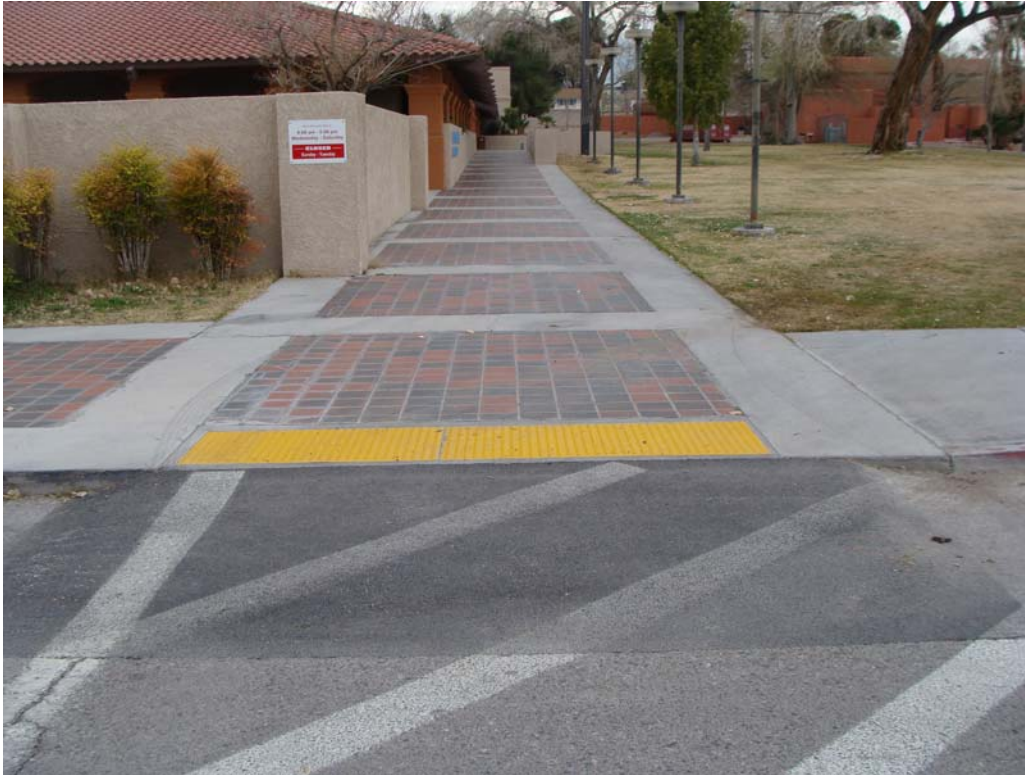
Las Vegas Museum & Historical Society Site - Site #9834
Description: Accessible route of travel from parking to entrance.

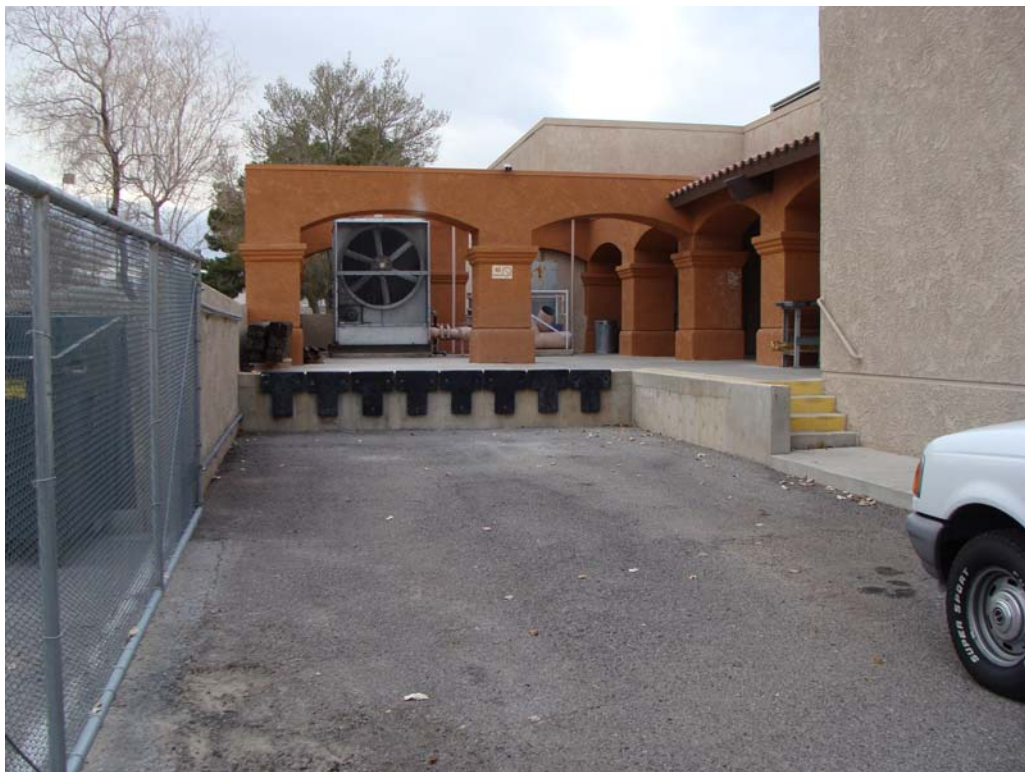
Las Vegas Museum & Historical Society - Site #9834
Description: Loading dock with cooling tower beyond.

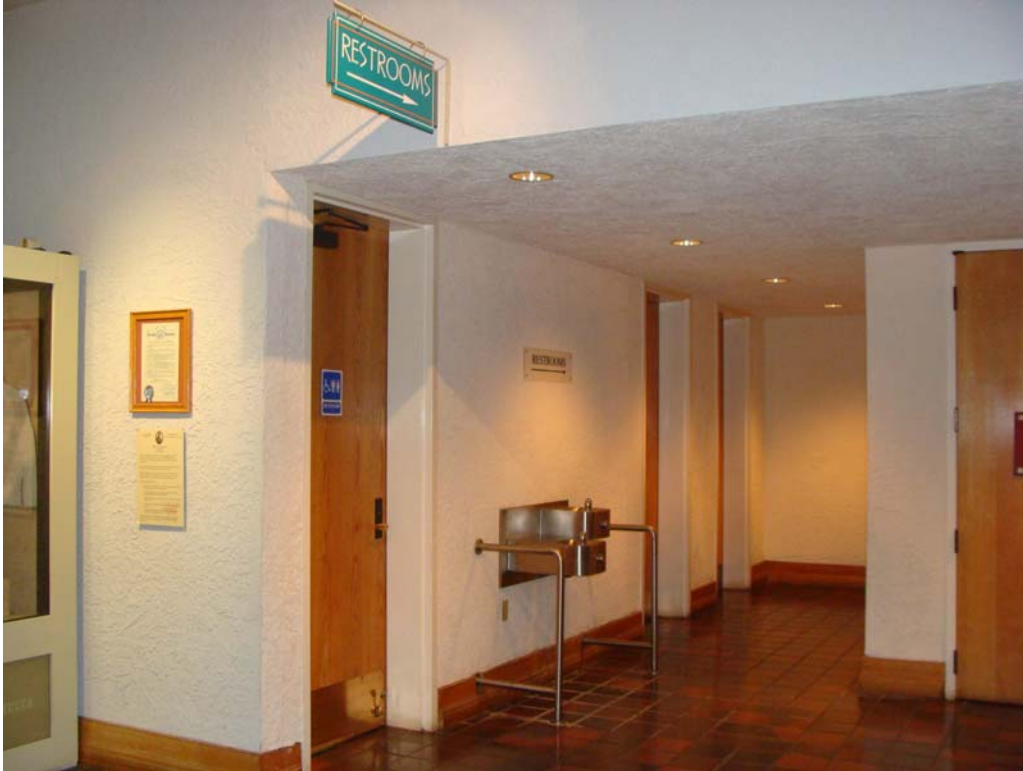
Las Vegas Museum & Historical Society - Building #0400
Description: Public restroom area, note unisex restroom on left.

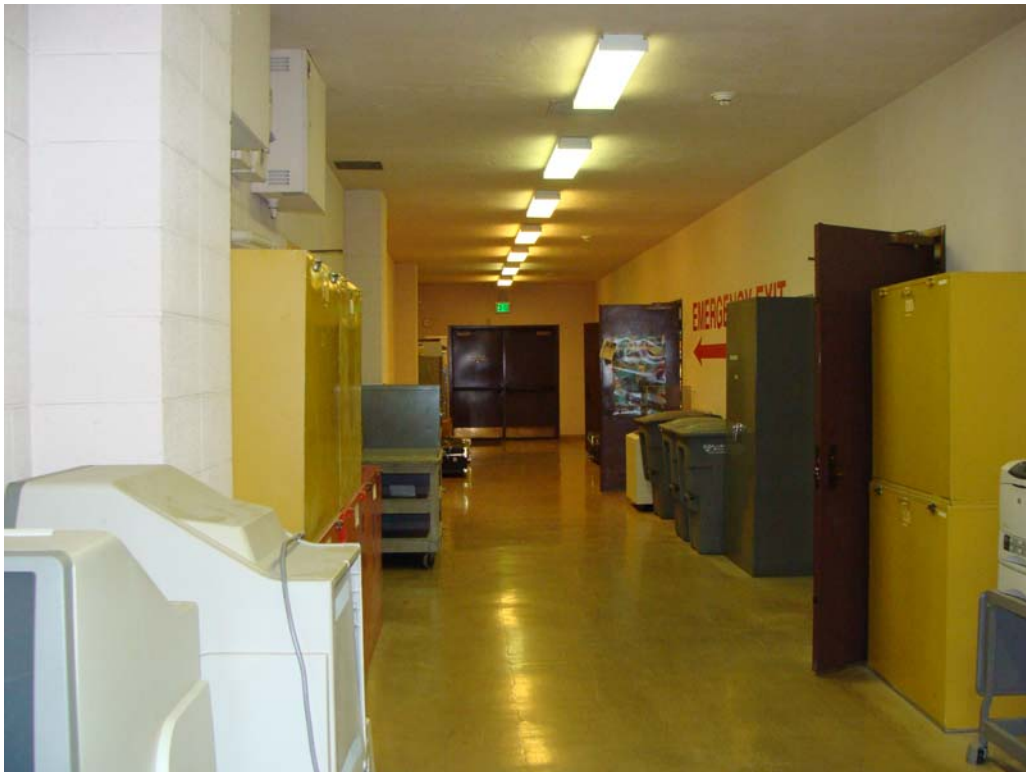
Las Vegas Museum & Historical Society - Building #0400
Description: Interior of the corridor.

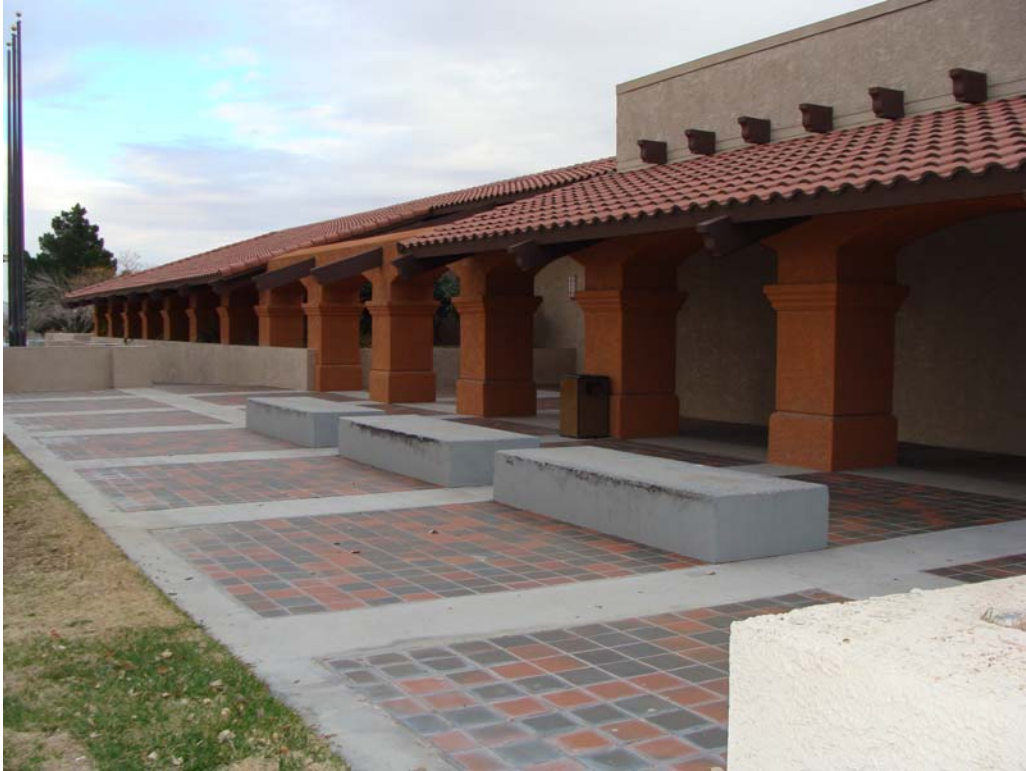
Las Vegas Museum & Historical Society - Building #0400
Description: Exterior of the building.

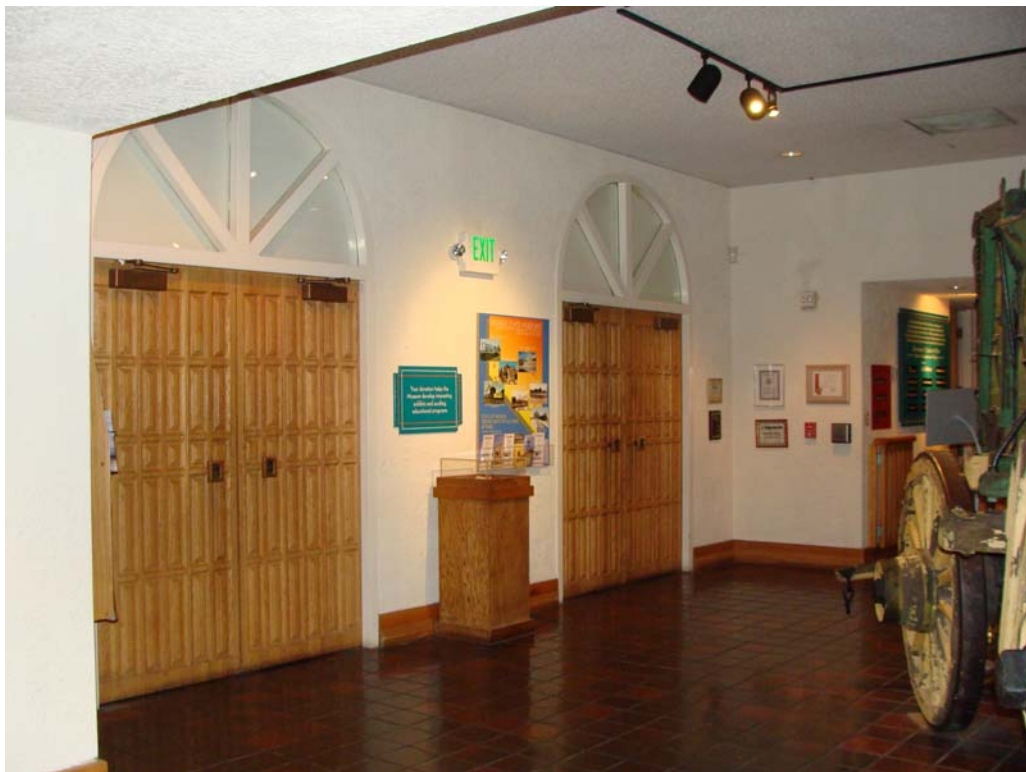
Las Vegas Museum & Historical Society - Building #0400
Description: Lobby – Entrance to the museum.
