State of Nevada
Department of Administration
Buildings and Grounds
Grant Sawyer State Office
Facility Condition Analysis

GRANT SAWYER STATE OFFICE

555 East Washington Ave.
Las Vegas, Nevada 89101

Site Number: 9835
STATE OF NEVADA PUBLIC WORKS DIVISION
FACILITY CONDITION ANALYSIS

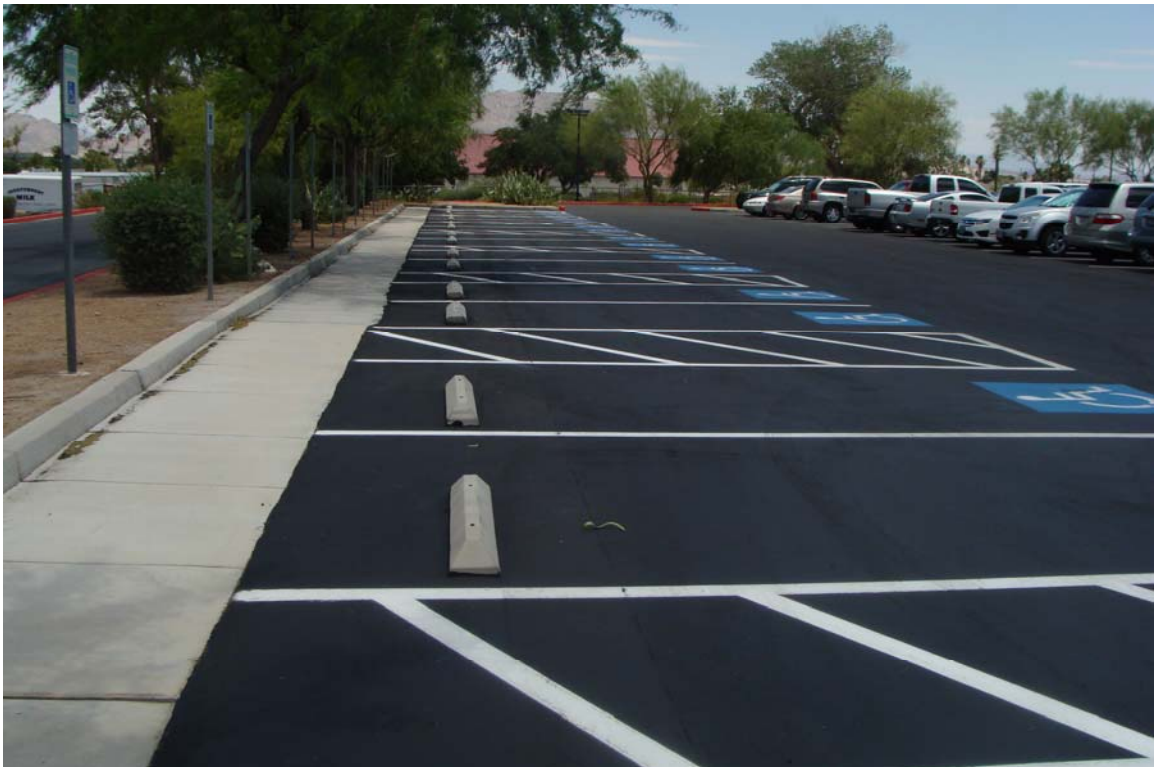
The Americans with Disabilities Act (ADA) provides for accessibility to sites and services for people with physical limitations. The concrete parking area and passenger loading area are missing proper signage in accordance with ADA requirements. This project would provide for purchasing and installing a "NO PARKING" sign at one of the loading zones next to the accessible parking space and replacing a "WHEEL CHAIR" sign with a current directional sign on the east elevation of the building. NRS 338.180, IBC - 2006, ICC/ANSI A117.1 - 2003 and the most current version of the Americans with Disabilities Act Accessible Guidelines (ADAAG) were used as a reference for this project.

Grant Sawyer Office Site - Site #9835
Description: View of the ADA accessible parking.

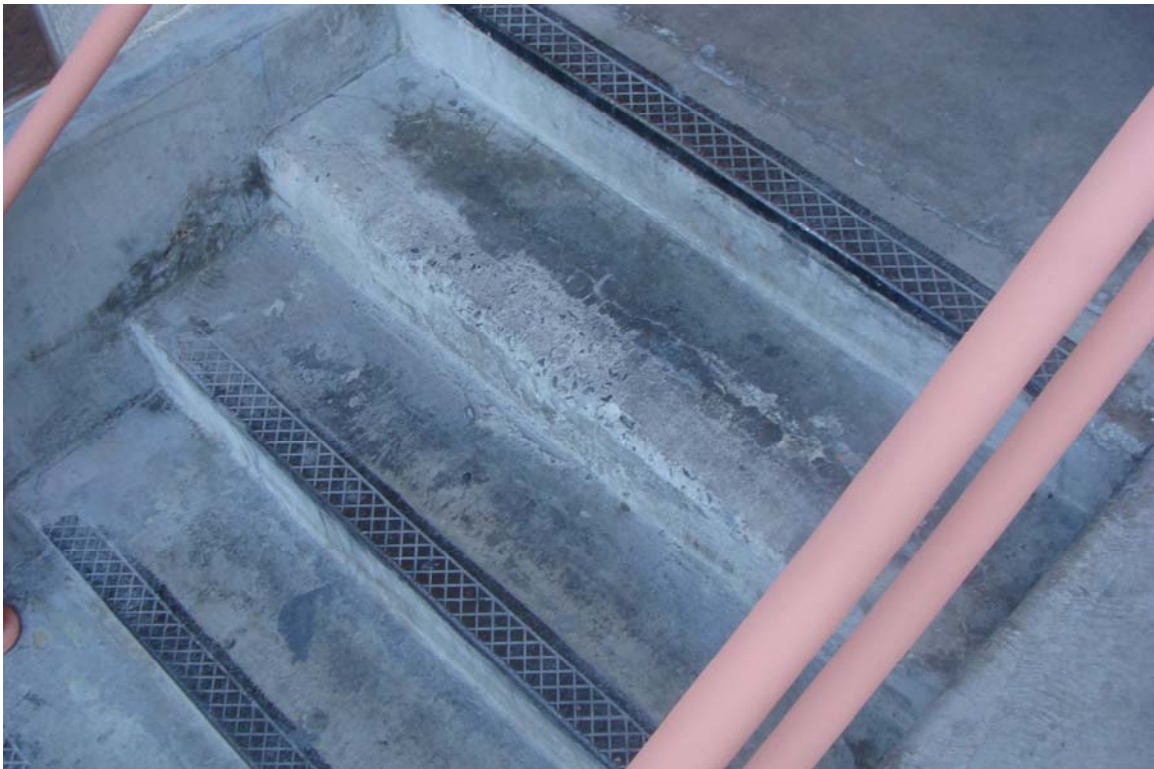
The existing loading dock does not accommodate smaller delivery trucks requiring personnel to lift equipment onto the loading dock. The loading dock is also missing a ramp which would provide for some of the smaller deliveries to be wheeled up. Gaming Commission deliveries must be brought into the building through the building's rear personnel door which poses a security risk. This project would install a powered 6' x 8' loading dock lift and a concrete ramp for smaller deliveries in place of the damaged stairs.

Grant Sawyer Office - Building #1680
Description: Damaged concrete stairs at loading dock.

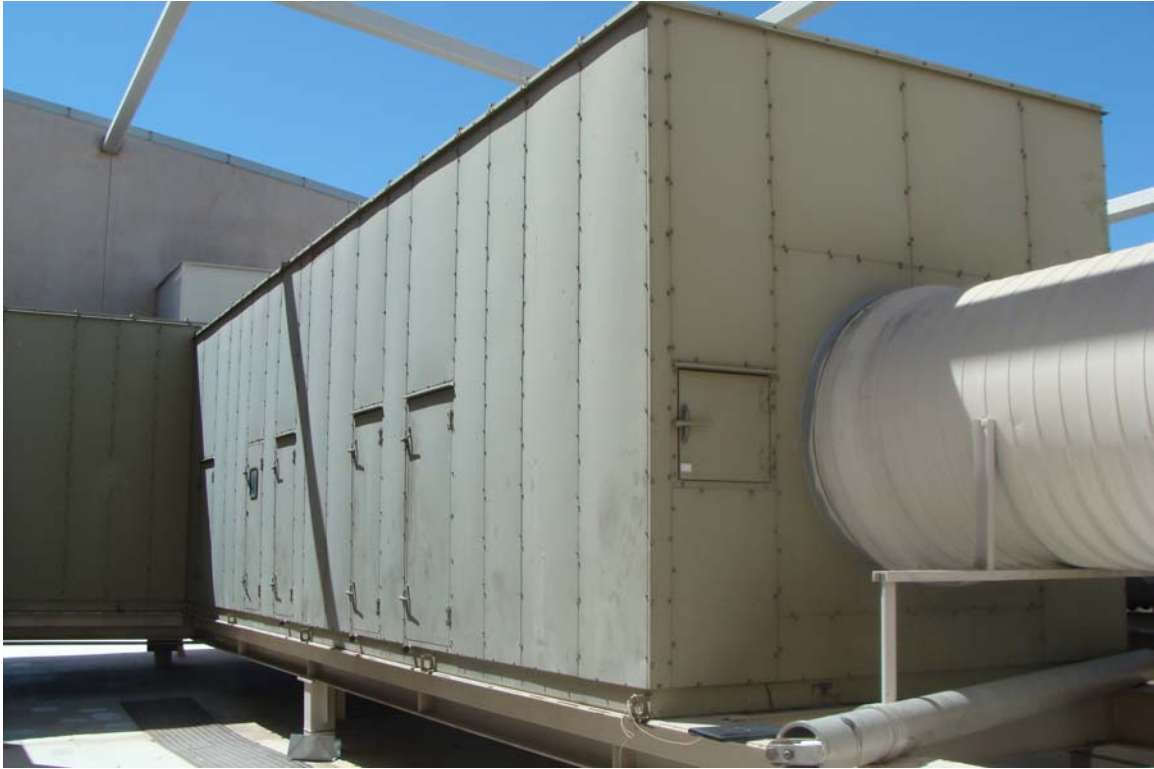
The HVAC system in the building is approaching the end of its expected life and should be scheduled for replacement. The cooling towers have already been replaced. The boilers, chillers, air handlers, control system, water treatment equipment and piping are all original to the building. Most equipment has an expected life of about 20-25 years. Also, the piping for the HVAC water lines is steel that is crimped at the connections. This type of piping is prone to leaking and should be replaced. The existing system is not energy efficient and has reached the end of its expected and useful life. This project would provide for installation of new HVAC equipment throughout the building and cleaning of the existing duct work and grilles. This project includes removal and disposal of the existing HVAC equipment and all required connections to utilities.

Grant Sawyer Office - Building #1680
Description: View of roof top mechanical equipment.
