State of Nevada
Department of the Military
Nevada National Guard
Ely Armory
Facility Condition Analysis

ELY ARMORY

545 Mill Street
Ely, Nevada 89301

Site Number: 9841

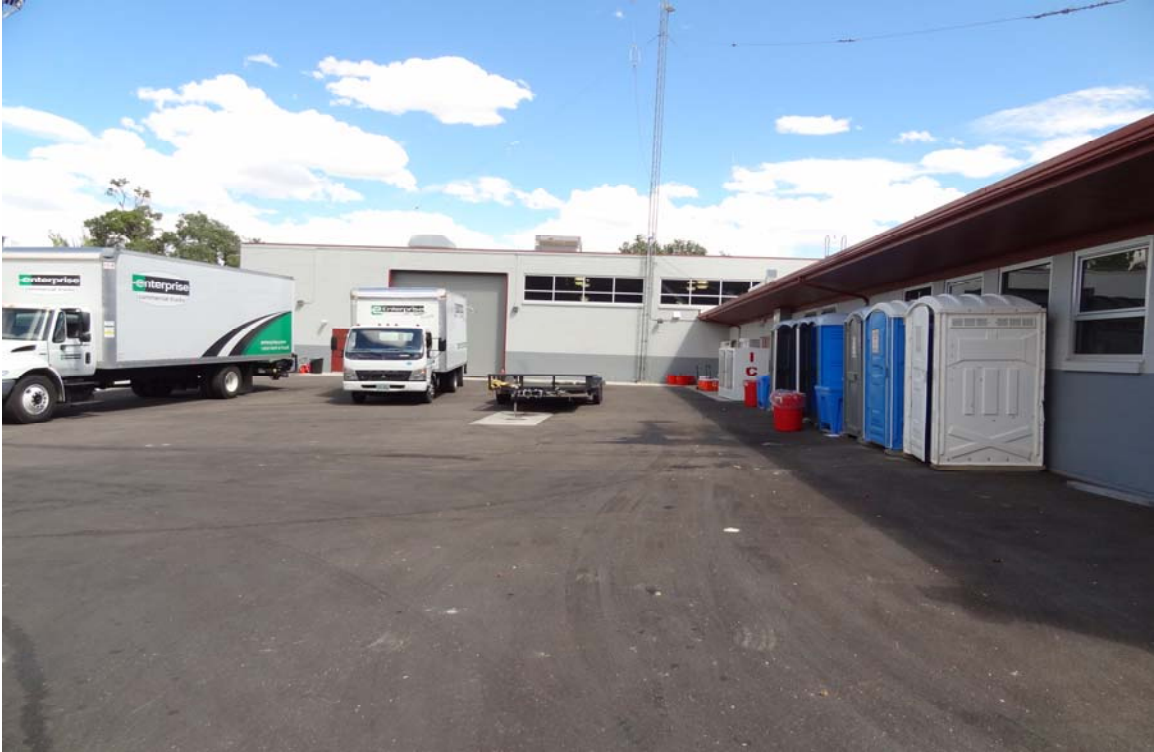
The existing paved area around the building is in good condition. This project would provide for striping some designated parking spaces which should be done within the next year and sealing the new AC paving in the next 5 years. The striping should be coordinated with the ADA parking/striping project. This project or a portion thereof was previously recommended in the FCA report dated 08/16/2005. It has been amended accordingly to reflect conditions observed during the most recent survey date of 08/24/2011.

Ely Armory Site - Site #9841
Description: AC paving on north side of the building.

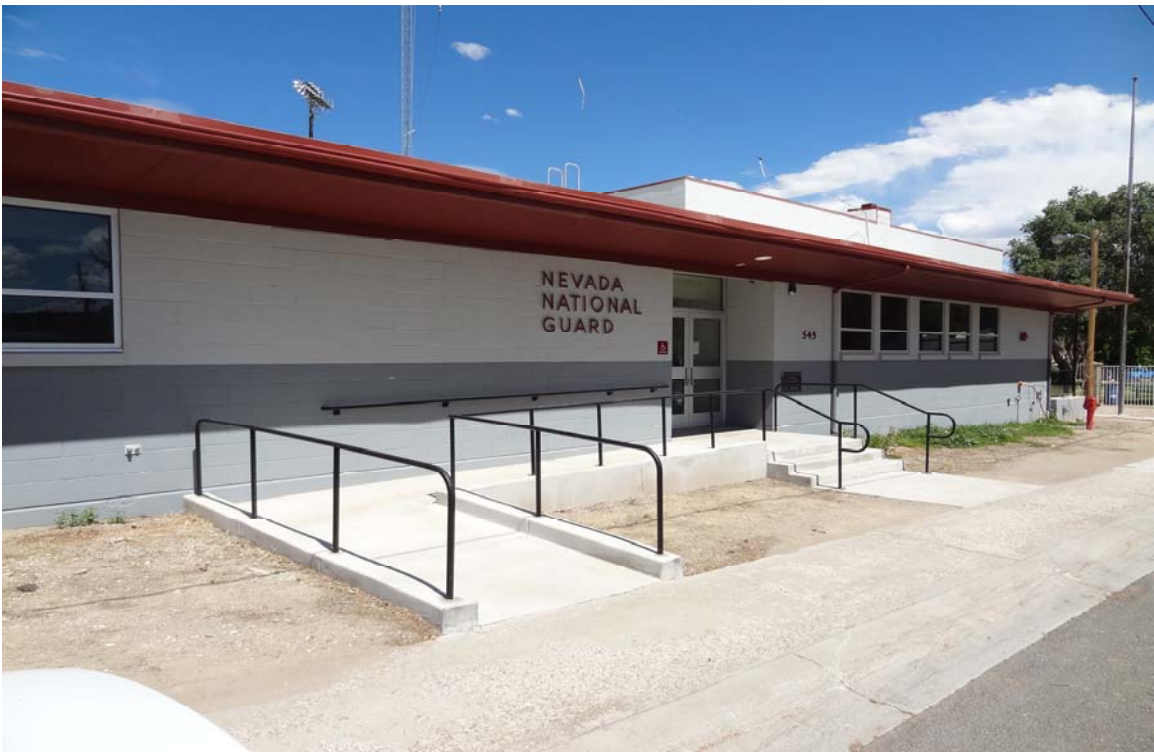
Ely Armory - Building #0676
Description: ADA accessible ramp into building.

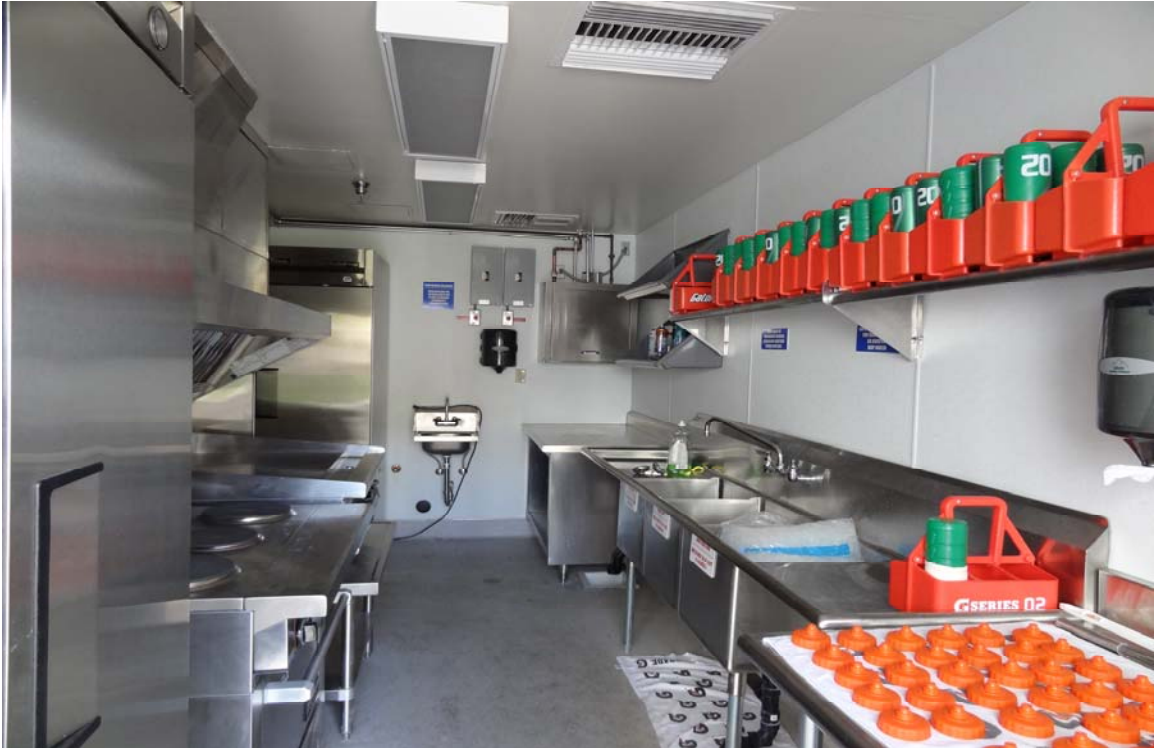
Ely Armory - Building #0676
Description: View of the kitchen.

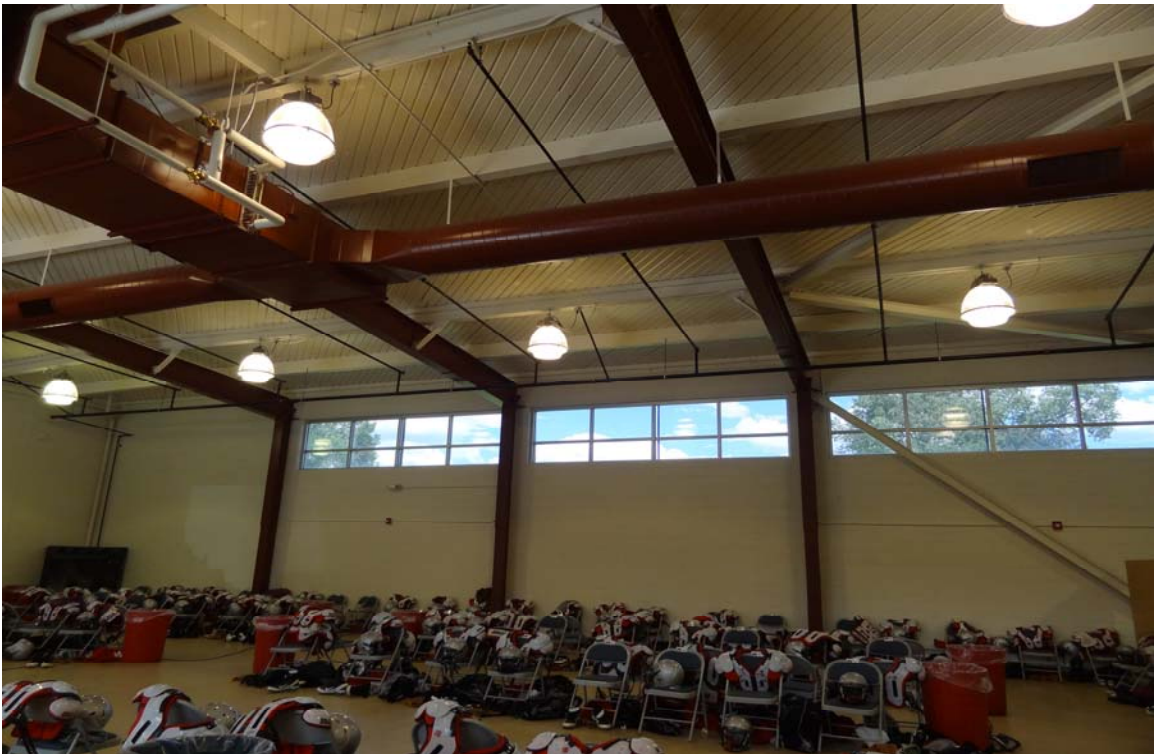
Ely Armory - Building #0676
Description: View of the gym / drill hall.

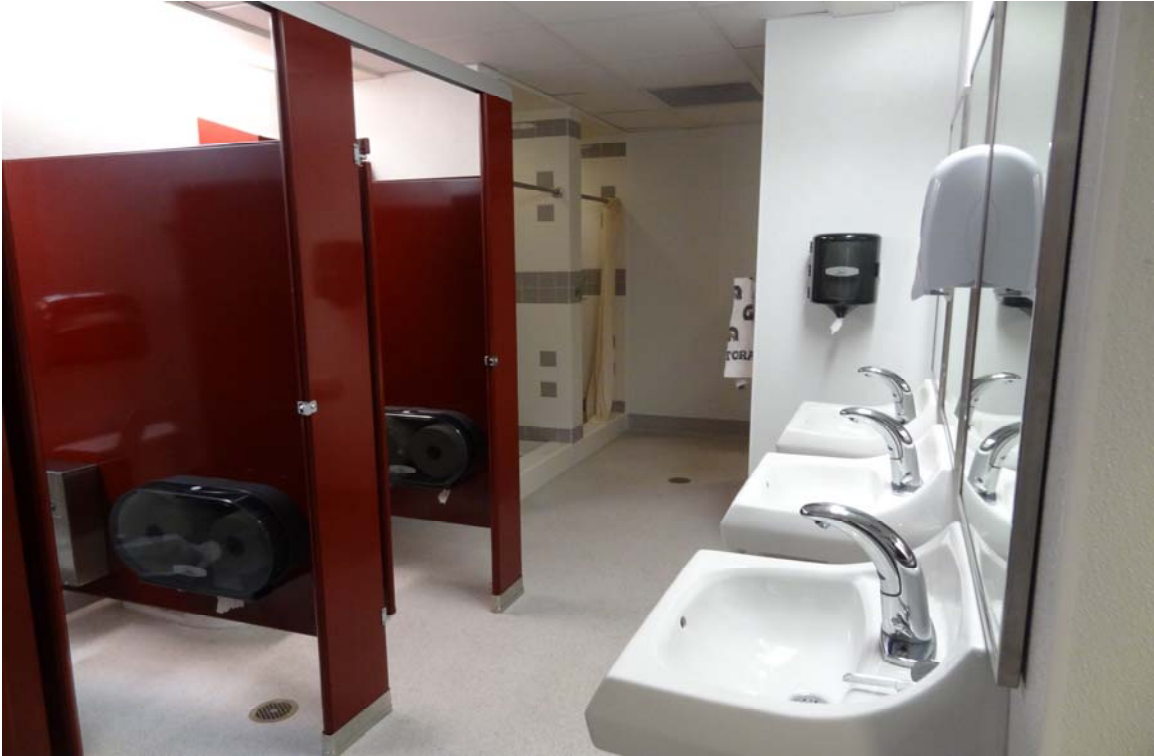
Ely Armory - Building #0676
Description: View of the restroom.

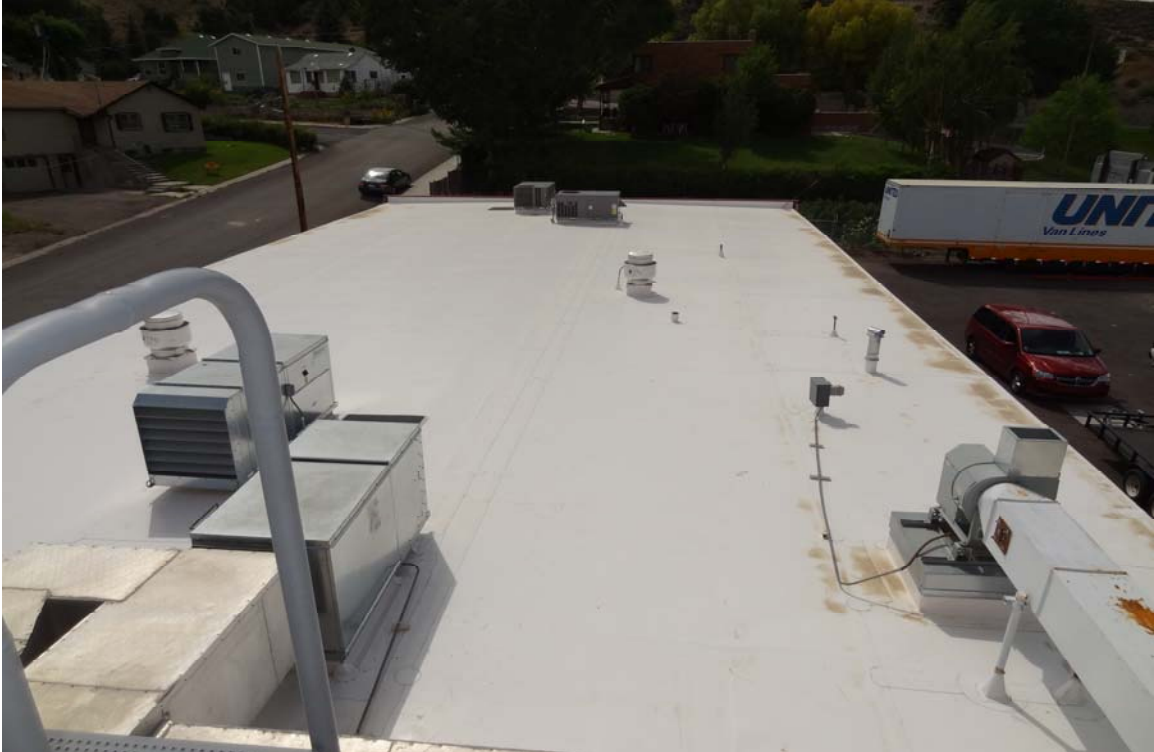
Ely Armory - Building #0676
Description: View of the roof and equipment.
