State of Nevada  
Department of Conservation & Natural Resources  
Division of Forestry  
Kyle Canyon Fire Station No. 1  
Facility Condition Analysis

# KYLE CANYON FIRE STATION NO. 1

State Route 157  
Kyle Canyon, Nevada

**Site Number: 9843**  
**STATE OF NEVADA PUBLIC WORKS BOARD**  
**FACILITY CONDITION ANALYSIS**

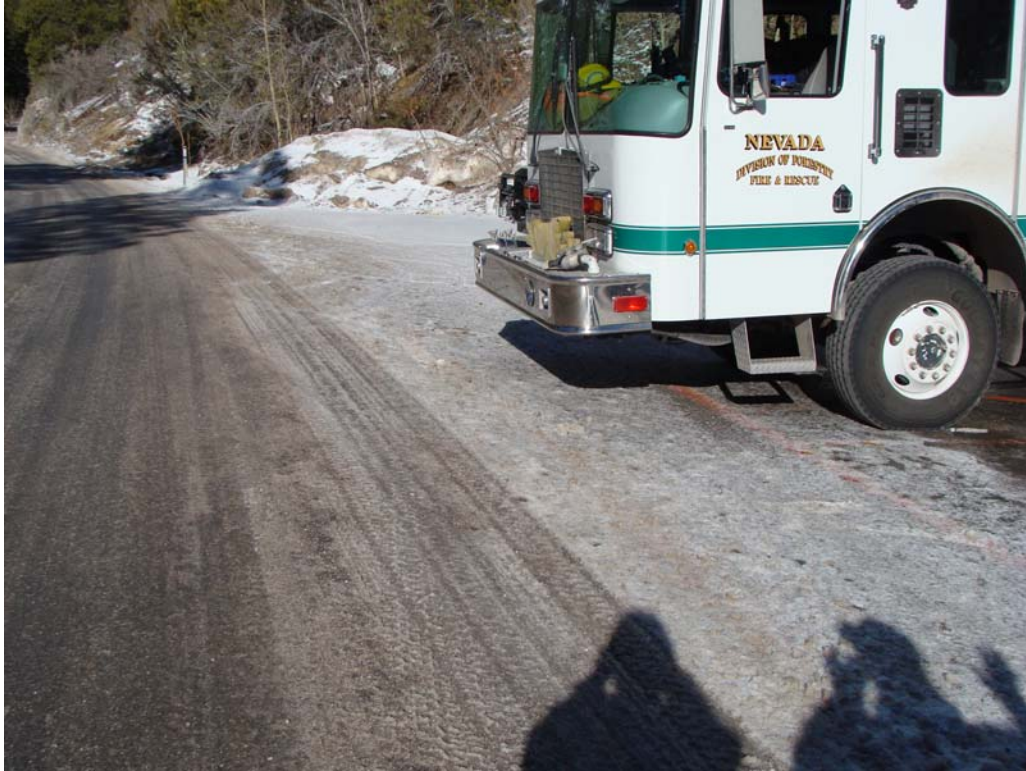
Kyle Canyon Fire Station No. 1 Site - Site #9843  
Description: State Route 157 and parking of apparatus.

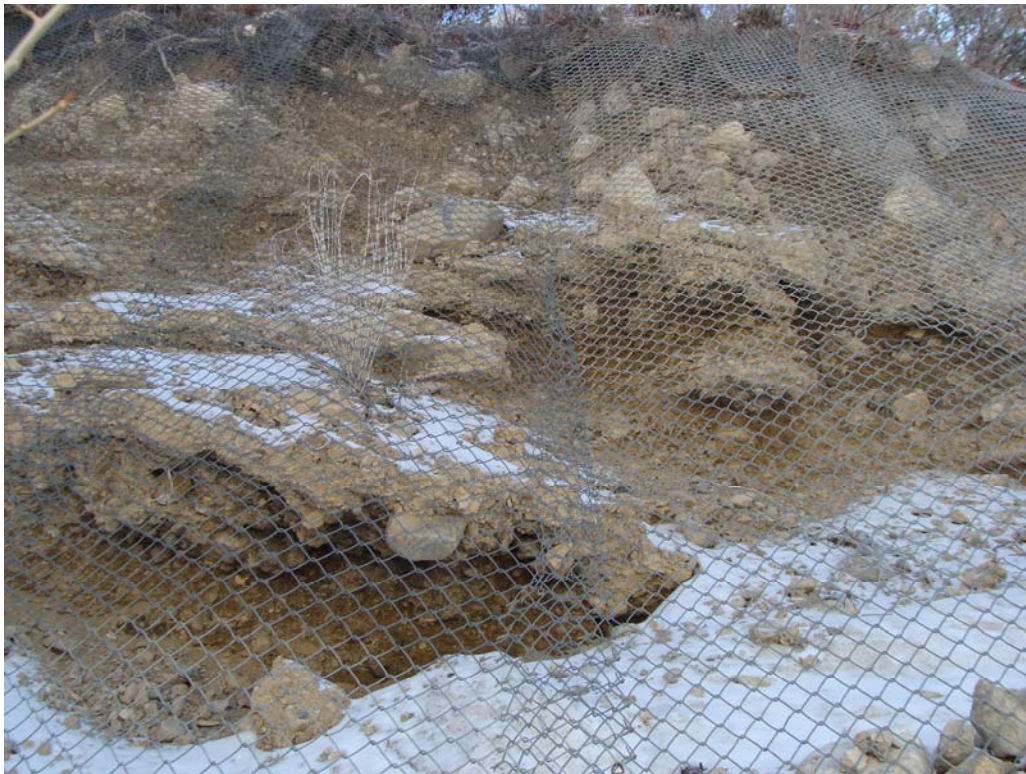
On the north side of the fire station, the exposed steep slope is eroding considerably. Rocks and debris roll down the hill and hit the building daily, as was observed during the survey. The dirt bank has slowly crept closer to the building and has left little space for rain and snow to drain around the building. This is now causing damage to the building from standing water and snow. There have been several minor improvements accomplished to control the situation, but it is apparent that a major improvement must happen in order to protect the building from permanent damage. This project recommends installing a retaining wall between the building and the slope in order to provide proper drainage and erosion control. The estimate is based on a 100 foot long, 12'-0" high reinforced concrete masonry unit retaining wall. An engineered rockery wall or gabions may be used based on what would be the most cost effective solution per the final design from an engineer.

Kyle Canyon Fire Station No. 1 Site - Site #9843  
Description: Unstable slope directly behind station.

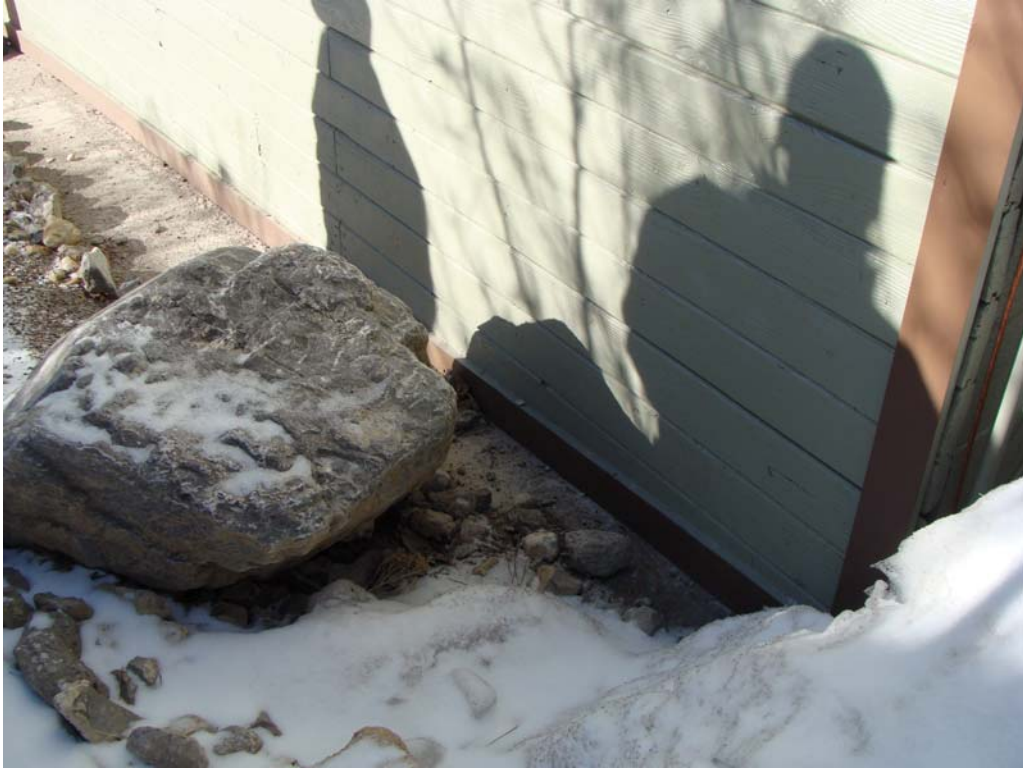
Kyle Canyon Fire Station No. 1 Site - Site #9843  
Description: Fallen debris from slope above.

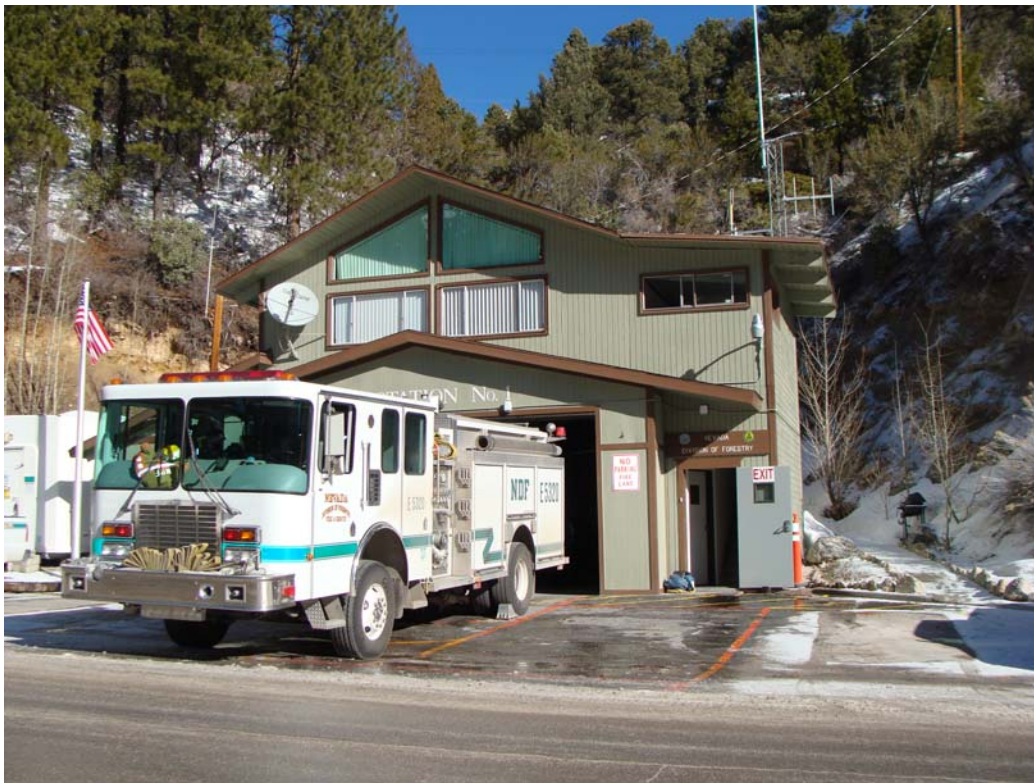
Kyle Canyon Fire Station No. 1 - Building #0285  
Description: Exterior of the building.

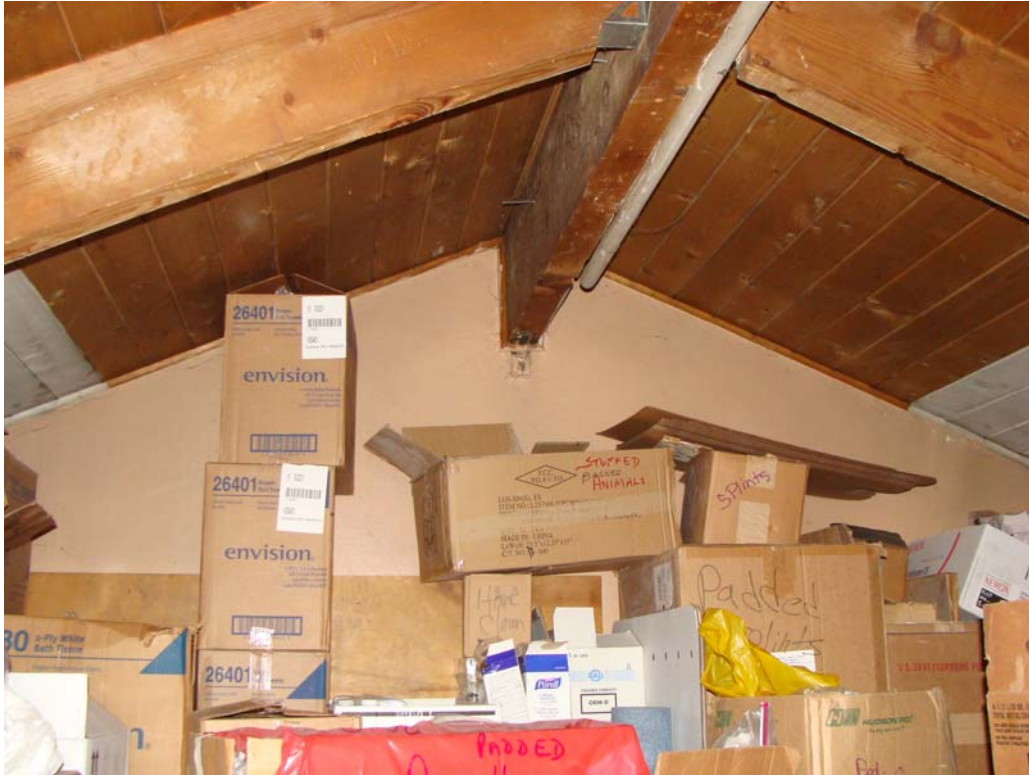
The asphalt composition shingle roof on this building was in poor condition at the time of the survey and the roof assembly does not have any insulation. It is recommended that this building be re-roofed in the next one to two years with a new 50 year asphalt composition roofing shingle, new underlayments, and a rigid insulation and sleeper system installation over the existing 2x6 T&G decking. This estimate includes removal and disposal of the old roofing.

Kyle Canyon Fire Station No. 1 - Building #0285  
Description: View of the unisulated attic space.

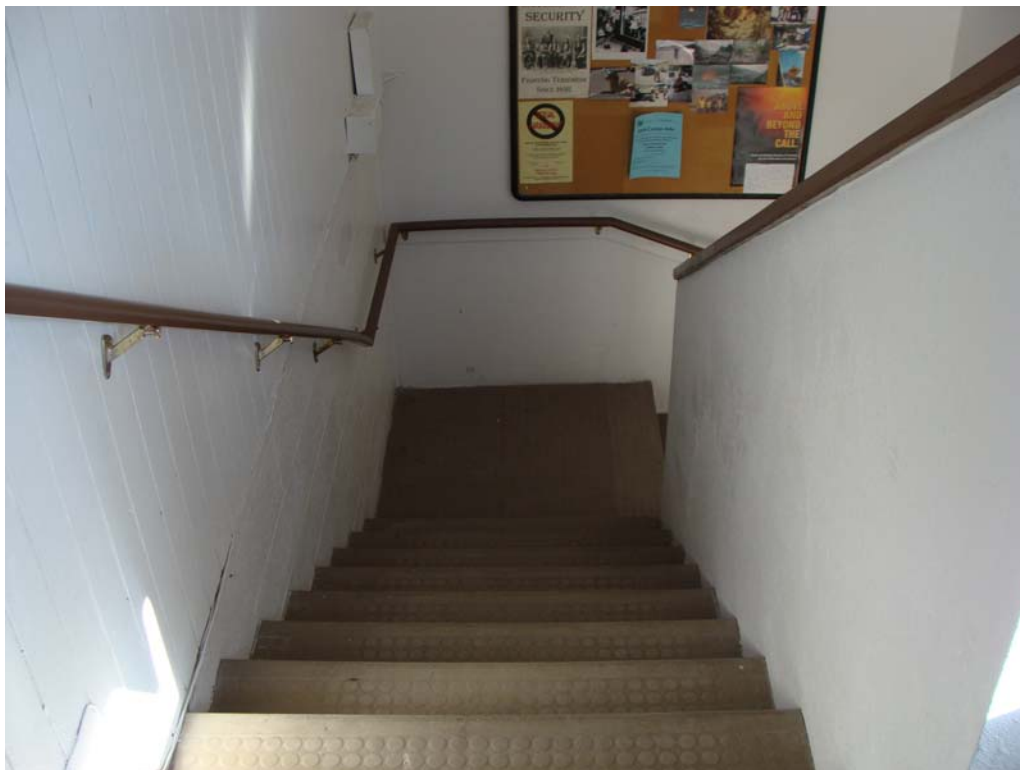
Kyle Canyon Fire Station No. 1 - Building #0285  
Description: Entry stairs to living quarters.

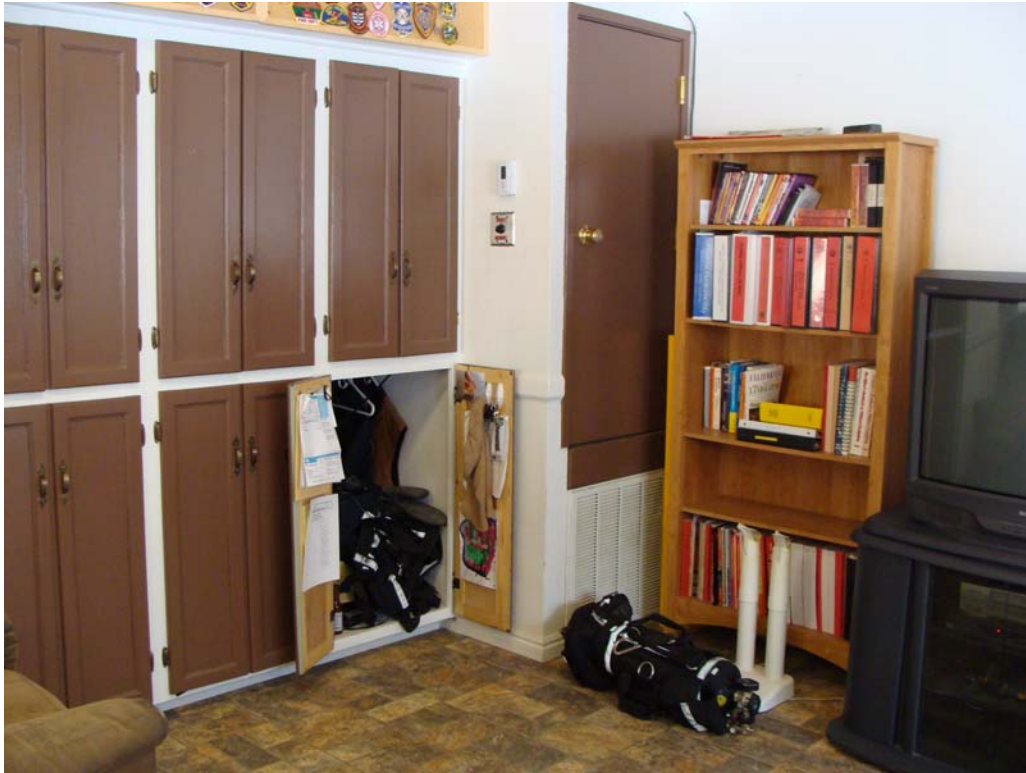
Kyle Canyon Fire Station No. 1 - Building #0285  
Description: View of the bedroom and staff lockers.

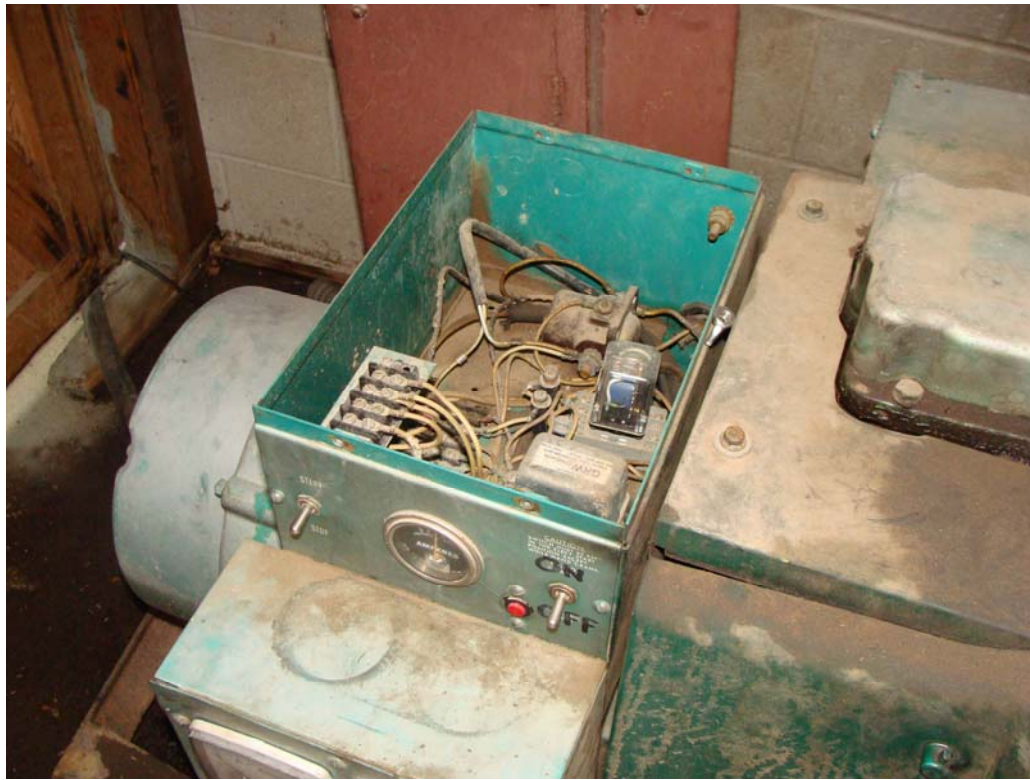
There is a propane-fired generator on site that has reached the end of its expected life. It does not have automatic switch gear, has poor ventilation and the existing location provides for poor access, especially during times of snow. The generator provides backup power for the building which is a high priority based on the function of the building. It is recommended that a new 12 kW propane-fired generator be installed. This estimate includes removal and disposal of the old roofing.

Kyle Canyon Fire Station No. 1 - Building #0285  
Description: Emergency generator.
