State of Nevada
Department of Conservation & Natural Resources
Division of Forestry
Lee Canyon Fire Station No. 2
Facility Condition Analysis

LEE CANYON FIRE STATION NO. 2

State Route 156
Lee Canyon, Nevada

Site Number: 9844
STATE OF NEVADA PUBLIC WORKS BOARD
FACILITY CONDITION ANALYSIS

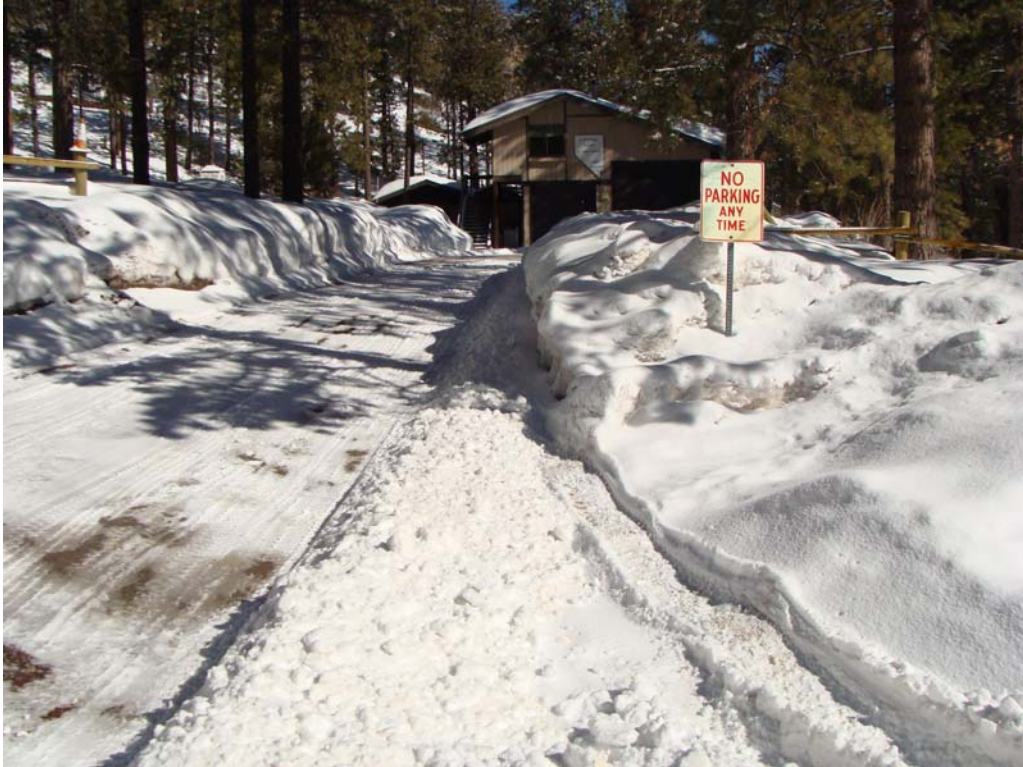
Lee Canyon Fire Station No. 2 Site - Site #9844
Description: Ingress / egress to fire station.

The access road and parking area in front of the building are not paved. This project would provide asphalt cement paving for a 20' wide access road and a parking area in front of the building. The estimate includes grading, 6" base, compaction, and installation of 4" thick asphalt cement paving. The final design may require different thicknesses of the base and paving, and impact the construction cost estimate.

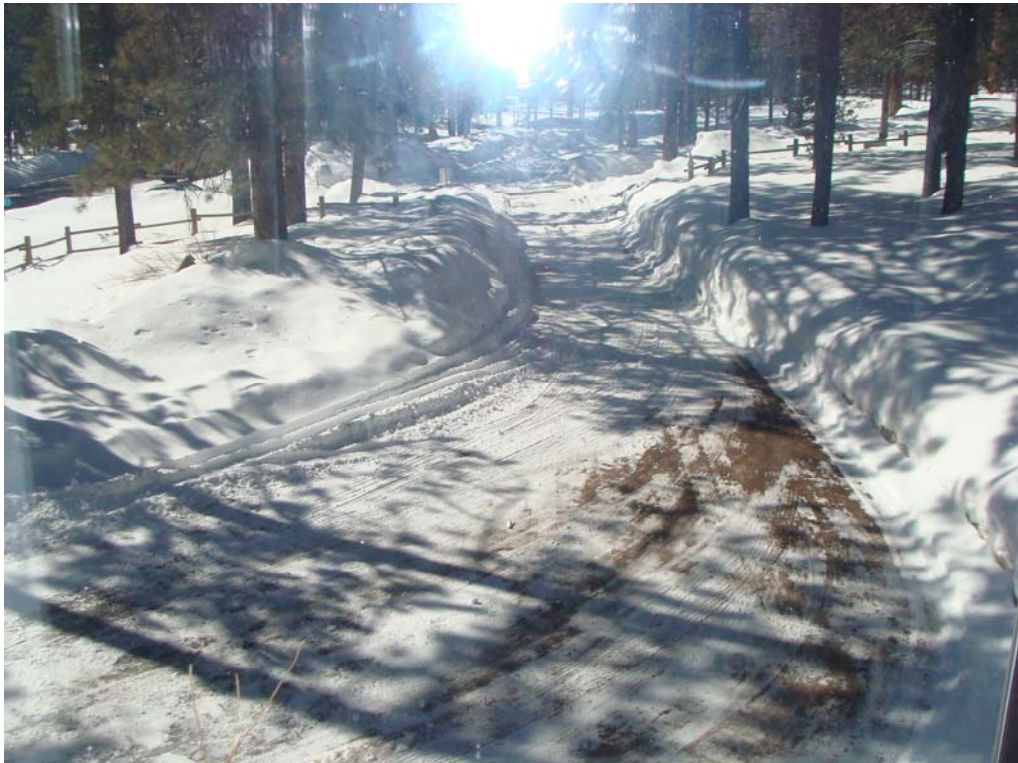
Lee Canyon Fire Station No. 2 Site - Site #9844
Description: View of the driveway from the garage.

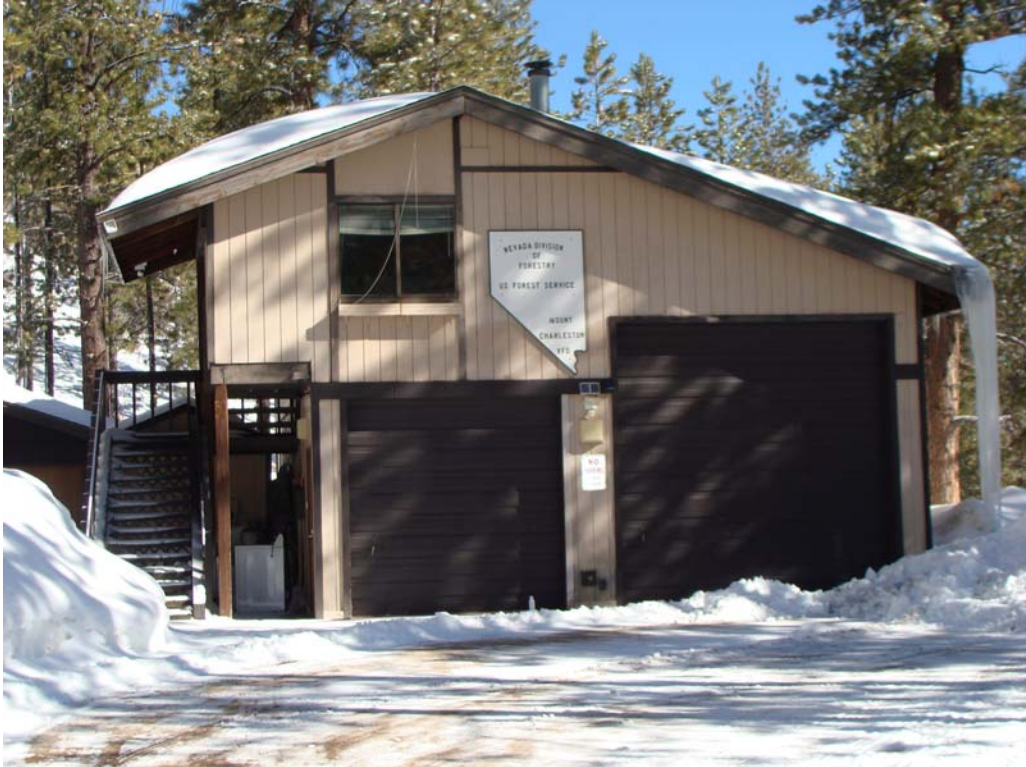
Lee Canyon Fire Station No. 2 - Building #0284
Description: Exterior of the building.

It is important to maintain the finish, weather resistance, and appearance of the building. This project would provide funding to protect the exterior of the building. Included in the cost is sanding, priming and painting, and caulking of the windows, flashing, fixtures, and all other penetrations. The paint scheme should match the nearby U.S. Forestry structure. It is recommended that the building be painted in the next year and that this project be scheduled on a cyclical basis to maintain the integrity of the structure.

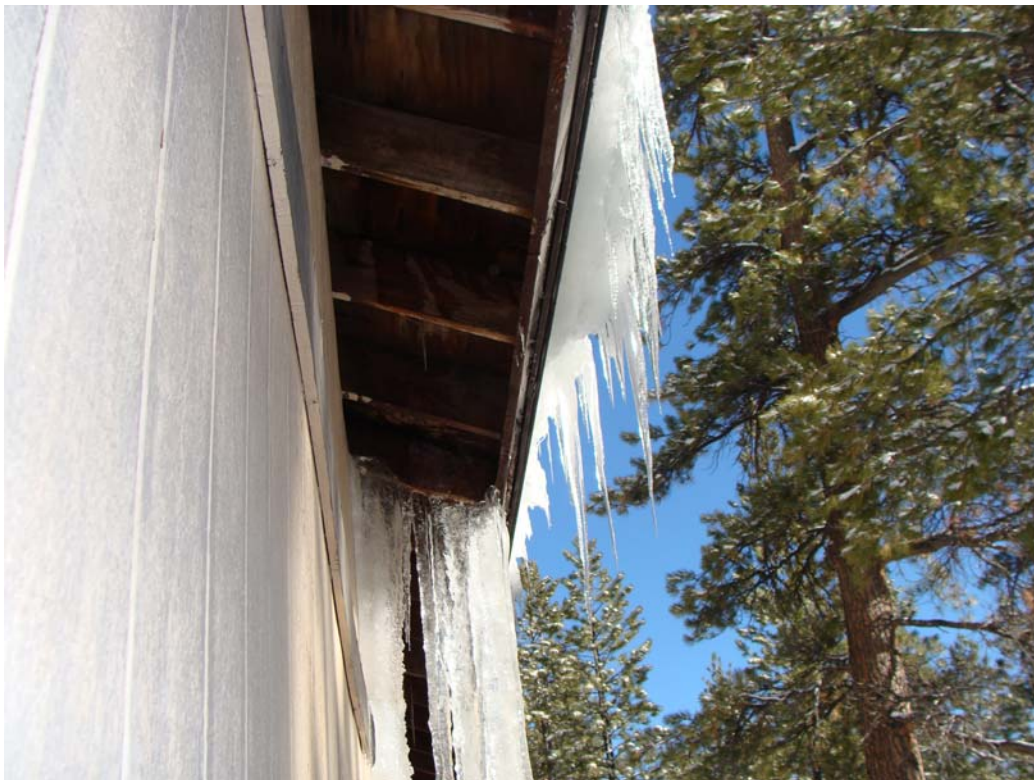
The asphalt composition shingle roof on this building was in poor condition at the time of the survey including many active leaks and ice dam problems. It is recommended that this building be re-roofed in the next one to two years with a new 50 year asphalt composition roofing shingle and new underlayments. This estimate includes removal and disposal of the old roofing.

Lee Canyon Fire Station No. 2 - Building #0284
Description: Ice damming on the roof.

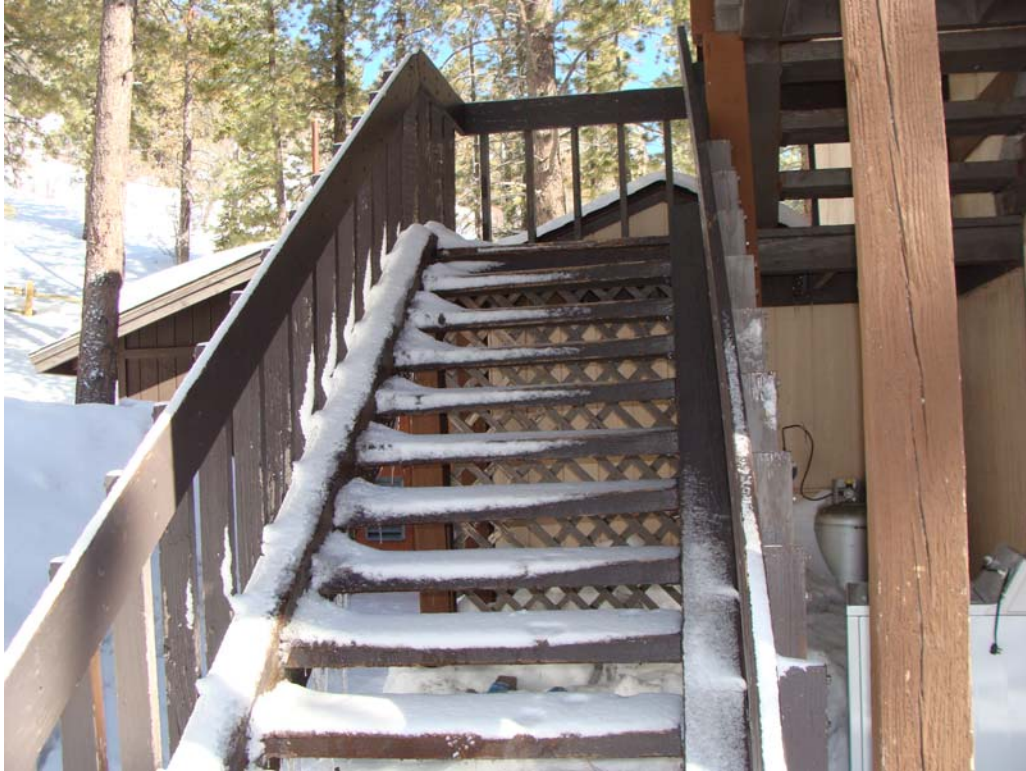
Lee Canyon Fire Station No. 2 - Building #0284
Description: Entry stairs, only entrance to facility.

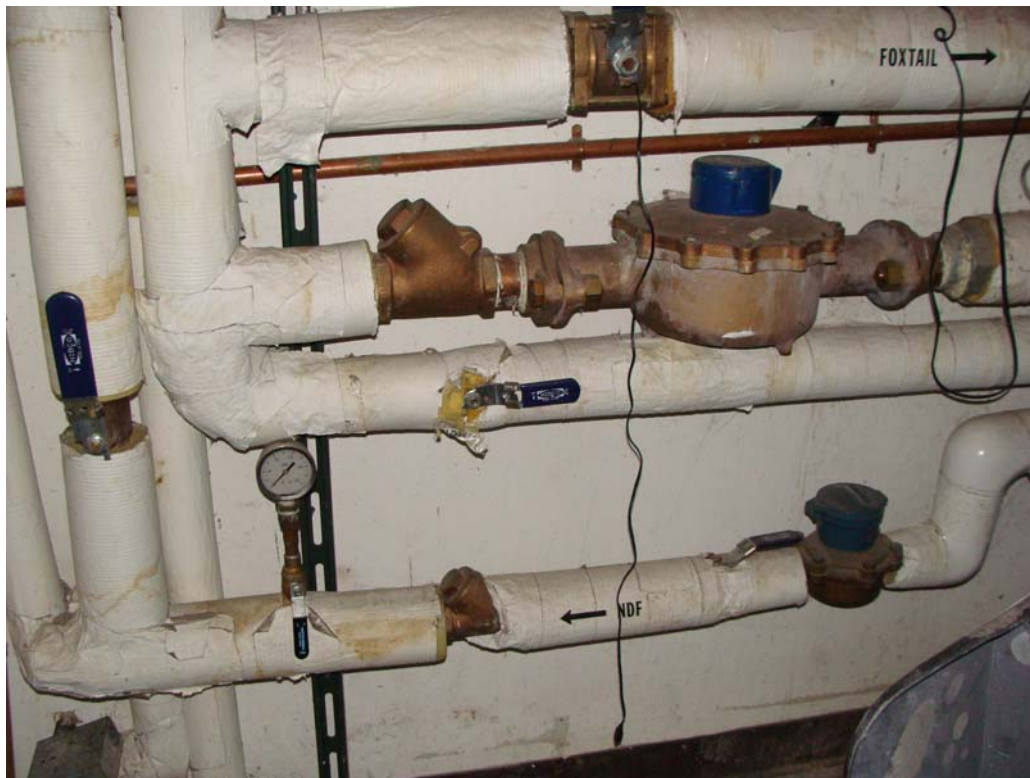
The plumbing and waste system is older, subject to freezing, and in poor condition. Most of the system appears to be original to the building and should be scheduled for replacement. This project recommends replacing all of the water and sewer lines in the building. This estimate includes removal and disposal of the existing system as required.

Lee Canyon Fire Station No. 2 - Building #0284
Description: Domestic water distribution piping.

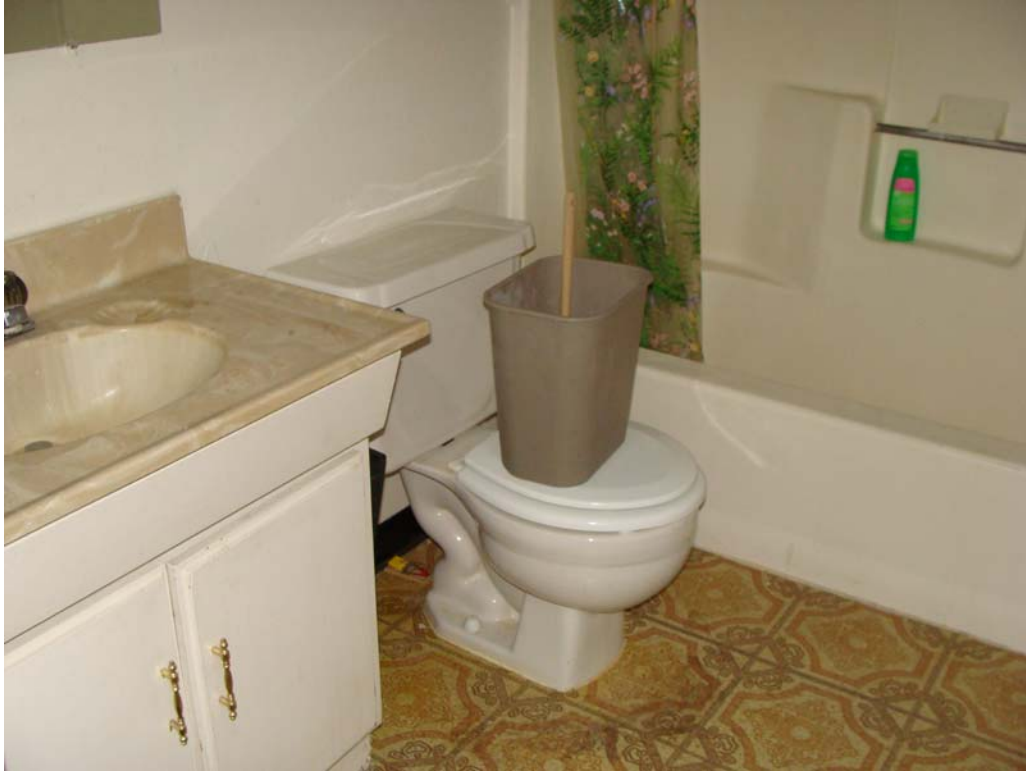
Lee Canyon Fire Station No. 2 - Building #0284
Description: Interior of the restroom.

The interior fixtures and finishes are in general disrepair and the building is due for a complete remodel. The fire station is also lacking ADA compliance and segregated living quarters for female firefighters. It is recommended that the interior walls be painted at least once in the next two years. Prior to painting, all surfaces should be repaired and prepped. An epoxy-based paint should be utilized in wet areas for durability. This project would also provide for removal and replacement of the flooring, interior doors and frames, cabinetry, trim, baseboards, kitchen appliances, lighting fixtures, restroom fixtures and any other interior finishes and fixtures in need of replacement at the time. The wall mounted gas lamps are a fire hazard. These should be removed and replaced with T-8 or CFL light fixtures. In order to provide ADA compliance, a new unisex restroom may need to be built in the garage. If there is not enough space for the segregated living quarters, an addition may need to be undertaken to provide this space. This project provides a lump sum construction cost estimate for the items described in this project only.

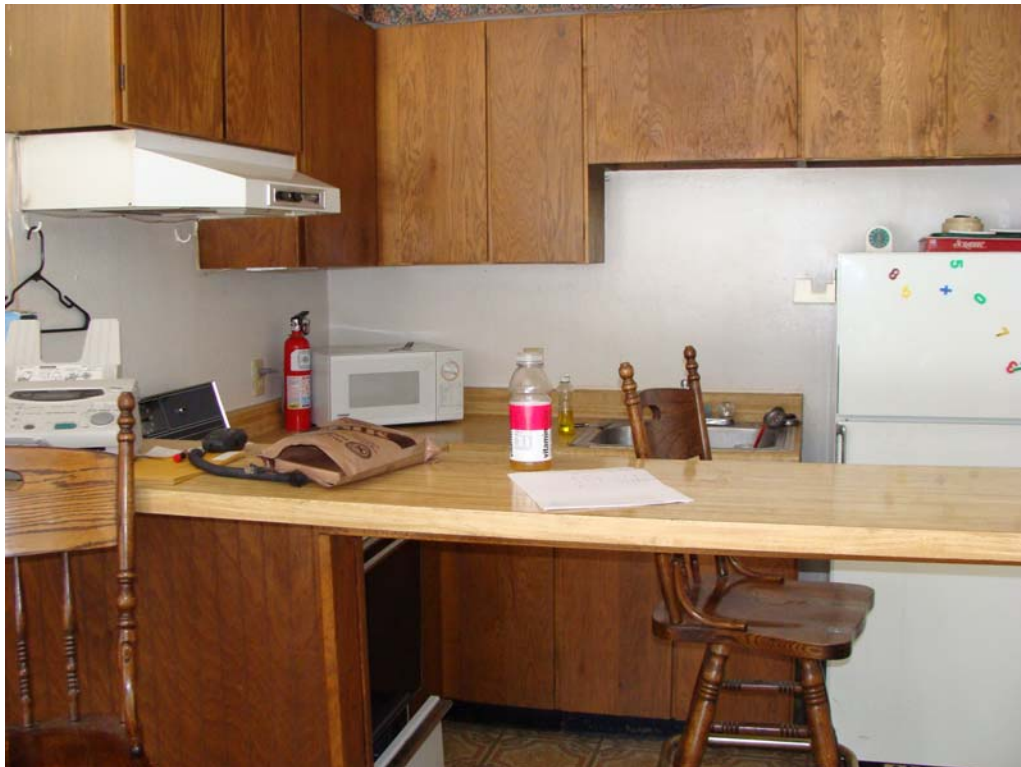
Lee Canyon Fire Station No. 2 - Building #0284
Description: Interior of the kitchen.
