RENO PURCHASING WAREHOUSE

2250 Barnett Way
Reno, Nevada 89512

Site Number: 9845

STATE OF NEVADA PUBLIC WORKS DIVISION FACILITY CONDITION ANALYSIS

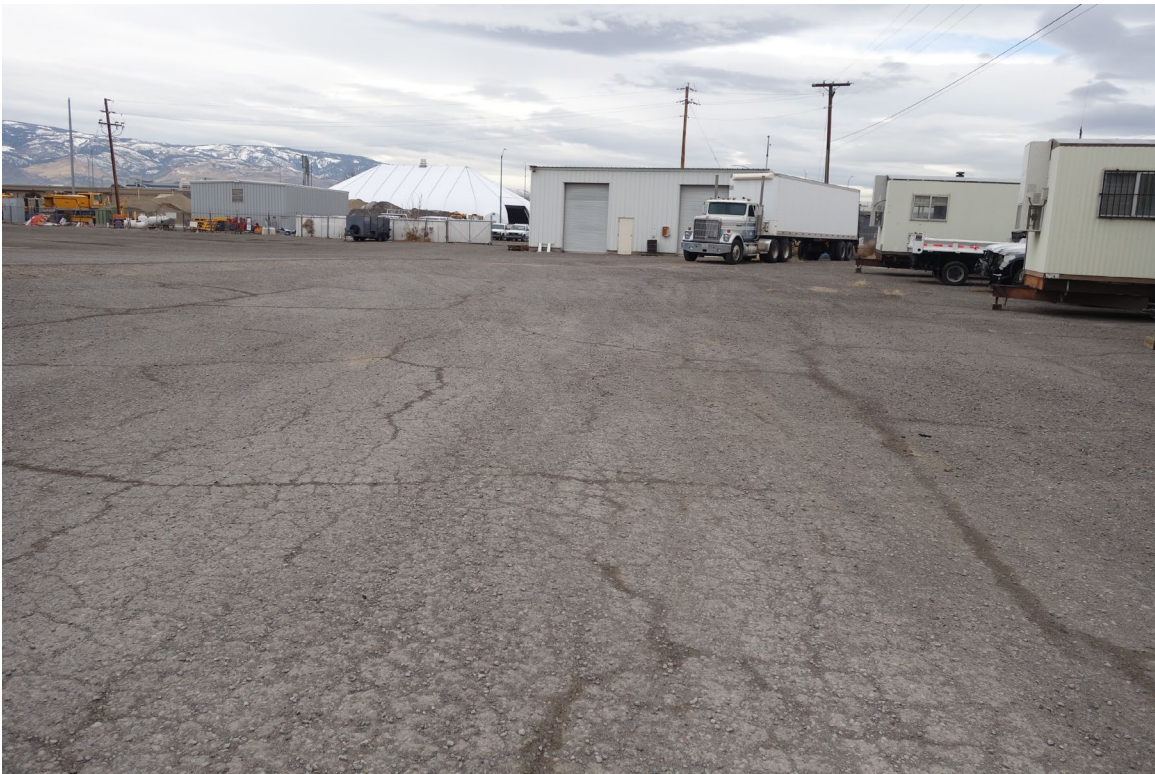
The asphalt around the building has failed, with significant alligating, settling, cracks and complete erosion. This project covers the removal and replacement of the existing asphalt for parking and site access. Striping for safety, parking and loading zones is included in this estimate. 120,000 square feet was used to generate this estimate.

Reno Purchasing Warehouse Site - Site #9845
Description: Damaged AC Paving Replacement Needed.

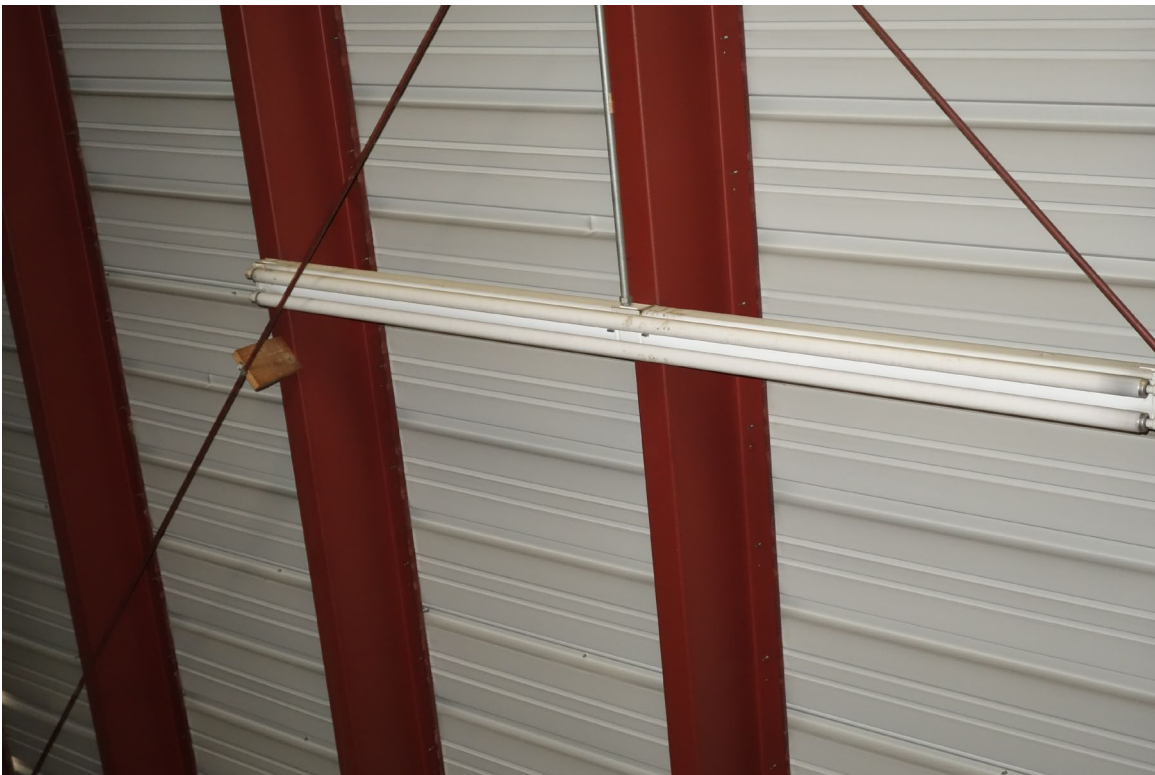
The existing lighting fixtures are the older fluorescent type and are not energy efficient. This project will upgrade fixtures to higher efficiency units with a longer life cycle. 5,000K LED lamps, without the ballasts are suggested, and new tombstones (if needed). Occupancy sensors will be installed in low occupancy areas for additional savings. Electrical wiring upgrades are not included in this estimate.

Storage Building - Building #3098
Description: Lighting Upgrade Recommended.

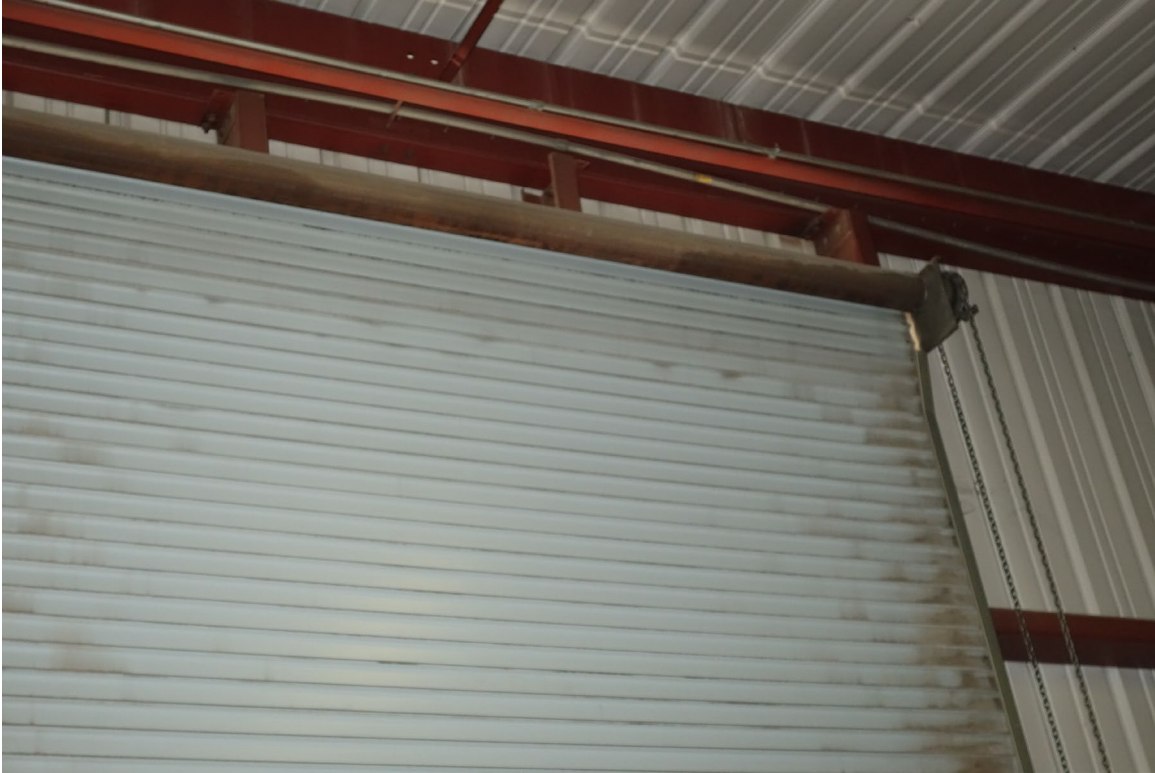
There are two 10'x14' overhead coiling doors which are damaged and do not function properly. It is original to the building and should be scheduled for replacement. This project would provide for the removal and disposal of the manually operated overhead coiling door and replacement with a motorized door.

Storage Building - Building #3098
Description: Overhead Coiling Door Replacement Recommended.

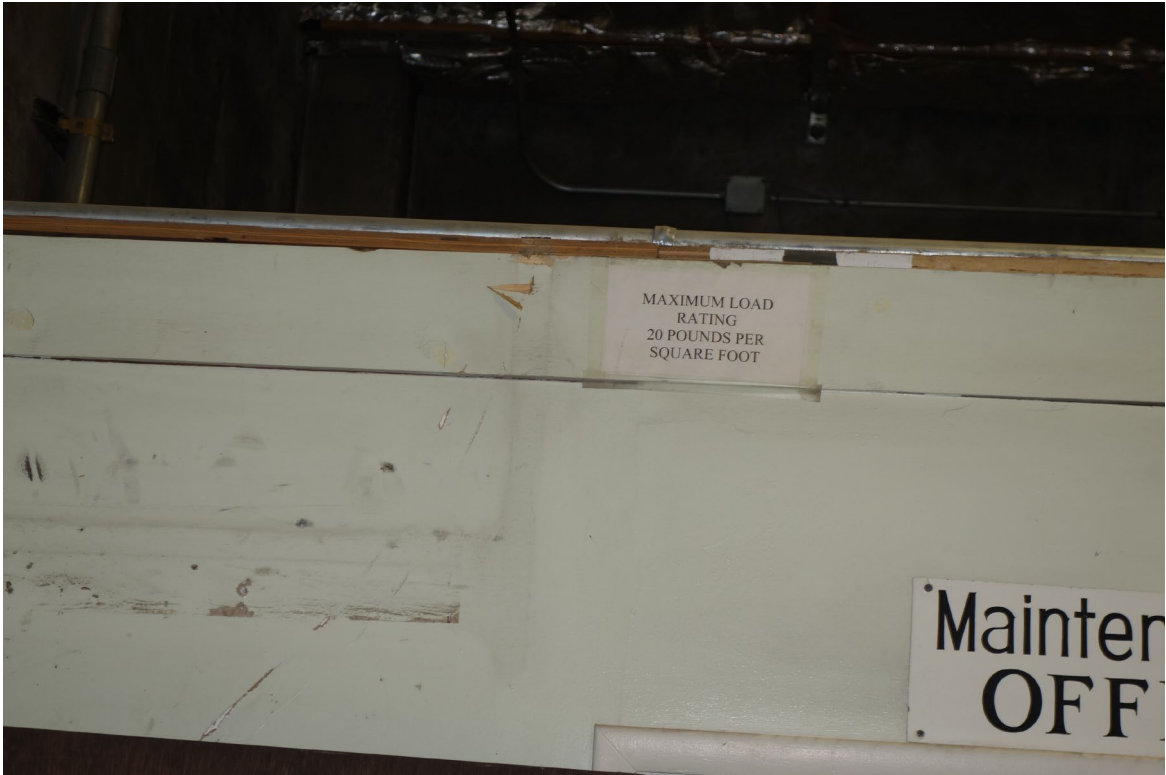
The hard lid over the B&G office was previously been used for storage. A sign is still posted with the load rating, however, the space is no longer used for storage due to lack of structural evaluation. This project will provide for the removal of the existing load rating signage and installation of new signage signifying "No Storage" on the perimeter of the hard lid.

Reno Purchasing Warehouse - Building #0399
Description: B&G Office Hard Lid “No Storage” Signage Needed.

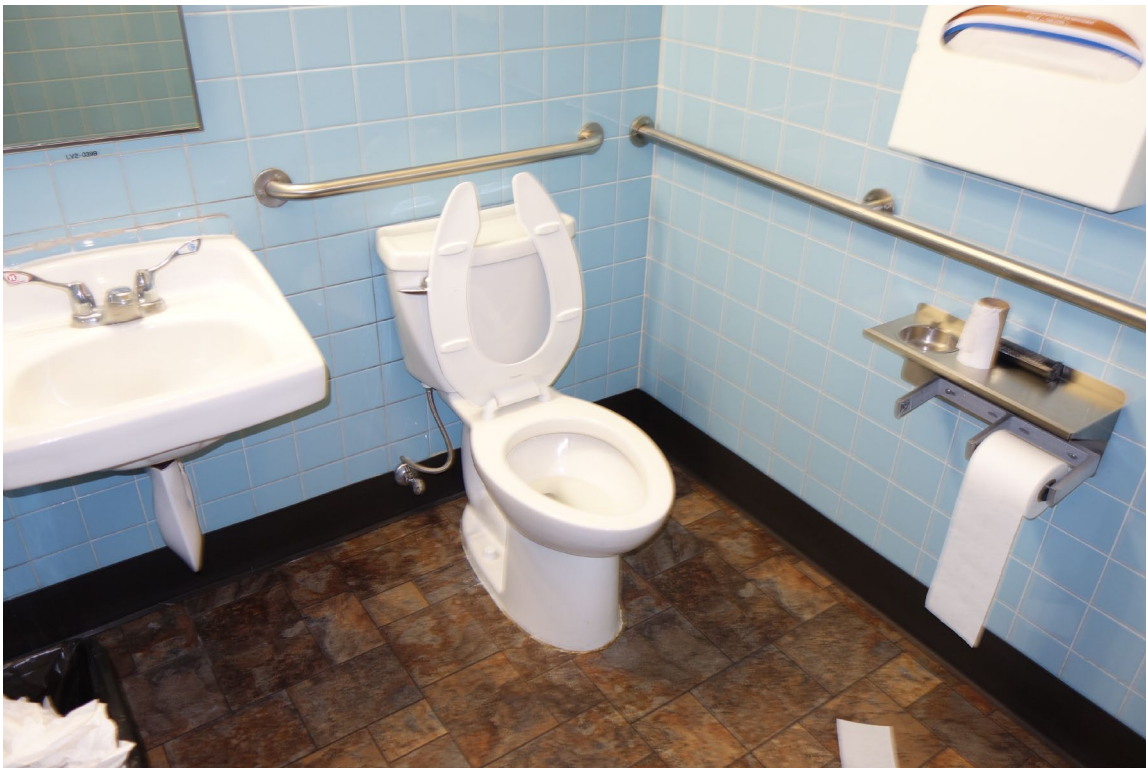
The existing restrooms do not meet the Americans with Disabilities Act (ADA) requirements. A complete retrofit is necessary. This project would provide funding for remodeling the Men's and Women's restrooms into ADA compliant restrooms. These items may include a new sink, toilet, hardware, mirrors, fixtures, flooring and paint. NRS 338.180, IBC - 2018, ICC/ANSI A117.1 and the most current version of the Americans with Disabilities Act Accessible Guidelines (ADAAG) were used as a reference for this project.

Reno Purchasing Warehouse - Building #0399
Description: View of Non-ADA Compliant Restroom - Toilet too far from wall.

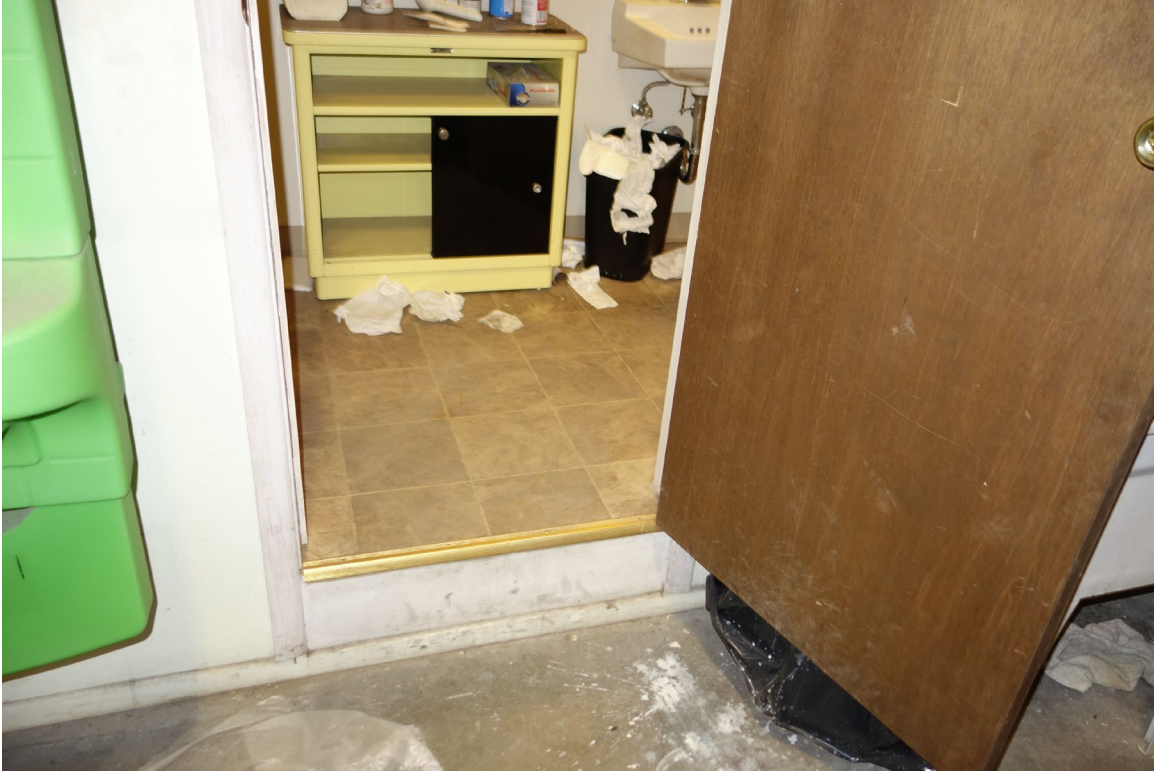
There is an out-swinging interior door at the B&G bathroom, which swings out over a step that does not have a landing. This does not comply with 2018 IBC Section 1008.1, which requires a proper landing and for the landing to not be more than 1/2" below the threshold. This project would provide for the installation of compliant landings and accessible ramp.

Reno Purchasing Warehouse - Building #0399
Description: B&G Office Restroom Landing Needed.

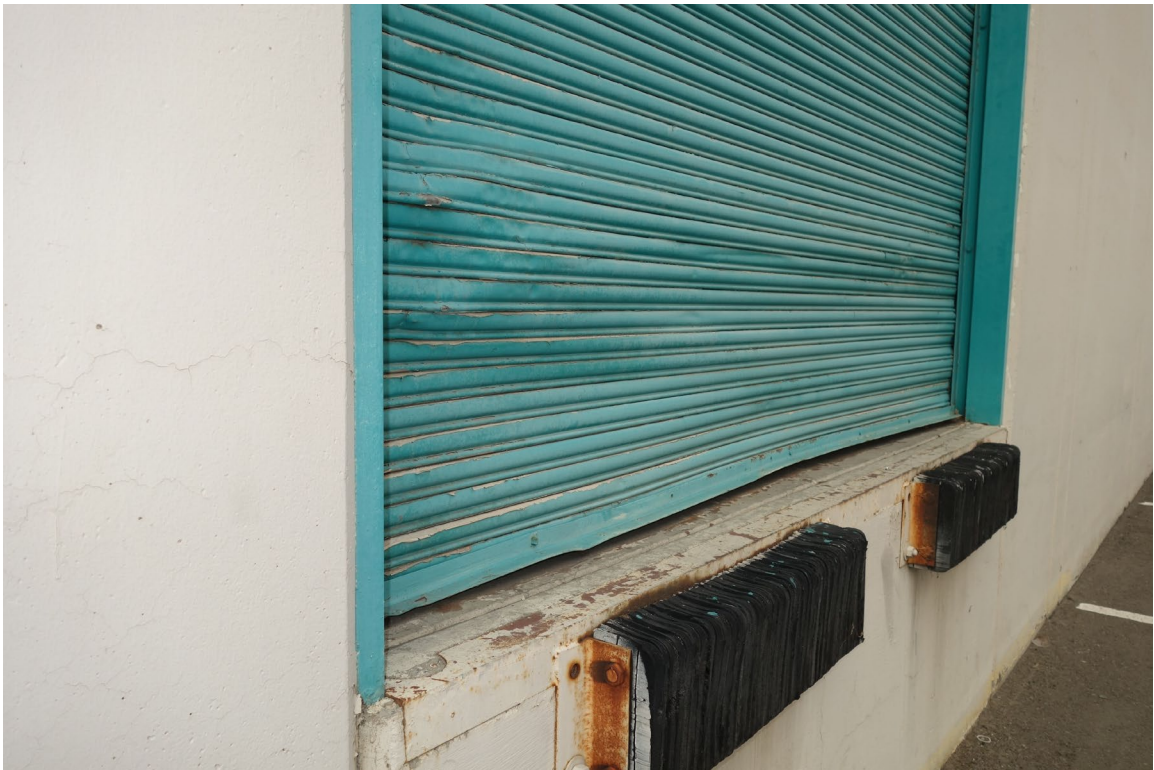
There are six overhead coiling doors throughout the facility in various stages of disrepair. Three of the doors are damaged and do not function properly. Exposure, wind and general wear and tear have caused the doors to bend, crack and lose their finish. They are original to the building and should be scheduled for replacement. The other three doors are in need of new weather seals to minimize air and debris infiltration. This project would provide for the removal and disposal of the doors and installing new weather seals.

Reno Purchasing Warehouse - Building #0399
Description: Damaged Overhead Coiling Doors Replacement Needed.

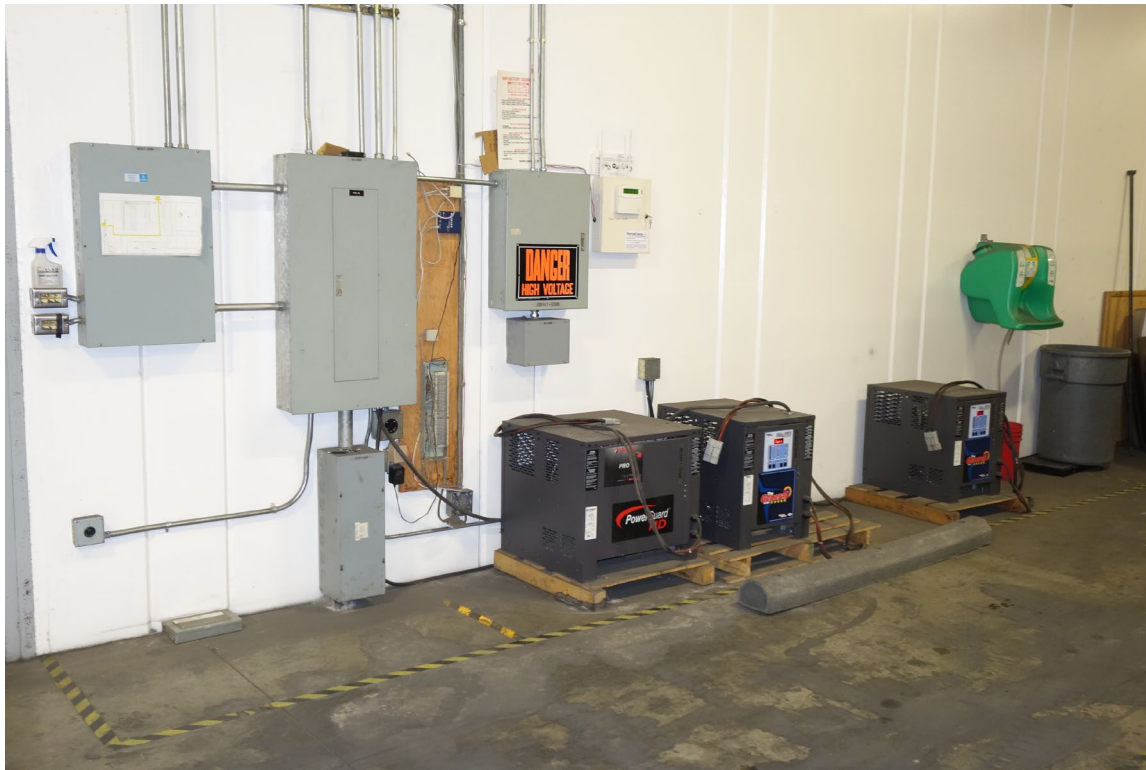
An arc flash and electrical coordination study has not been performed or is more than 5 years since the last coordination study. The latest electrical code requires coordination studies be verified and performed every 5 years and arc flash labeling on all electrical panels to provide the safety requirements for maintenance personnel. This project will perform the required coordination study, evaluation, adjustments and labeling for the building electrical distribution system.

Reno Purchasing Warehouse - Building #0399
Description: Arc Flash Study / Labeling Needed.

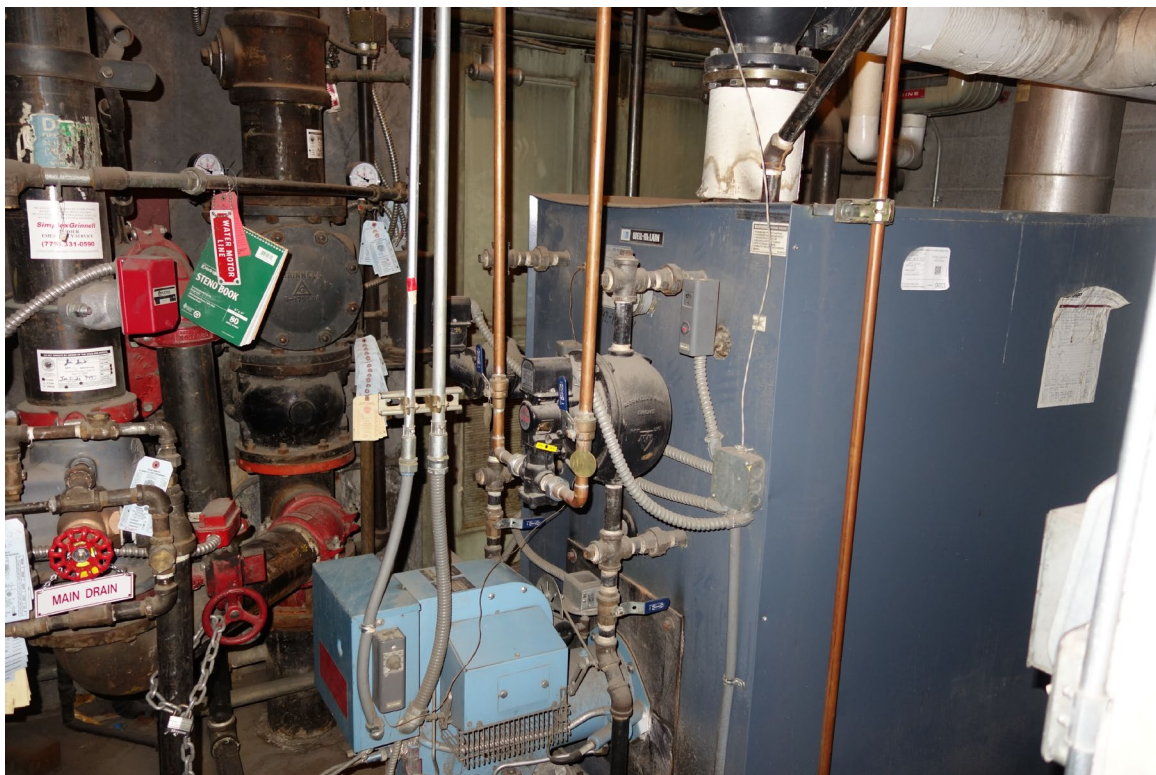
The hot water boiler servicing the building was installed almost 30 years ago and should be scheduled for replacement. The life expectancy of this unit is 20 to 25 years with proper maintenance and water treatment programs. Replacement parts for performing routine and emergency maintenance are hard to find for this older equipment. The controls and mixing valves should be replaced for the same reasons. There are currently several areas of the building which have stand alone electric heaters. It is recommended to remove those units and replace them with fan coil units serviced by the boiler. This project would provide for the removal and disposal of the existing boiler, controls and mixing valves and replacement with new equipment including all required connections to utilities and equipment. The estimate is based on a 1,700 MBH maximum output hot water boiler, associated equipment and new equipment to replace the electric heaters. The existing chemical water treatment system will need to be tested and adjusted once equipment is operational. \$2,000 is included in this estimate for testing of the chemical water treatment system.

Reno Purchasing Warehouse - Building #0399
Description: Boiler Replacement Planning Recommended.
