State of Nevada  
Department of Tourism & Cultural Affairs  
Division of Museums & History  
Museum Administration Office  
Facility Condition Analysis

# MUSEUM ADMINISTRATION OFFICE

708 North Curry Street  
Carson City, Nevada 89701

**Site Number: 9850**  
**STATE OF NEVADA PUBLIC WORKS DIVISION**  
**FACILITY CONDITION ANALYSIS**

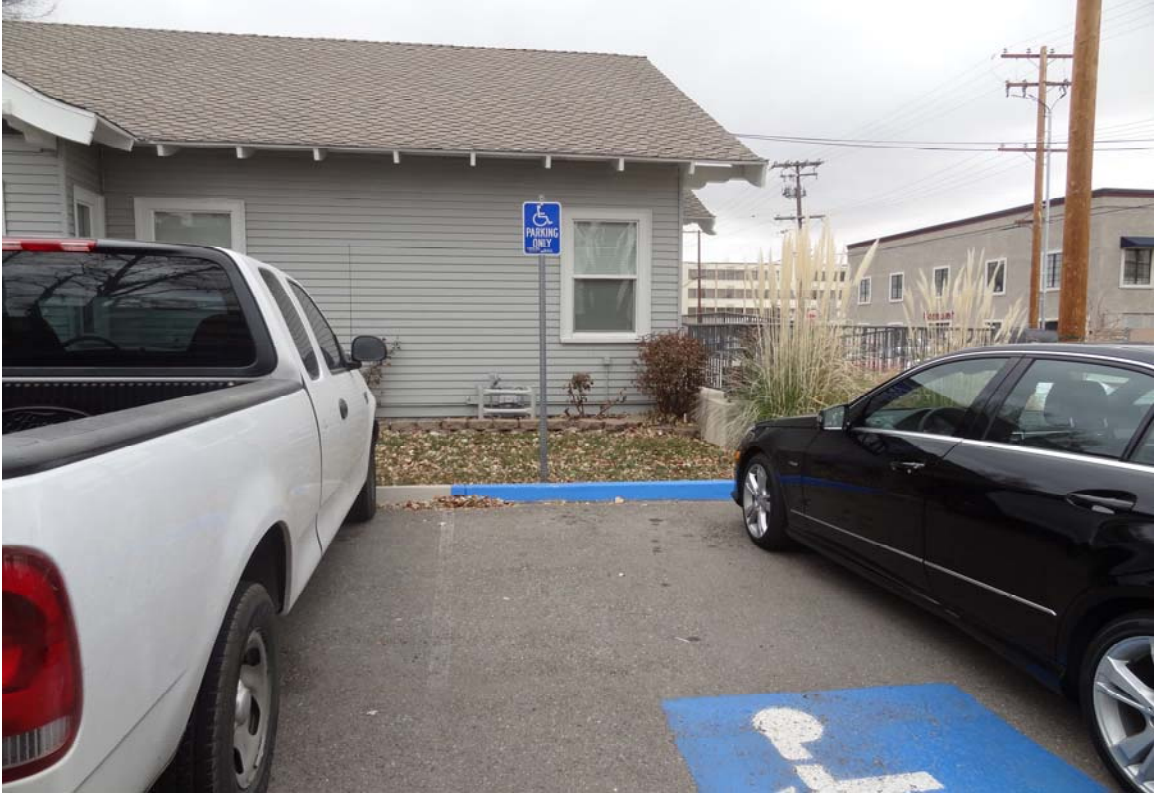
The Museum Administration site is located on North Curry Street and the building is on a large shared parcel of land owned by the State. It is mostly paved parking with one designated ADA accessible parking space. Staff indicated that maintenance responsibility of the paving is not real clear and it is in need of some crack fill, sealing and striping. The site is serviced by city water and sewer services as well as natural gas and electricity. The ADA accessible route from the parking to the building is not compliant and part of the route is the sidewalk in front of the building to the ramp and stairs.

Museum Administration Office Site - Site #9850  
Description: ADA accessible parking.

It is important to maintain the asphalt concrete paving on the site. This project would provide for minor crack filling and slurry sealing of the paving in the parking lot. Striping and signage including updated ADA parking requirements are included in this estimate. This project should be scheduled on a 5 year cyclical basis to maintain the integrity of the paving and prevent premature failure. 15,000 square feet of asphalt area was used to generate this estimate. The pavement maintenance is currently Carson City's responsibility even though the State owns the property. This project is for information only.

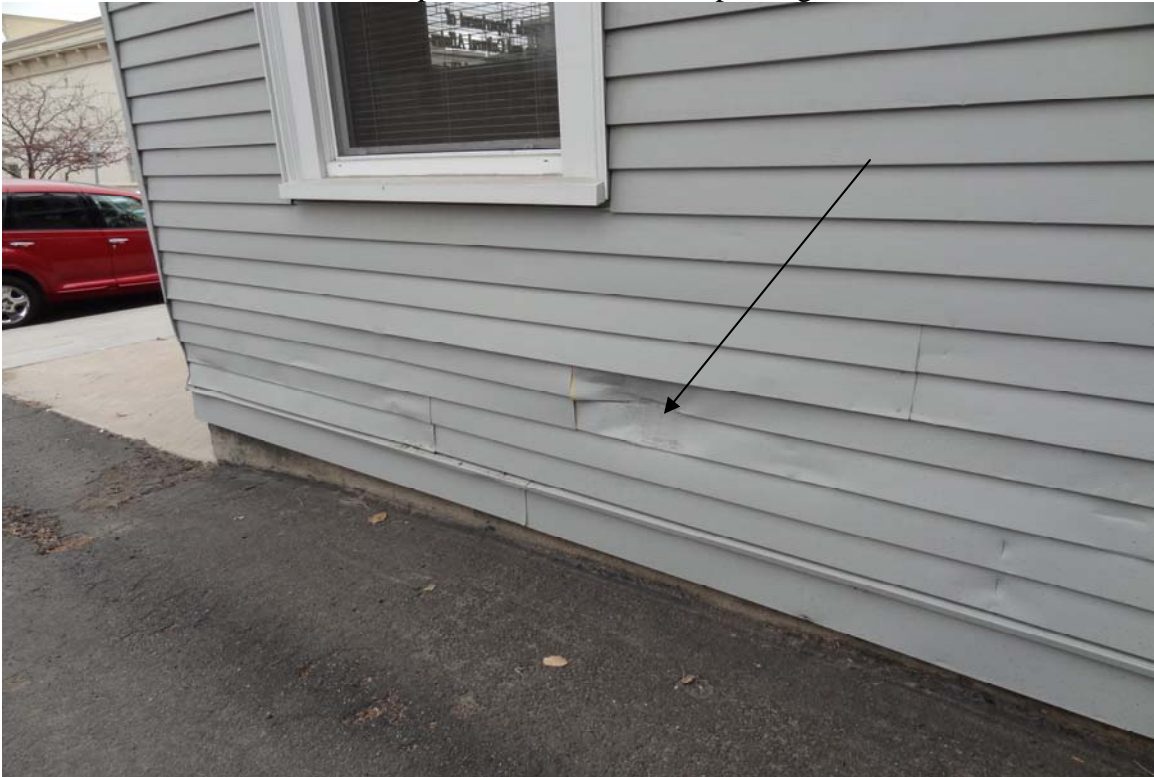
To the north of the building, there is a parking lot for the office building next door. There have been several incidents of vehicles colliding with the building and damaging the siding and possibly the structure. This area is in need of pipe bollards to protect the building. This project would provide funding for 4 eight inch diameter pipe bollards to be located near the north elevation of the building.

Museum Administration Office - Building #2028  
Description: Exterior of the building, note damaged siding.

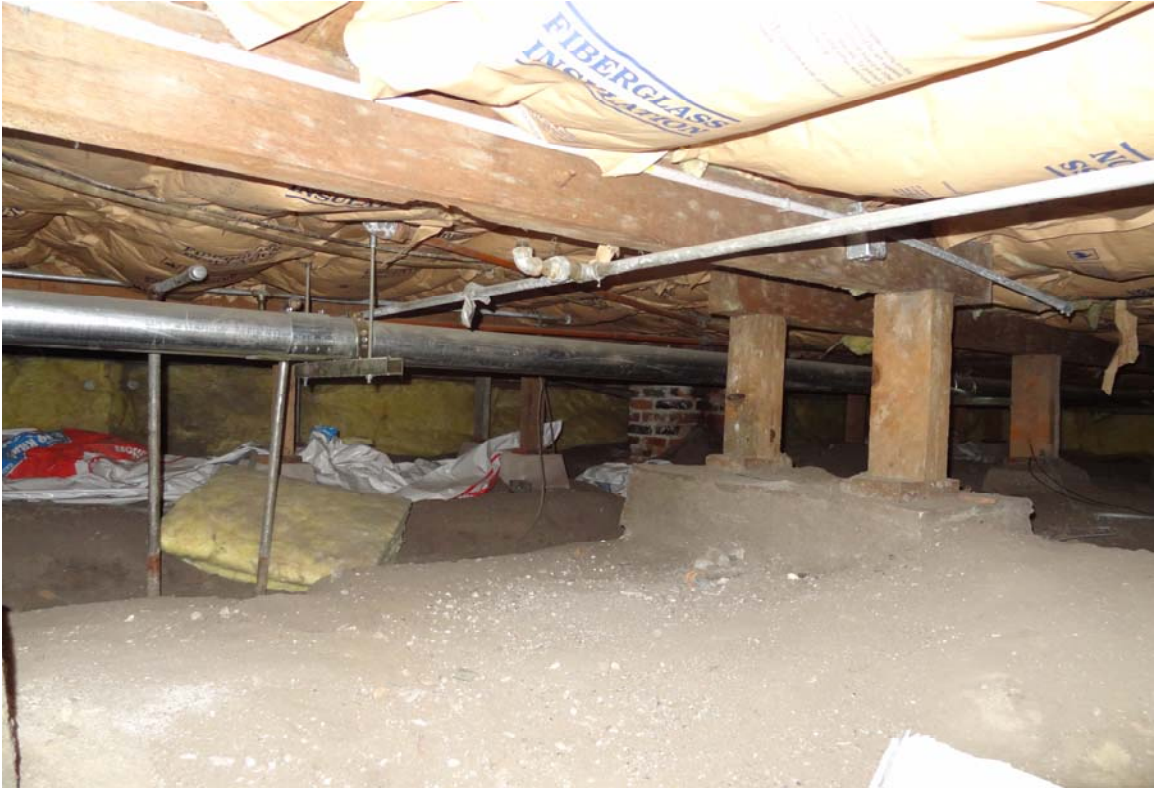
This building is a historic wood framed structure on an old concrete foundation consisting of a perimeter stem wall and interior post and piers. The concrete in the stem wall and piers is crumbling and cracked and the wood framing is not properly anchored into the concrete foundation. Additional bracing is also required for the roof and wall framing to stabilize the structure in the event of an earthquake. It is recommended to design and construct a seismic retrofit on the structure to meet current life safety codes. The estimate is for the construction costs only.

Museum Administration Office - Building #2028  
Description: Crawl space / basement.

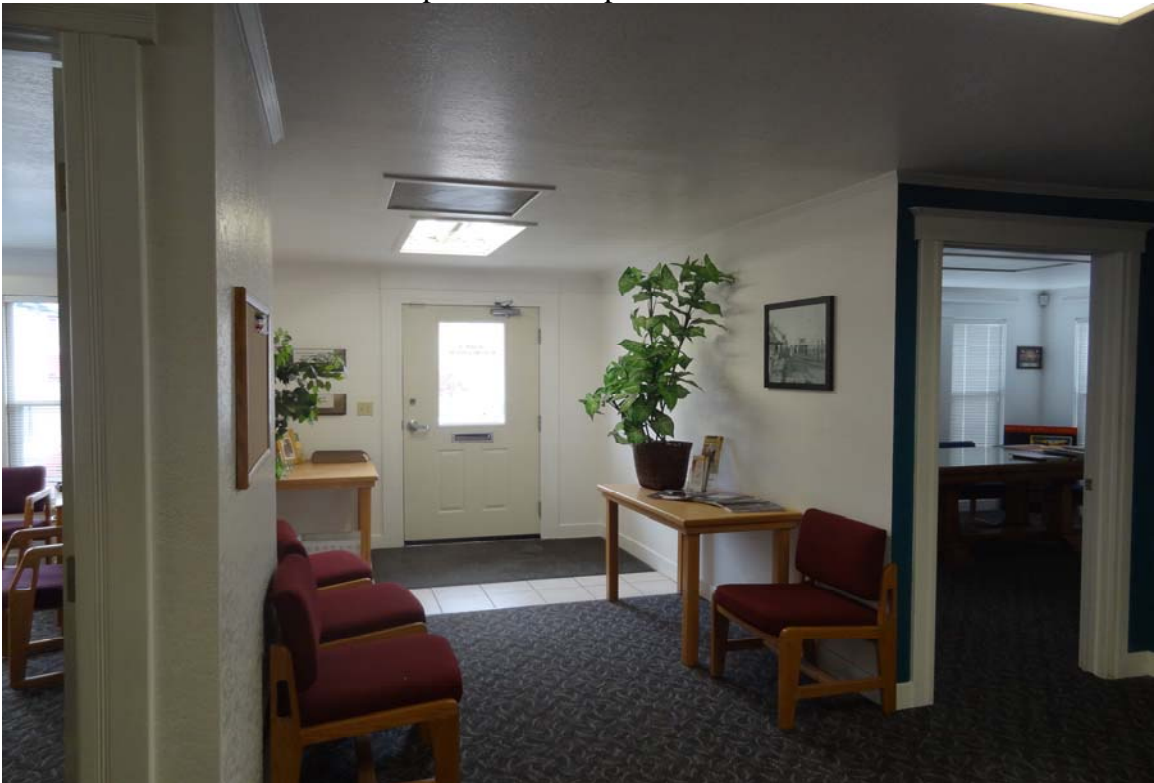
The interior finishes are in fair condition. It is recommended that the interior walls and ceilings be painted at least once in the next 3-4 years and that this project be scheduled on a cyclical basis to maintain the integrity of the structure. Prior to painting, all surfaces should be repaired and prepped. An epoxy-based paint should be utilized in wet areas for durability.

Museum Administration Office - Building #2028  
Description: Interior of the building.
