# DPS TRAINING FACILITY

2101 Snyder Avenue  
Carson City, Nevada 89701

**Site Number: 9851**  
**STATE OF NEVADA PUBLIC WORKS DIVISION**  
**FACILITY CONDITION ANALYSIS**

Report Printed in December 2011

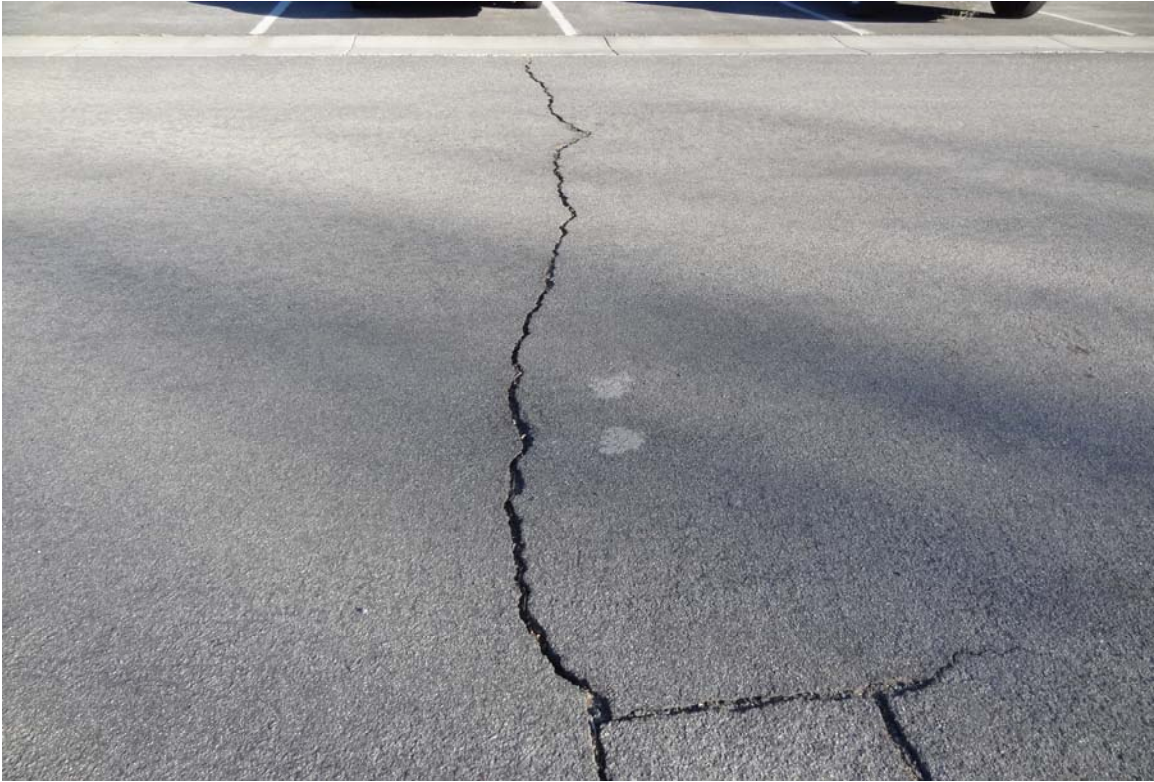
It is important to maintain the asphalt concrete paving on the site. This project would provide for minor crack filling and slurry sealing of the paving site wide including access roads and parking areas. Striping is included in this estimate. This project should be scheduled on a 4- 5 year cyclical basis to maintain the integrity of the paving and prevent premature failure. 40,000 square feet of asphalt area was used to generate this estimate.

DPS Training Facility Site - Site #9851  
Description: AC paving in need of crack filling and sealing.

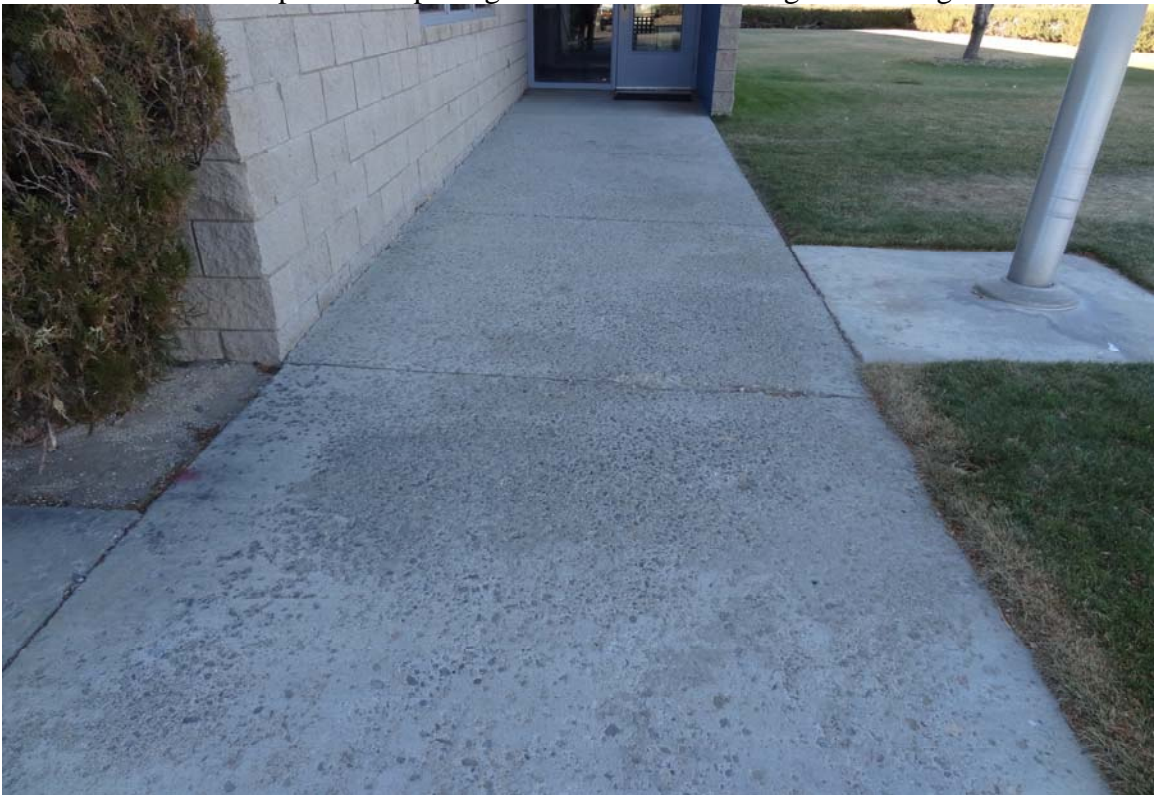
The concrete walkways from the parking lot to the main entrance and the concrete walk along the east side of the building are damaged from freeze / thaw cycles and ice melting chemicals. This project would provide for the removal and replacement of the concrete walkway including disposal of the existing concrete. 400 square feet of concrete was used to generate this estimate.

DPS Training Facility Site - Site #9851  
Description: Damaged concrete walkway at entrance to building.

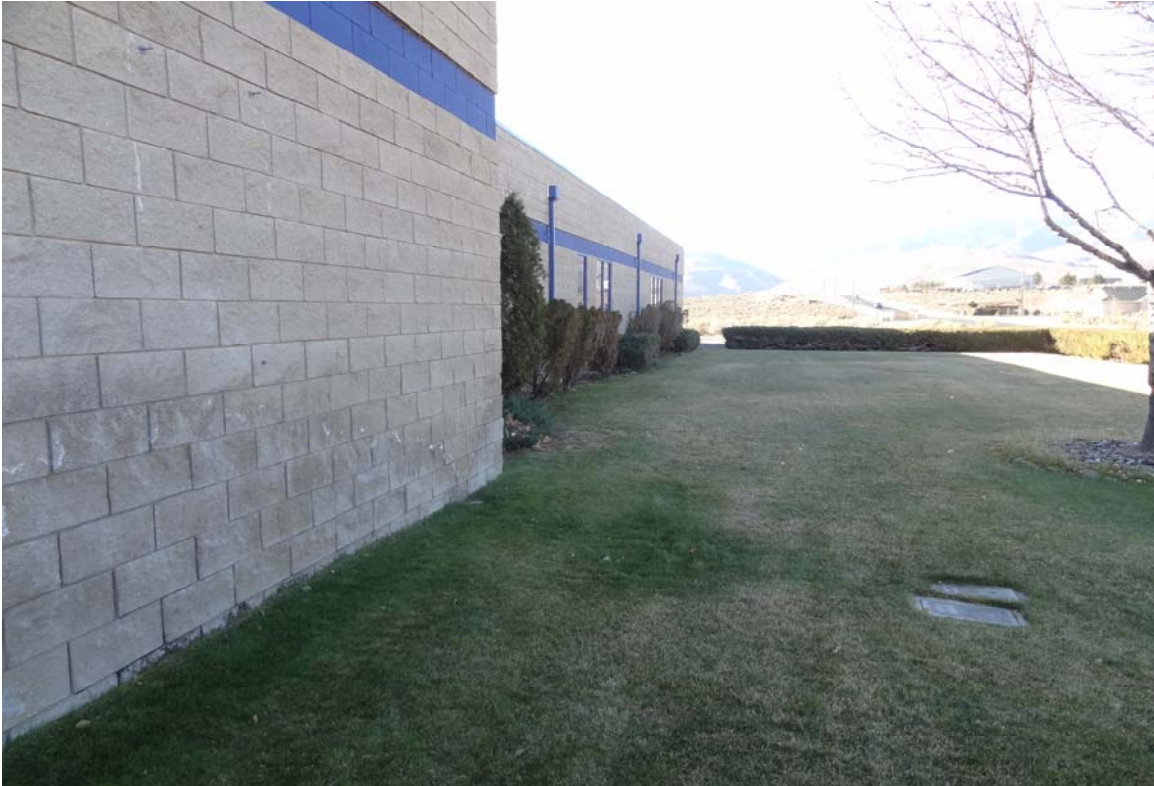
The irrigation system is currently wetting the north and south sides of the building and is causing damage to the concrete masonry units (CMU). This may lead to water infiltration into the building. This project would relocate the sprinklers and lawn away from the building and install 36' wide mow strip next to the building along the north and south sides of the building where the lawn abuts the CMU.

Description: One location of lawn area recommended for mow strip.

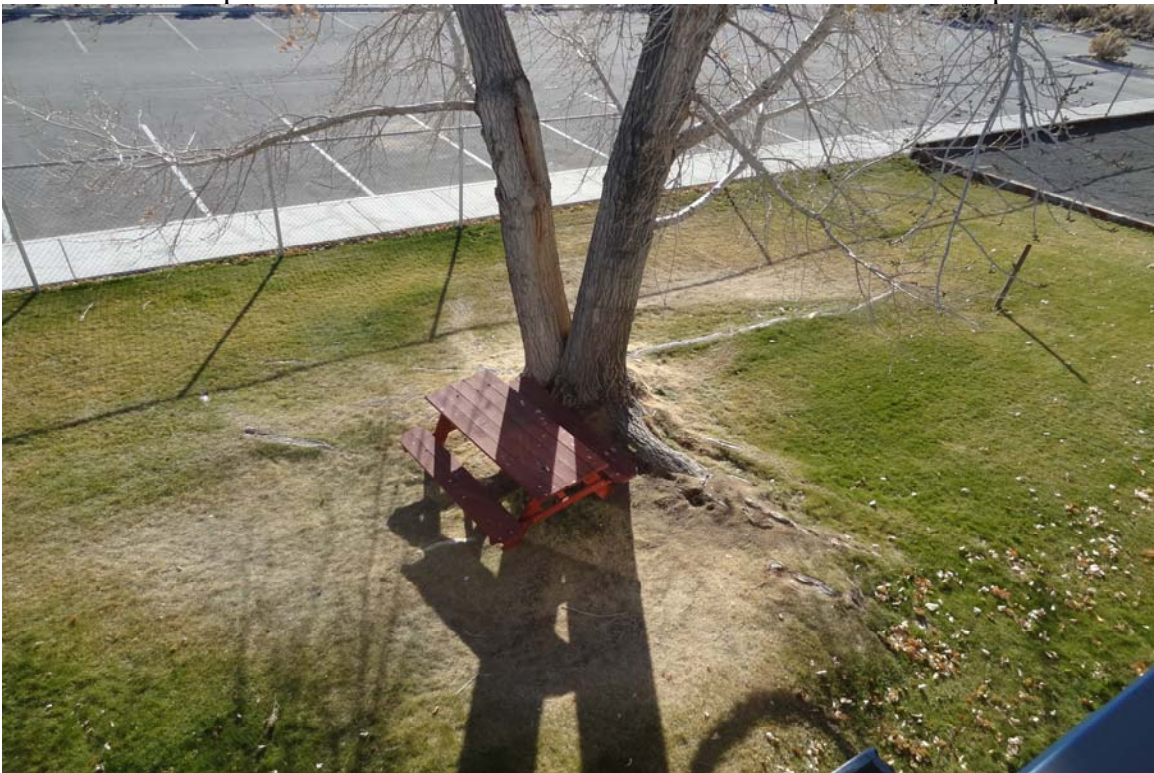
There is a large tree on the south side of the building which has shallow roots that may cause damage to the foundation of the building as it continues to grow.

Description: Tree recommended for removal, south side of building.

This project would provide for the removal of the tree to prevent damage to the building's foundation.

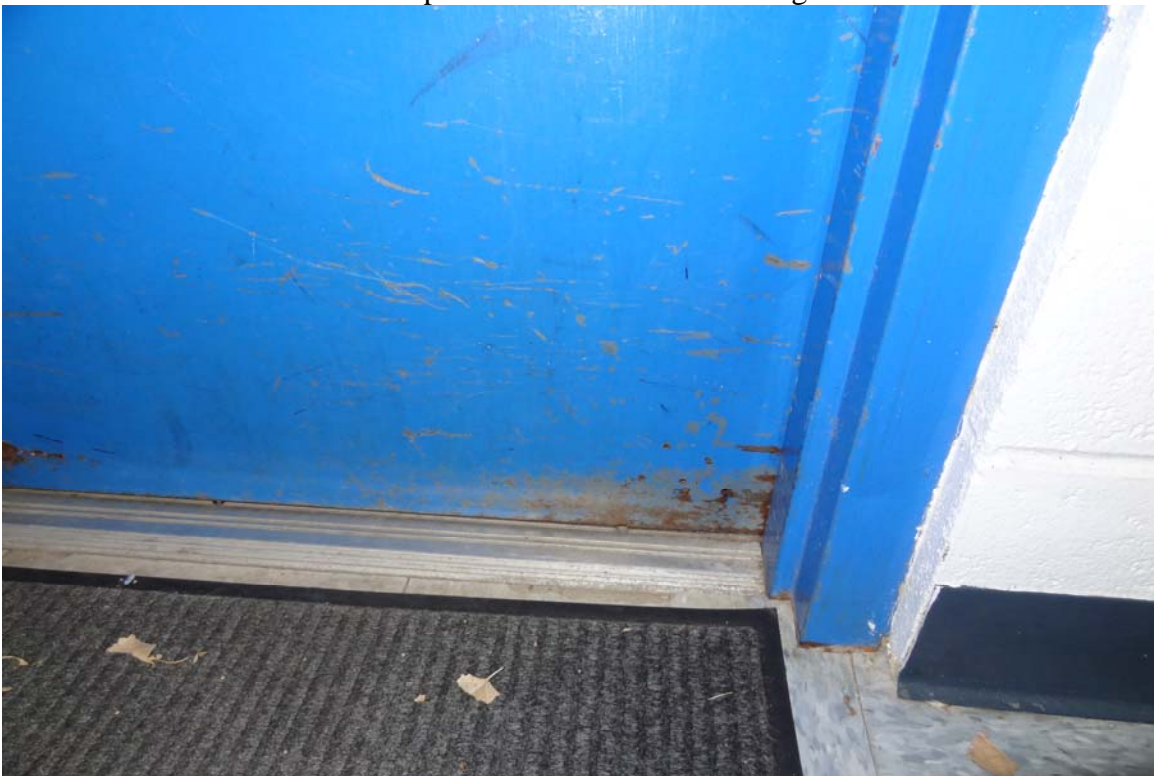
The east and west exterior metal doors are damaged from heavy use and the hardware and weather stripping are showing signs of wear.

DPS Training Facility - Building #0898  
Description: Exterior door due for replacement.

This project would provide for two new metal door assemblies including hardware. Painting and removal / disposal of existing door assemblies is included in this estimate.

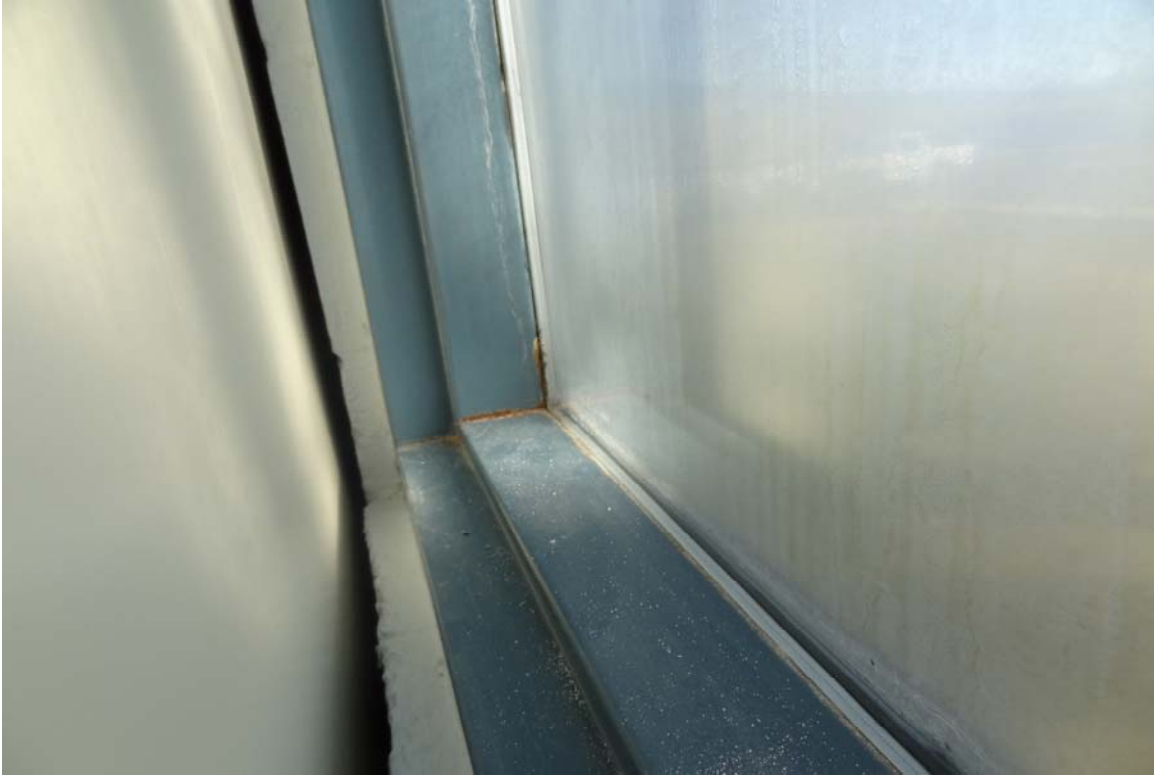
The existing dual pane fixed windows are original to the building and are showing signs of failure. Some of the seals have failed and is allowing moisture in between the glazing panels. These old units are no longer energy efficient and should be scheduled for replacement. This project would provide for 34 new energy efficient dual pane window units including frames. Removal and disposal of the old units are included in this estimate.

DPS Training Facility - Building #0898  
Description: Interior of window / frame in need of upgrade.
