Department of Cultural Affairs
Division of Museums & History
East Ely Railroad Depot Museum
Facility Condition Analysis

EAST ELY RAILROAD DEPOT MUSEUM

1100 Avenue A
Ely, Nevada 89301

**STATE OF NEVADA PUBLIC WORKS DIVISION
FACILITY CONDITION ANALYSIS**

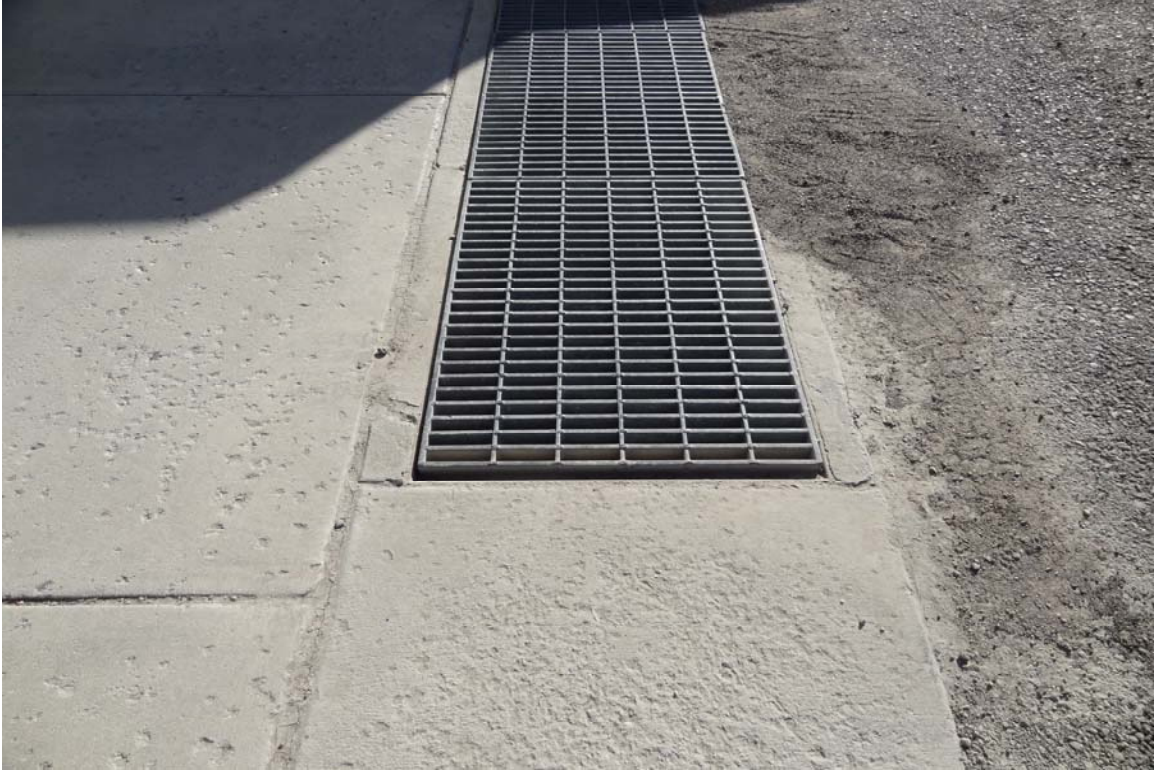
East Ely Railroad Depot Museum Site - Site #9857
Description: Grate on south side in need of modifications.

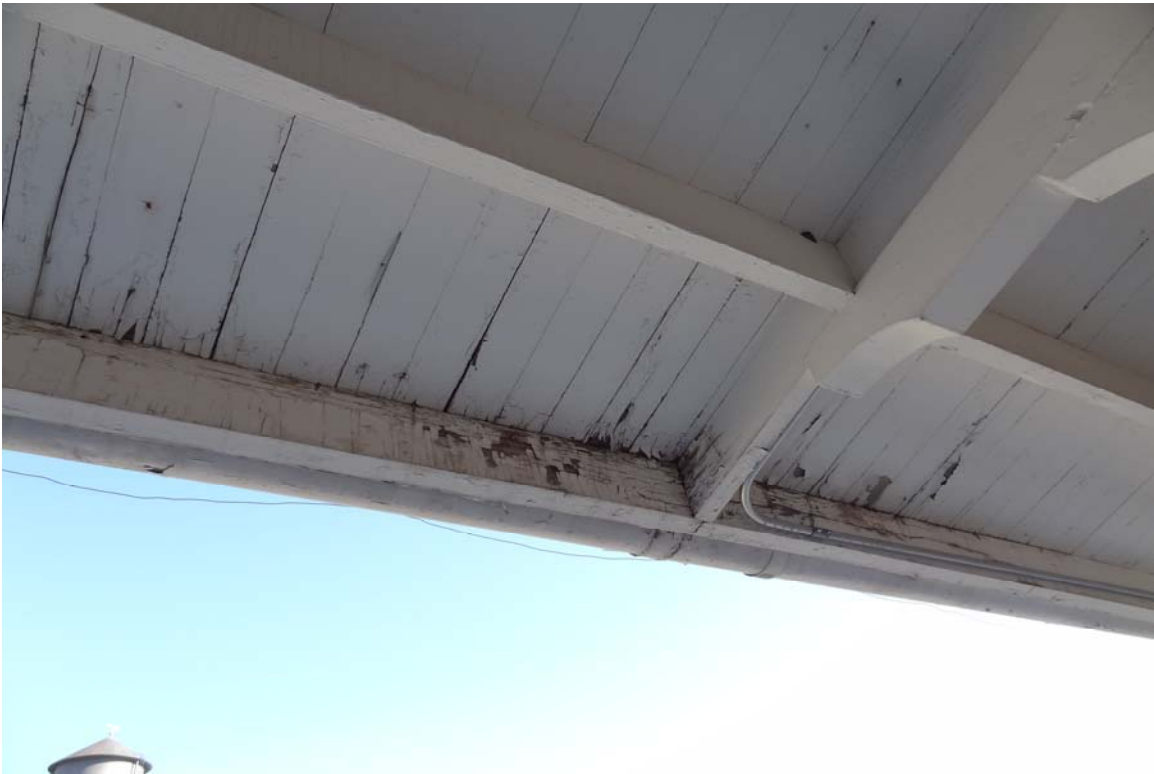
The metal roof on the north elevation of the building was in poor condition at the time of the survey and had active leaks. This shed roof partially covers the boarding platform and has a gutter and downspout system that is in poor condition. When the gutters leak, water pools up and freezes on the boarding platform creating a safety hazard. The gutters and downspouts around the rest of the building are also in poor condition with active leaks. It is recommended to re-roof the metal shed roof and repair or replace the gutters and downspouts around the entire building. This project should be coordinated with the Nevada State Historical Preservation Office for possible restrictions or requirements which are not included in this estimate.

East Ely Railroad Depot - Building #2227
Description: Water damage on north shed roof.

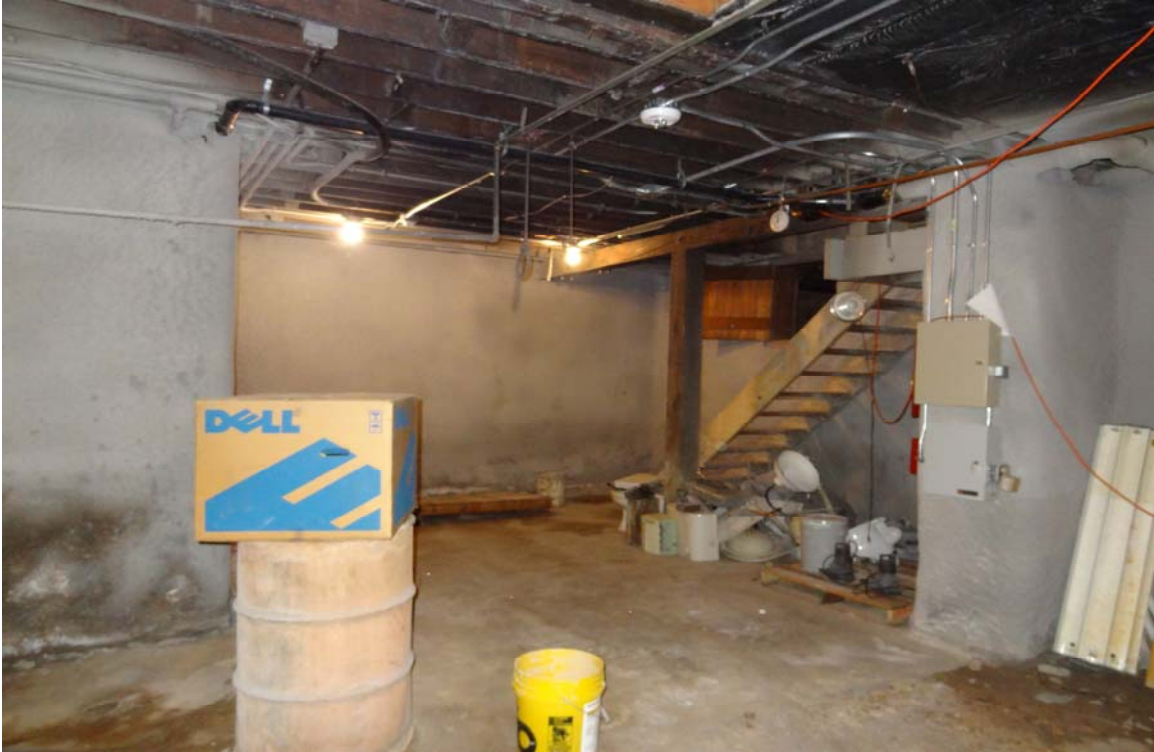
East Ely Railroad Depot - Building #2227
Description: View of the basement.

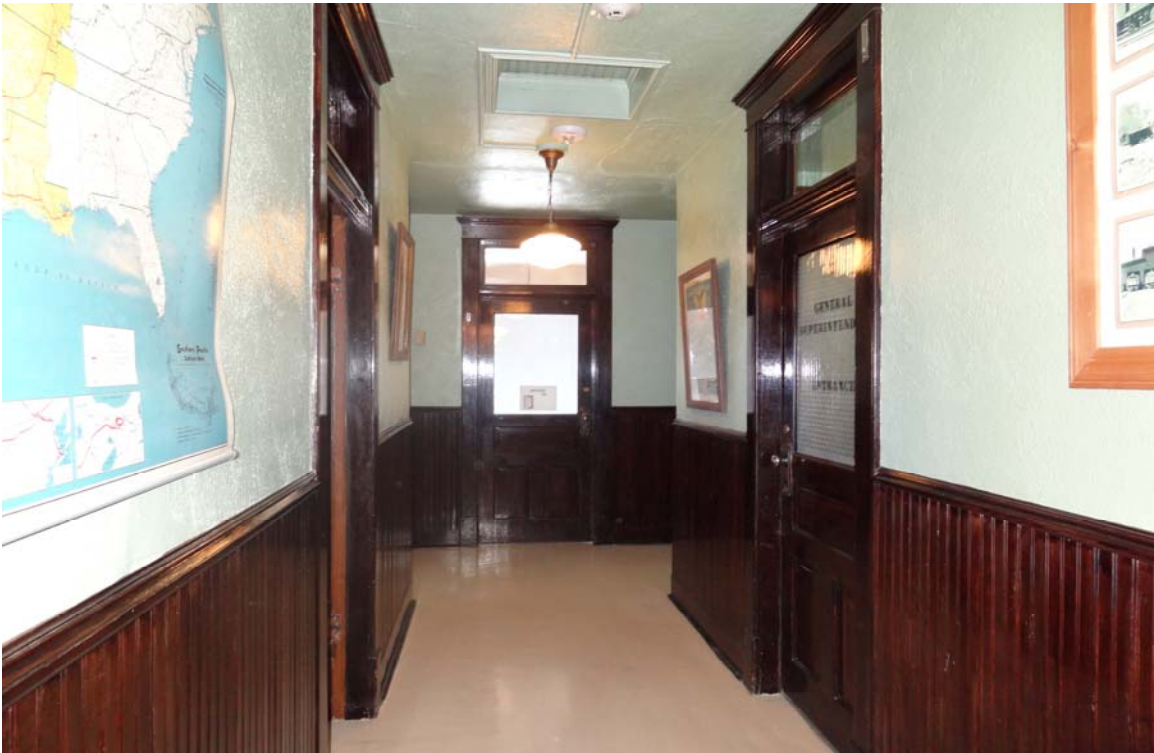
East Ely Railroad Depot - Building #2227
Description: Upper level interior hallway.

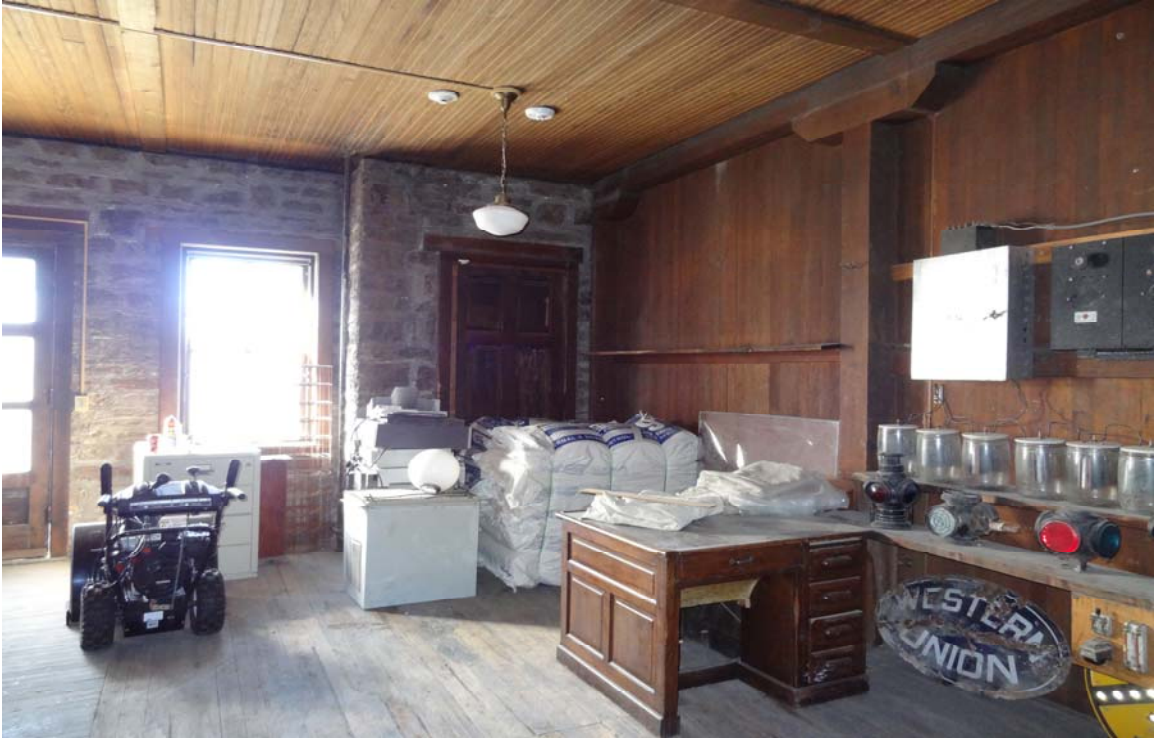
East Ely Railroad Depot - Building #2227
Description: Lower level interior.

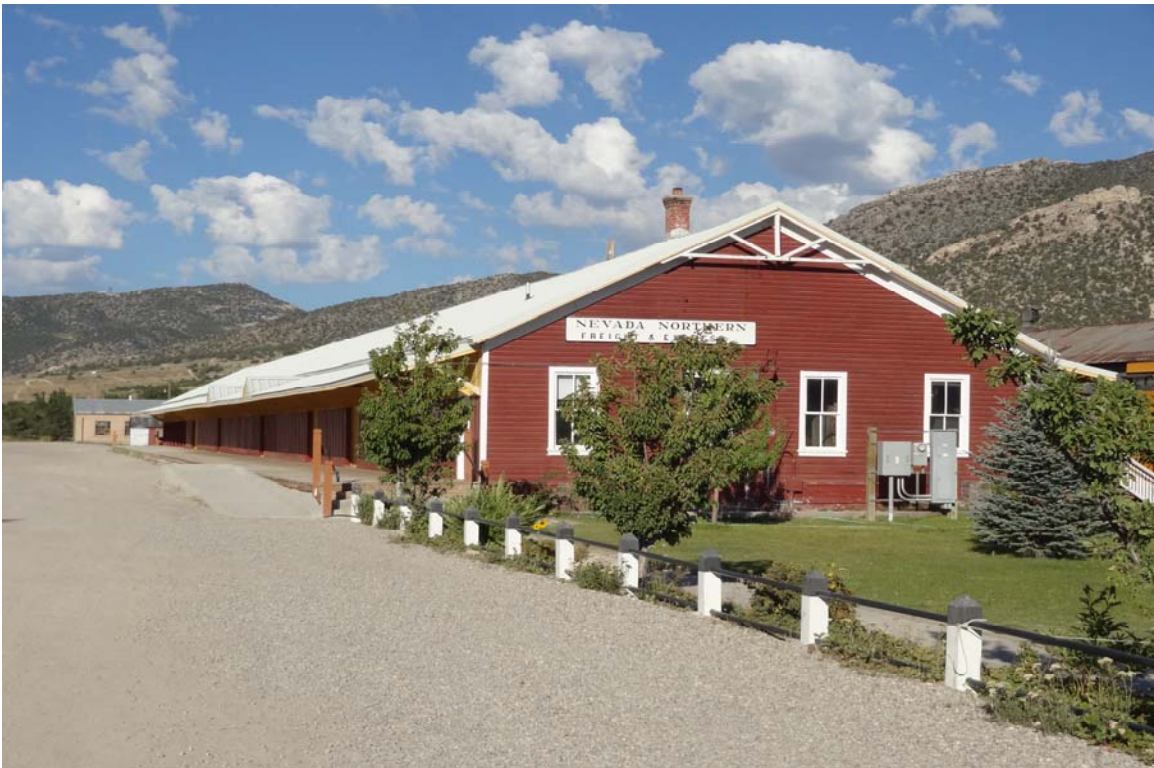
East Ely Railroad Freight Barn - Building #2128
Description: Exterior of the building.

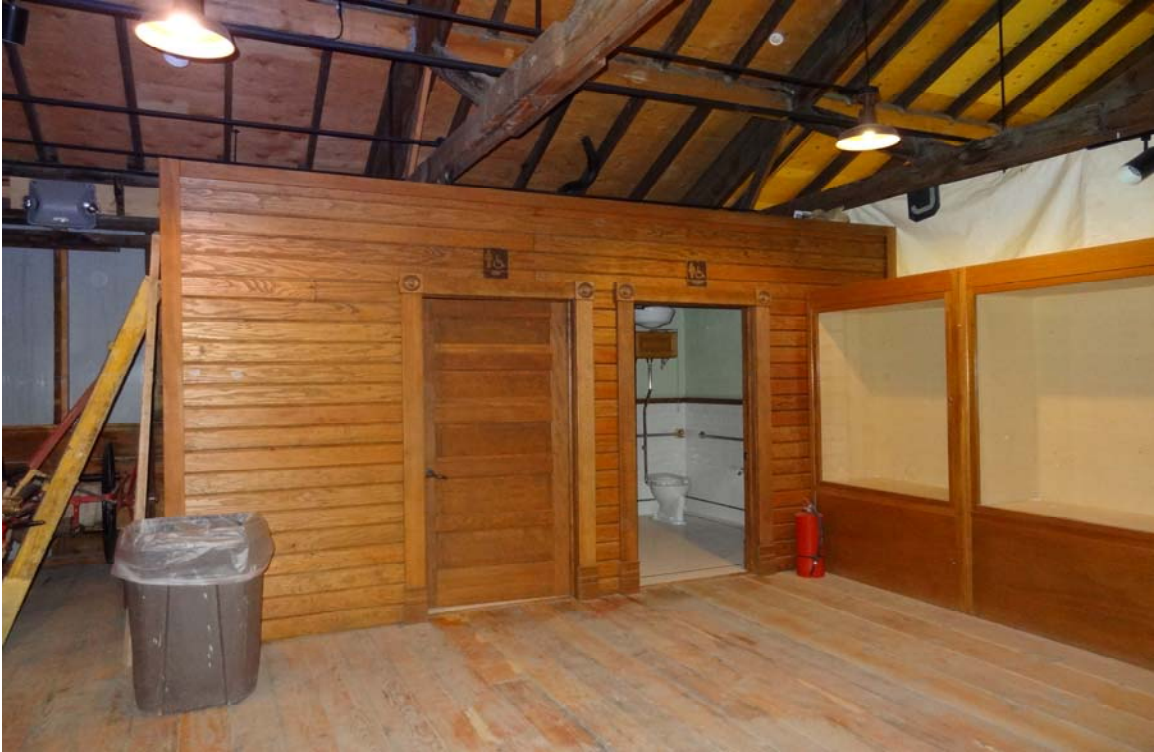
East Ely Railroad Freight Barn - Building #2128
Description: Interior view of restrooms.

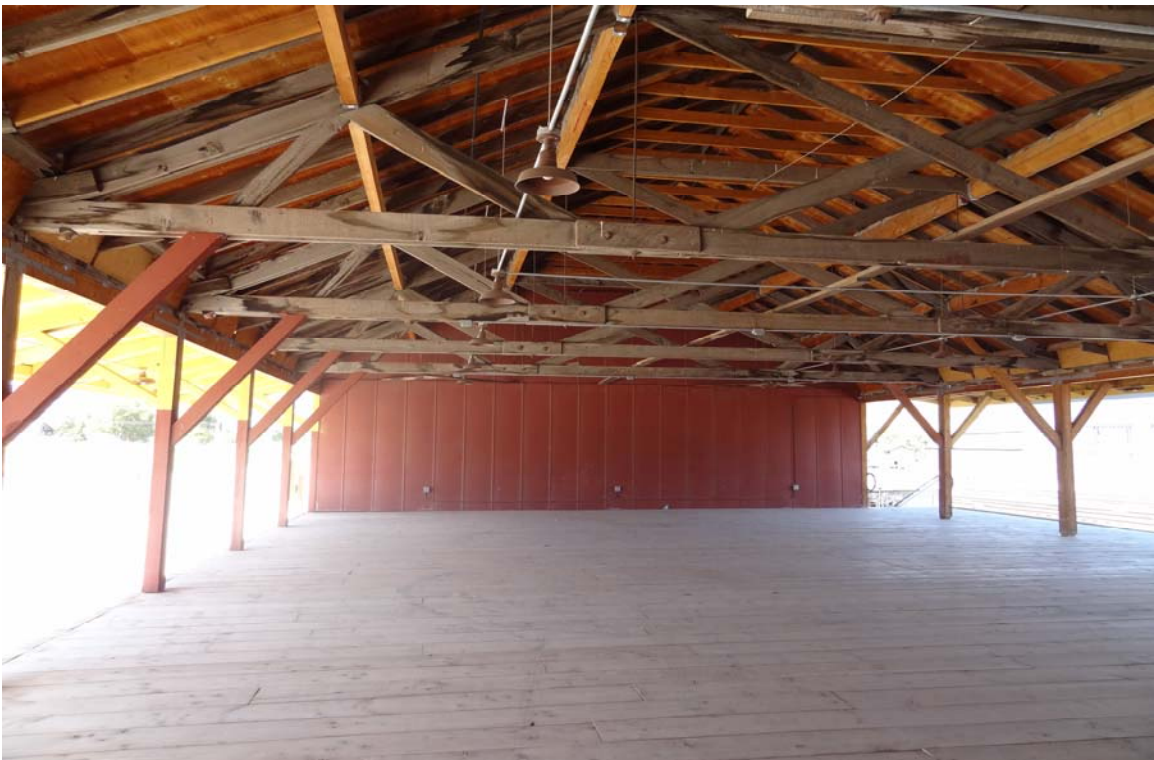
East Ely Railroad Freight Barn - Building #2128
Description: Exterior of the building.
