EAST ELY RAILROAD DEPOT MUSEUM SITE

Site Number: 9857 STATE OF NEVADA PUBLIC WORKS DIVISION FACILITY CONDITION ANALYSIS

State of Nevada / Tourism & Cultural Affairs EAST ELY RAILROAD DEPOT MUSEUM SITE

EAST ELY RAILROAD DEPOT BUILDING REPORT

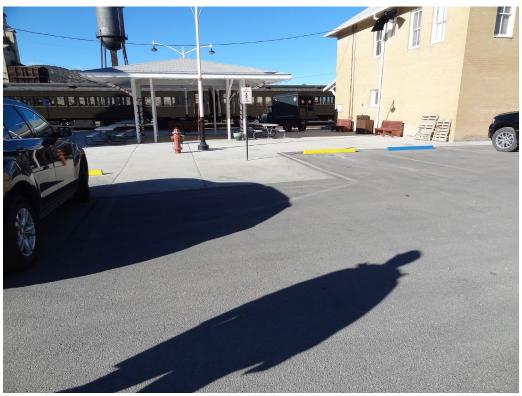
The ADA provides for accessibility to sites and services for people with physical limitations. The concrete parking area and passenger loading area are missing proper signage and striping to comply with ADA requirements. This project would provide for striping, signage and any other necessary upgrades to the parking space. The 2018 IBC, ICC/ANSI A117.1, NRS 338.180 and the most current version of the ADA Standards for Accessible Design were used as a reference for this project.

East Ely Railroad Depot Museum Site - Site #9857 Description: ADA Parking Signage & Striping Needed.

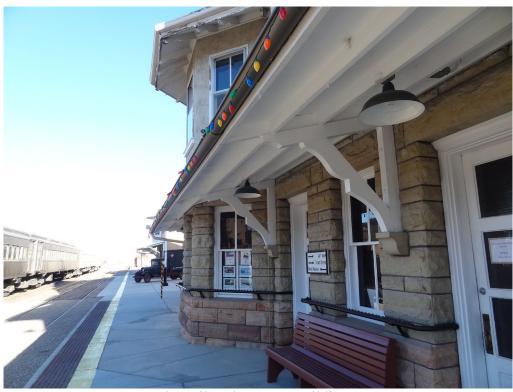
The exterior finishes are in poor condition. It is important to maintain the finish, weather resistance and appearance of the building. This project would provide funding to protect the exterior of the building excluding the roof. Included in the cost is sanding, priming and painting the wood trim and soffits, power washing and painting the stucco, cleaning and sealing the stone masonry and caulking of the windows, flashing, fixtures and all other penetrations. It is recommended that the building be painted, sealed and caulked in the next 3 - 4 years and that this project be scheduled on a cyclical basis to maintain the integrity of the structure. This project should be coordinated with the Nevada State Historical Preservation Office for possible restrictions or requirements which are not included in this estimate.

East Ely Railroad Depot - Building #2227 Description: Exterior Finishes on North Elevation.

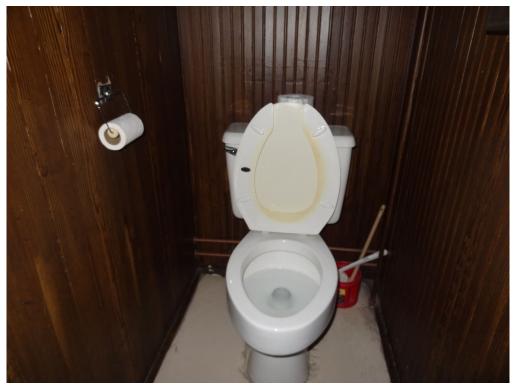
The building does not have an accessible restroom. The existing restroom does not meet the ADA requirements. A complete retrofit is necessary. This project would provide funding for remodeling the men's and women's restrooms per ADA regulations. Items may include a new sink, toilet, hardware, mirrors, fixtures, flooring and paint. The 2018 IBC, ICC/ANSI A117.1, NRS 338.180 and the most current version of the ADA Standards for Accessible Design were used as a reference for this project.

East Ely Railroad Depot - Building #2227 Description: ADA Restroom Upgrade.

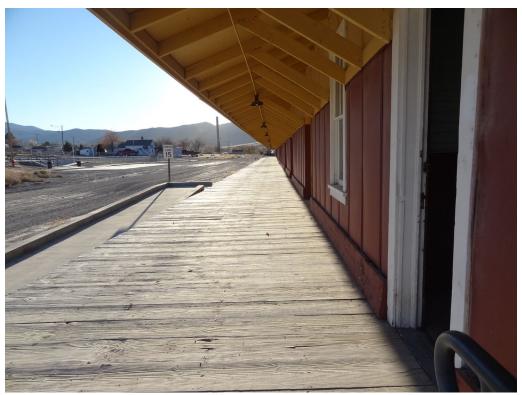
East Ely Railroad Freight Barn - Building #2128 Description: Accessible Ramp to Building Added.

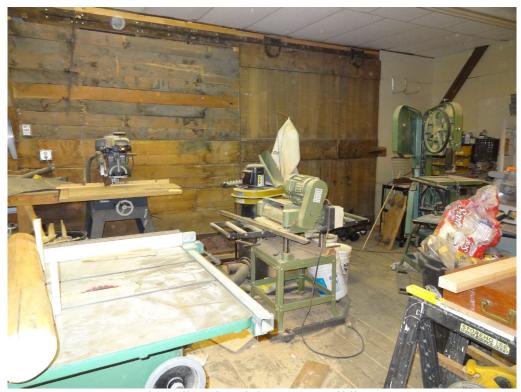
The existing wood working equipment has no dust collection capacity. In order to reduce the possibility of damage or injury, each piece of equipment should have full collection capability. This project will provide for the installation of a full dust collection system to minimize explosion hazard and disruption to production.

East Ely Railroad Freight Barn - Building #2128 Description: Dust Collection System Installation Needed.
