State of Nevada  
Department of Motor Vehicles and Public Safety  
Department of Motor Vehicles Office - Reno  
Facility Condition Analysis

# DEPARTMENT OF MOTOR VEHICLES OFFICE-RENO

305 Galletti Way  
Reno, Nevada 89512

**Site Number: 9858**  
**STATE OF NEVADA PUBLIC WORKS BOARD**  
**FACILITY CONDITION ANALYSIS**

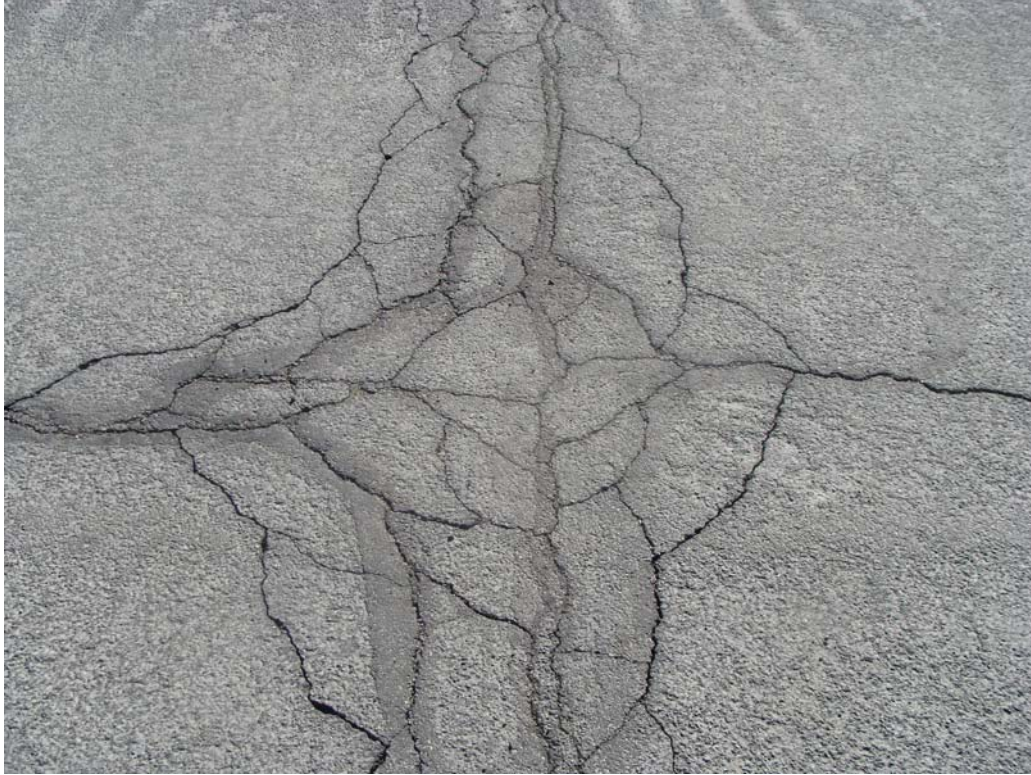
Department of Motor Vehicles Office - Site #9858  
Description: Alligator cracking in pavement.

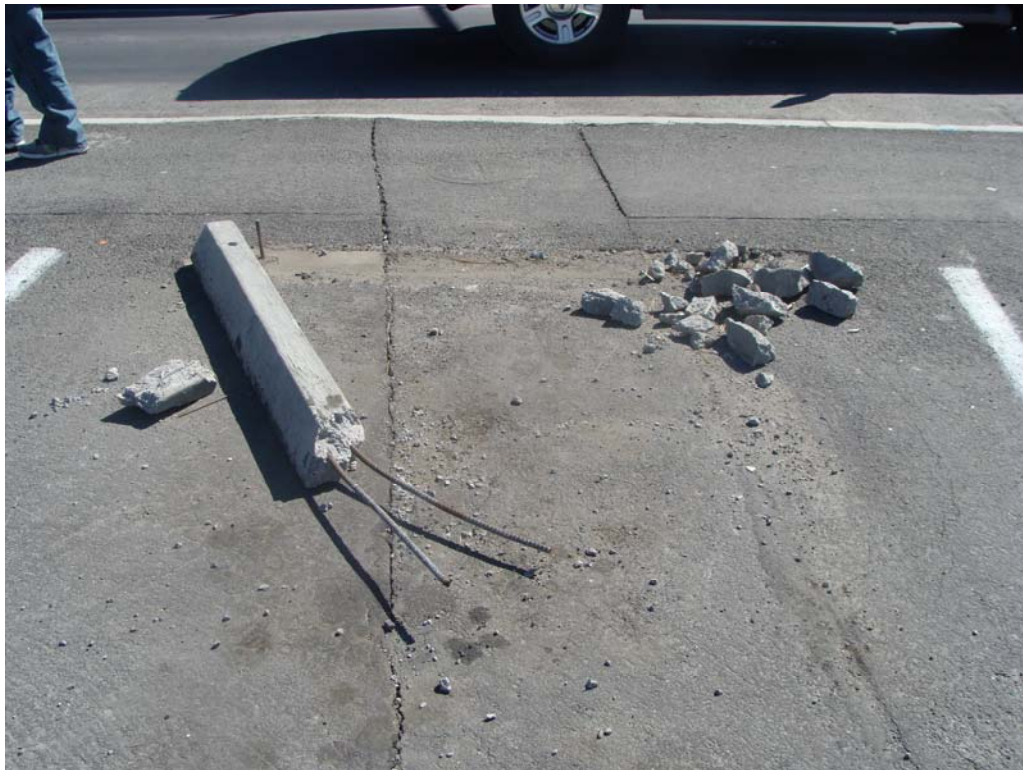
Department of Motor Vehicles Office - Site #9858  
Description: Damaged wheel stop.

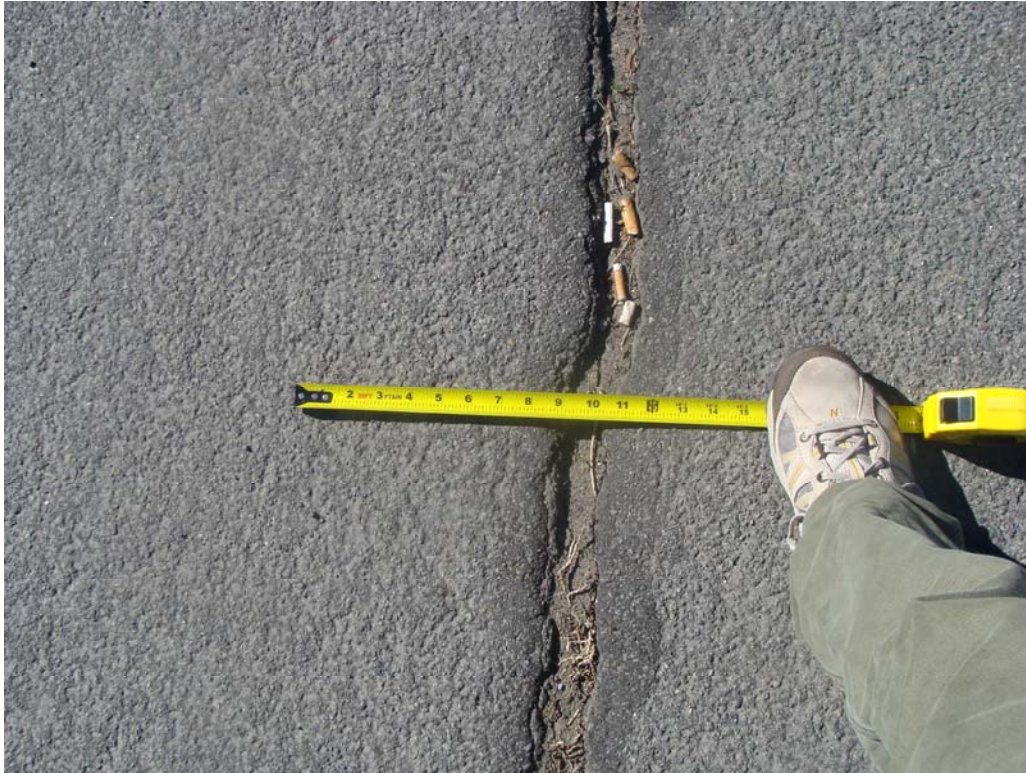
Department of Motor Vehicles Office - Site #9858  
Description: Cracking in paved parking area.

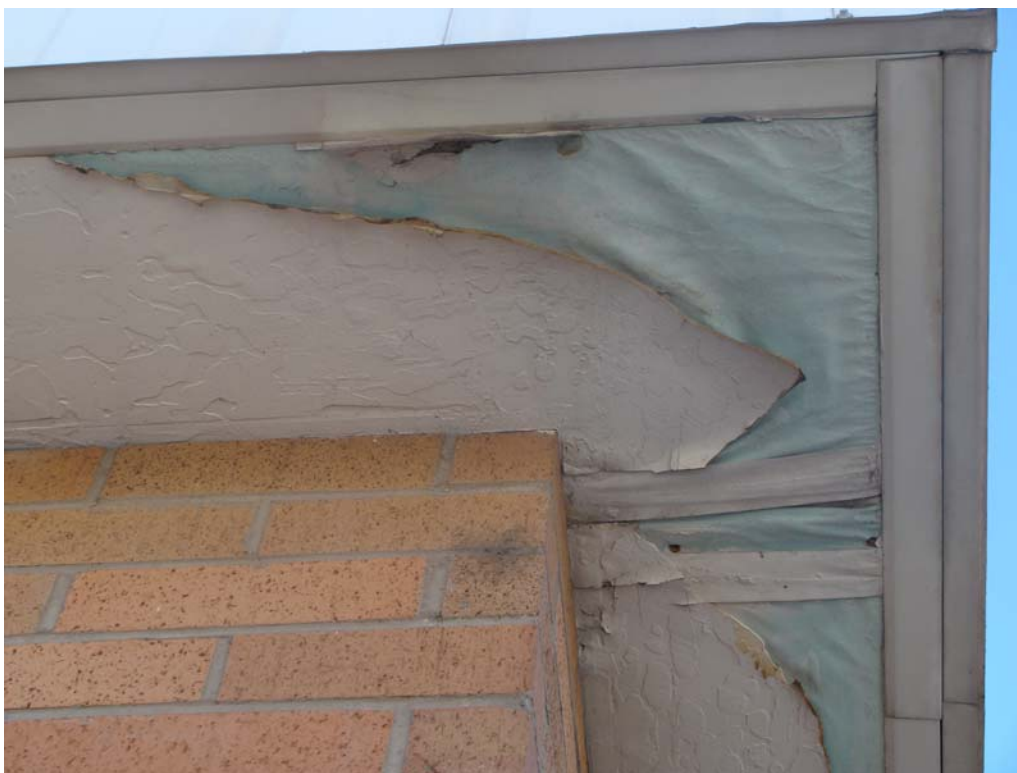
The exterior gypsum board soffit under the roof eave is damaged from exposure to moisture and should be scheduled for replacement. This project would provide for removal of the gypsum board soffit and replacement with a more substantial material such as exterior grade plywood or metal to match the metal fascia on the structure.

Reno DMV Inspection Station - Building #2169  
Description: Damaged exterior gypsum board soffit.

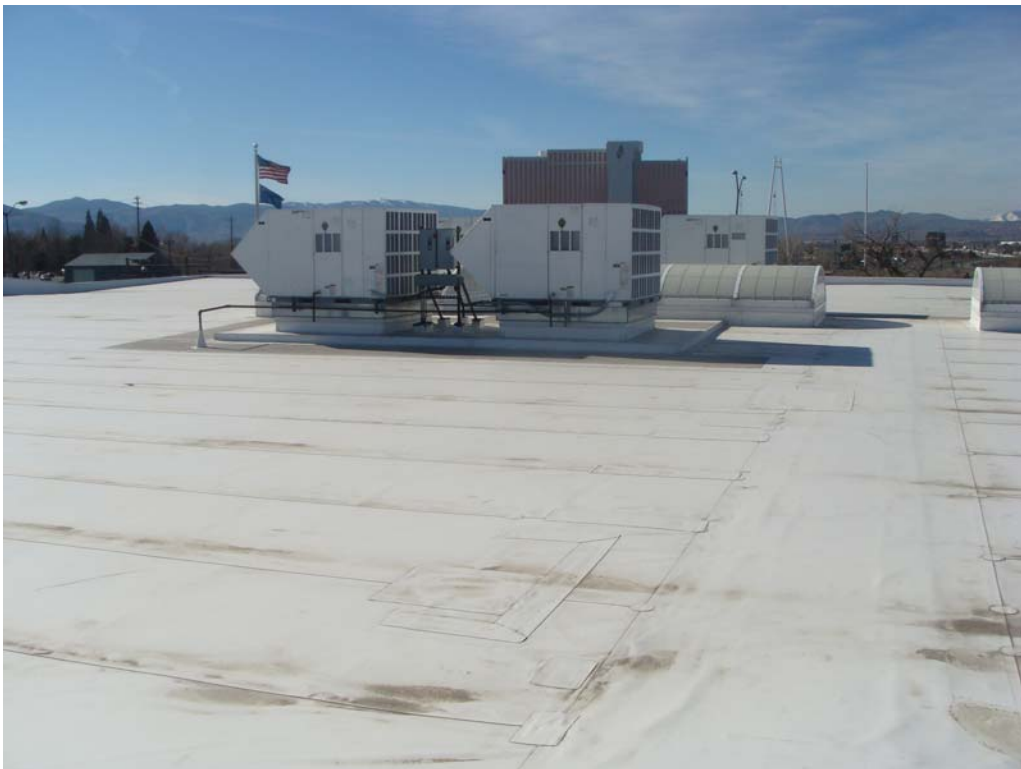
The eight HVAC roof top units were installed in 1994. During the survey of 2009, no major problems were occurring but the units are reaching the end of their expected service life and should be scheduled for replacement. This project would provide for the purchase and installation of eight new HVAC packaged units and cleaning of the existing duct work and grilles. This project includes removal and disposal of the existing HVAC units and all required connections to utilities.

**DMV Reno Office - Building #0272**  
Description: Roof and roof top HVAC equipment.

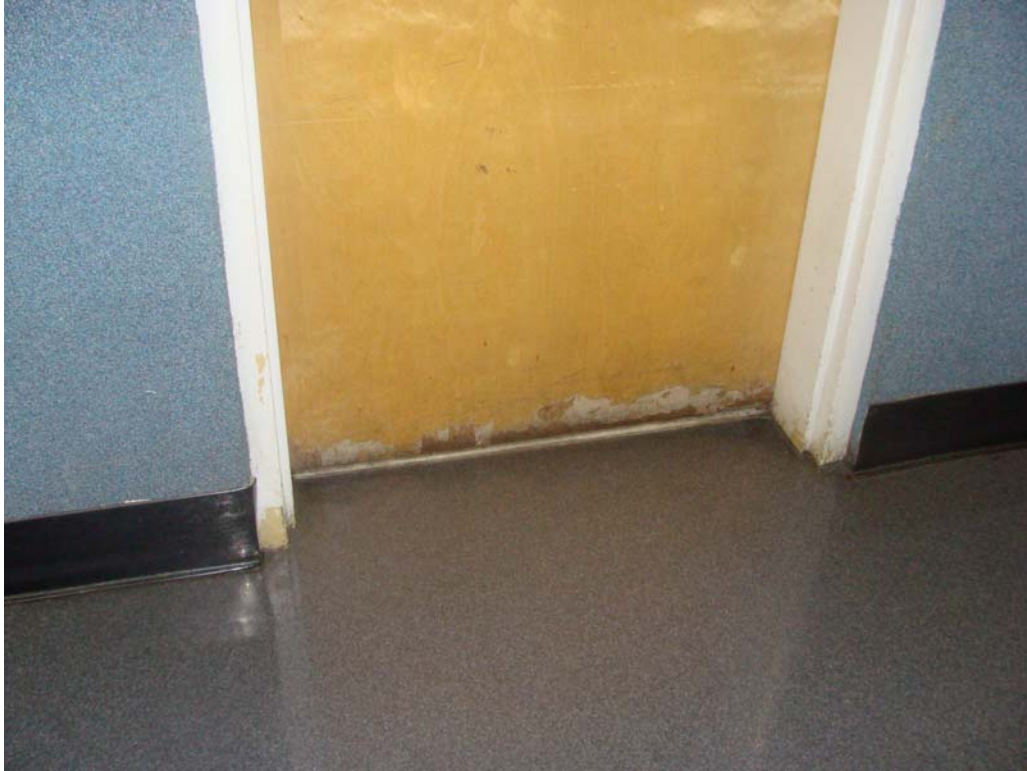
The interior hardwood doors were installed in 1994. They are showing signs of wear and tear and are beginning to lose their finish. This project would provide for refinishing the doors including sanding and / or painting. This estimate is for refinishing 35 doors.

DMV Reno Office - Building #0272  
Description: Typical interior wood door in need of refinishing.

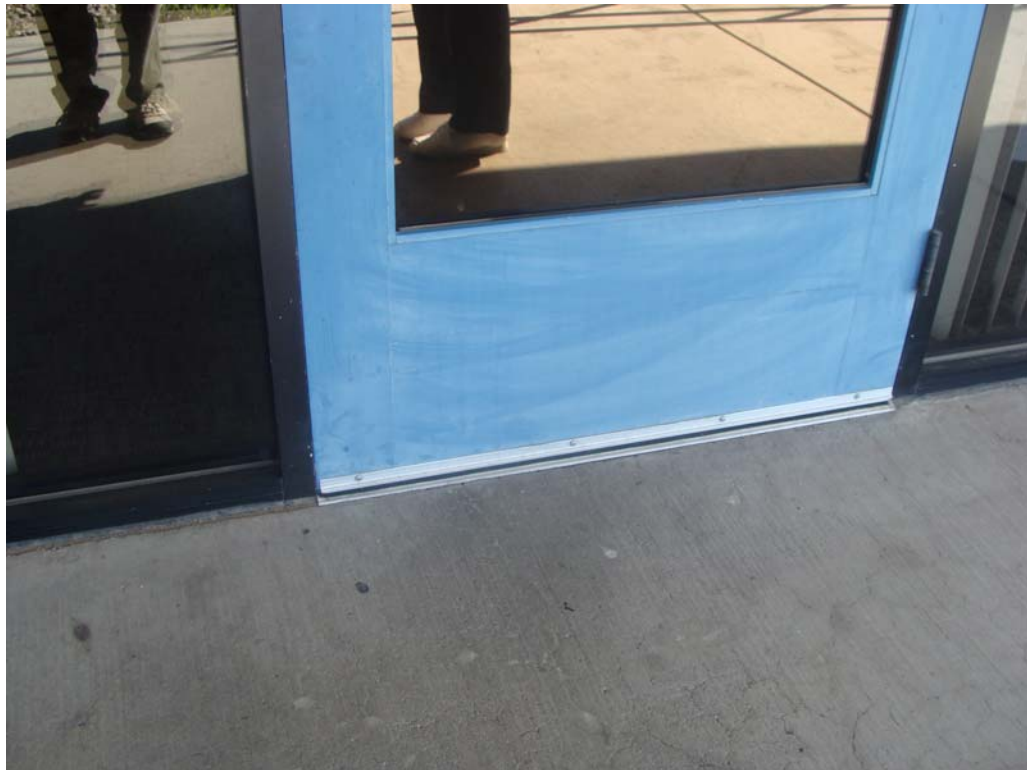
There are three sets of exterior aluminum entrance storefront systems that appear to be original to the building. They are damaged from age and general wear and tear and are a constant maintenance problem. This project would provide for the replacement and installation of three new exterior aluminum entrance storefront systems including hardware. Removal and disposal of the existing storefronts is included in this estimate.

DMV Reno Office - Building #0272  
Description: Exterior door in need of replacement.
