State of Nevada
Department of Motor Vehicles
Field Services Division
Facility Condition Analysis

DMV RENO

305 Galletti Way
Reno, Nevada 89512

Site Number: 9858
STATE OF NEVADA PUBLIC WORKS DIVISION
FACILITY CONDITION ANALYSIS

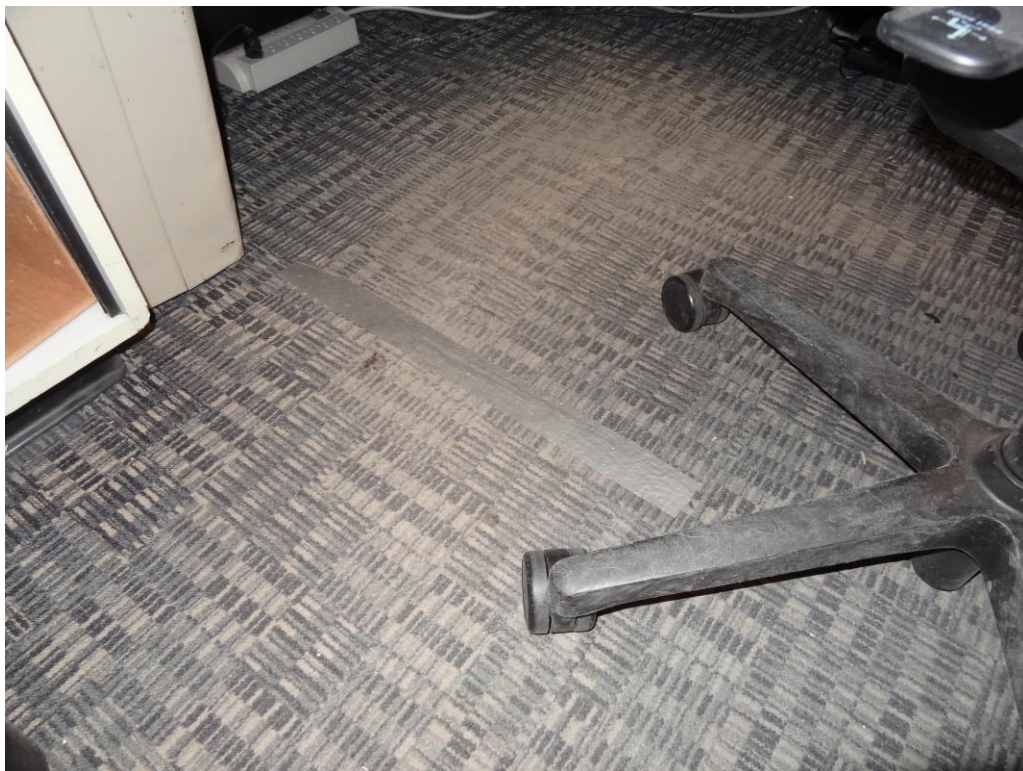
DMV Reno Office - Building #0272
Description: Carpet repaired with duct tape and due for replacement.

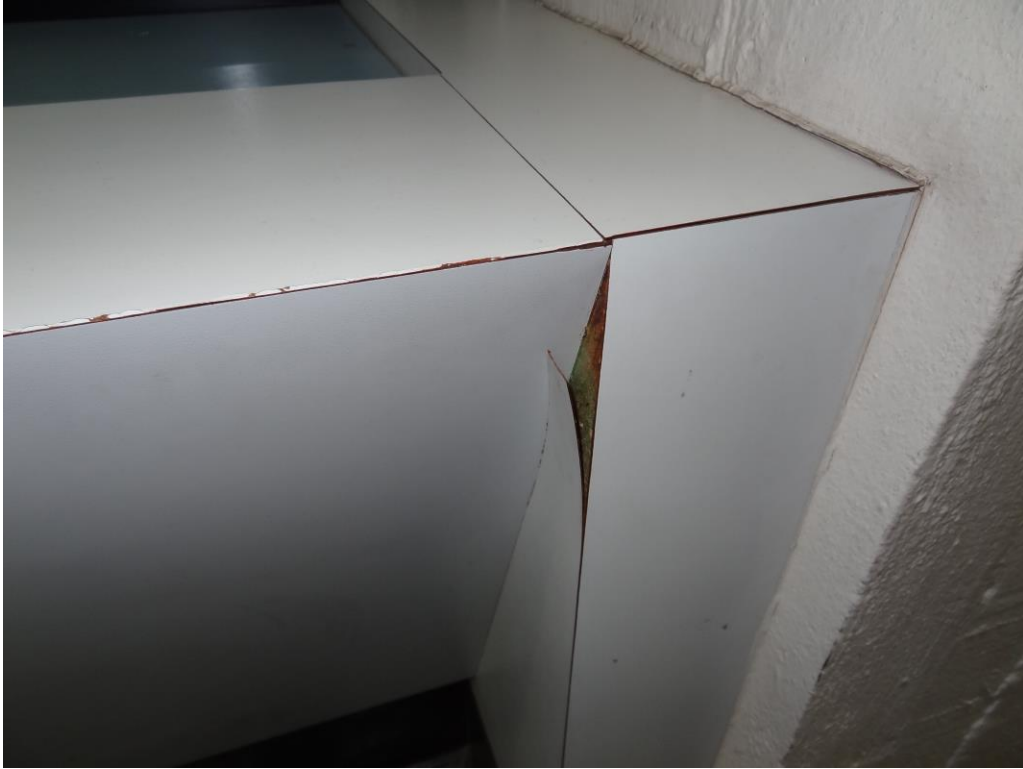
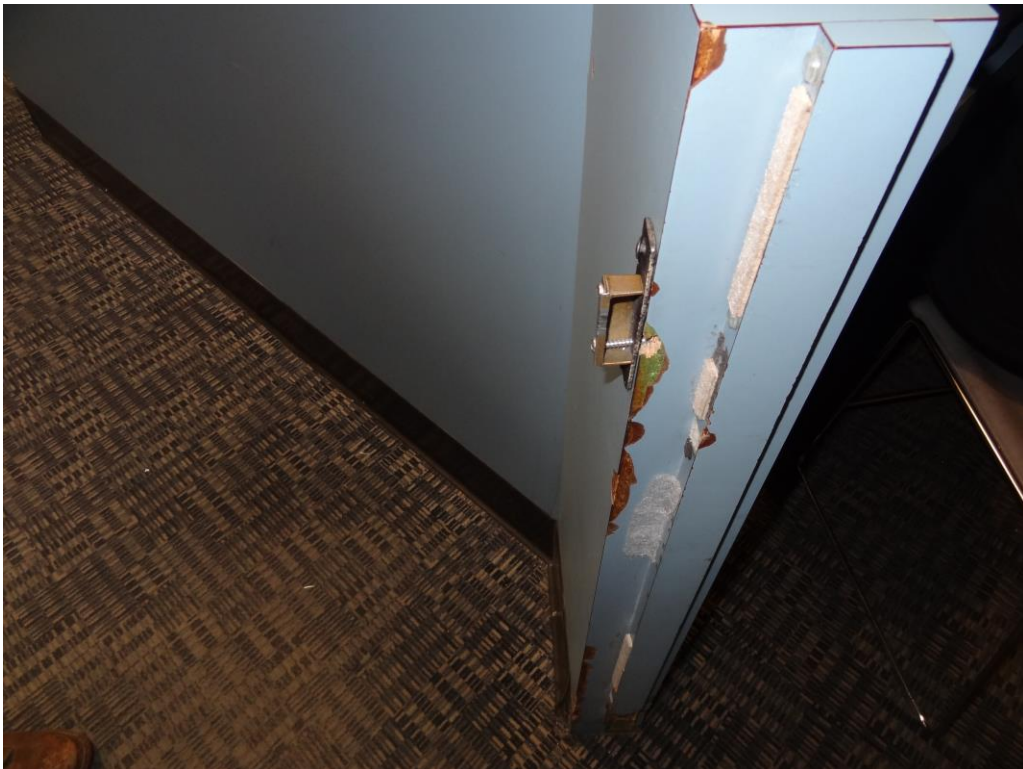
DMV Reno Office - Building #0272
Description: Typical damaged casework at customer stations.

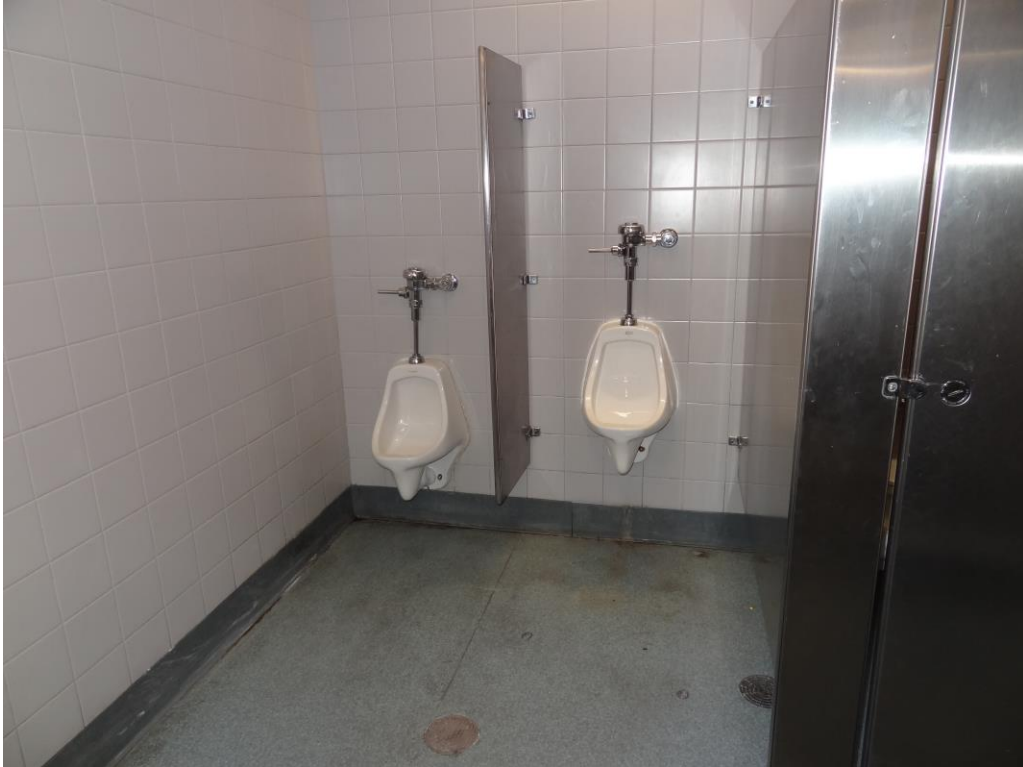
DMV Reno Office - Building #0272
Description: Typical worn and damaged restrooms.

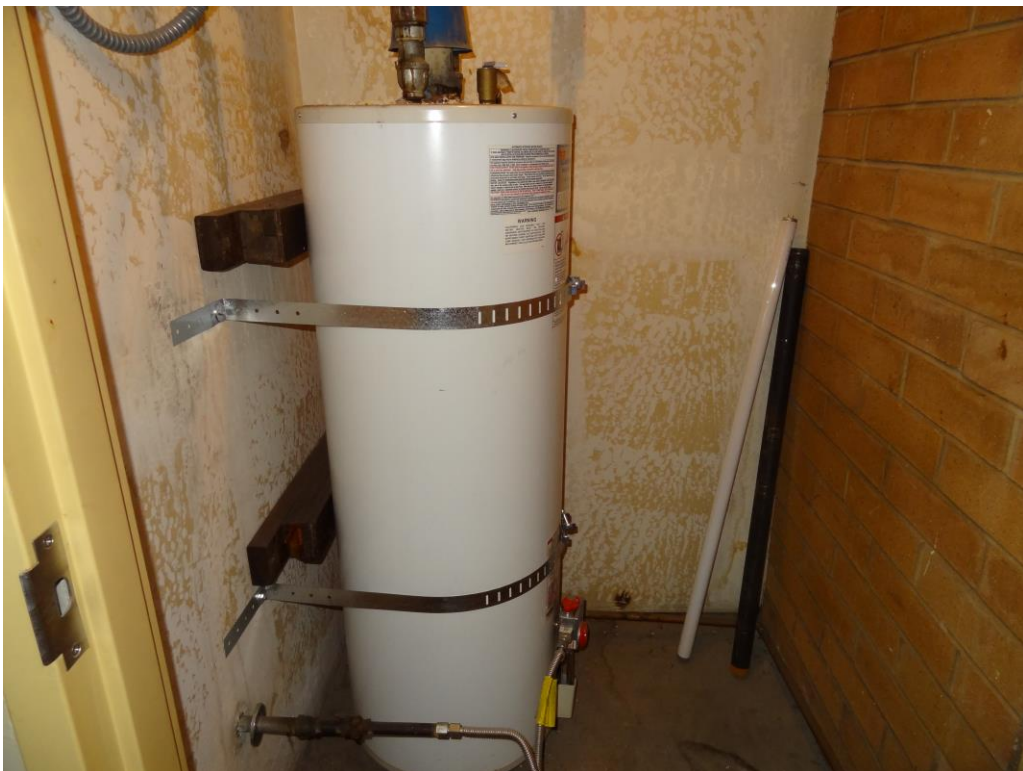
There is a 50 gallon gas-fired water heater in the building that was installed in 1996. The average life span of a water heater is eight to ten years. With the passage of time and constant use, this unit is showing signs of wear and should be scheduled for replacement in the next year. The 50 gallon capacity of the existing water heater is not sufficient for the demands of the building. It is recommended that the water heater be upgraded to a 75 gallon gas-fired water heater.

DMV Reno Office - Building #0272
Description: 21 year old water heater.

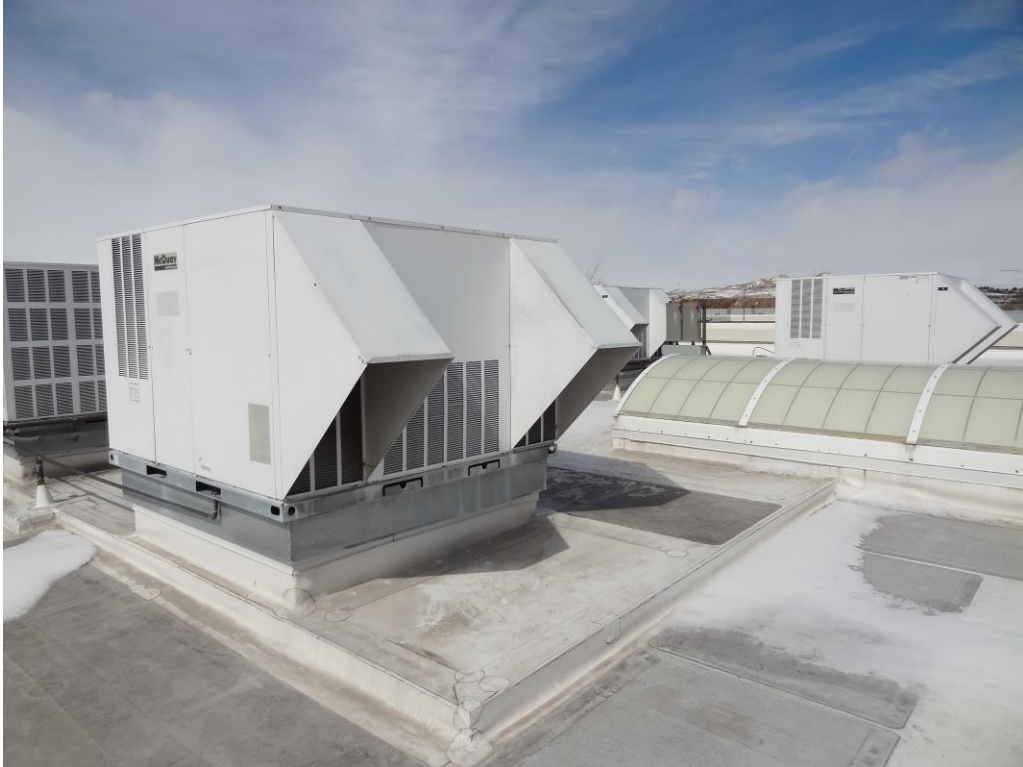
DMV Reno Office - Building #0272
Description: 23 year old rooftop HVAC equipment.

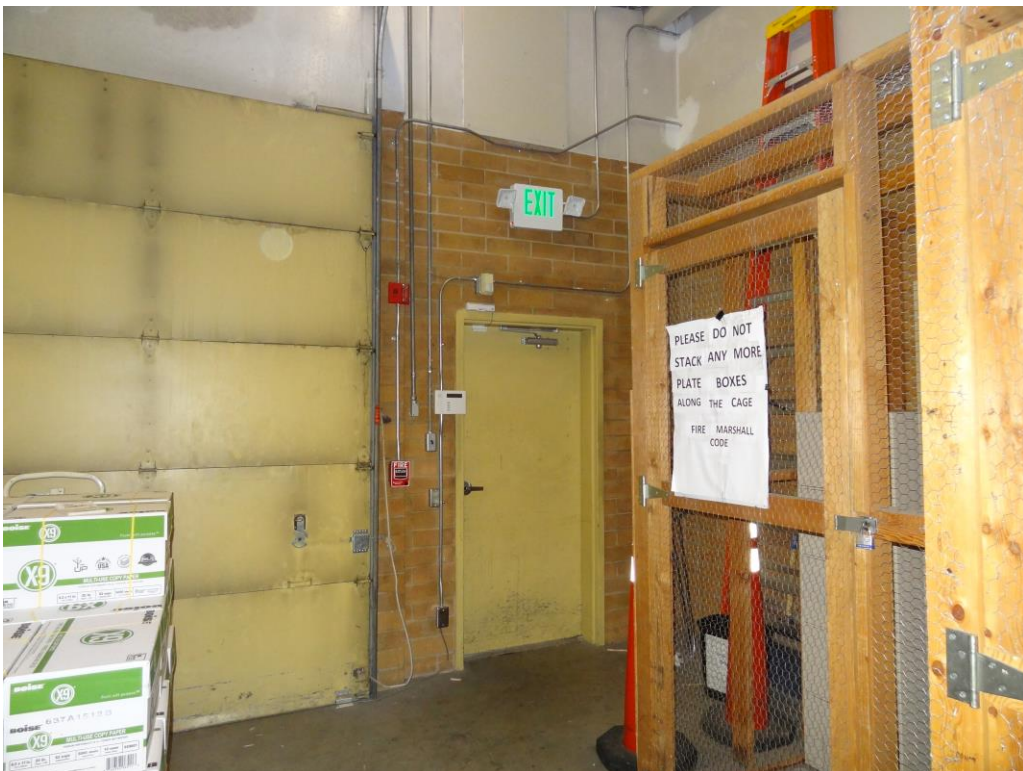
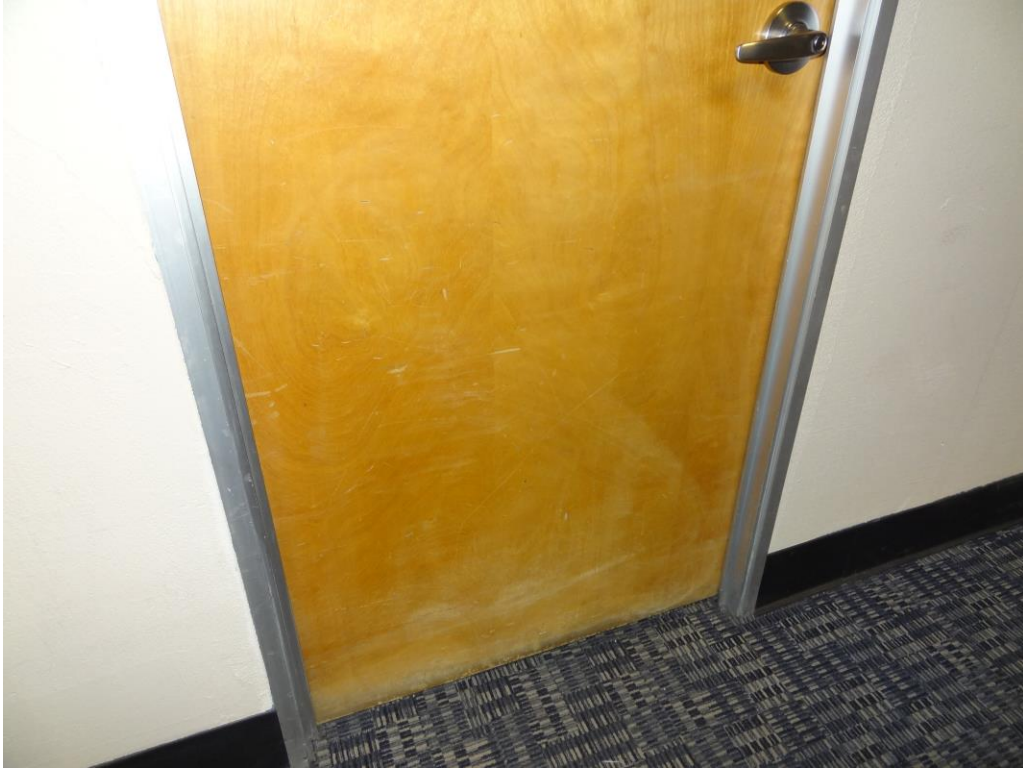
The exterior metal doors are damaged from age and general wear and tear and have reached the end of their expected life. This project would provide for the replacement of eleven exterior door assemblies with new metal doors, frames and hardware. Removal and disposal of the existing doors is included in this estimate.

DMV Reno Office - Building #0272
Description: Worn and damaged doors.

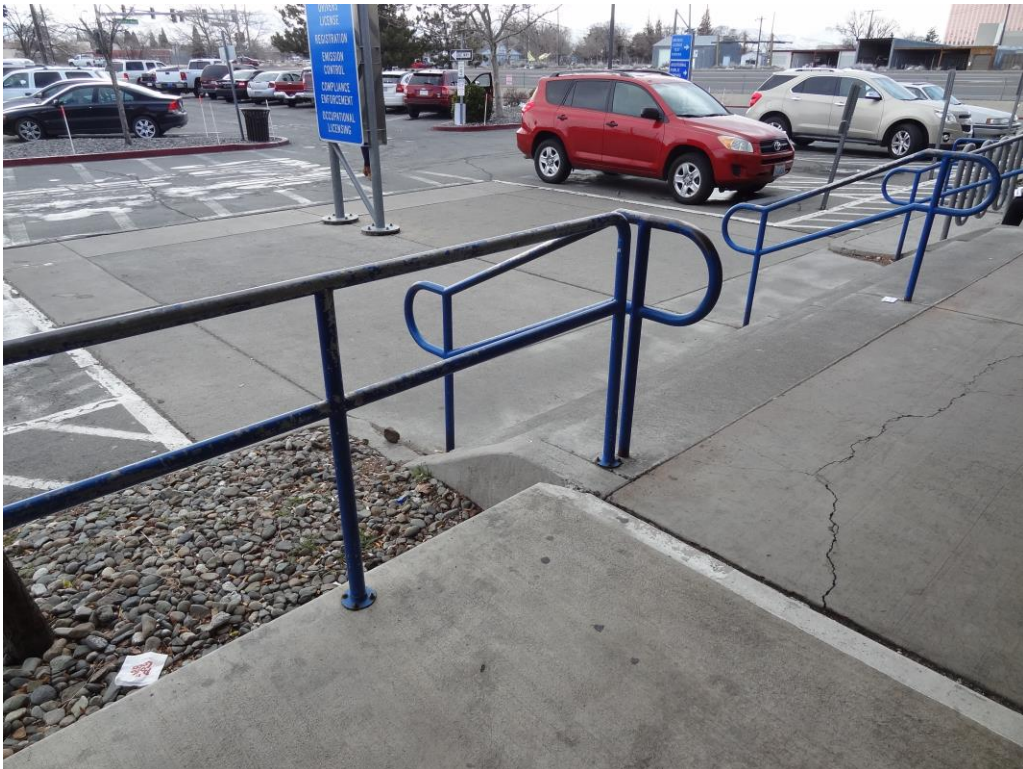
Reno DMV Site - Site #9858
Description: Cracked concrete and asphalt at entrance.

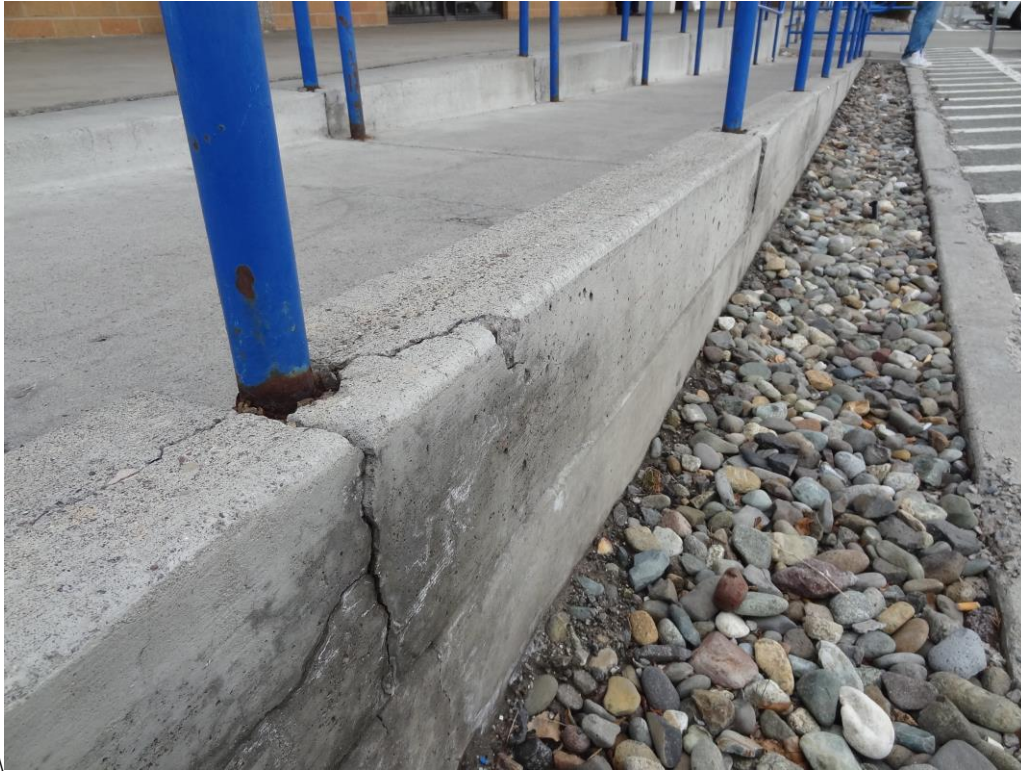
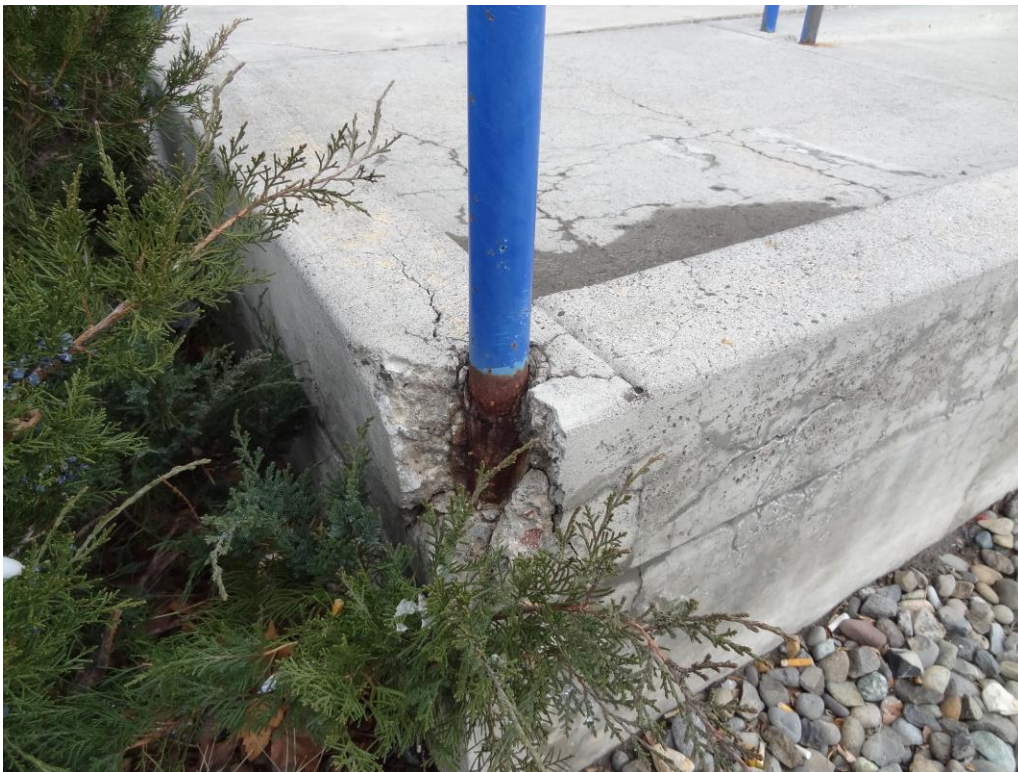
Reno DMV Site - Site #9858

The handrails around the sidewalks are older, are rusting at their bases and are not safe. The gripping surfaces are incorrect and they are not continuous from the top to the bottom landings. This project recommends the installation of new handrails at the sidewalks and for the proper returns and supports to be installed. Removal and disposal of the existing handrails is included in this estimate. The 2012 IBC, ICC/ANSI A117.1 - 2009, NRS 338.180 and the most current version of the ADA Standards for Accessible Design were used as references for this project.

In order to comply with current ADA requirements, modifications will be necessary for the ADA ramps and stairs on the east and west sides of the building. The standards for a ramp require a 36" clear space. Currently, the handrails encroach on this clearance and reduce the clear space to less than 32". The concrete on the stairs and the ramp is deteriorating and the steel poles are rusting at their bases. Exposure to the elements is a contributing factor. This project recommends replacing the steel handrails to comply with ADA guidelines, repairing the concrete on the ramp, and replacing the concrete stairs. The 2012 IBC, ICC/ANSI A117.1 -2009, NRS 338.180 and the most current version of the ADA Standards for Accessible Design were used as references for this project.

Description: Cracked concrete and rusted handrails at the east ADA ramp.

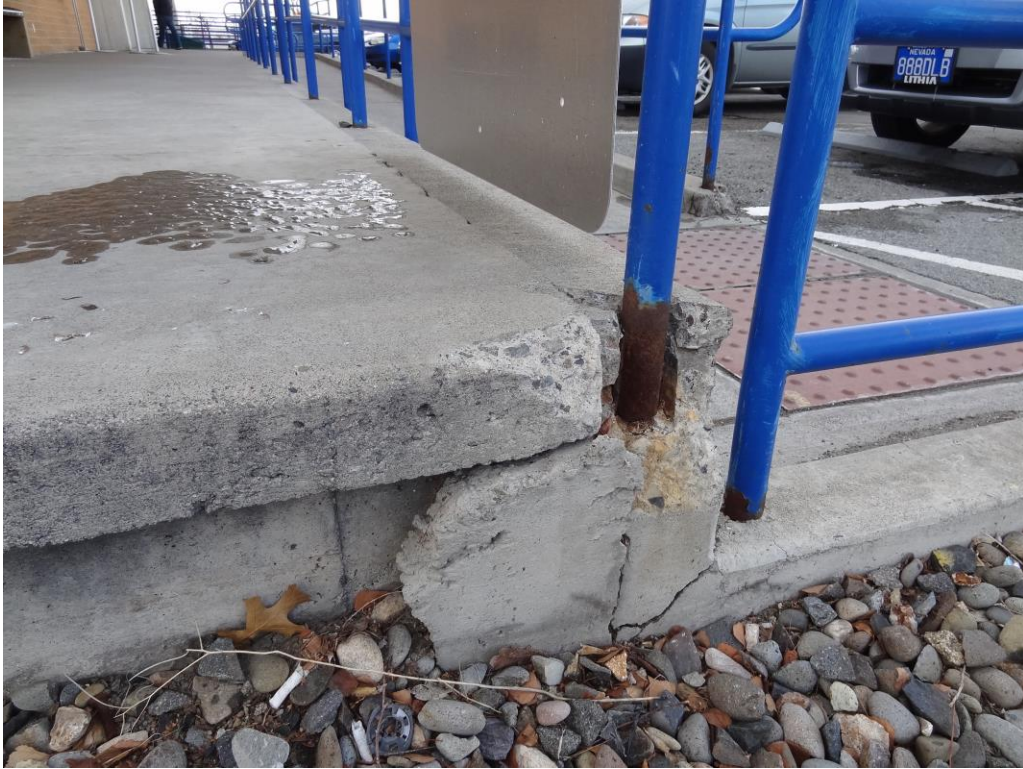
Reno DMV Site - Site #9858

Description: Cracked concrete and rusted handrails at the west ADA ramp.

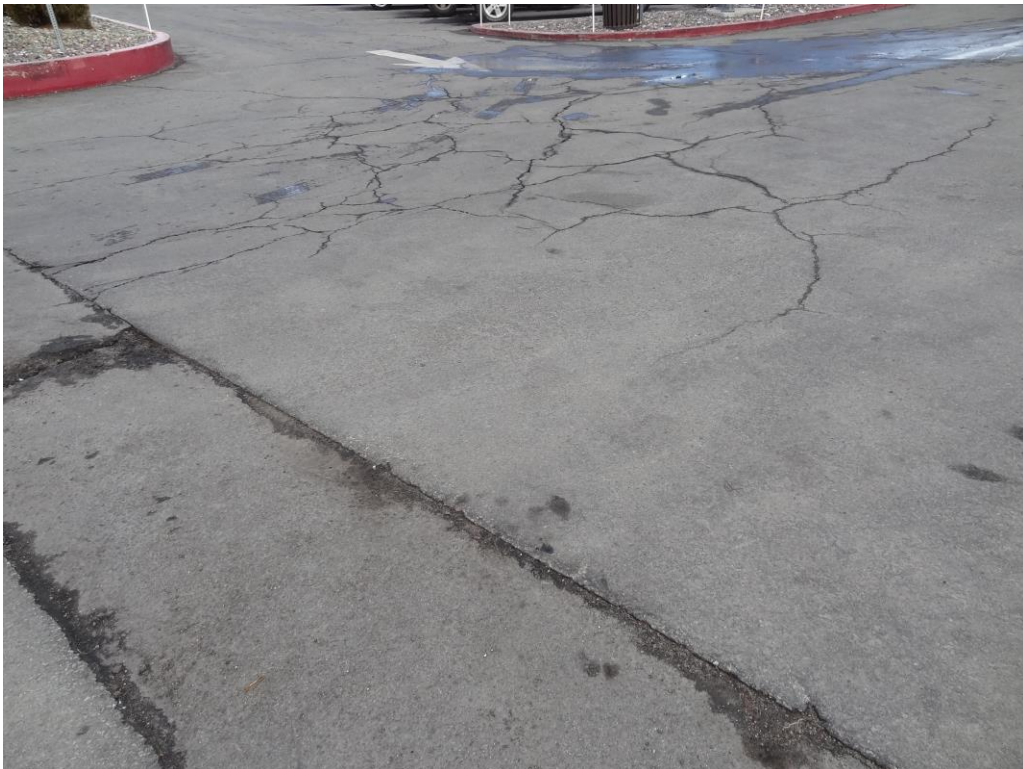
Reno DMV Site - Site #9858

The existing public and employee asphalt paved parking areas are in poor condition. There are numerous asphalt patches, alligator cracking and it has been overlaid to the extent that paving is level with the curbs in some areas causing problems with the drainage. The existing parking spaces provided are at their maximum capacity. This project would provide for the redesign of the parking area to address drainage and overcrowding, removal of the existing landscaped areas, asphalt paving and base as required and installation of new Type II base and valley gutters, 4" of new asphalt paving, striping, and wheel stops. 202,500 square feet was used to generate this estimate.

Description: Cracked asphalt in the parking lot.

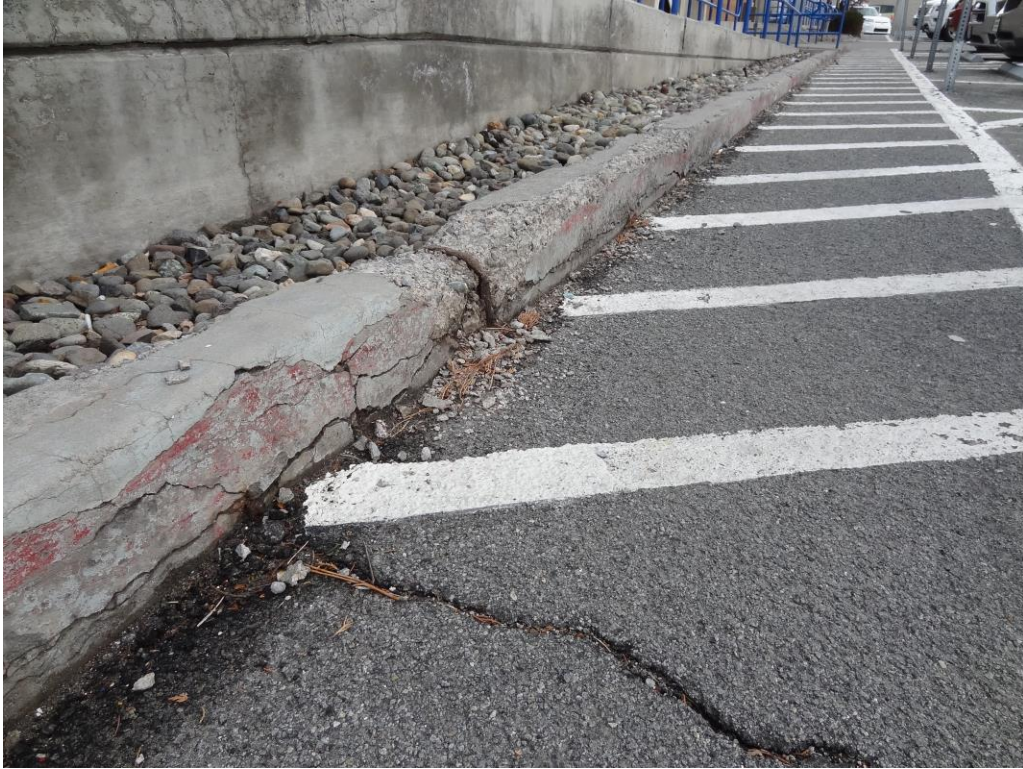
Reno DMV Site - Site #9858

The sidewalks and curbs serving the buildings on this site are deteriorated and failing. In some areas the concrete has heaved and there is settling in other locations. The concrete is pitted and spalling. This project addresses removal and replacement of existing sidewalks and curbs as needed. 10,000SF of 4" thick concrete sidewalk was used for this estimate. NRS 338.180, IBC 2012, ICC/ANSI A117.1 - 2009 and the most current version of the ADAAG were used as references for this project.

Description: Deteriorated concrete curbs along the east ADA path of travel.

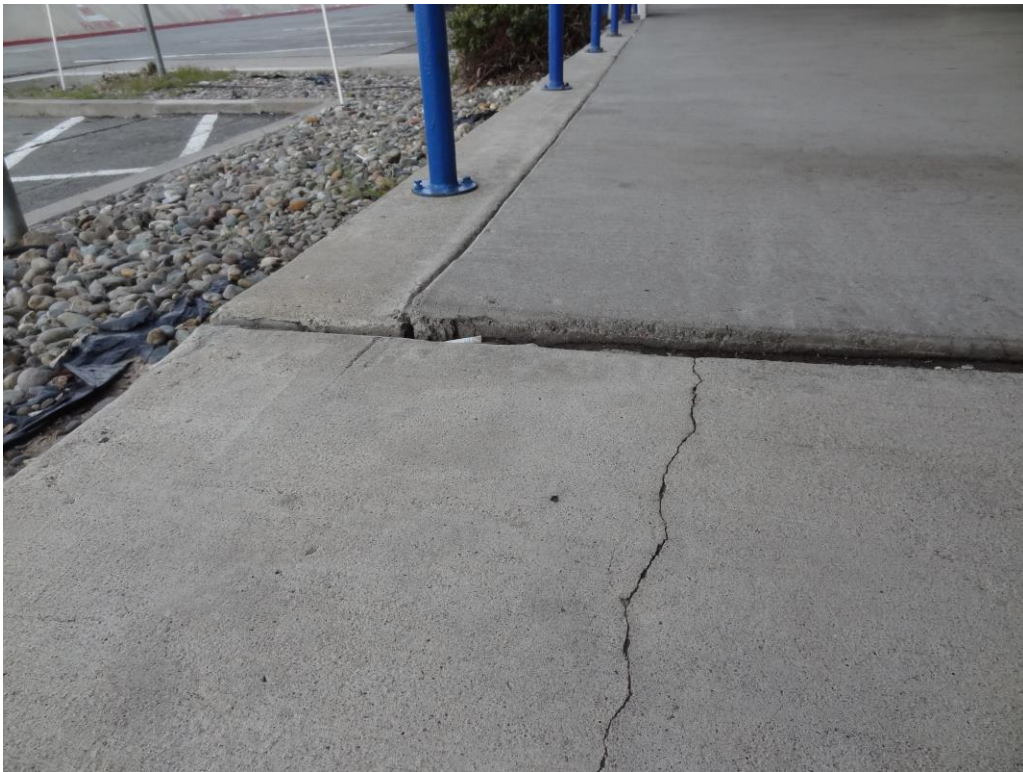
Reno DMV Site - Site #9858

Description: Concrete sidewalk that is heaving and cracked.

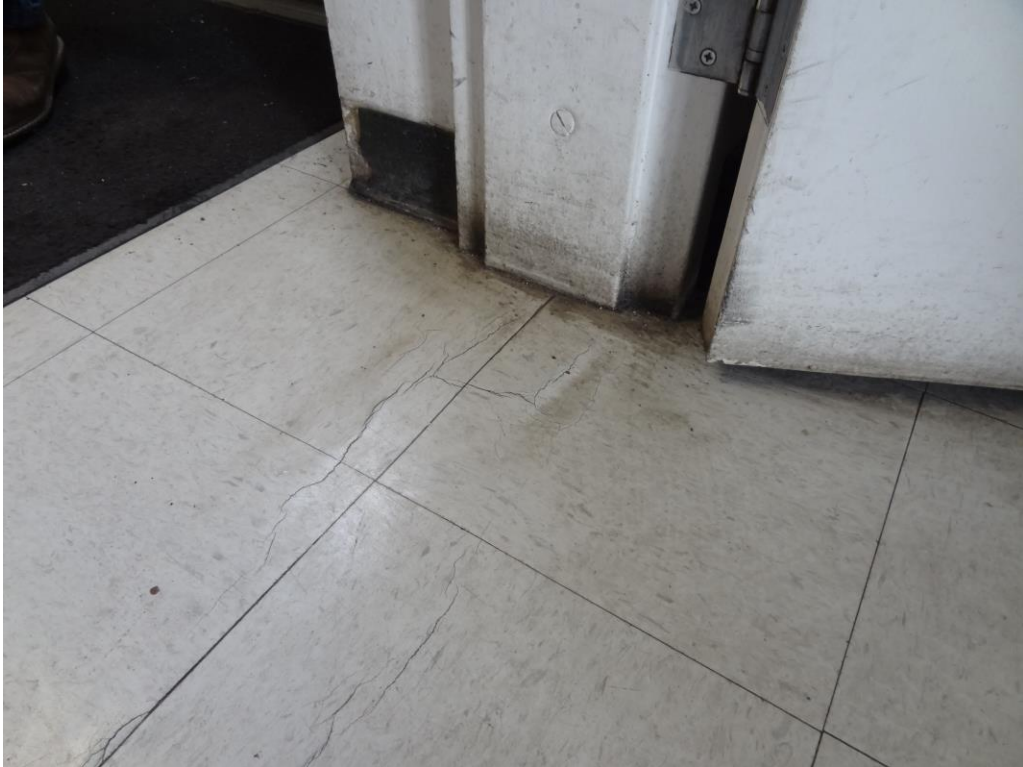
The VCT flooring in the office areas is damaged and reaching the end of its useful life. It is recommended that the VCT flooring be replaced. This project would provide for removal and disposal of the VCT and installation of new 12x12 VCT with a 6" base.

DMV Reno Inspection Station - Building #2169
Description: Damaged flooring.

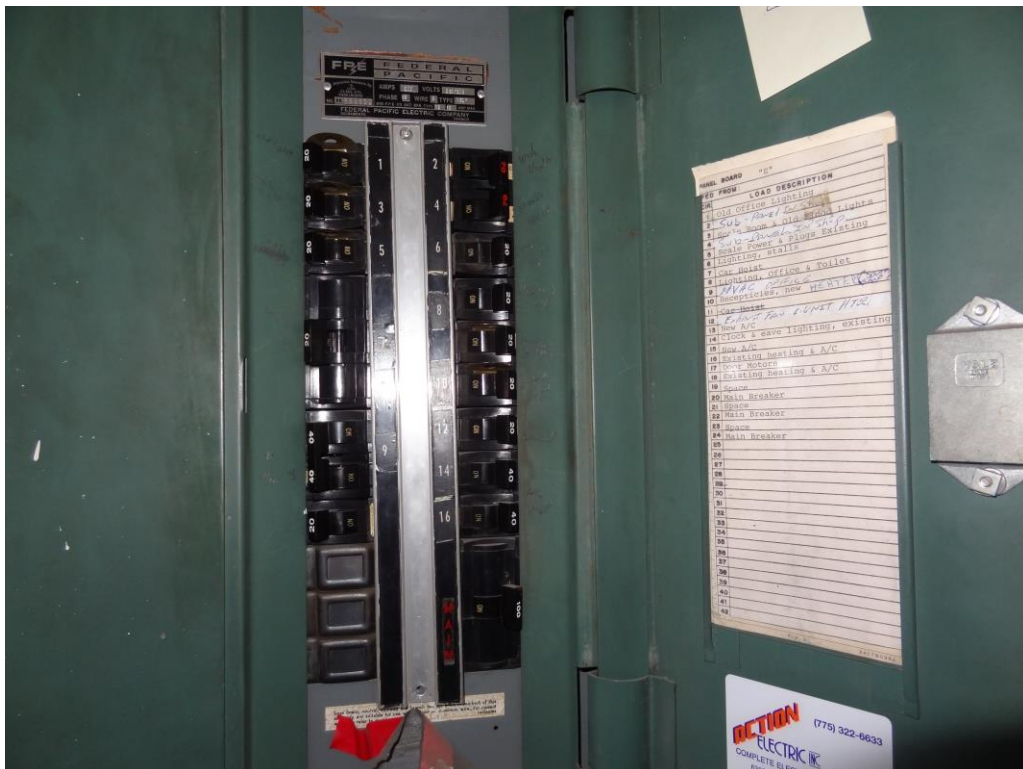
This building was constructed before the high demand for electrical services were needed for computers, communications systems and other electrical devices. As time has progressed, the buildings electrical demand and communications system has changed. The electrical system is utilized to its current maximum potential and the communications system is outdated. The electrical panels, switches and receptacles are at their limit. It is recommended to upgrade the entire electrical system and communications system to meet the evolving needs of the building.

DMV Reno Inspection Station - Building #2169
Description: 40 year old electrical equipment.

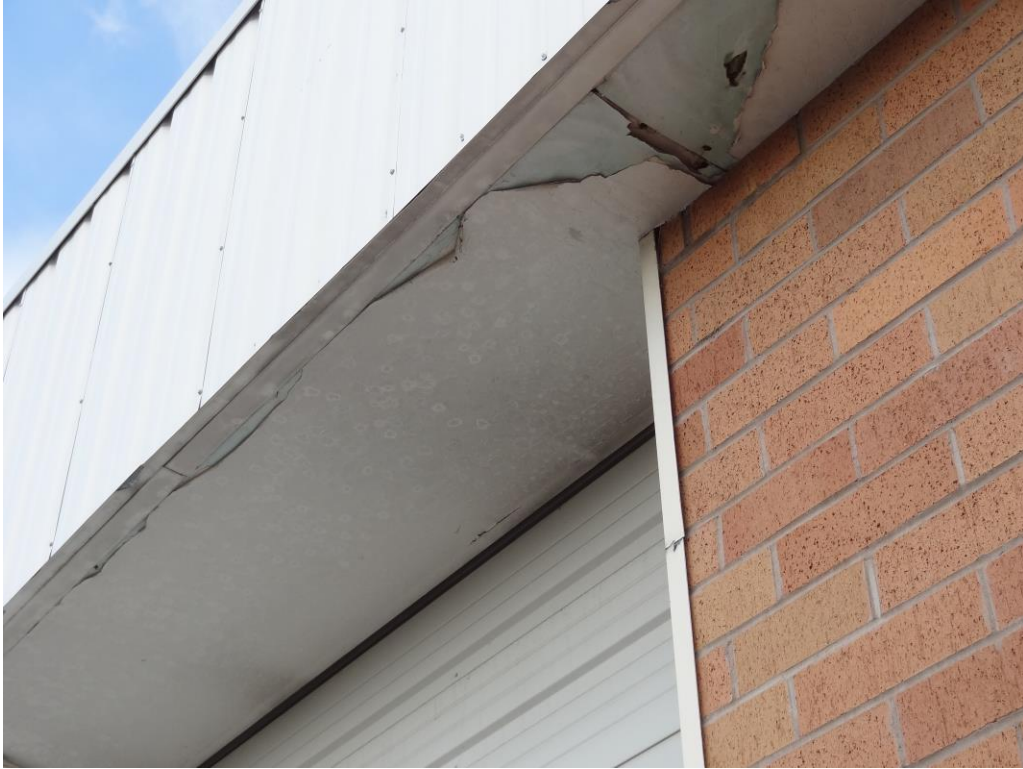
It is important to maintain the finish, weather resistance and appearance of the building. This project would provide funding to protect the exterior of the building excluding the roof. Included in the cost are cleaning and sealing the brick masonry and caulking of the windows, flashing, fixtures and all other penetrations. It is recommended that the building be sealed and caulked in the next 2-3 years and that this project be scheduled on a cyclical basis to maintain the integrity of the structure.

DMV Reno Inspection Station - Building #2169
Description: Damaged exterior finishes.
