State of Nevada
Department of Administration
Division of Buildings & Grounds
Blasdel Office Building
Facility Condition Analysis

BLASDEL OFFICE BUILDING

209 East Musser Street
Carson City, Nevada 89701

Site Number: 9960
STATE OF NEVADA PUBLIC WORKS BOARD
FACILITY CONDITION ANALYSIS

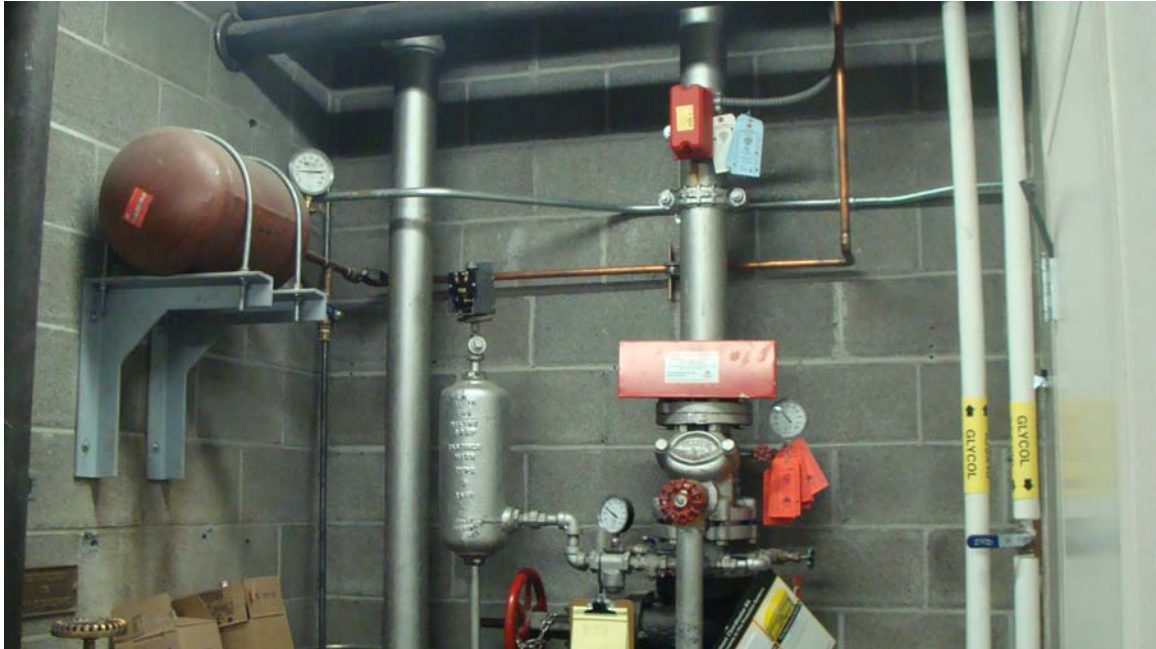
The building is a B occupancy per the 2006 IBC. It does not have a fire suppression system on the first, second or third floors. Pursuant to the Nevada State Fire Marshal Regulation, NAC 477.915 (c) states, that every building owned or occupied by the state which is designated as a B occupancy, or has a floor area greater than 12,000 square feet on any floor or 24,000 square feet on all floors or is an R-1 occupancy, must have sprinklers installed when the building is remodeled or an addition is proposed. This project would provide funding for the installation of a fire sprinkler system and backflow prevention in the event the building is remodeled or an addition is undertaken. Costs are lower on this project because there is a fire suppression system installed in the basement and a 4" dry standpipe that supplies the fire hoses on the upper floors with fire department connections at the roof, basement, and at grade.

Blasdel Office Building - Building #0200
Description: Fire sprinkler riser in basement.

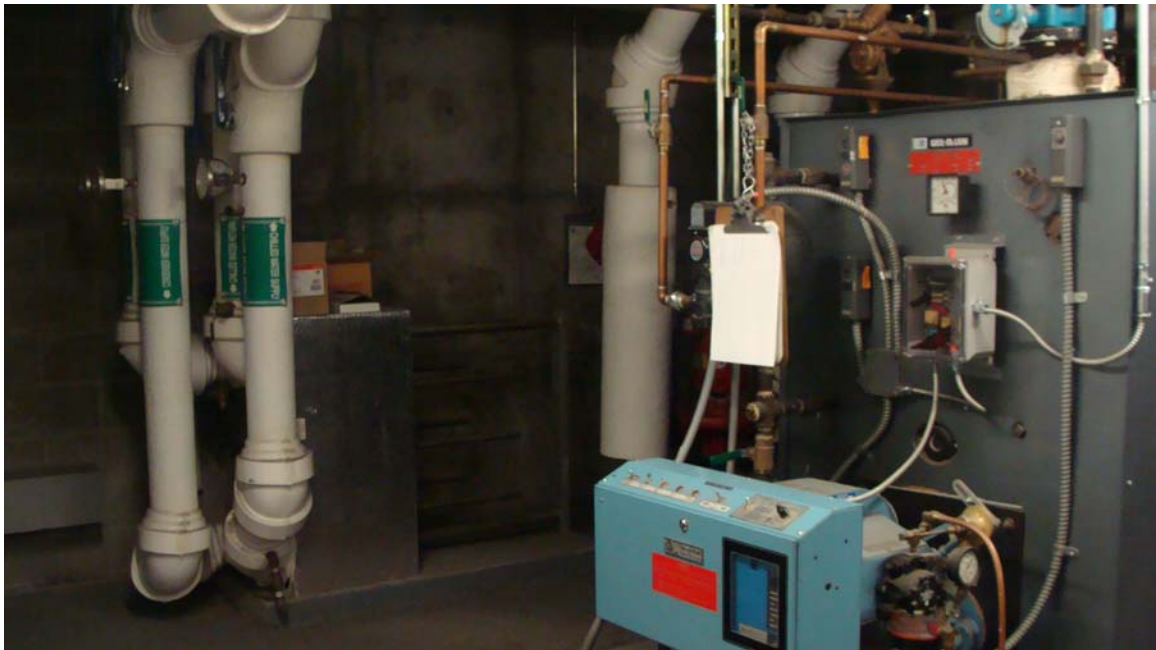
The building has an older HVAC system, most of which is original to the building. The boiler is approximately 22 years old, with radiant heaters under the windows. This project recommends replacing the HVAC system for improved comfort and efficiency. This project would provide for the removal and disposal of the existing air handler, cooling tower, boiler, radiators and controls, and replacement with new equipment including a new boiler, air handler, cooling tower, controls, all required connections to utilities, ductwork, and required equipment. The existing chemical water treatment system will need to be tested and adjusted once equipment is operational. \$2,000 is included in this estimate for testing of the chemical water treatment system.

Blasdel Office Building - Building #0200
Description: Boiler in the basement Mechanical Room.

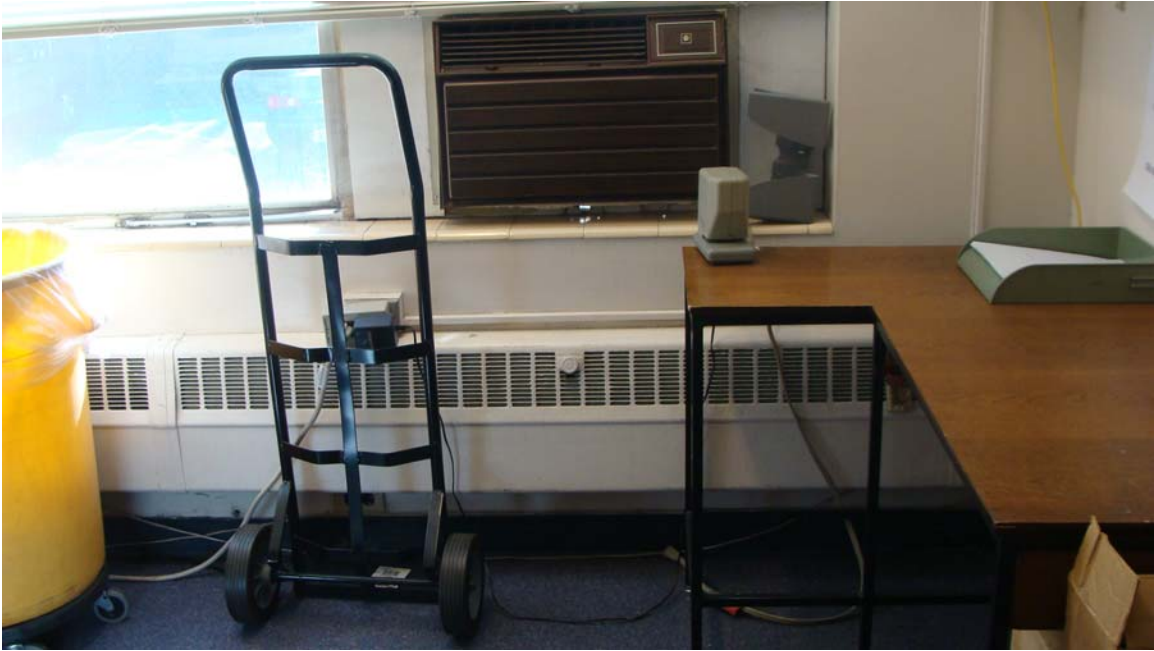
Blasdel Office Building - Building #0200
Description: Typical exterior wall mounted radiator.

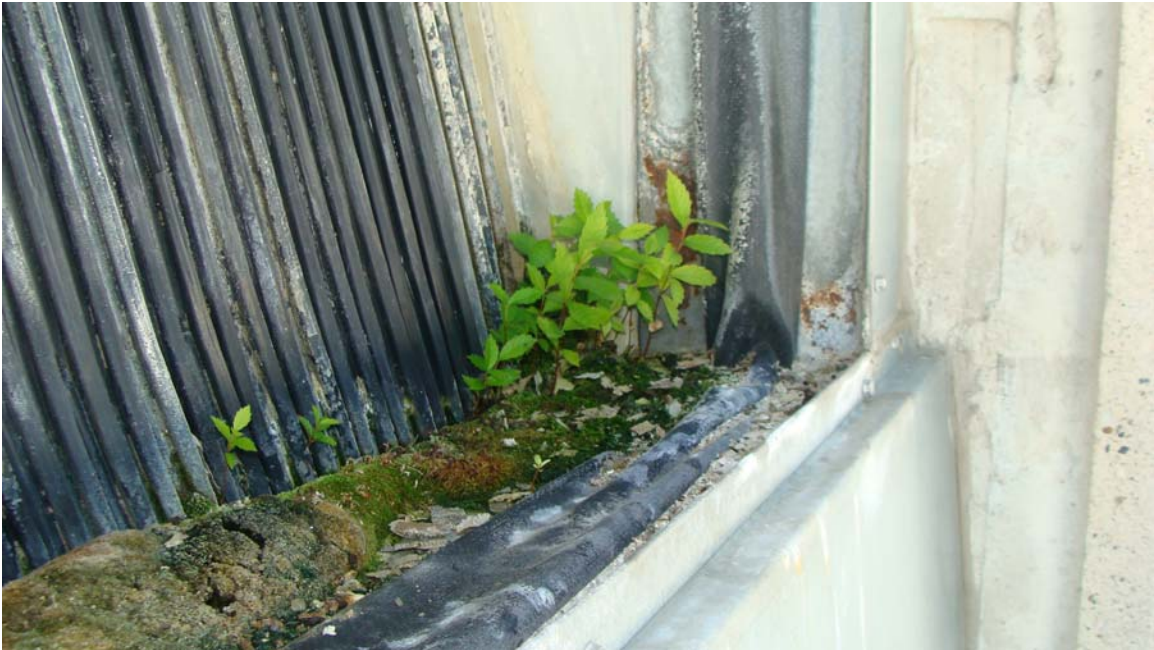
Blasdel Office Building - Building #0200
Description: Plant growth at cooling tower exhaust.

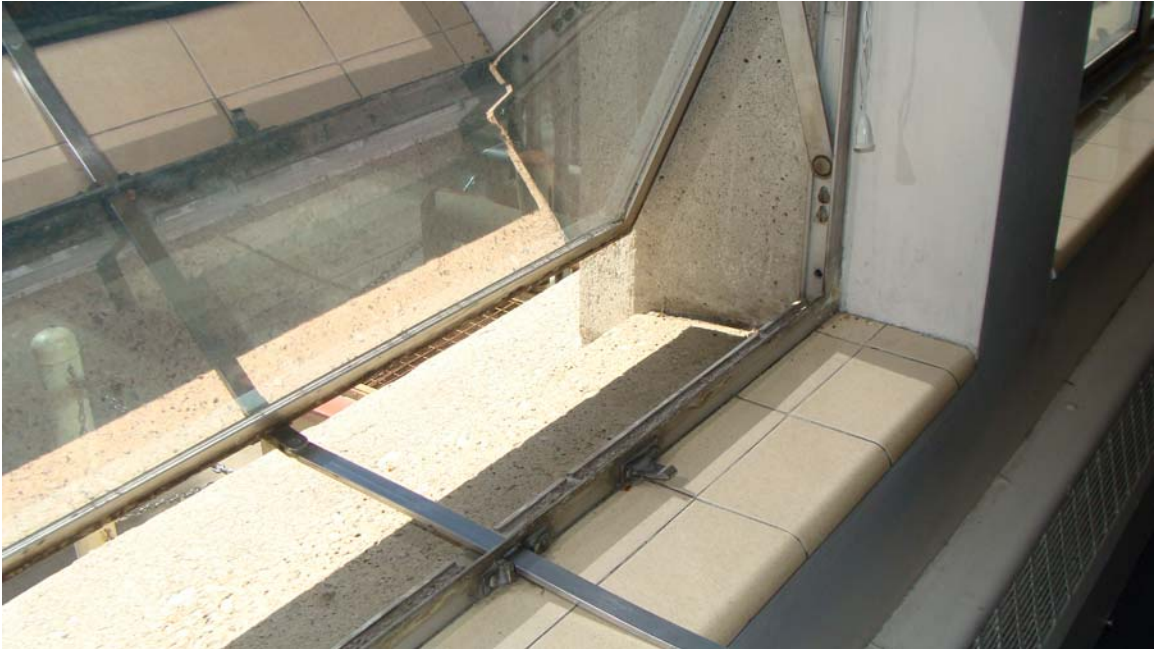
The windows are original, single pane construction in a metal frame. These older windows are drafty and not energy efficient. This project recommends replacing the windows with dual pane, higher efficiency units. This estimate is for the replacement of 144 units consisting of one large pane with two operable windows below. Removal and disposal of the existing windows is included in this estimate.

Blasdel Office Building - Building #0200
Description: Typical operable window installation.

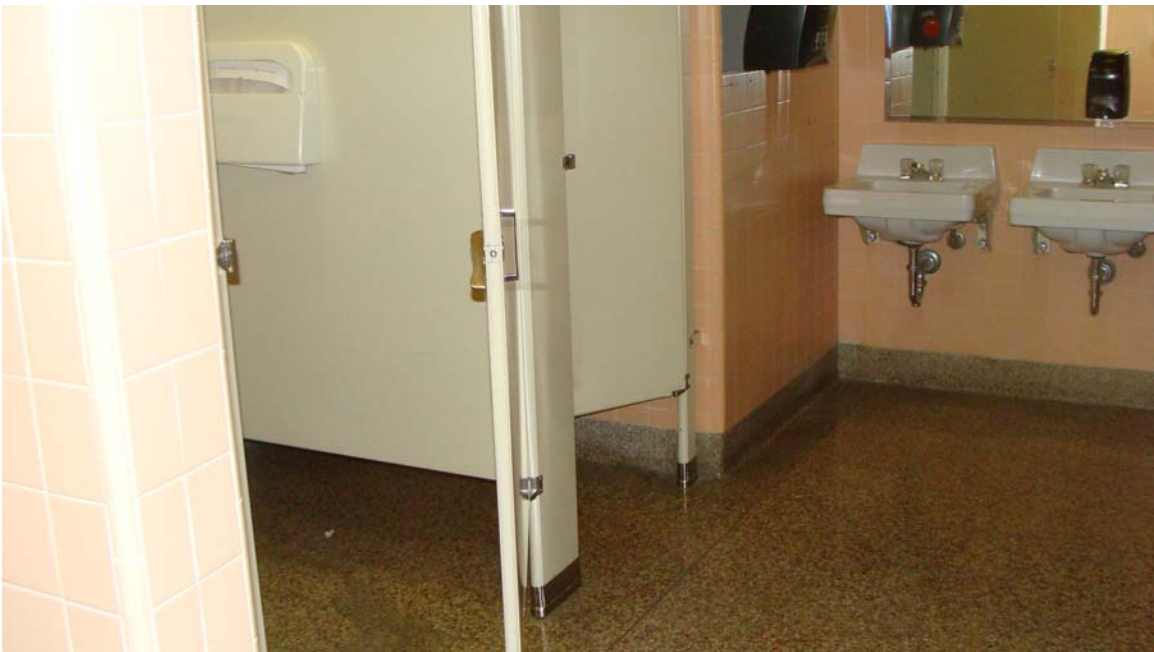
The Men's and Women's designated ADA restrooms on the first floor do not fully meet the Americans with Disabilities Act (ADA) requirements. The restrooms on the second and third floors should be remodeled to comply with the ADA as well. A complete retrofit is necessary on all four restrooms on the second and third levels including new partitions, water closets, urinals, lavatories, faucets, handles and any other necessary fixtures and finishes and minor modifications to the first floor designated ADA restrooms. This project would provide funding to bring all of the restrooms into ADA compliance. NRS 338.180, IBC - 2006, ICC/ANSI A117.1 - 2003 and Americans with Disabilities Act Accessibility Guidelines (ADAAG) - 2003 were referenced for this project.

Blasdel Office Building - Building #0200
Description: Women's restroom in need of ADA upgrades.
