BLASDEL OFFICE BUILDING

Site Number: 9860
STATE OF NEVADA PUBLIC WORKS DIVISION
FACILITY CONDITION ANALYSIS

SPWD Facility Condition Analysis - 0200

Survey Date: 1/26/2021

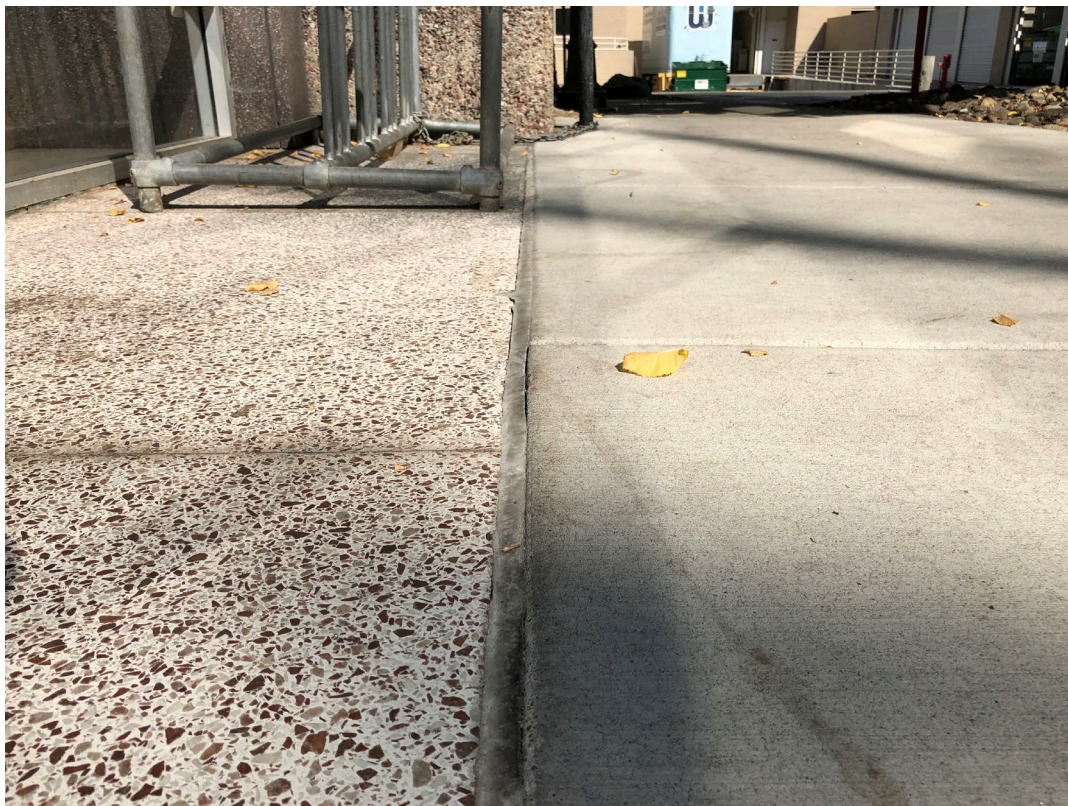
The concrete sidewalk on the south side of the building appears to have heaved significantly since it was installed. The transition from the sidewalk concrete to the existing concrete adjacent to the buildings south entrance has an elevation change of more than 1/2". This is on the accessible means of egress and should be remedied immediately. The concrete should be ground down to reduce the elevation change to less than 1/4". NRS 338.180, IBC - 2018, ICC/ANSI A117.1 and Americans with Disabilities Act Accessibility Guidelines (ADAAG) - 2003 were referenced for this project. This project or a portion thereof was previously recommended in the FCA report dated 8/3/2010. It has been amended accordingly to reflect conditions observed during the most recent survey date of 01/26/2021.

Blasdel Office Building - Building #0200
Description: Walking Surface Creating Ponding Water at South Entrance.

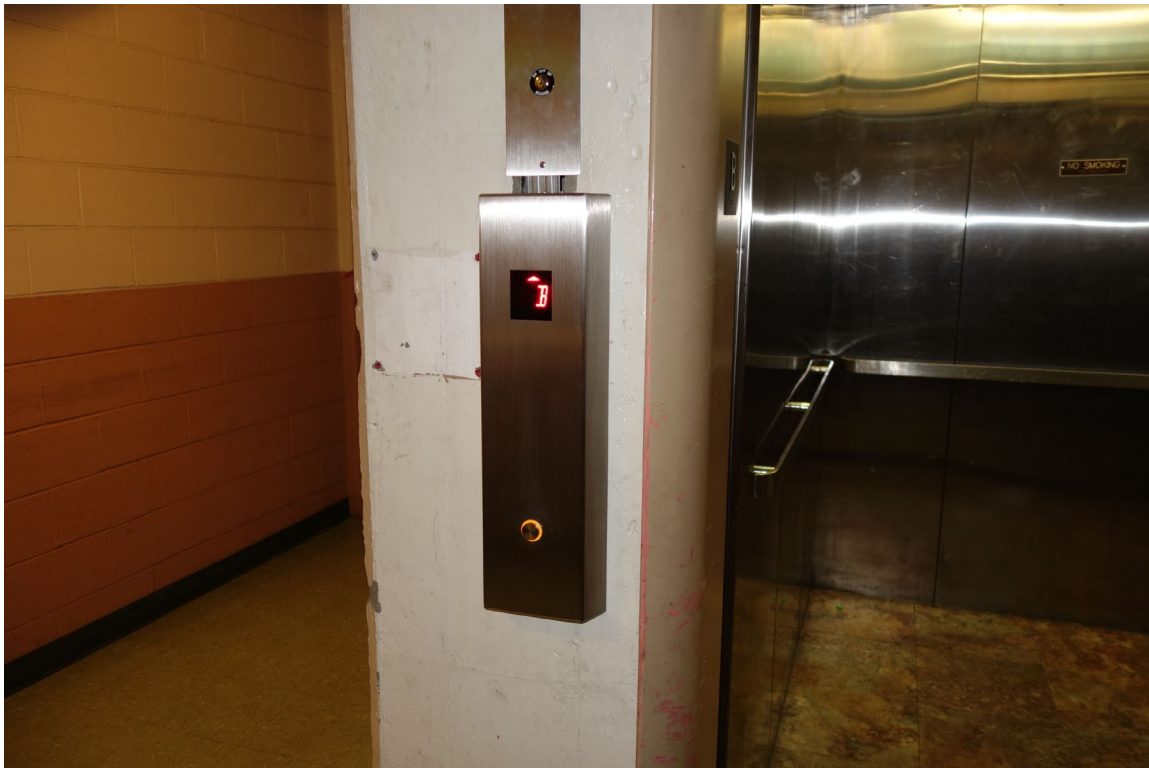
The existing elevator control system and drive components have not been upgraded since the system was remodeled in 2000. It is due to be upgraded with new state-of-the-art ADA accessible controls and drive components. The scope of work is to replace the control system, various drive components and electrical and mechanical elements to increase safety and ensure current code compliance.

Blasdel Office Building - Building #0200
Description: Elevator Upgrade Needed.

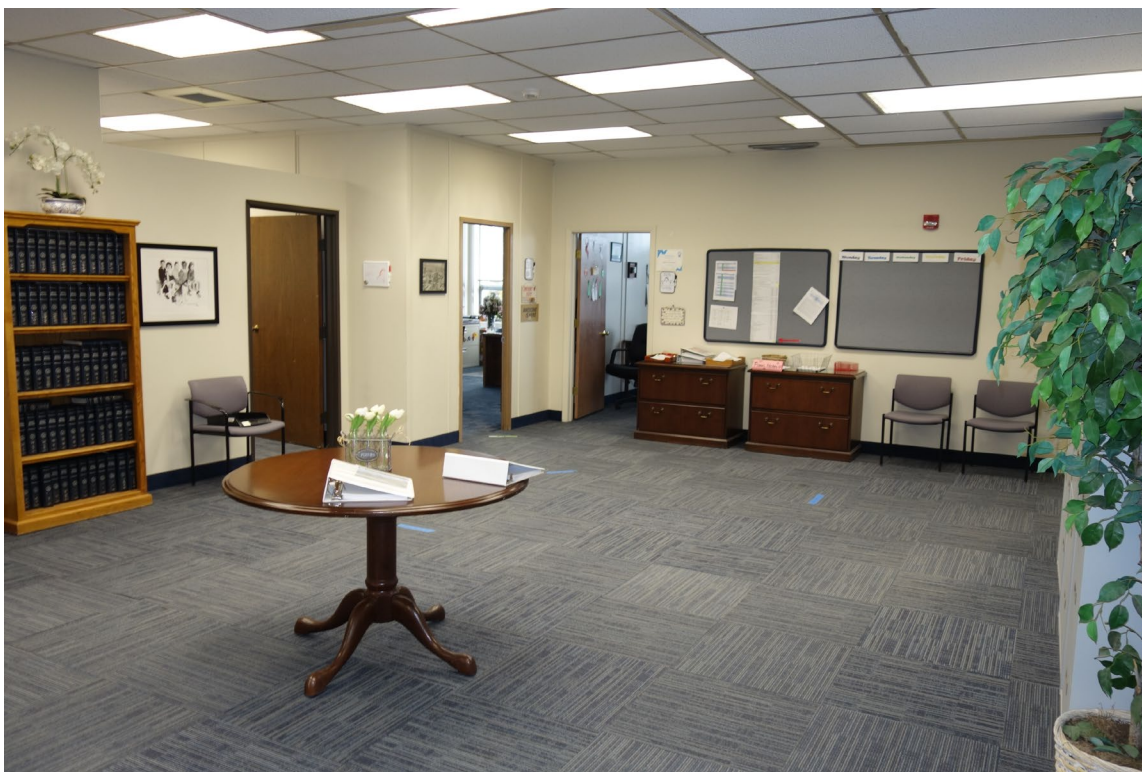
The building does not have a fire suppression system on the first, second or third floors. Pursuant to the Nevada State Fire Marshal Regulation, NAC 477.915 (c) states, that every building owned or occupied by the state which is designated as an R occupancy, or has a floor area greater than 12,000 square feet on any floor or 24,000 square feet on all floors or is an R-1 occupancy, must have sprinklers installed when the building is remodeled or an addition is proposed. This project would provide funding for the installation of a fire sprinkler system and backflow prevention in the event the building is remodeled or an addition is undertaken. Costs are lower on this project because there is a fire suppression system installed in the basement and a 4" dry standpipe that supplies the fire hoses on the upper floors with fire department connections at the roof, basement, and at grade.

Blasdel Office Building - Building #0200
Description: Typical Interior – Note Absence of Fire Sprinklers.

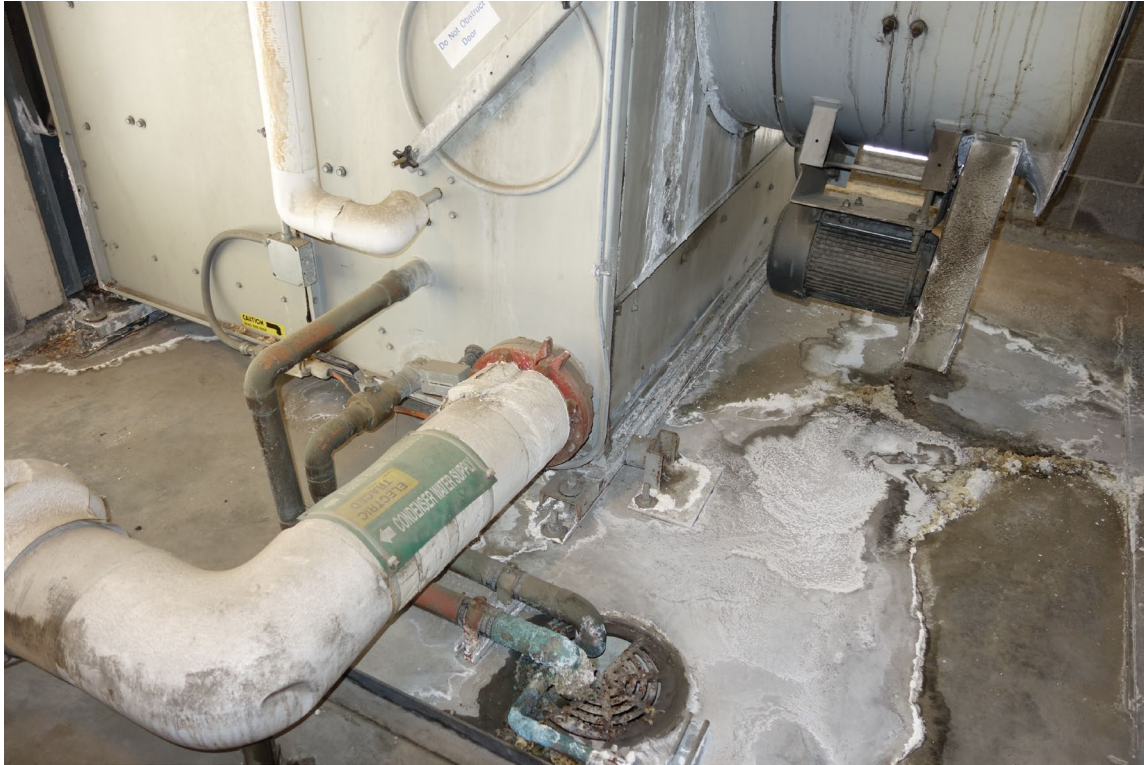
The HVAC system was originally installed in 1957 with upgrades to the air distribution system in 1997 and replacement of the air handler in 2015. The hydronic radiant heating system is original to the building. This project would provide for the removal and disposal of the air handler, cooling tower, hydronic radiators, zone dampers, duct systems and controls and replace with new equipment including a new variable air volume (VAV) air distribution system.

Blasdel Office Building - Building #0200
Description: HVAC Systems Replacement Recommended.

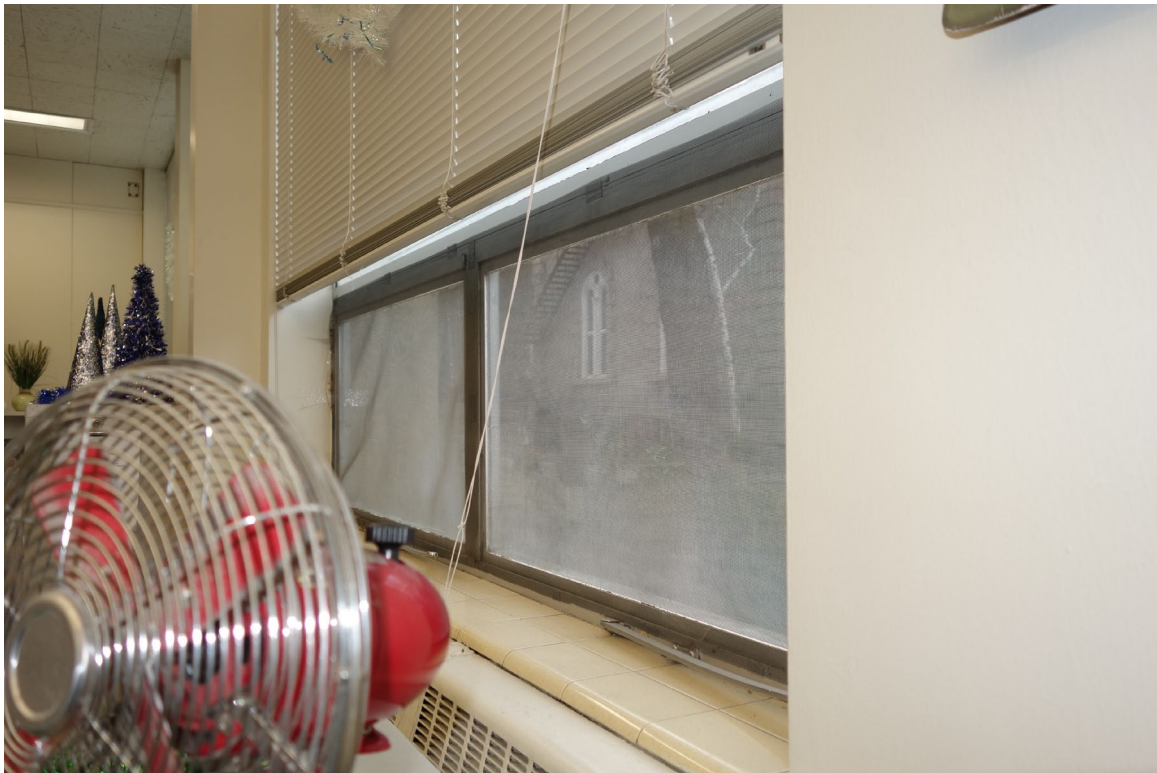
The windows are original, single pane construction in a metal frame. These older windows are drafty and not energy efficient. This project recommends replacing the windows with dual pane, higher efficiency units with thermally broken frames. This estimate is for the replacement of 150 units consisting of one large pane with two operable windows below. Removal and disposal of the existing windows is included in this estimate.

Blasdel Office Building - Building #0200
Description: Window & Hydronic Baseboard Replacement Needed.
