State of Nevada Department of Administration
Buildings & Grounds Division/Kinkead Building
Facility Condition Analysis

KINKEAD BUILDING

505 E. King Street, Carson City, NV

FACILITY CONDITION ANALYSIS

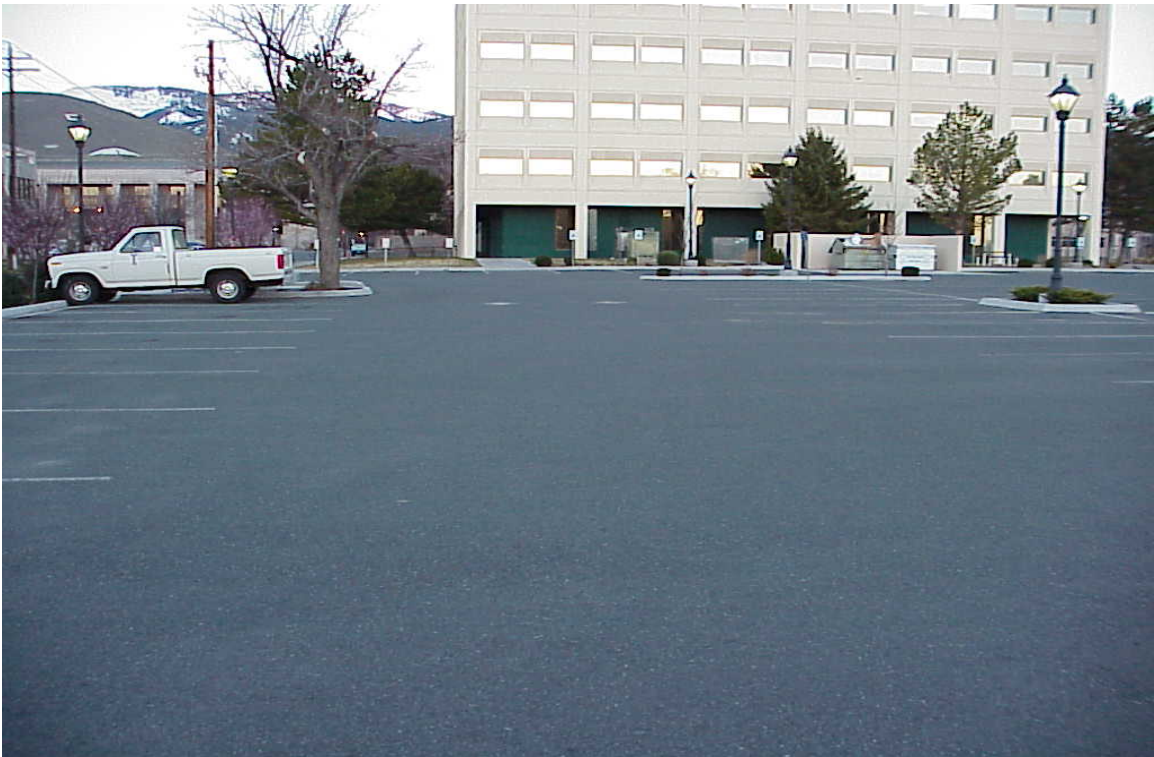
The paving is in average condition. It is recommended the parking area be fog sealed and re-stripped to extend the life of the asphalt.

Buildings & Grounds Division/Kinhead Building - Building #0201
Description: View of parking area.

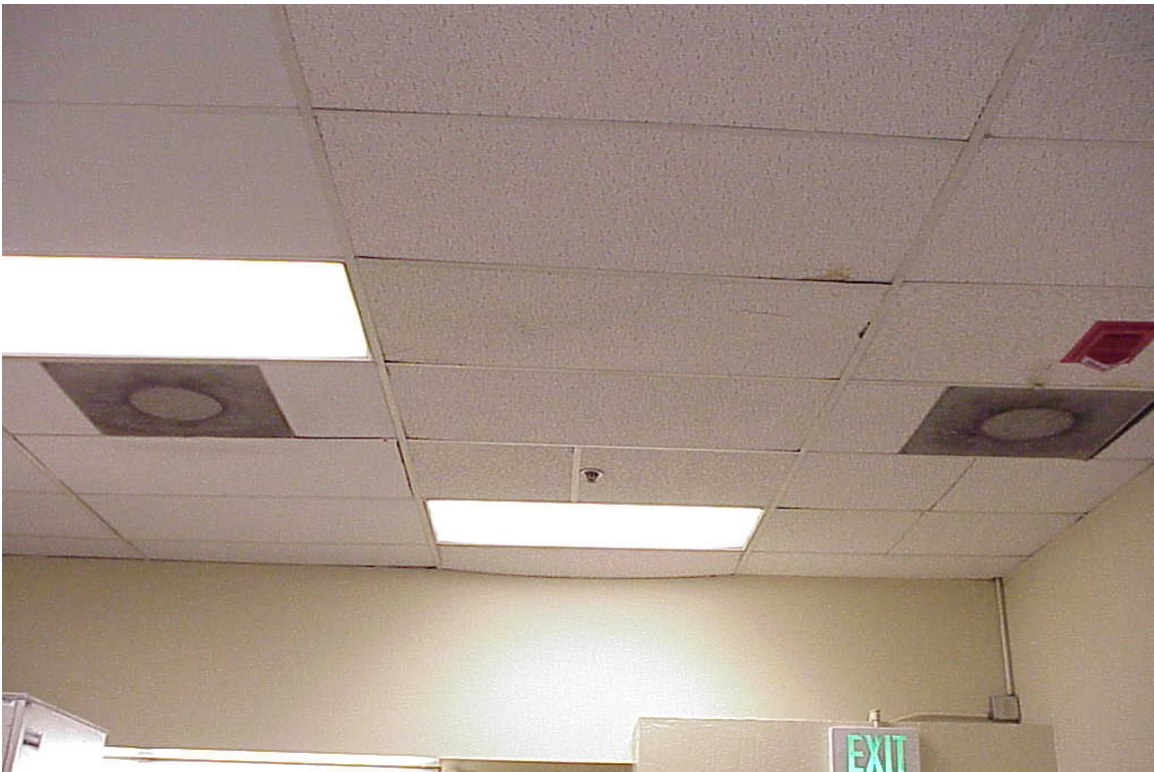
Buildings & Grounds Division/Kinhead Building - Building #0201

The suspended ceiling is in average condition, but a number of the tiles are damaged, not properly installed or not washable.

Description: Sagging ceiling in the Café.

This project recommends replacing the cafeteria t-bar system and ceiling tiles.

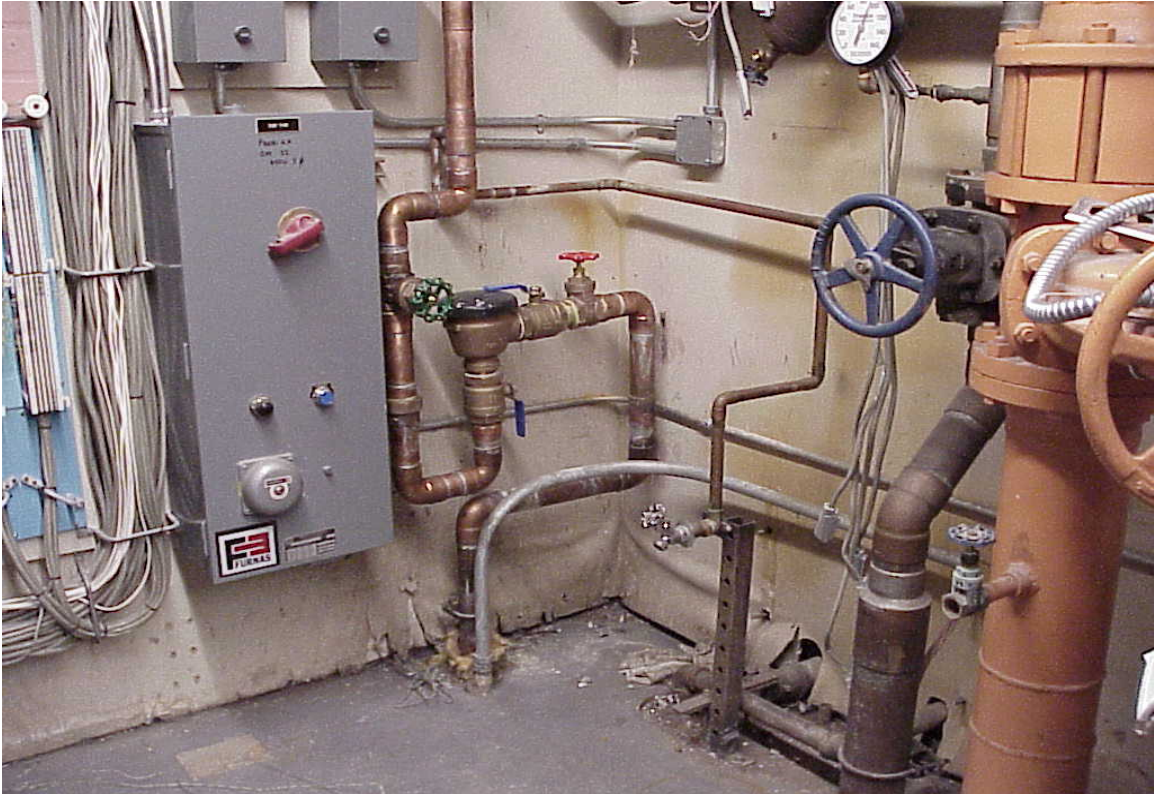
Buildings & Grounds Division/Kinhead Building - Building #0201

This building was constructed before the high demand for new types of electrical devices were needed. As time progressed, the buildings' electrical demand has changed, and is utilized to its current maximum potential. The electrical panels and receptacles are at their limit. The system should be upgraded to meet the evolving needs of the building.

Description: Electrical room for the first floor.

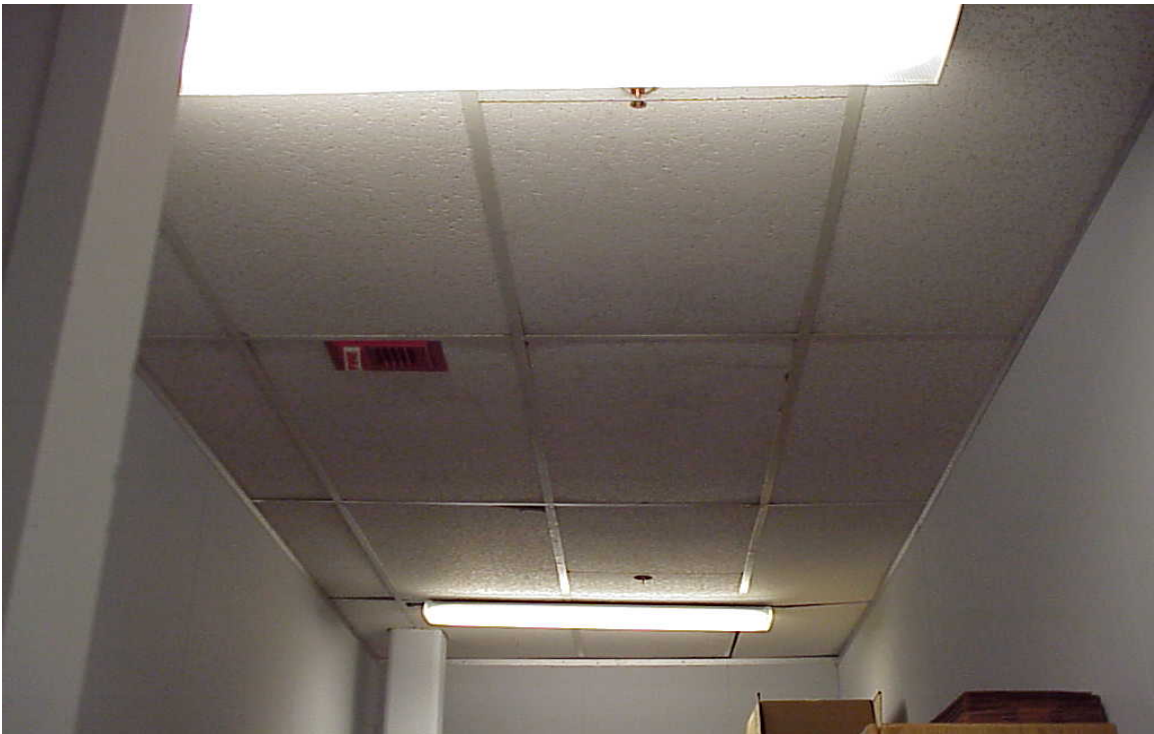
Buildings & Grounds Division/Kinhead Building - Building #0201

Description: Sagging ceiling in an office on the first floor.

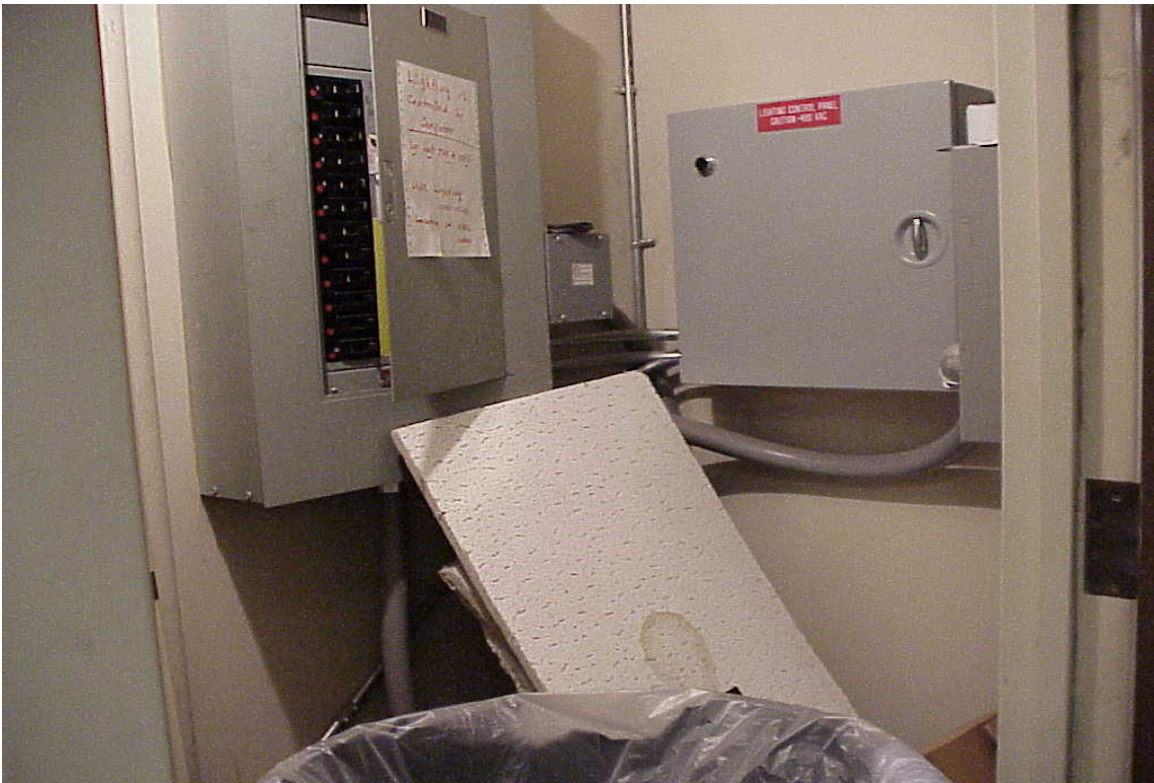
Buildings & Grounds Division/Kinthead Building - Building #0201
Description: Typical view of an electrical room in each floor.

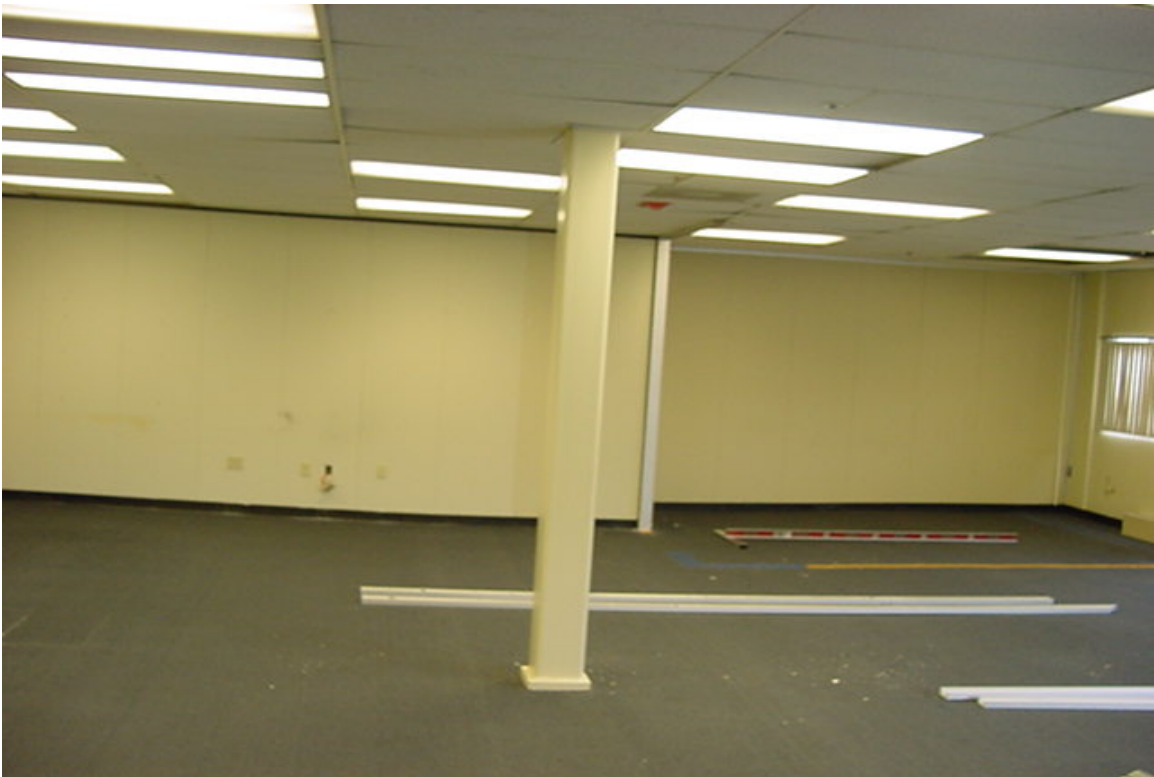
Buildings & Grounds Division/Kinthead Building - Building #0201

Description: View of ceiling failure, second floor office.

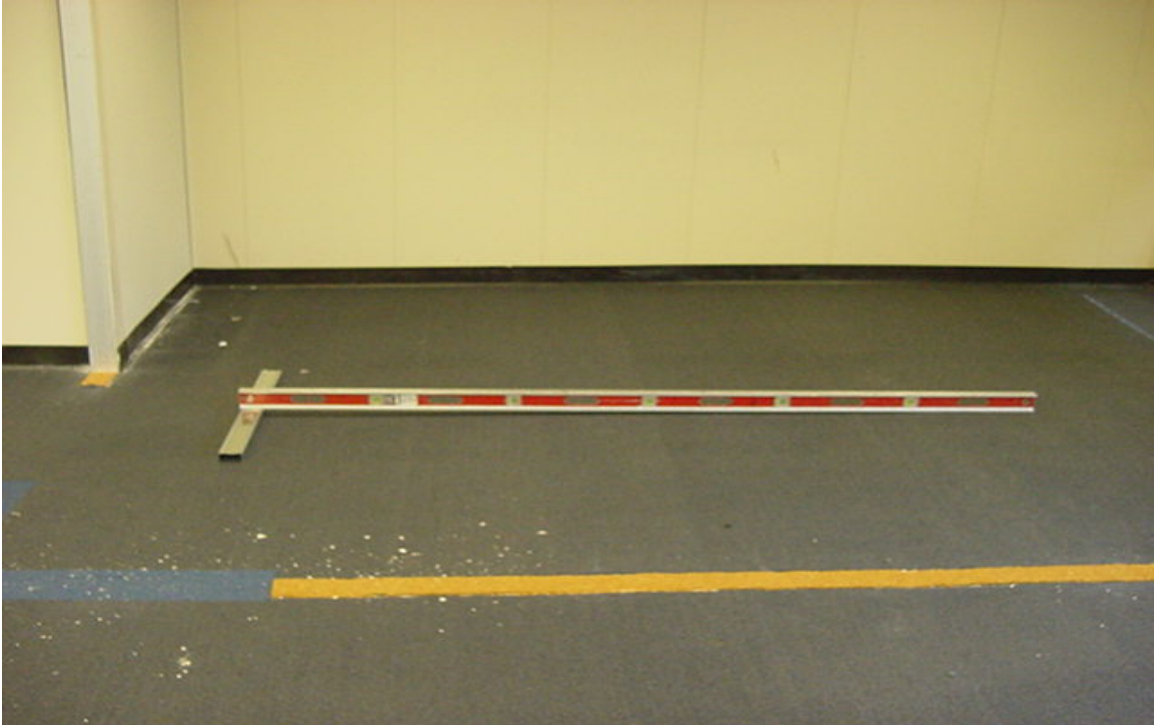
Buildings & Grounds Division/Kinhead Building - Building #0201

Description: Uneven floor, second floor office.

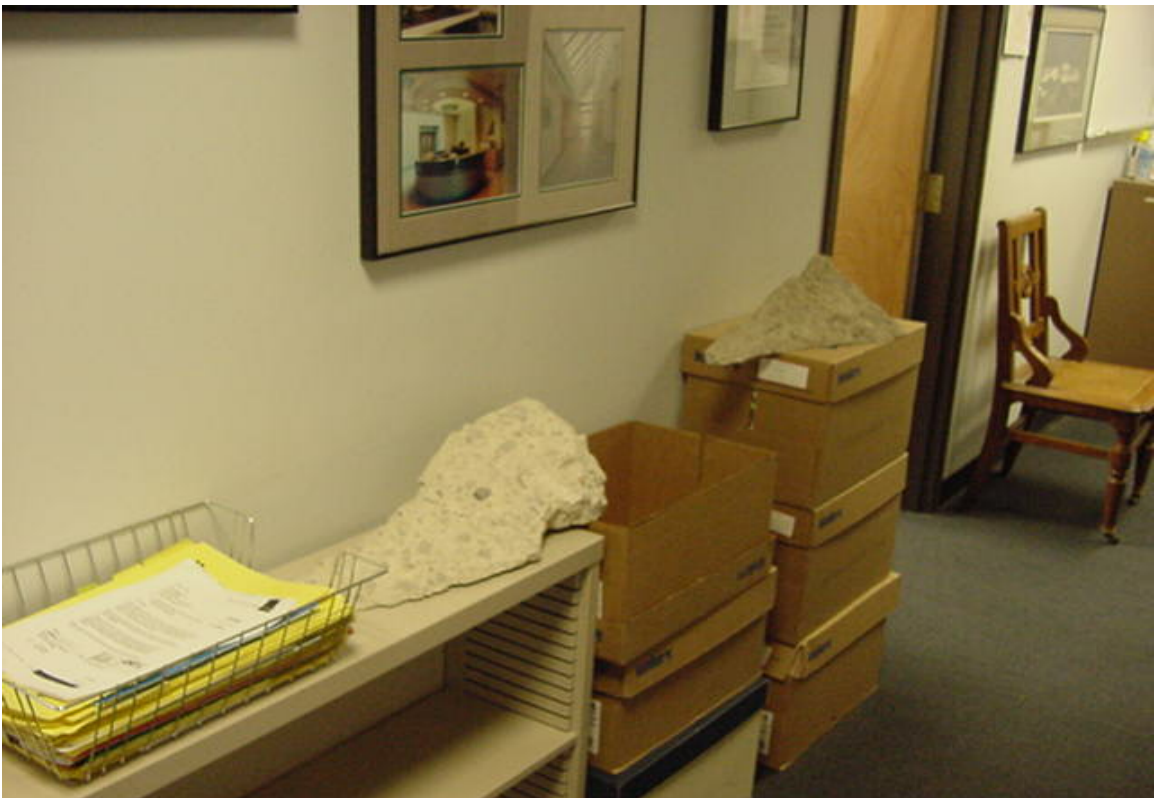
Buildings & Grounds Division/Kinhead Building - Building #0201

Description: Broken wall sections of concrete from second floor office.
