State of Nevada
Department of Administration
Public Works Division / Buildings & Grounds Section
Carson City Motor Pool
Facility Condition Analysis

CARSON CITY MOTOR POOL

750 East King Street
Carson City, Nevada 89701

Site Number: 9862
STATE OF NEVADA PUBLIC WORKS DIVISION
FACILITY CONDITION ANALYSIS

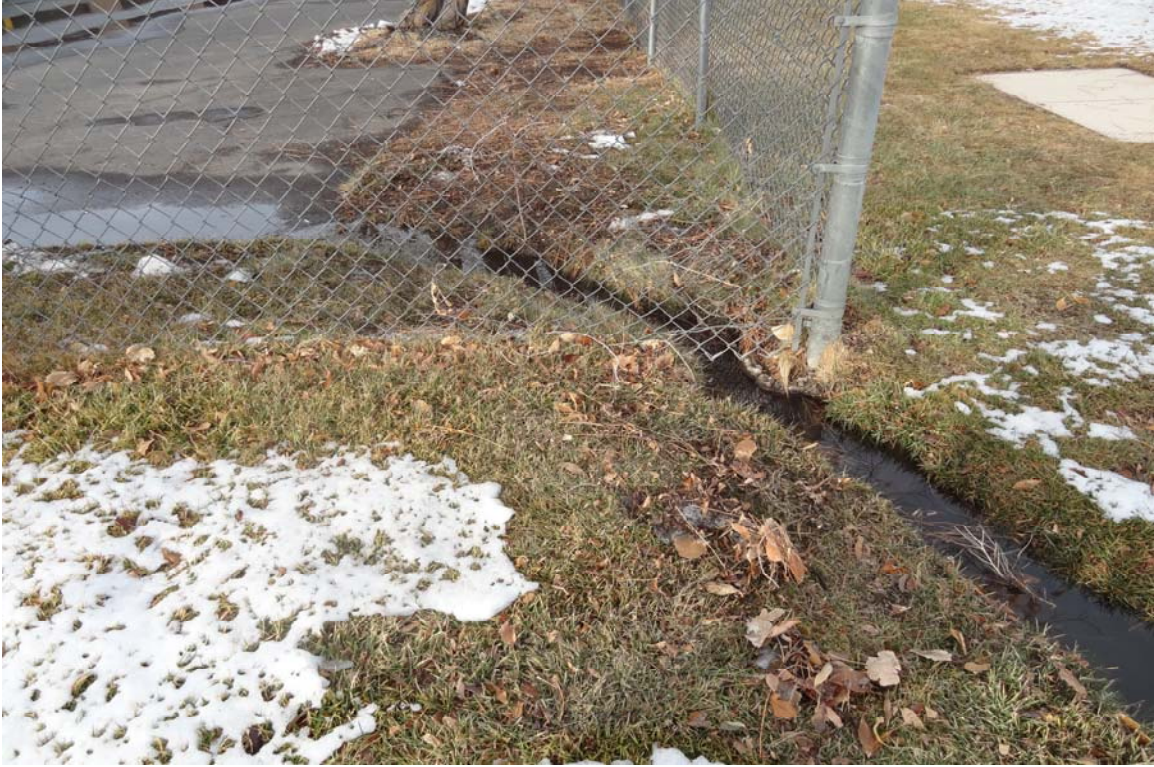
The site has several drainage problems around the site. On the north side the water drains towards the building and into one of the shop bays. On the perimeter of the site the runoff is directed across the public sidewalk creating a slip and fall hazard especially when it freezes. Several areas have standing water which causes premature deterioration of the paving. This project would create positive flow away from the building and to the storm drain system by regrading and installing French drains as needed. This project should be implemented concurrently with the SLURRY SEAL ASPHALT PAVING project.

Carson City Motor Pool Site - Site #9862
Description: Area where drainage improvements are needed.

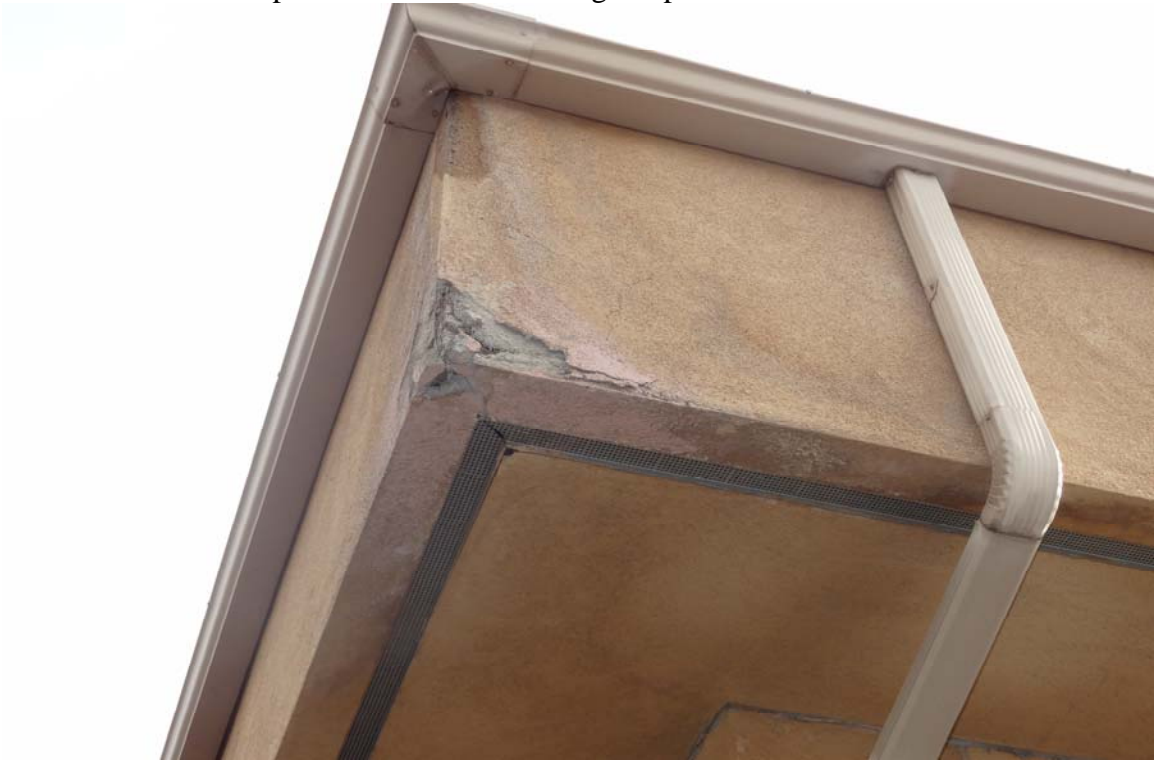
Carson City Motor Pool - Building #0204
Description: Damaged stucco fascia.

It is important to maintain the finish, weather resistance and appearance of the building. This project would provide funding to protect the exterior of the building excluding the roof. Included in the cost are cleaning and sealing the brick masonry, painting the stucco and caulking of the windows, flashing, fixtures and all other penetrations. It is recommended that the building be sealed and caulked in the next 1-2 years and that this project be scheduled on a cyclical basis to maintain the integrity of the structure. In addition, this project would repair damaged areas of the stucco and slump stone masonry.

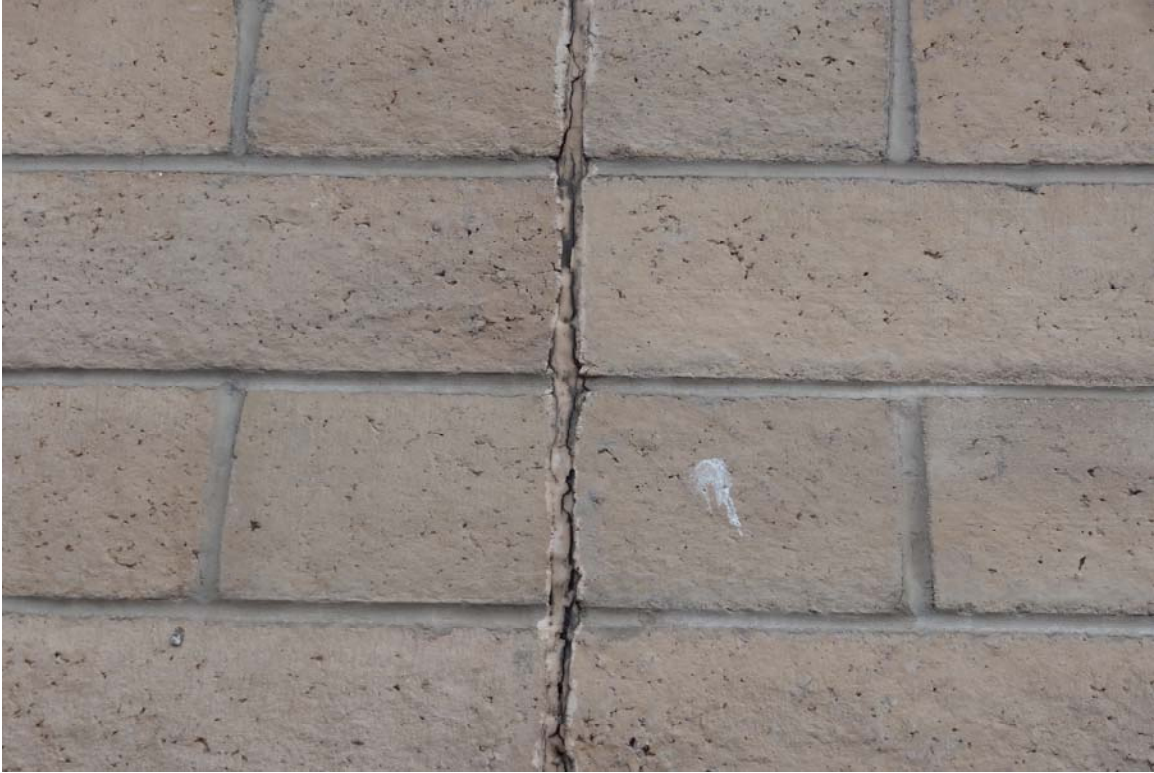
Carson City Motor Pool - Building #0204
Description: Control joint in need of caulking.

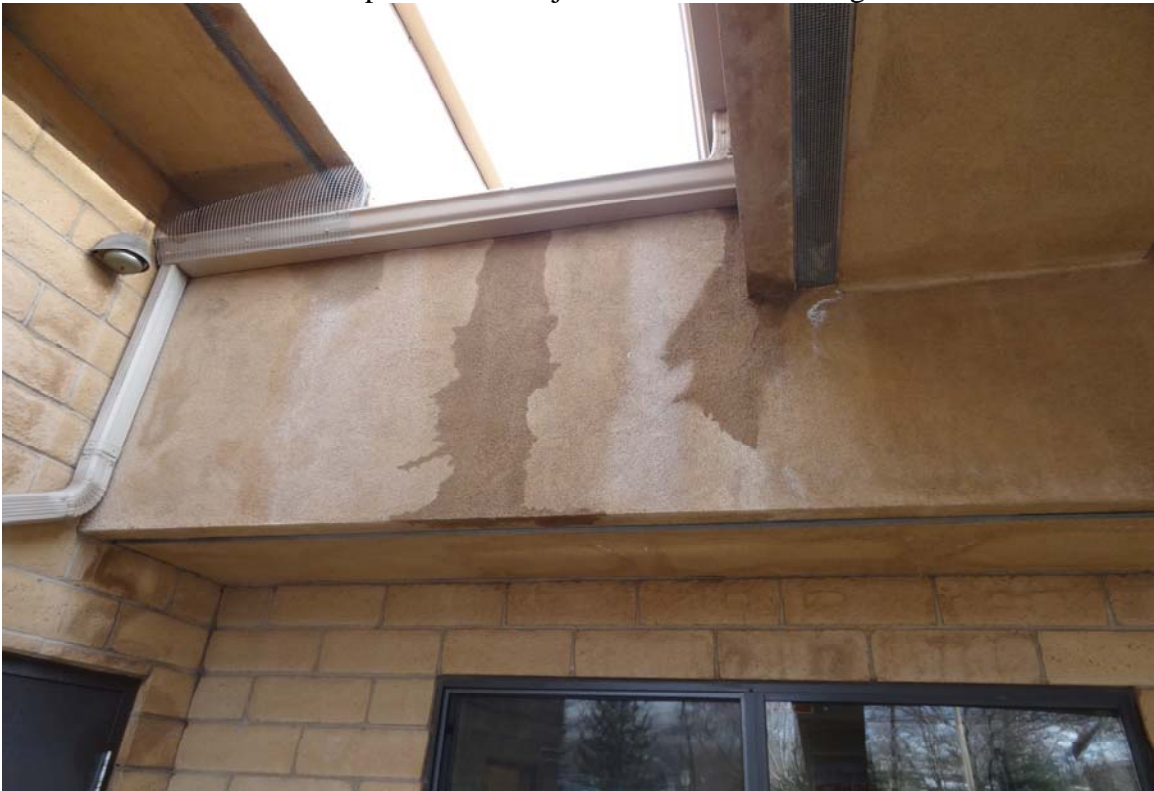
The existing gutters and downspouts around the building are due for replacement. The gutters leak and the downspouts are damaged in many areas. The leaking gutters will cause premature deterioration to the building finishes and the site hardscape. This project would replace the existing segmented gutter with seamless gutter and replace the downspouts. This project or a portion thereof was previously recommended in the FCA report dated 07/22/2004. It has been amended accordingly to reflect conditions observed during the most recent survey date of 01/24/2012.

Carson City Motor Pool - Building #0204
Description: Water damaged stucco / leaking gutters.

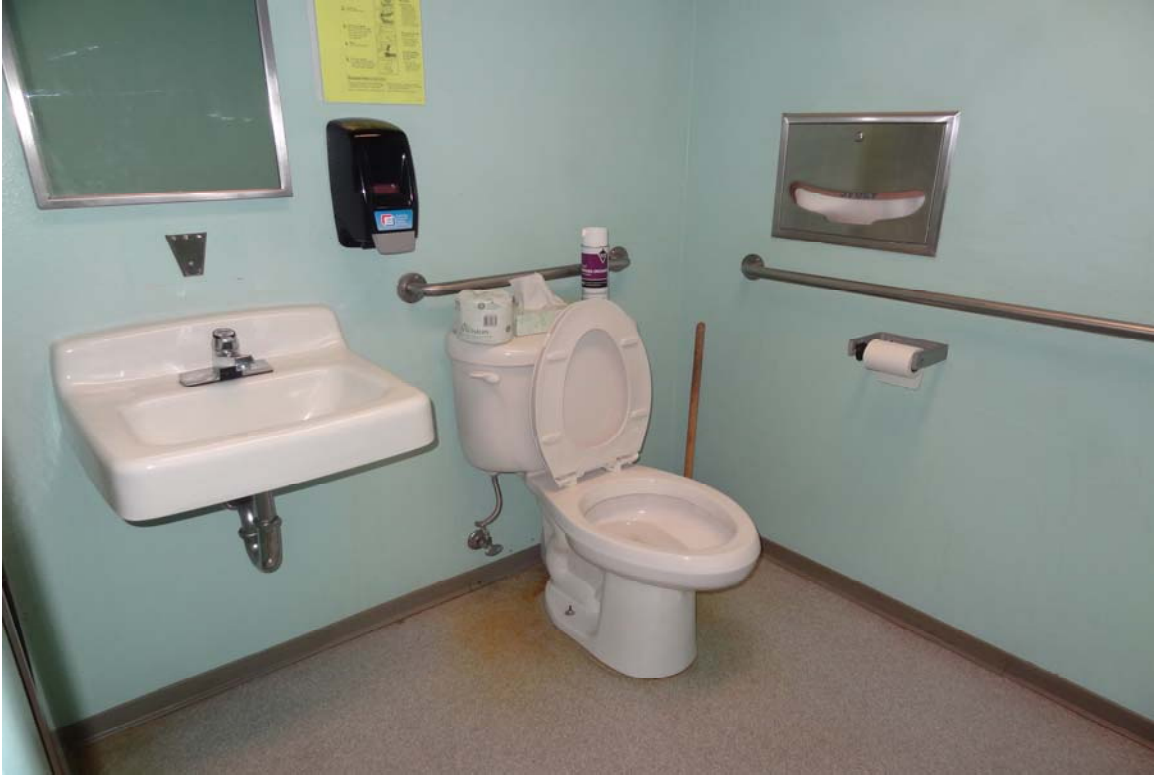
The designated ADA restroom does not meet the Americans with Disabilities Act (ADA) requirements. For example, the water closet and lavatory are too low, the soap dispenser and mirror are too high, the lavatory is missing under-sink protection and the toilet seat cover dispenser is too high. A complete retrofit is necessary. This project would provide funding for construction of a unisex accessible restroom. These items may include compliant hardware, mirrors, fixtures, flooring and paint. NRS 338.180, IBC - 2006, ICC/ANSI A117.1 - 2003 and the most current version of the Americans with Disabilities Act Accessibility Guidelines (ADAAG) were used as a reference for this project.

Carson City Motor Pool - Building #0204
Description: Unisex restroom, note fixture locations and toilet seat.

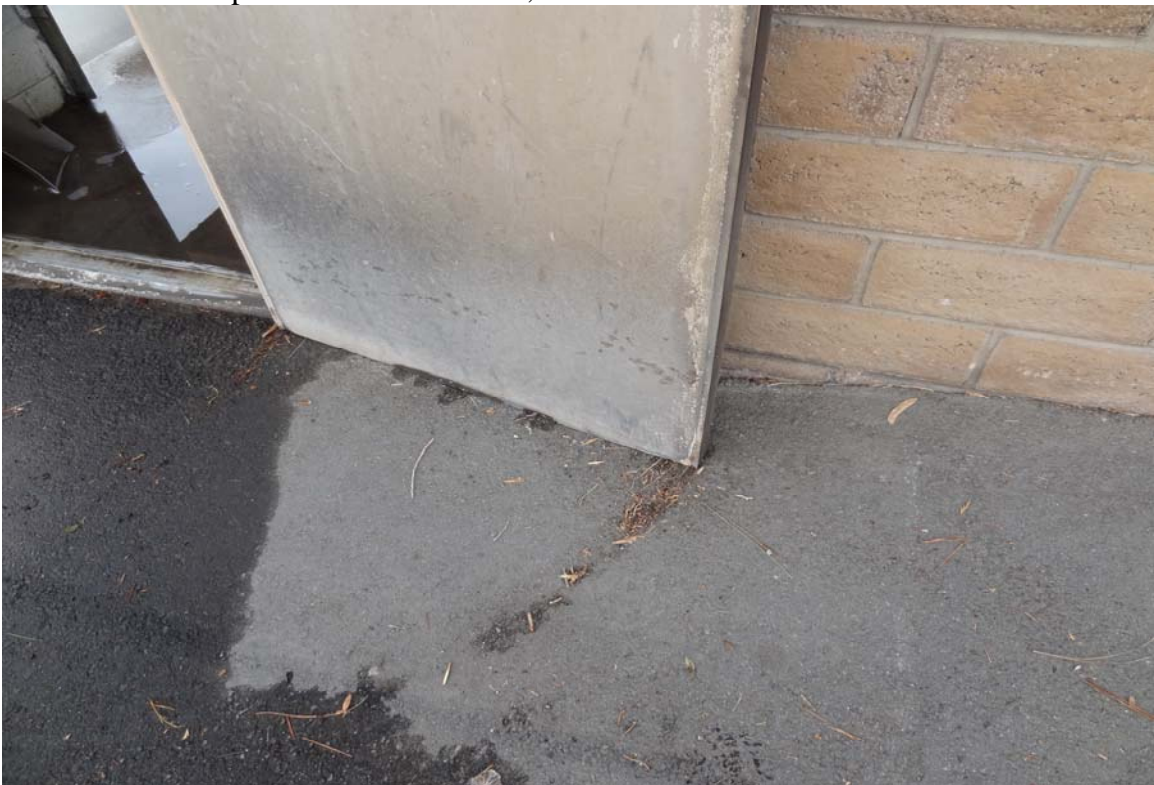
The exterior metal man door on the north side of the building is damaged from wear and tear due to improper grading / AC pavement placement at the landing. This project would provide for the replacement of the door assembly with a new metal door, frame and hardware and proper exterior landing. Removal and disposal of the existing door is included in this estimate.

Carson City Motor Pool - Building #0204
Description: Damaged exterior door.
