PAUL LAXALT STATE BUILDING

Site Number: 9863

STATE OF NEVADA PUBLIC WORKS DIVISION FACILITY CONDITION ANALYSIS

Survey Date: 8/9/2018

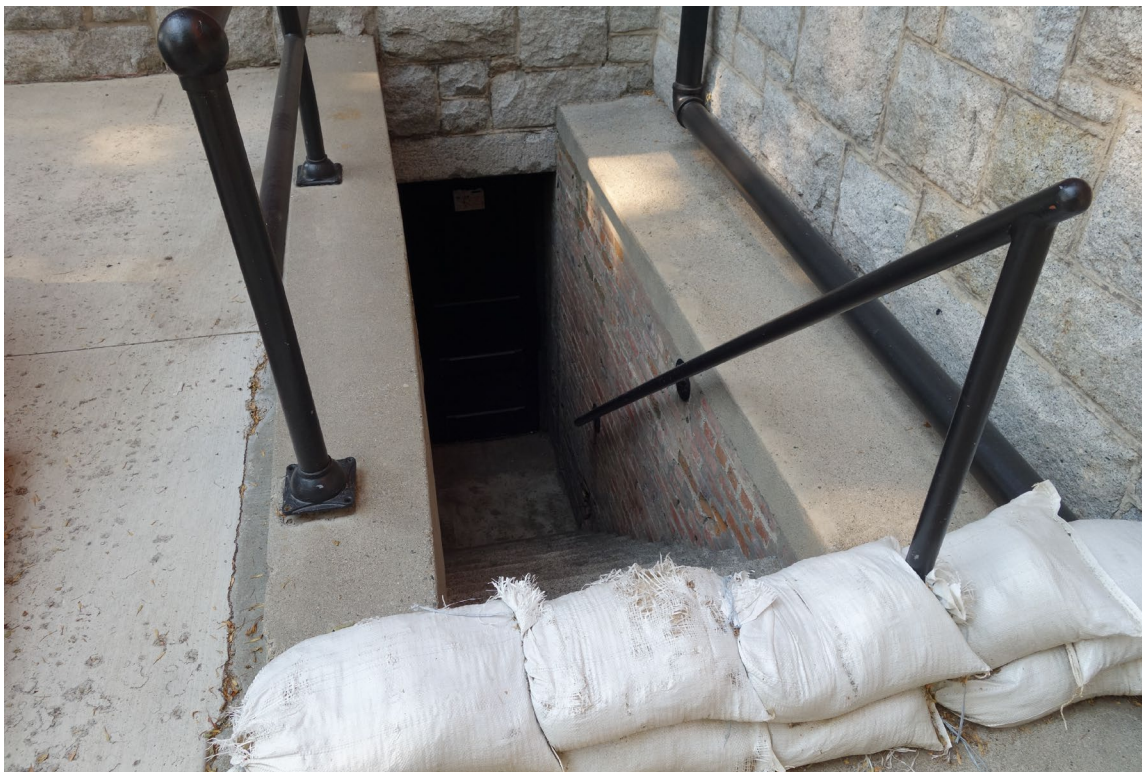
There are several sets of stair handrails around the exterior of the building that are older and do not meet code for safety. The gripping surfaces are incorrect, they are not continuous from the top to bottom landings and/ or they are installed on only one side of the stair. There is also a damaged rail near the north basement stairs that should be repaired. This project recommends the installation of handrails as needed in accordance with 2018 IBC Section 1011. This project will require the Nevada State Historic Preservation Office approval and excludes the plaza area on the north side of the property. This project or a portion thereof was previously recommended in the FCA report dated 01/28/2009. It has been amended accordingly to reflect conditions observed during the most recent survey date of 08/09/2018.

Paul Laxalt State Building Site - Site #9863
Description: Exterior Stair Handrail Replacement.

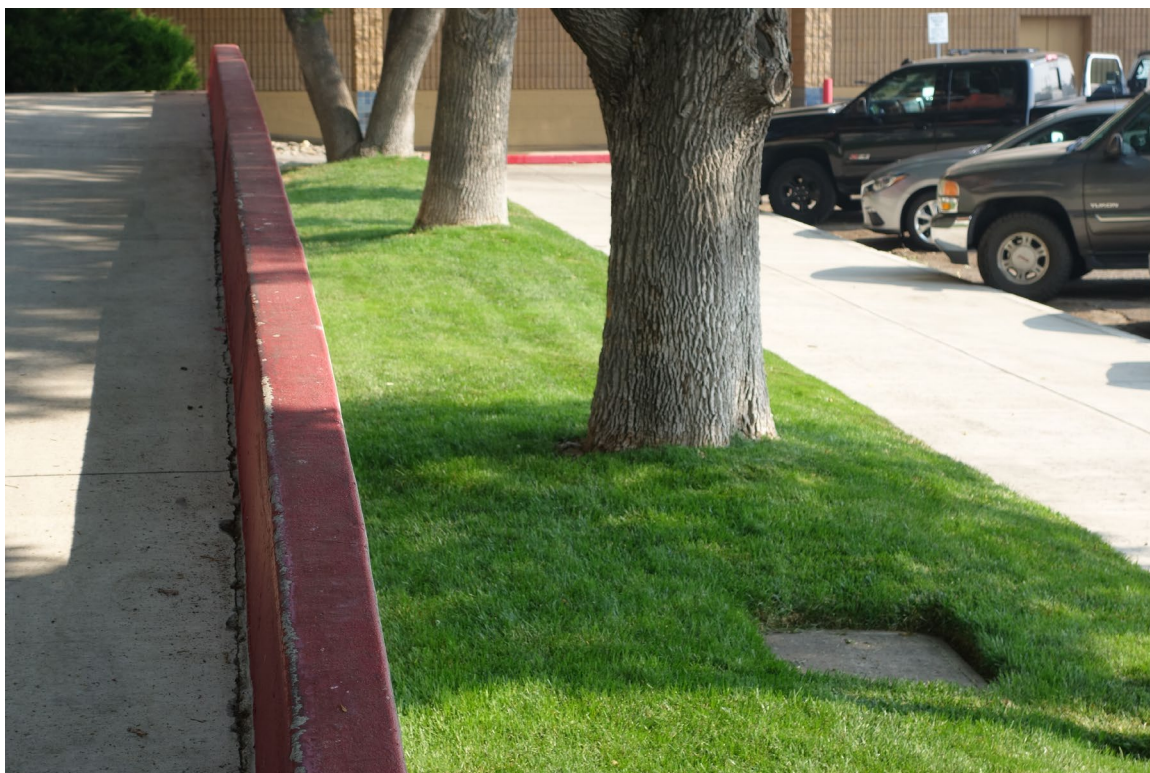
The east side approach to the loading dock area of the site has an elevation change from the concrete driveway to the natural grade below that exceeds 30 inches. This project recommends the installation of a guard to form a protective barrier along the open side in accordance with the 2018 IBC Chapter 10. Approval of this project will be required by the Nevada State Historical Preservation Office. 140 lineal feet was used to generate this estimate. This project or a portion thereof was previously recommended in the FCA report dated 01/28/2009. It has been amended accordingly to reflect conditions observed during the most recent survey date of 08/09/2018.

Paul Laxalt State Building Site - Site #9863
Description: Guard Installation Needed.

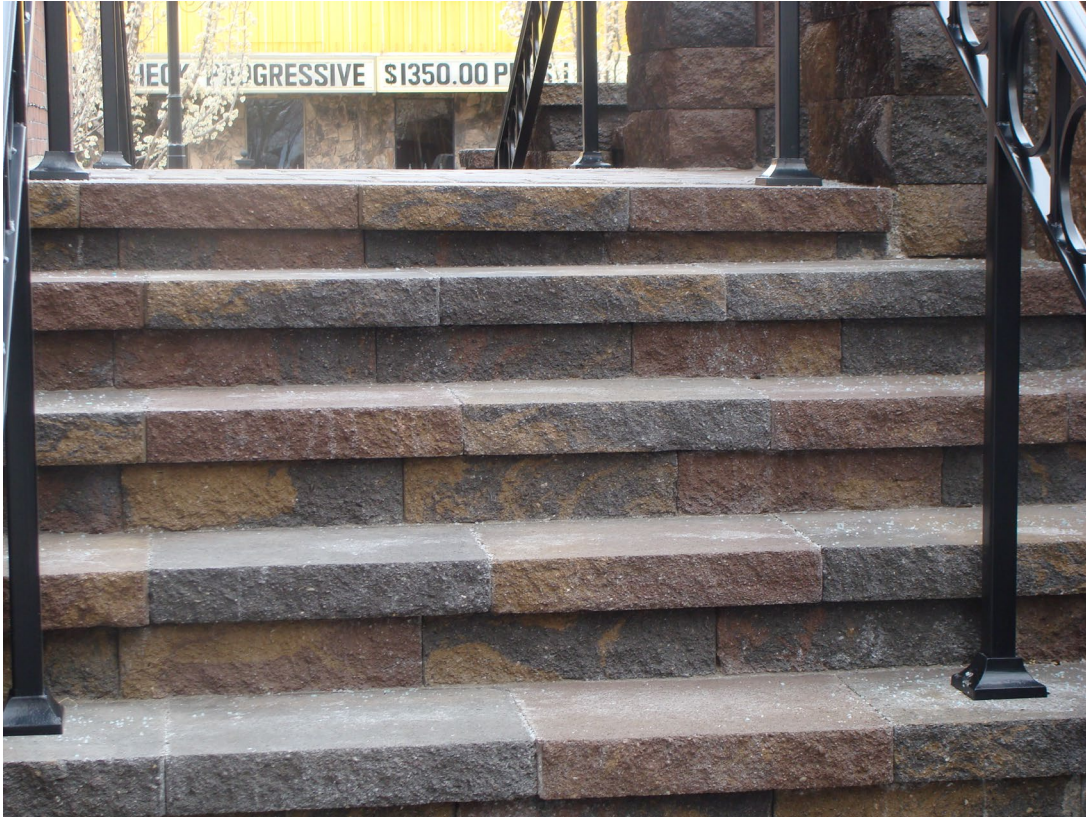
The Laxalt Plaza is constructed with paver stones. There are terraces with steps and a ramp along with seating areas for the public. This area also has the designated ADA accessible route from the parking stall to a platform lift. The platform lift does not have an ADA compliant landing at the lower level and the upper level platform lift door does not have the required forward approach clearance. The ADA ramp also does not have a compliant landing and a portion of the slope exceeds 8.3%. There are also some cross slopes that exceed 2%. There are some stair risers that exceed the 3/8" maximum uniformity requirement and some handrails are missing or non compliant on the stairs and ramp. The public table at the upper terrace is also not ADA compliant. This project would provide for the required modifications mentioned above including removal and reinstallation of the pavers as required, regrading, handrails and table modifications. This project will need to be approved by the Nevada State Historical Preservation Office. This project or a portion thereof was previously recommended in the FCA report dated 01/28/2009. It has been amended accordingly to reflect conditions observed during the most recent survey date of 08/09/2018.

Paul Laxalt State Building Site - Site #9863
 Description: Laxalt Plaza Stair Modifications – Risers Exceeding 3/8” Variation.

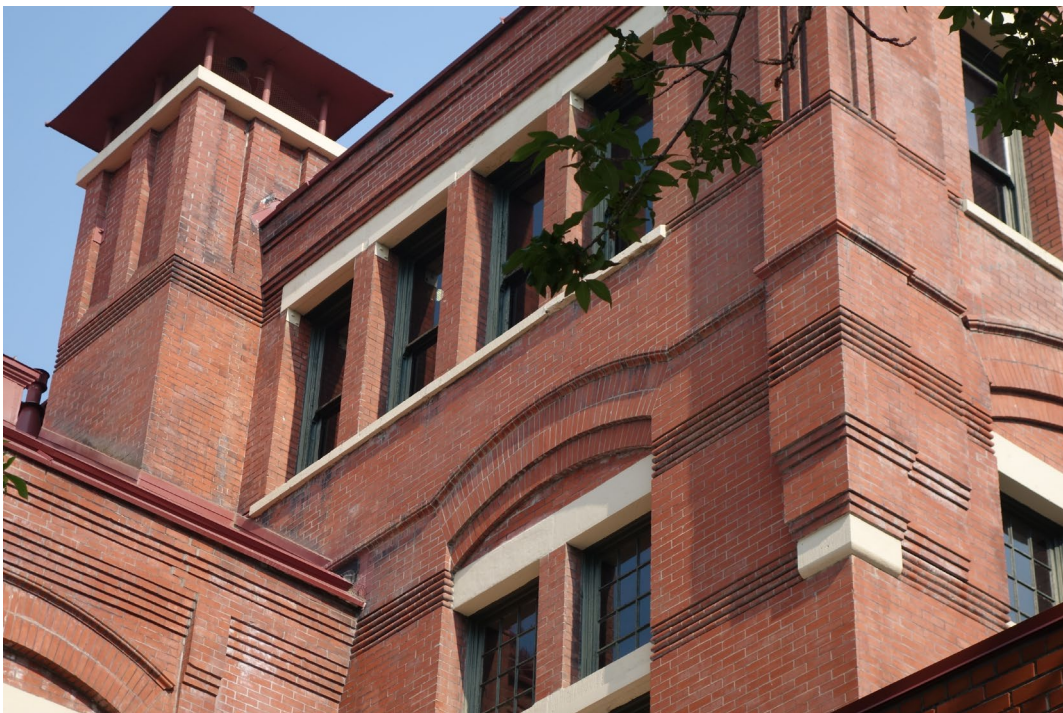
The exterior finishes are in fair condition. It is important to maintain the finish, weather resistance and appearance of the building. This project would provide funding to protect the exterior of the building. Included in the cost are sealing and tuck pointing the masonry and painting and caulking of the windows, flashing, fixtures and all other penetrations. It is recommended that the building be sealed, painted and caulked in the next 4 - 6 years and that this project be scheduled on a cyclical basis to maintain the integrity of the structure.

Paul Laxalt State Building – Building #0394
 Description: Exterior Finishes of the Building.

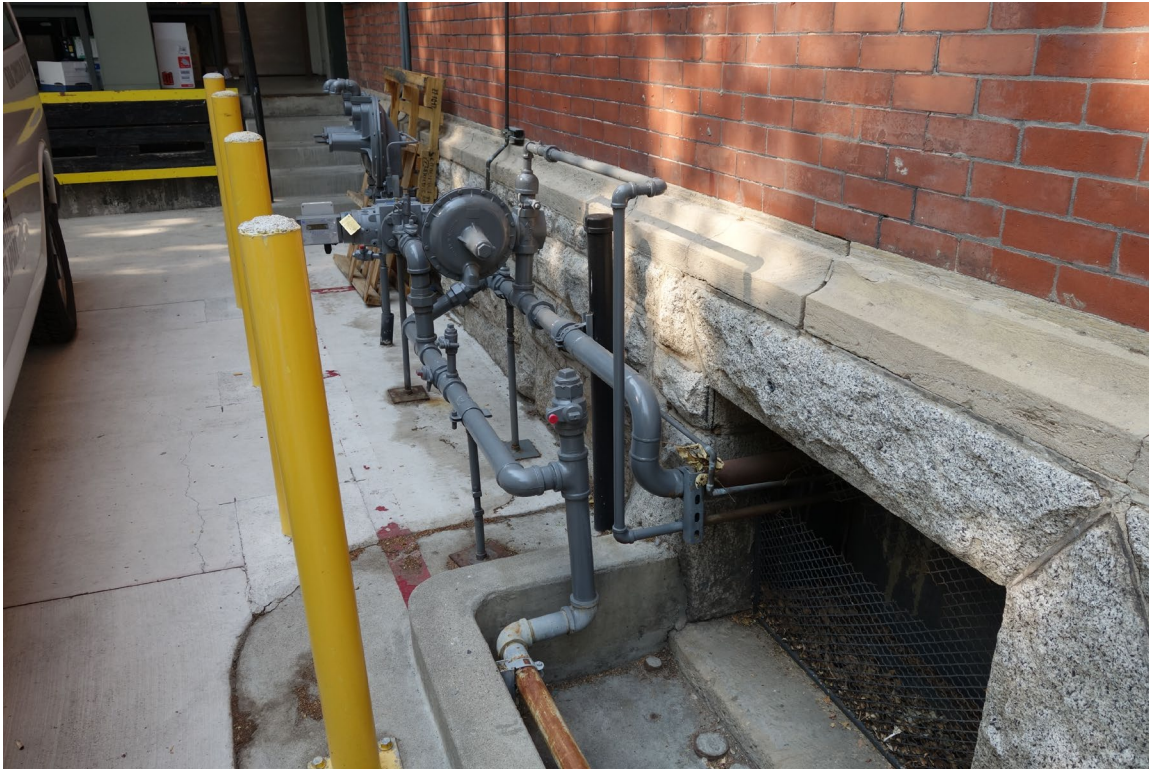
Paul Laxalt State Building – Building #0394
Description: Seismic Gas Shut-off Valve Needed.

This project would provide for the installation of a seismic gas shut-off valve on the main gas service piping prior to entering the building. This estimate is based on the manufacturer Pacific Seismic Products or approved equal, equipped with the optional Model MS remote monitoring switch (to be interfaced with the direct digital control system and/or with an audible alarm). The gas piping immediately adjacent to the seismic gas valve shall be secured to the building utilizing unistrut channel bracing.

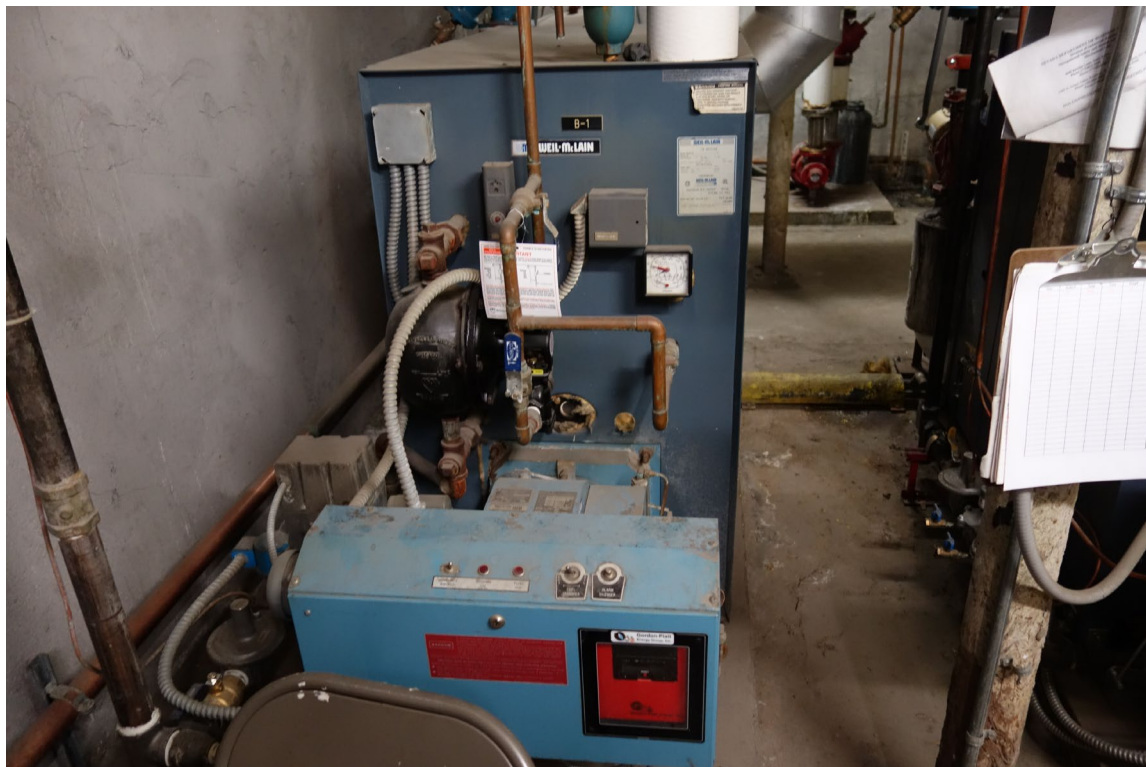
The existing central plant equipment is approximately 25 years old and has reached the end of its useful service life. The chiller equipment contains R-22 refrigerant which will no longer be available in the United States starting January 1, 2020. This project will replace the central plant heating and cooling equipment including the chiller, boilers, pumps, piping and related controls. Approval of this project may be required by the Nevada State Historical Preservation Office.

Paul Laxalt State Building – Building #0394
Description: HVAC Equipment Replacement.

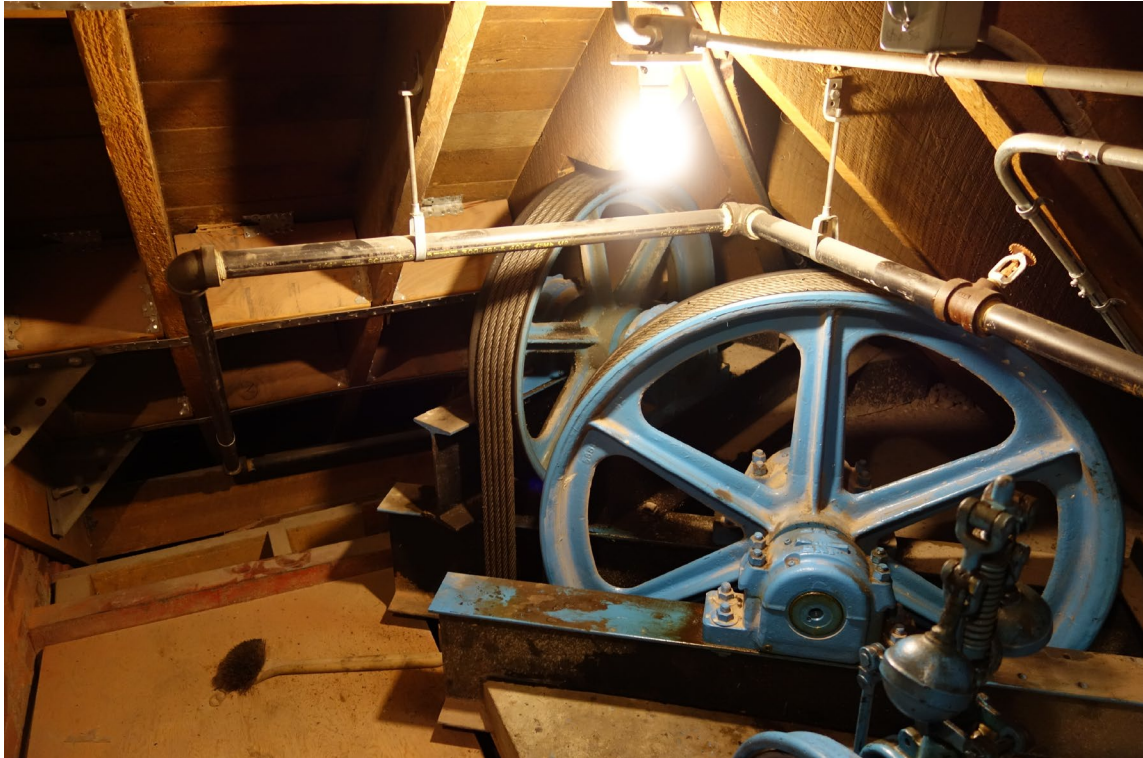
The existing elevator control system and drive components have not been upgraded since the system was refurbished in 1999 and is due to be upgraded with new state-of-the-art controls and drive components and code compliance enhancements. This project will replace the building elevator, associated electrical controls, and mechanical drive component systems. Also included are interior elevator cab finishes.

Paul Laxalt State Building – Building #0394
Description: Elevator Upgrade Recommended.

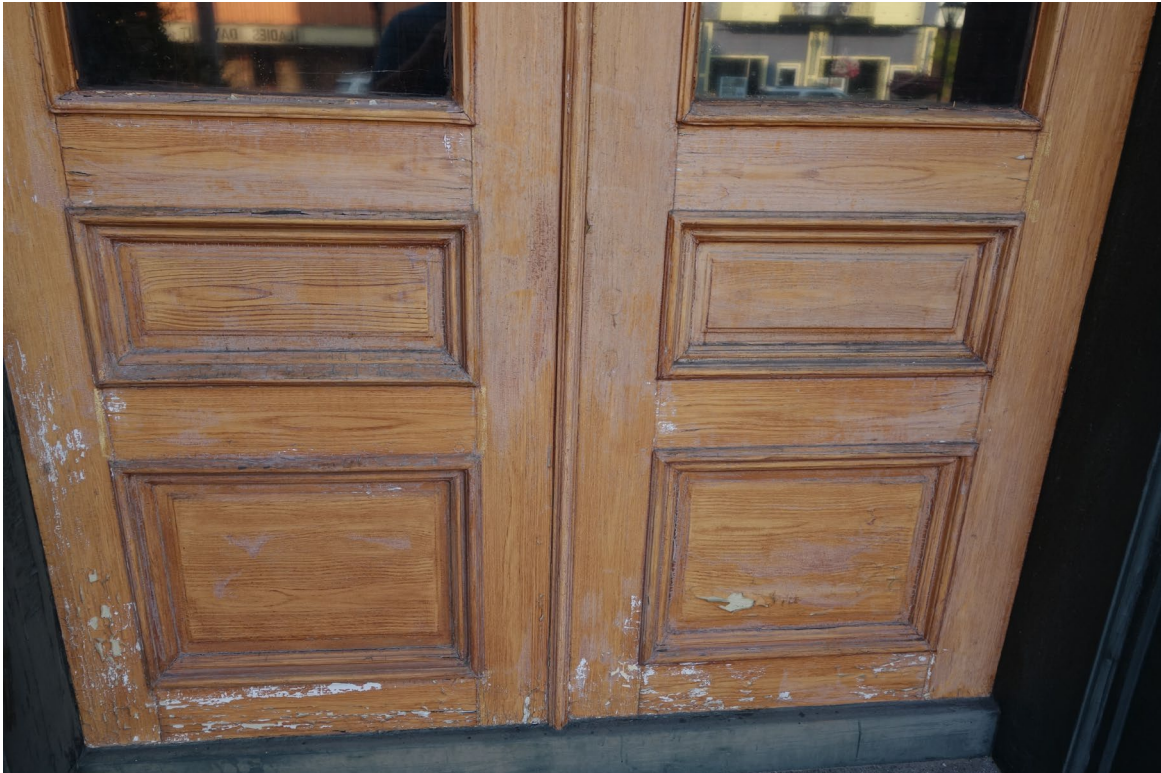
The main entry has four pair of wood doors facing West. The doors are exposed to direct afternoon sun and are losing their finish. This project would refinish the doors (this should be done biannually) and adjust the weather-strip to seal the entry.

Paul Laxalt State Building – Building #0394
Description: Refinish Main Entry Doors.

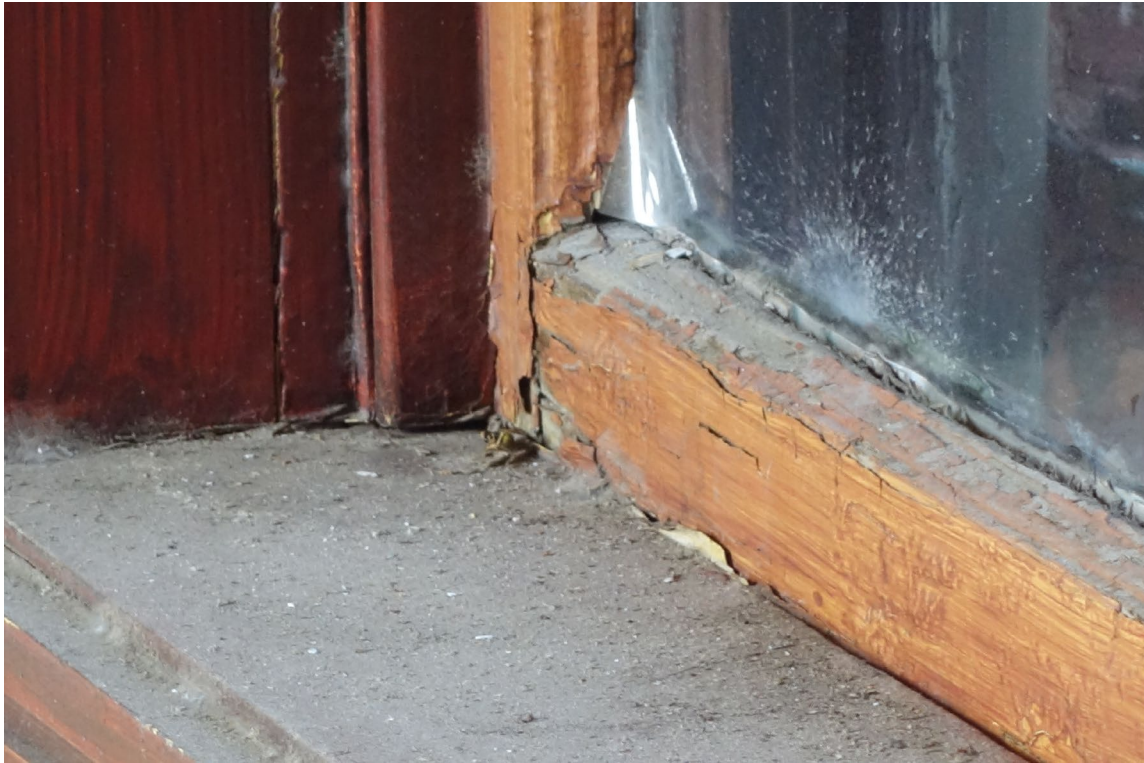
The windows are original, single pane construction in a wooden frame. These older windows are drafty, not energy efficient and the wooden frames have deteriorated significantly. This project recommends replacing the windows with dual pane, higher efficiency units. This estimate is for the replacement of 112 units including wooden frames which will require approval from the State Historical Preservation Office. Removal and disposal of the existing windows is included in this estimate.

Paul Laxalt State Building – Building #0394
Description: Window Replacement Recommended.

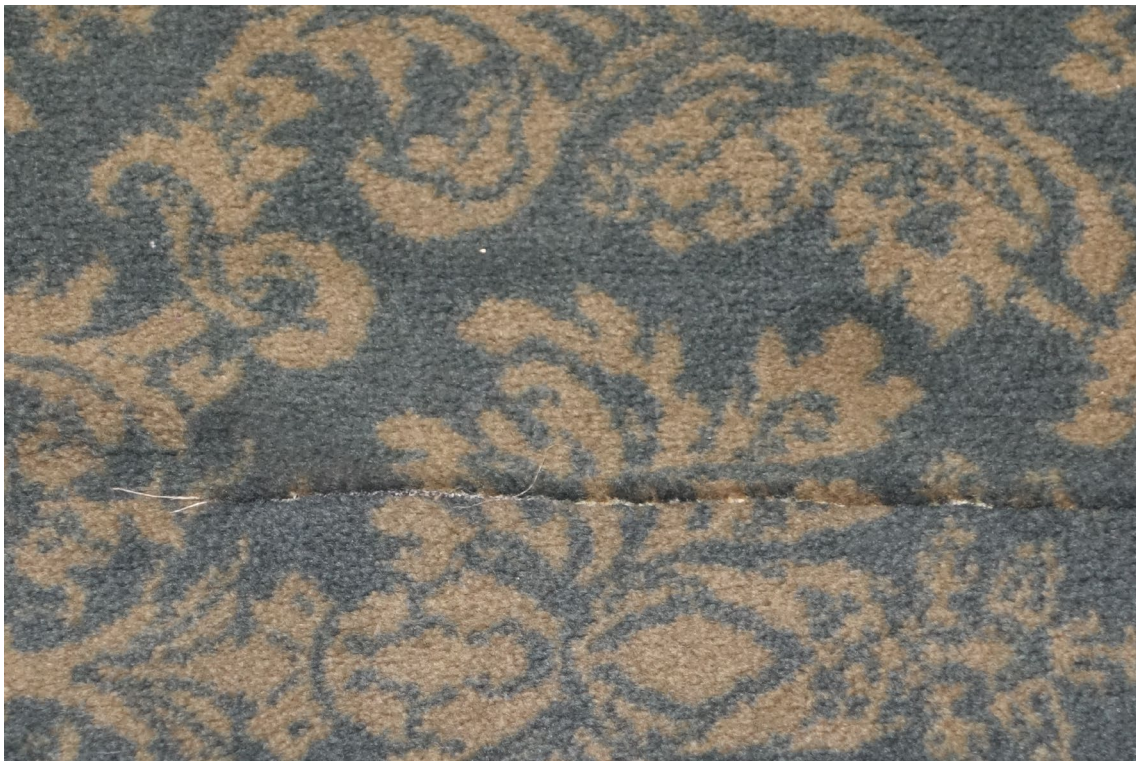
The carpet in the building, especially on the second and third floors, is beginning to show significant signs of wear. It is recommended that the carpet be replaced with heavy duty commercial grade carpet in the next two to three years. This project or a portion thereof was previously recommended in the FCA report dated 10/05/2004 and 01/28/2009. It has been amended accordingly to reflect conditions observed during the most recent survey date of 08/09/2018.

Paul Laxalt State Building – Building #0394
Description: Replace Carpet.
