State of Nevada
Department of Administration
Public Works Division / Buildings & Grounds Section
Carson City State Offices
Facility Condition Analysis

CARSON CITY STATE OFFICES BUILDING

515 East Musser Street
Carson City, Nevada 89701

Site Number: 9864
STATE OF NEVADA PUBLIC WORKS DIVISION
FACILITY CONDITION ANALYSIS

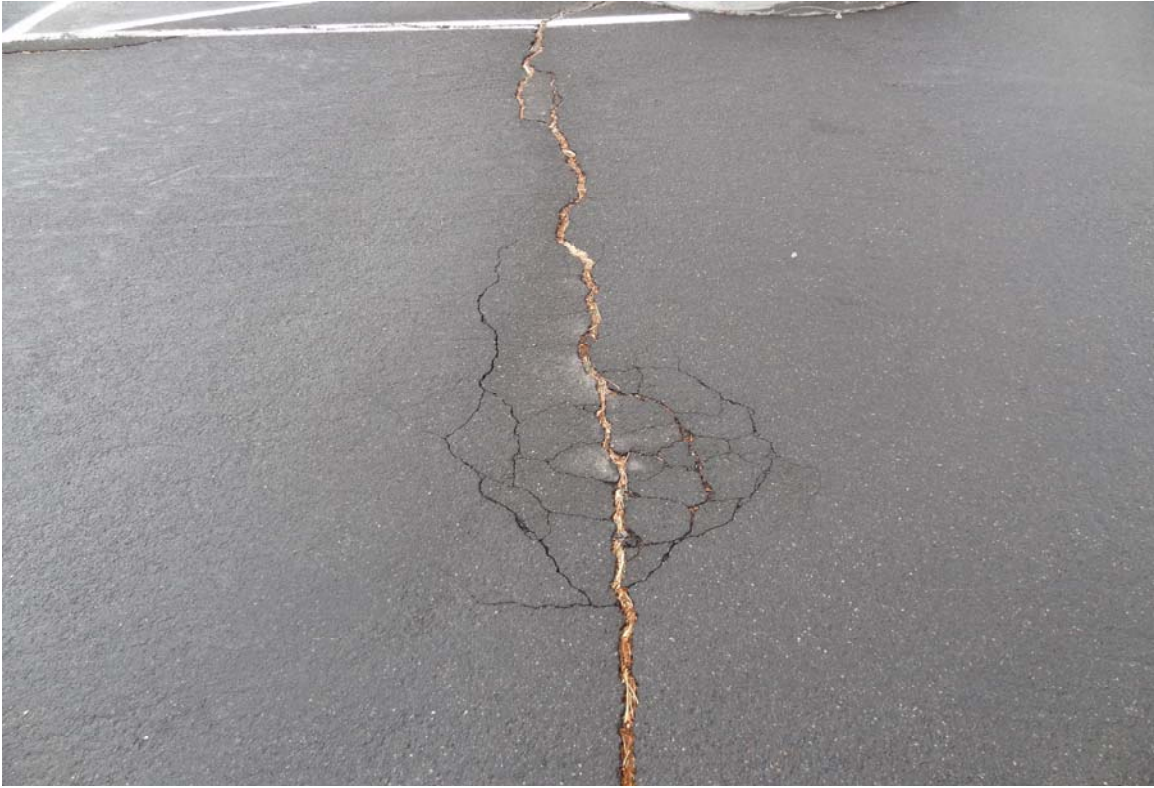
Carson City State Offices Site - Site #9864
Description: Paving in need of repair.

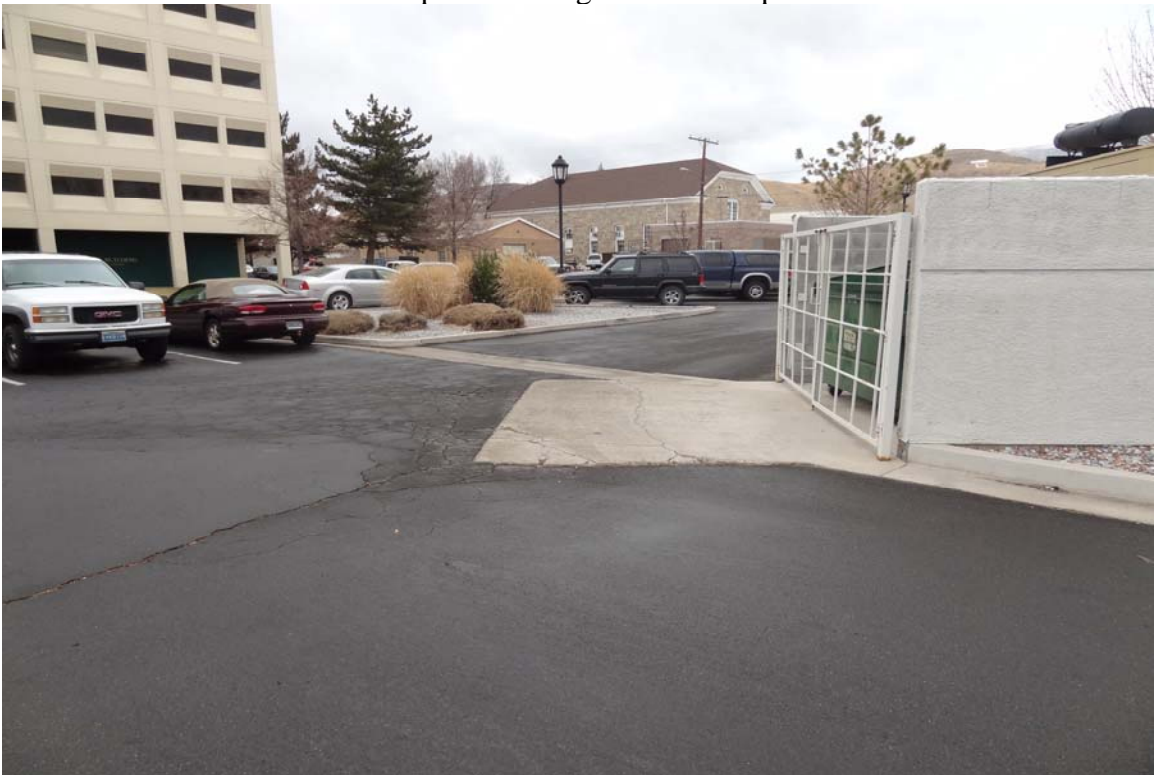
Carson City State Offices Site - Site #9864
Description: Dumpster area paving / concrete damage.

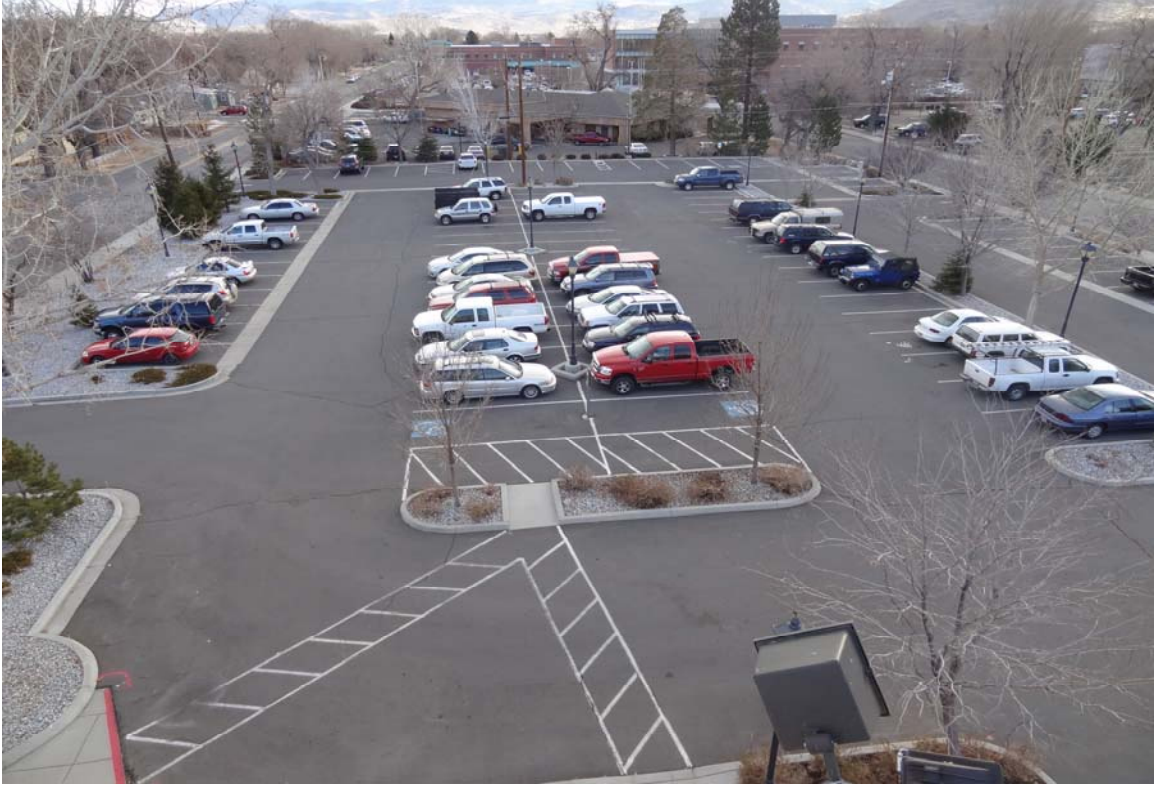
Carson City State Offices Site - Site #9864
Description: View of the east parking area.

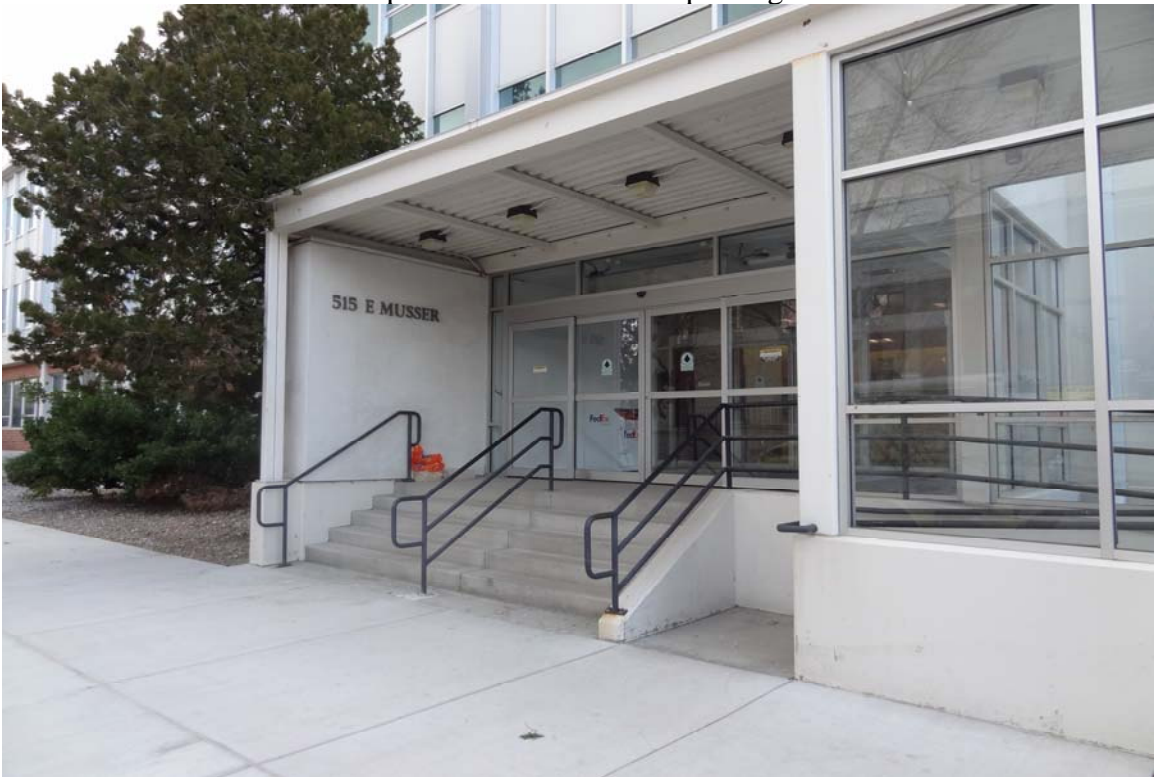
Carson City State Offices - Building #0397
Description: Public entrance.

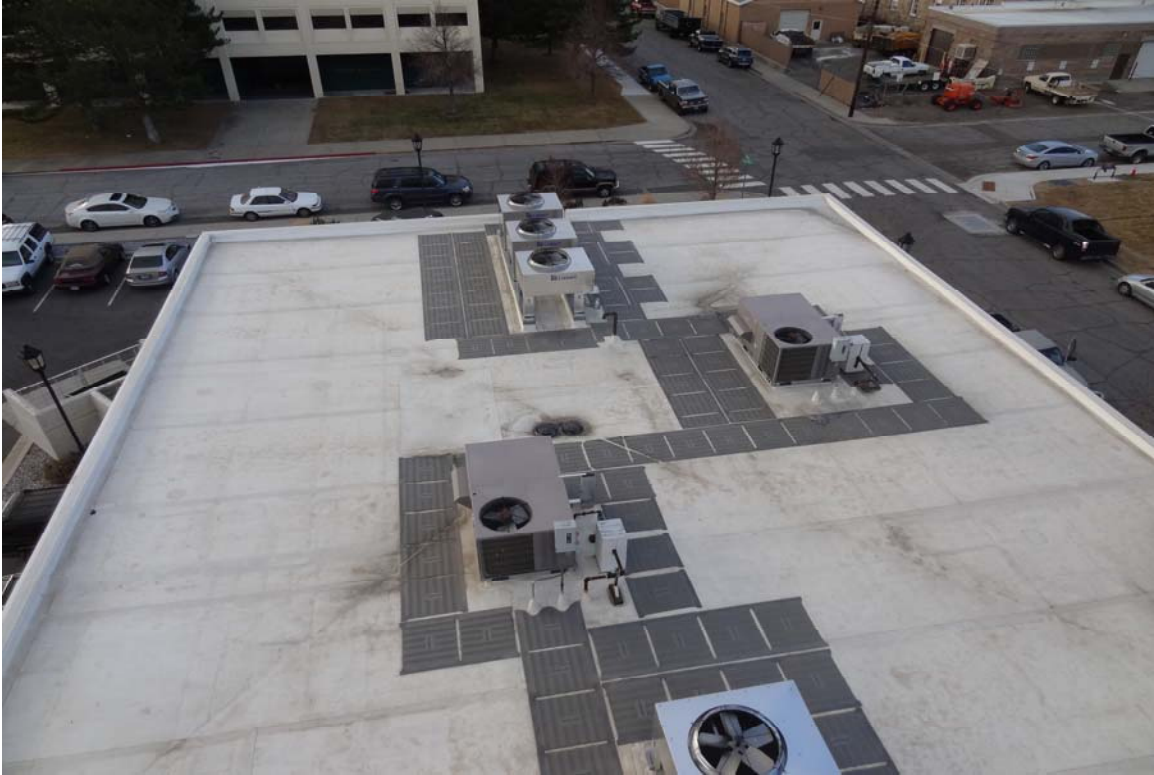
Carson City State Offices - Building #0397

Description: New roof mounted cooling equipment over Controller's office.

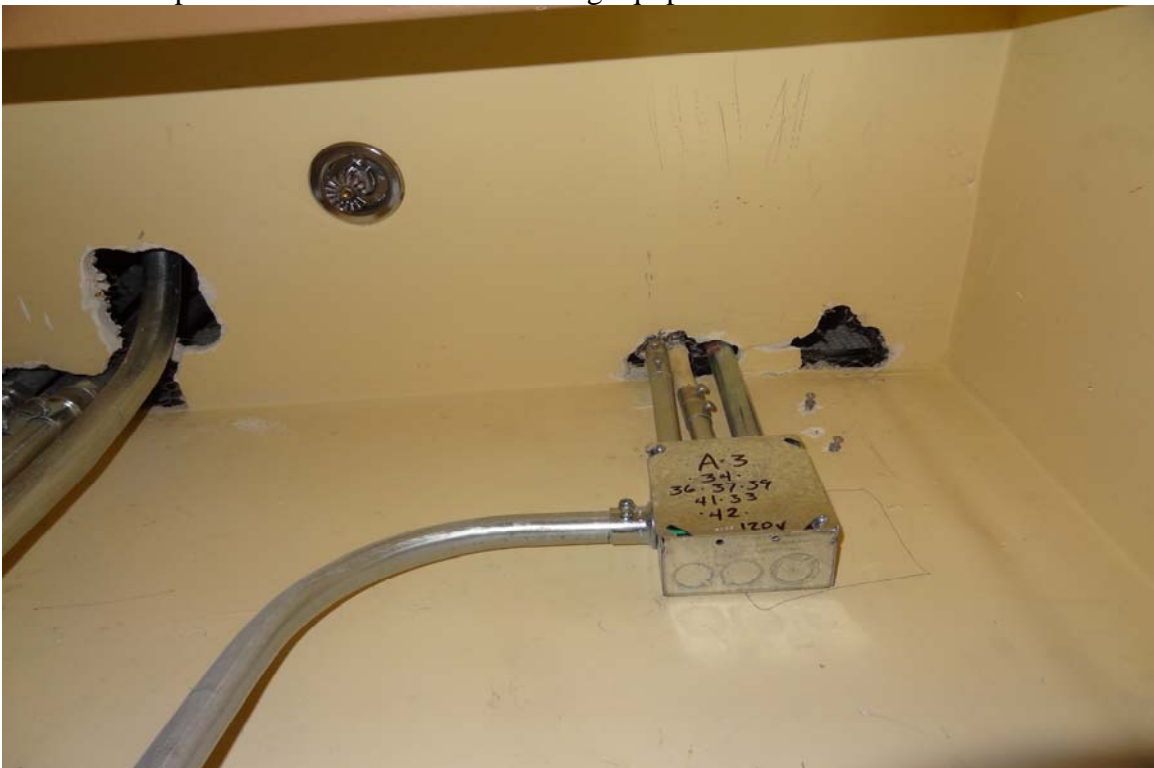
Carson City State Offices - Building #0397

Description: Penetrations in need of fire caulking.

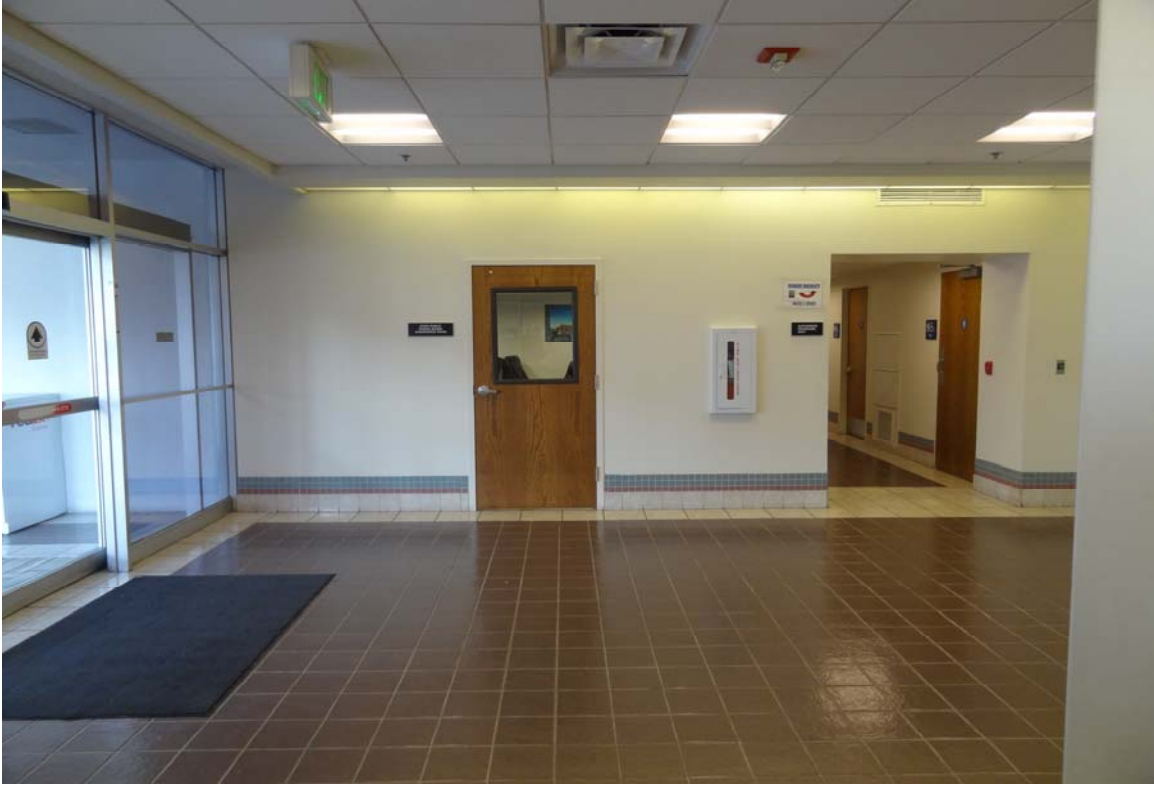
Carson City State Offices - Building #0397

Description: Lower floor lobby area.

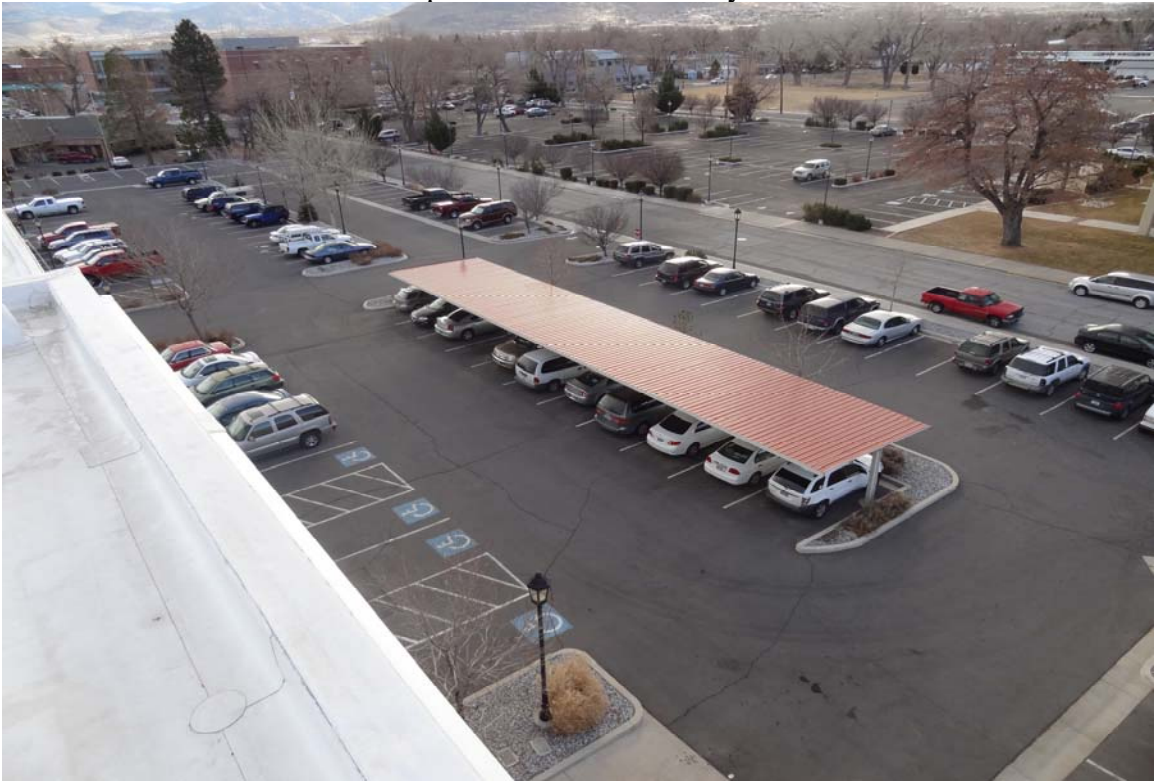
State Offices Carport - Building #3110

Description: Exterior of the carport structure from roof.
