State of Nevada
Department of Administration
State Library, Archives and Public Records Division

NEVADA STATE LIBRARY AND ARCHIVES

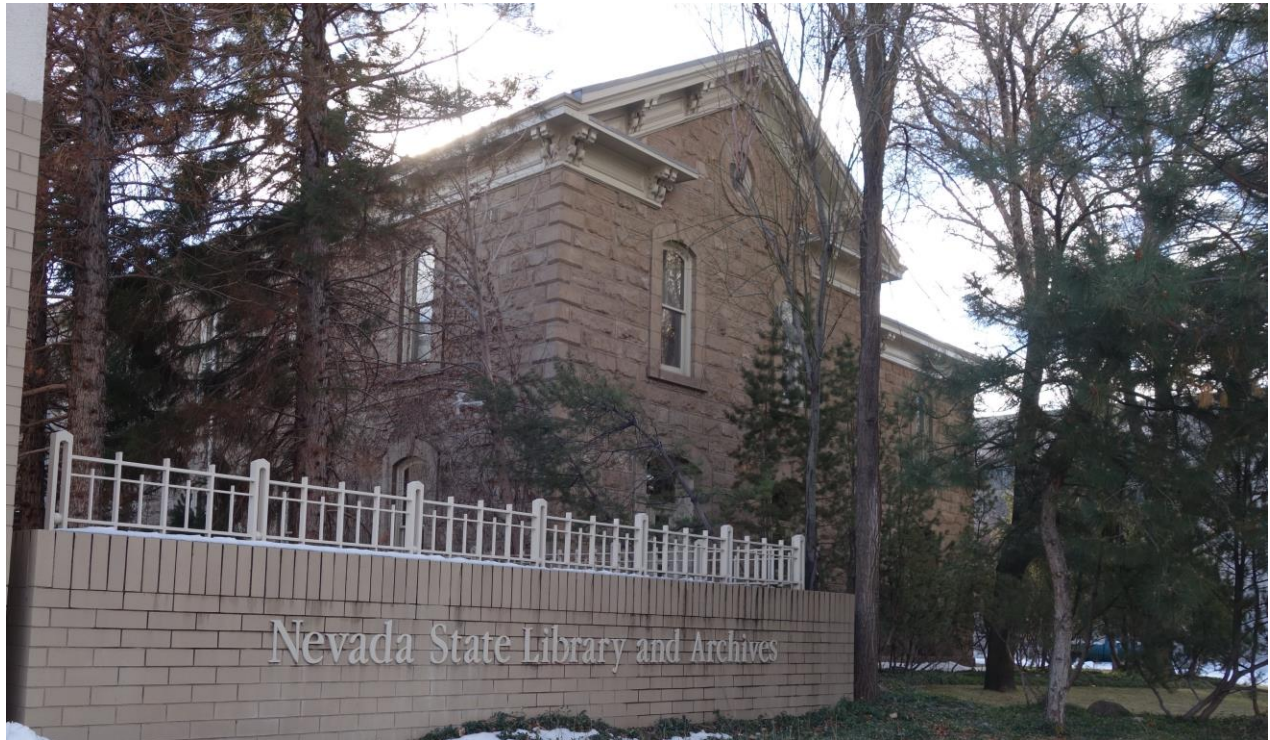
Report Printed in June 2021

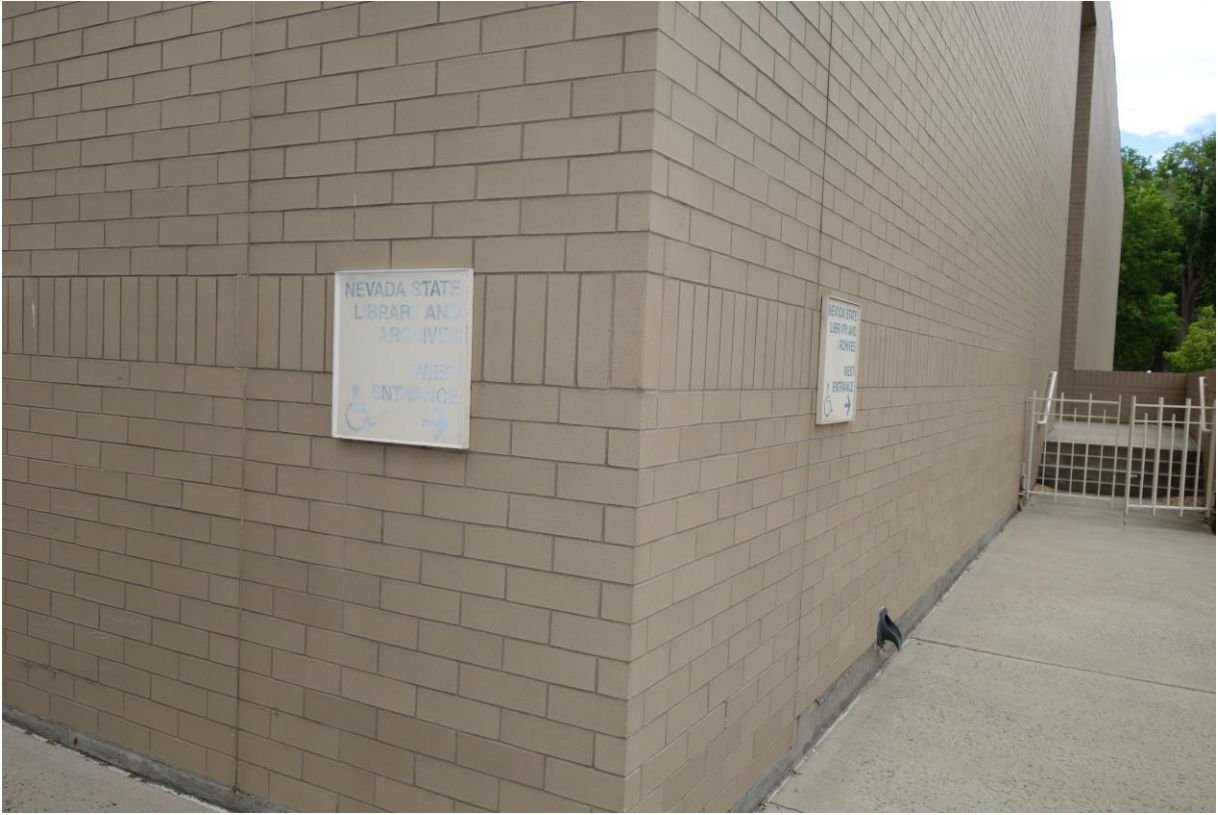
Nevada State Library & Archives - Site #9866
Description: ADA Site Path of Travel Signage Replacement Needed.

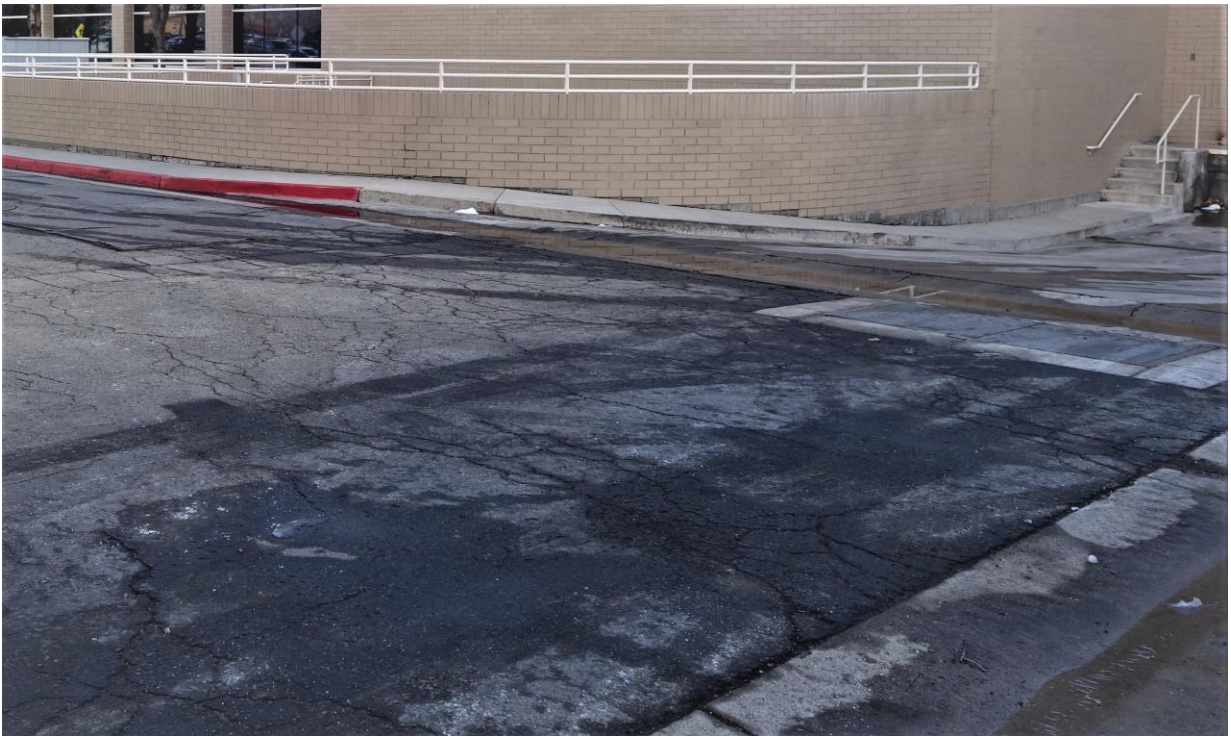
Nevada State Library & Archives - Site #9866
Description: Pavement Replacement Needed.

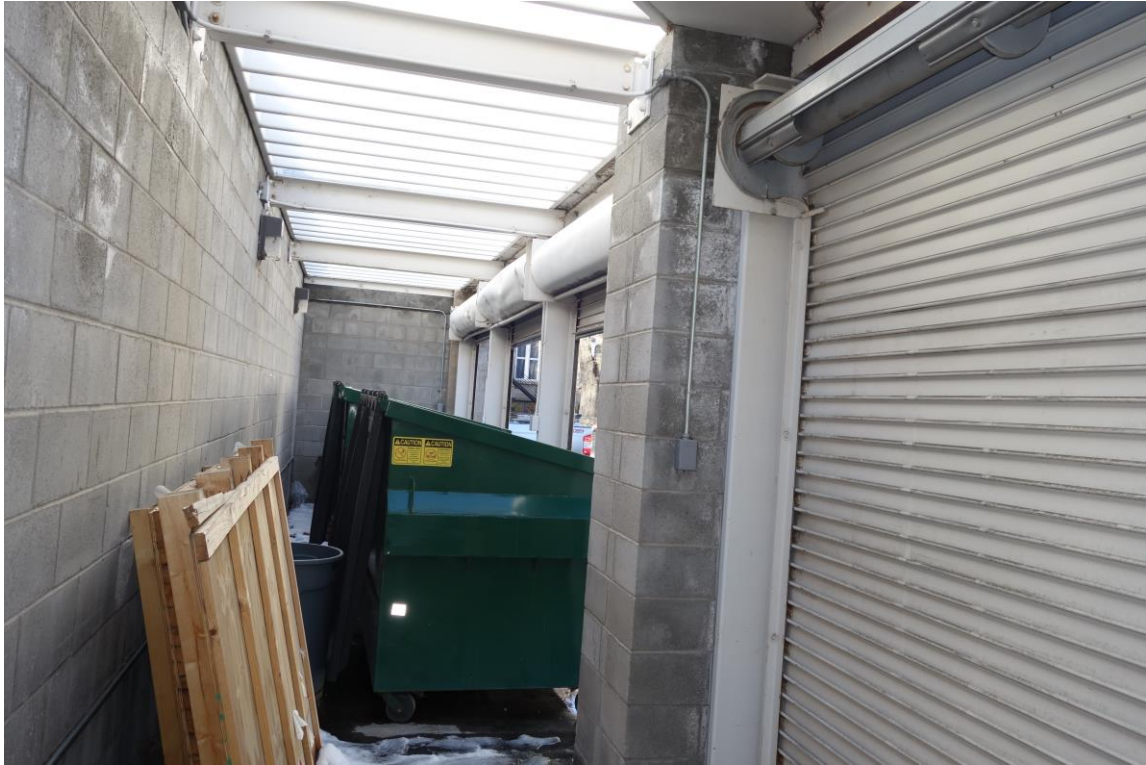
Nevada State Library & Archives - Site #9866
Description: Overhead Door Replacement Needed.

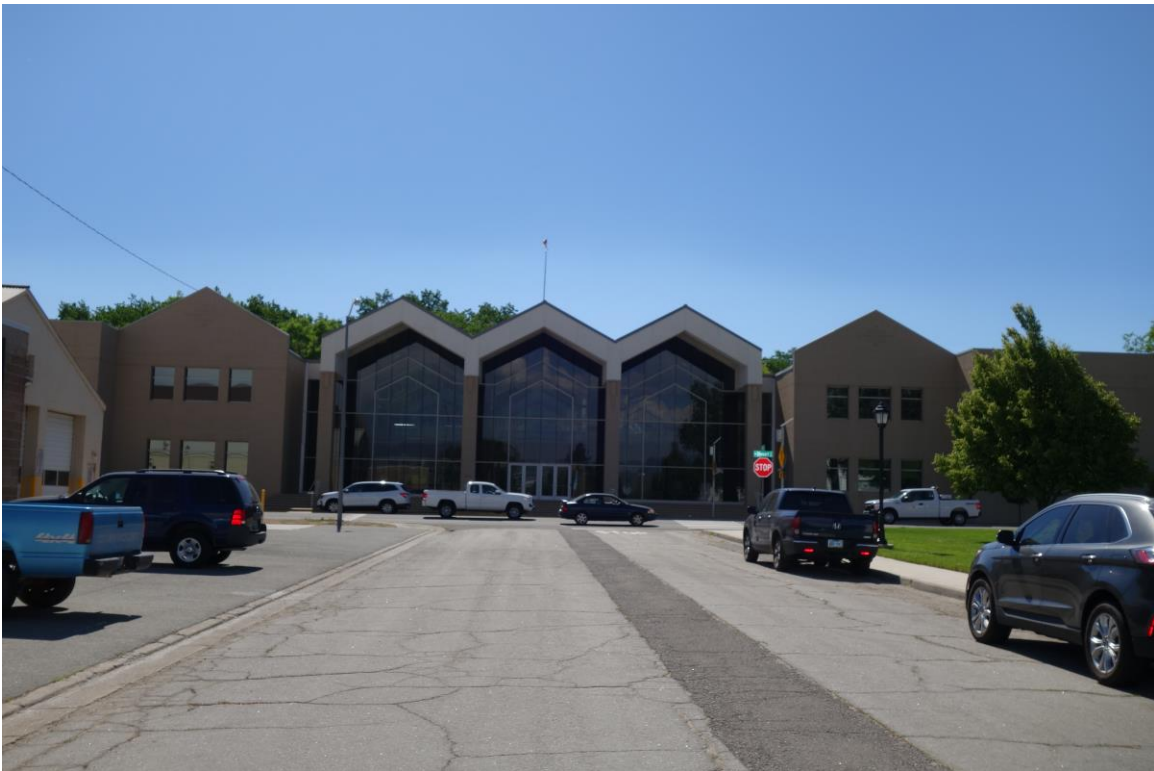
Nevada State Library & Archives - Building #1675
Description: East Public Entrance

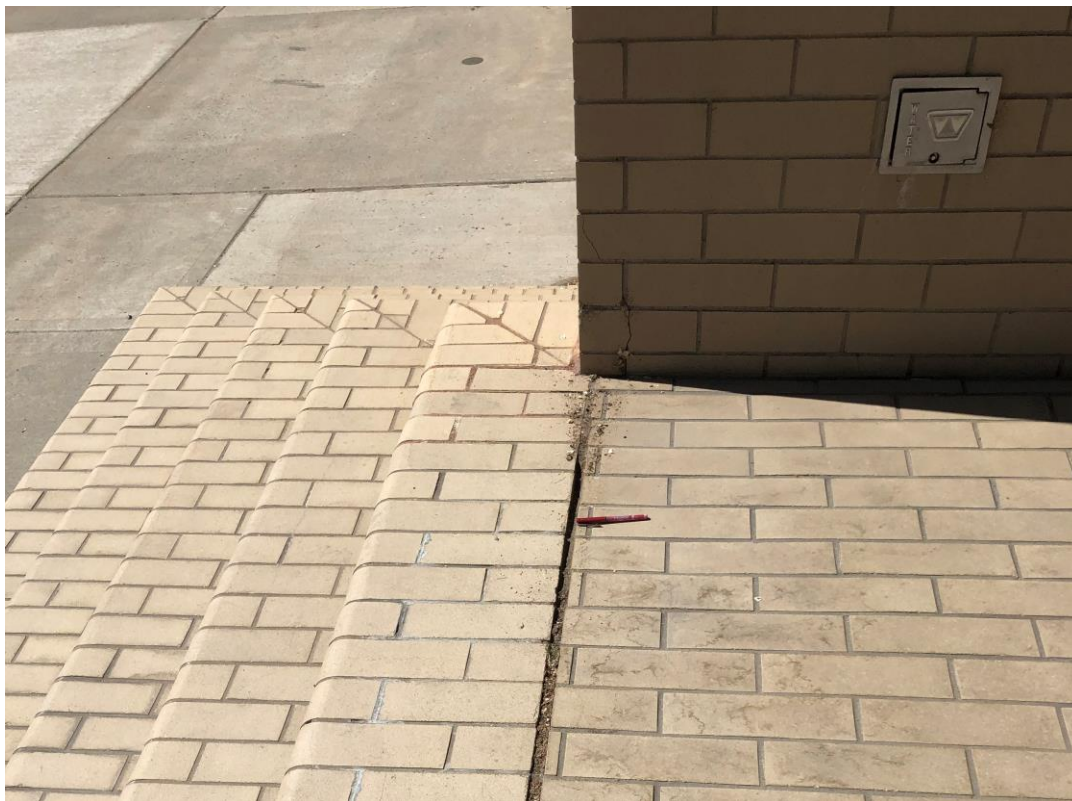
Nevada State Library & Archives - Building #1675
Description: Building Leak Repairs East Side Patio.

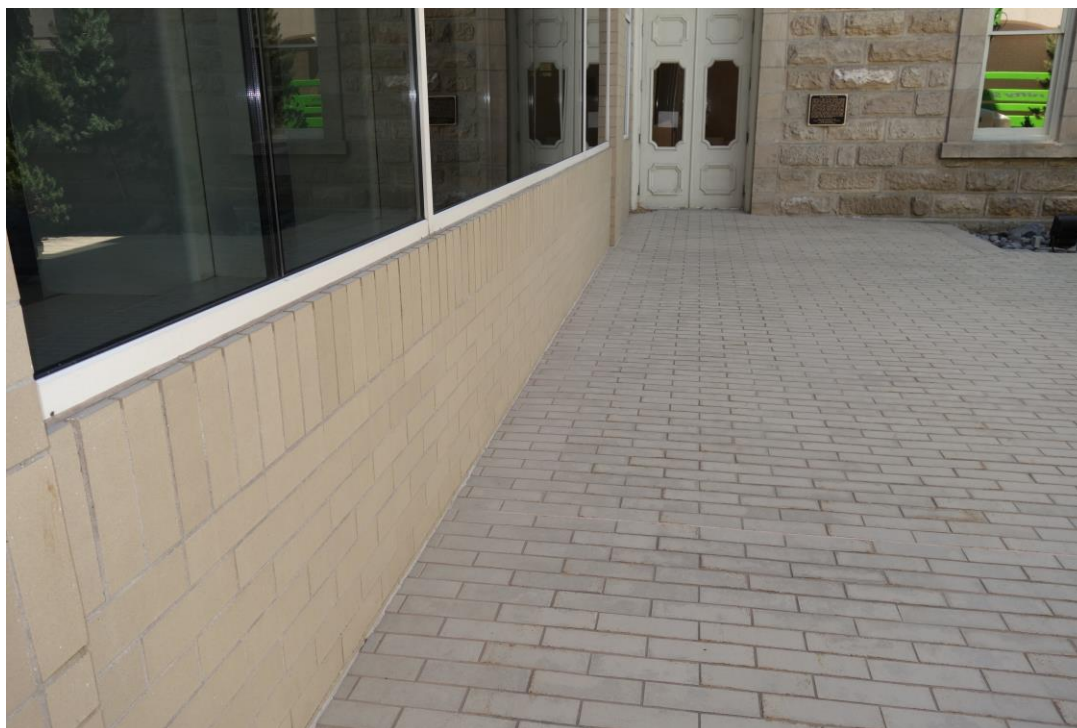
Nevada State Library & Archives - Building #1675
Description: Building Leak Repairs West Side Patio (Pic 1 of 2)

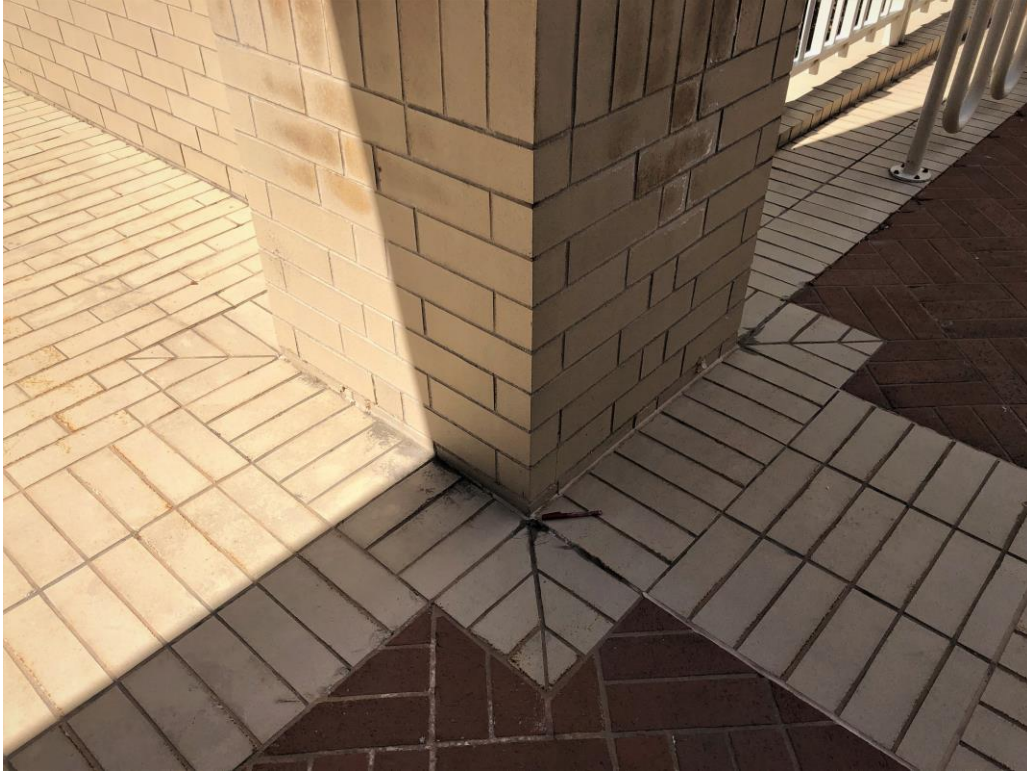
Nevada State Library & Archives - Building #1675
Description: Building Leak Repairs West Side Patio (Pic 2 of 2).

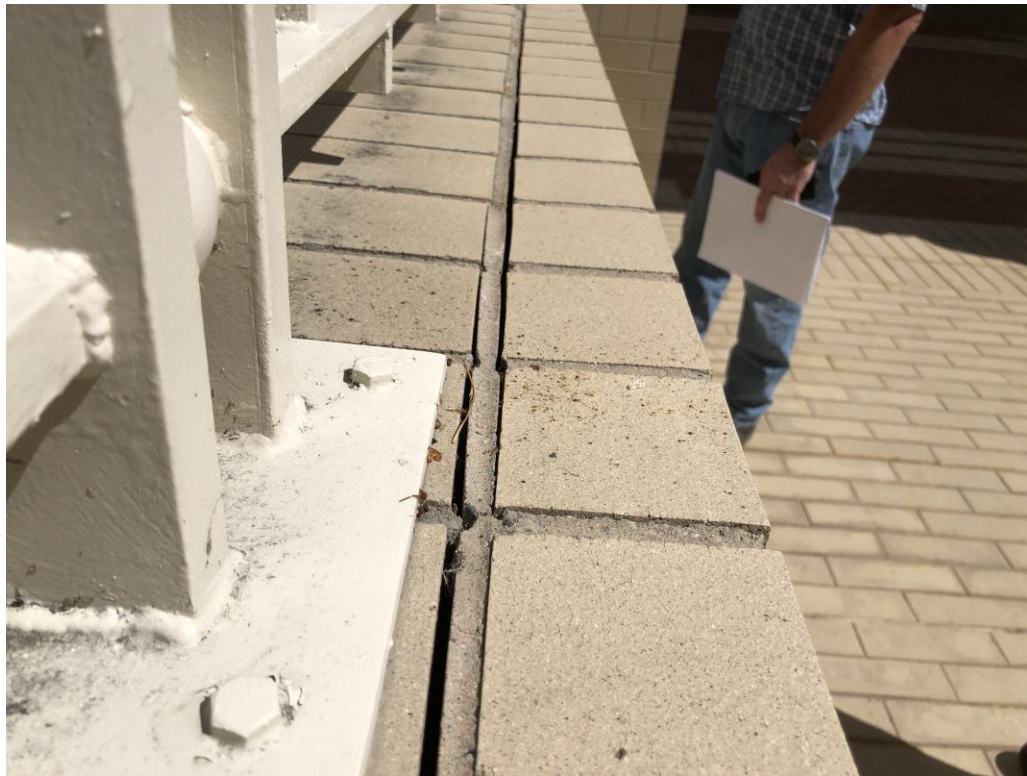
Nevada State Library & Archives - Building #1675
Description: Stainless Steel Flashing Caps for Masonry Guard Rails.

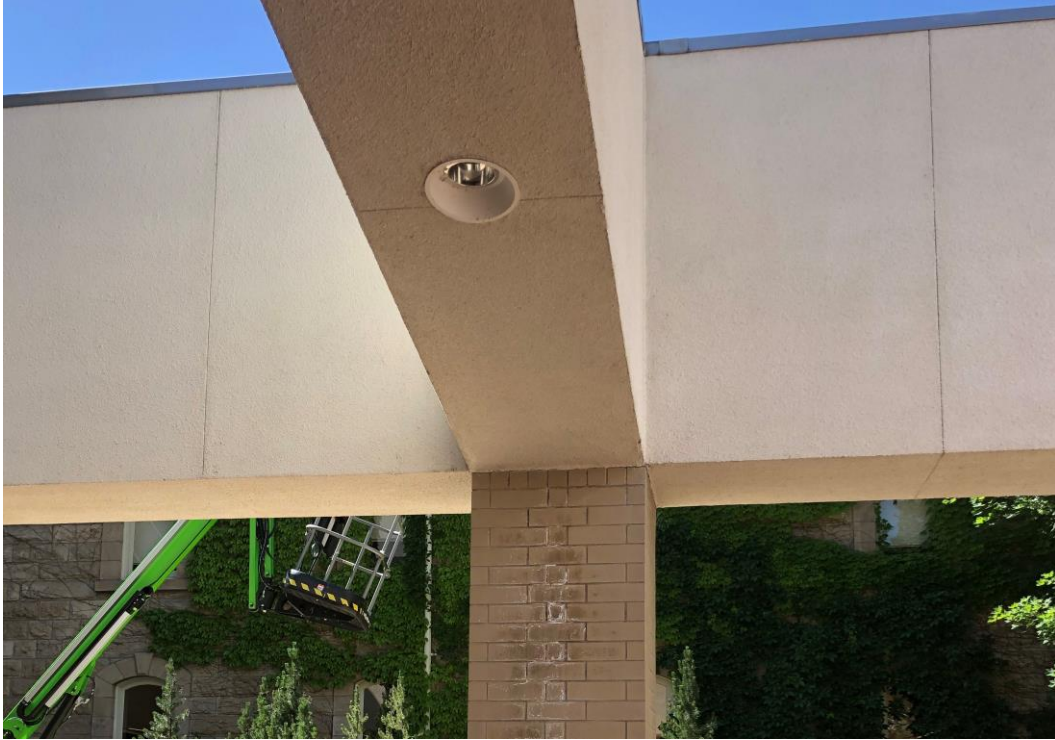
Nevada State Library & Archives - Building #1675
Description: Stucco Repairs Needed.

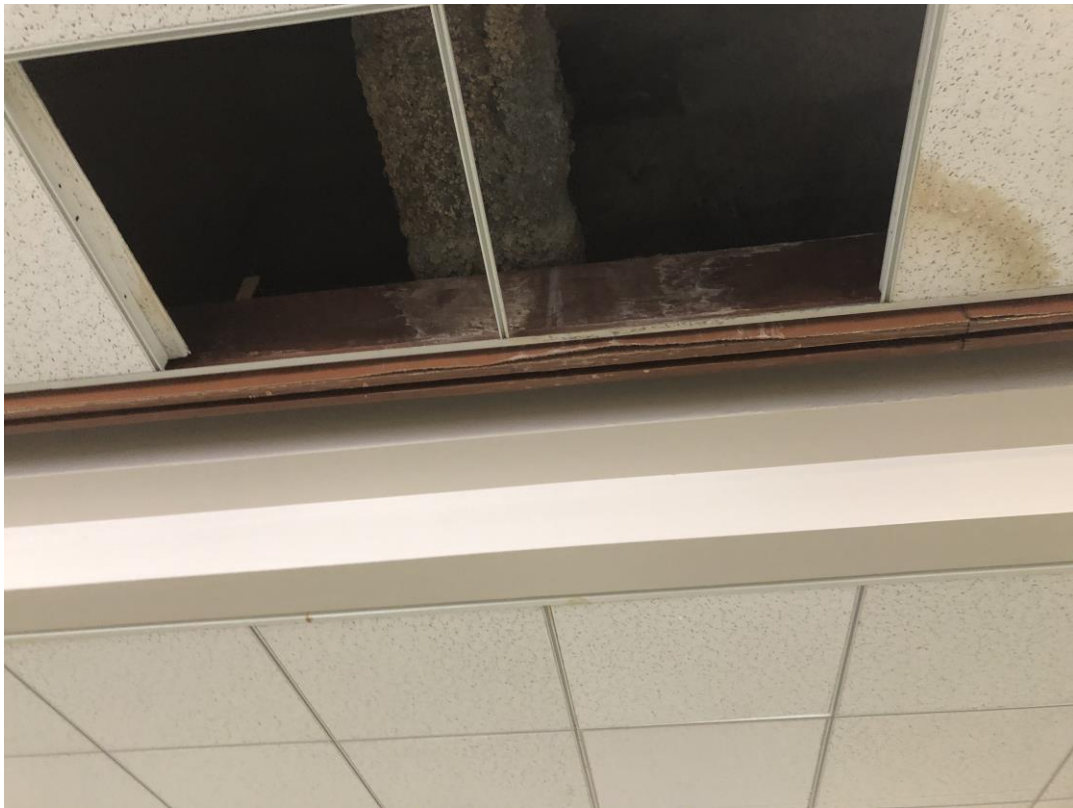
Nevada State Library & Archives - Building #1675
Description: Ceiling Condition in Old Talking Books Room.

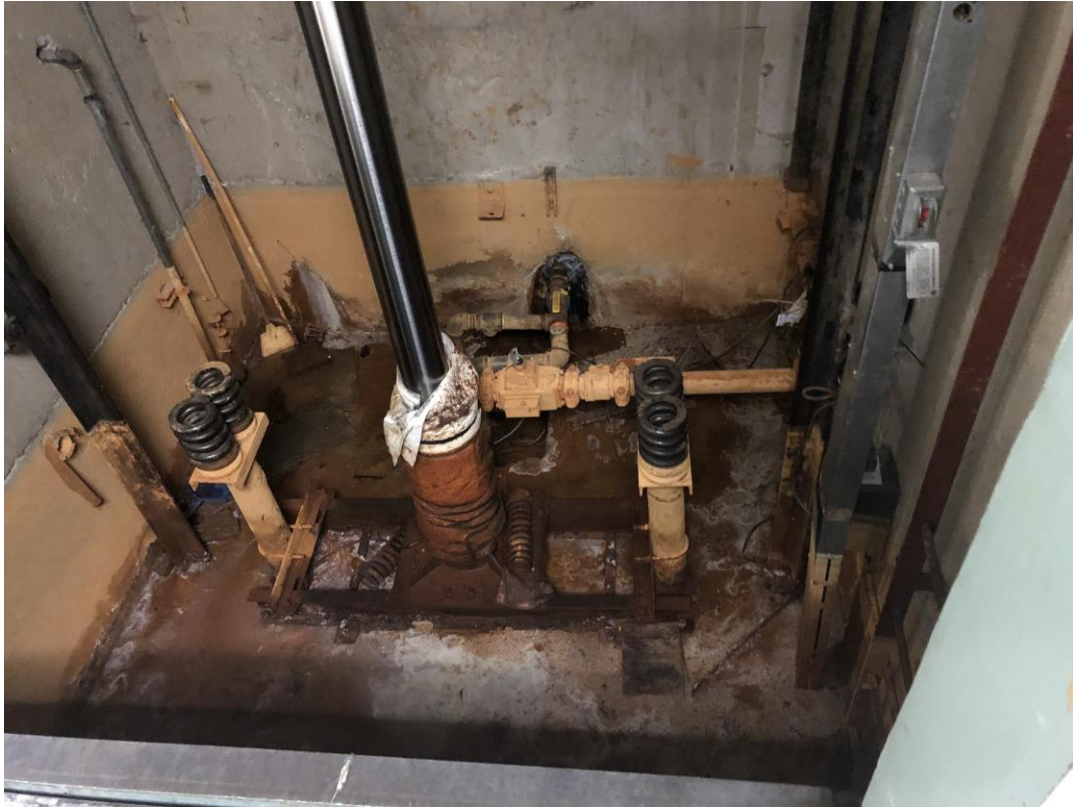
Nevada State Library & Archives - Building #1675
Description: Elevator Sump Repairs.

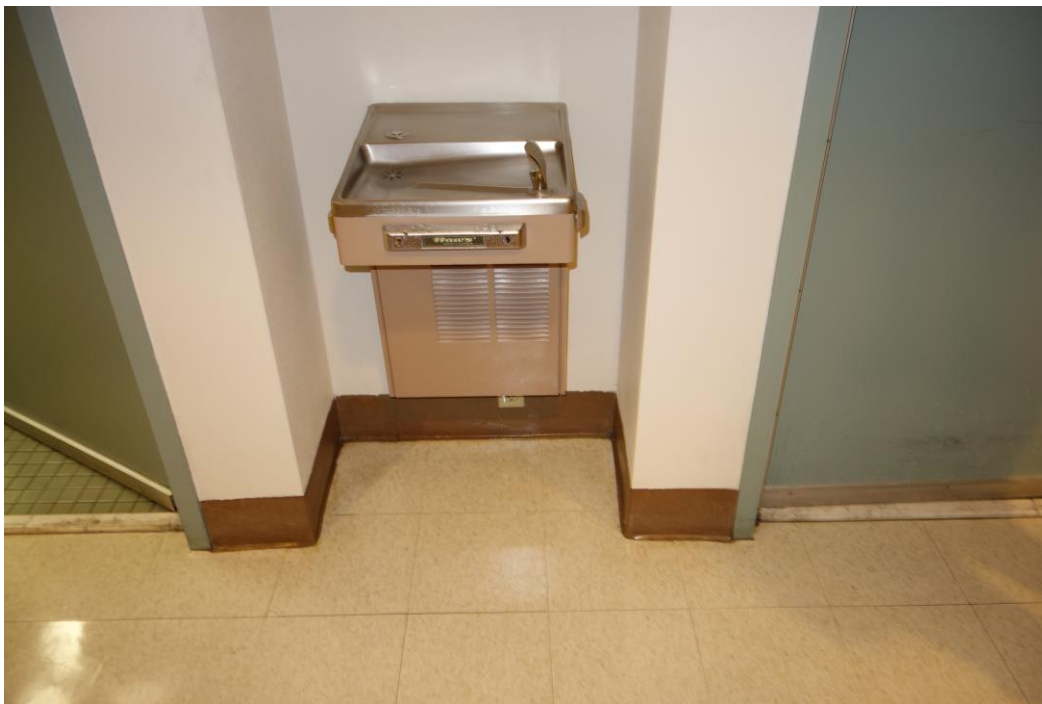
Nevada State Library & Archives - Building #1675
Description: Dual Level Drinking Fountains Needed.

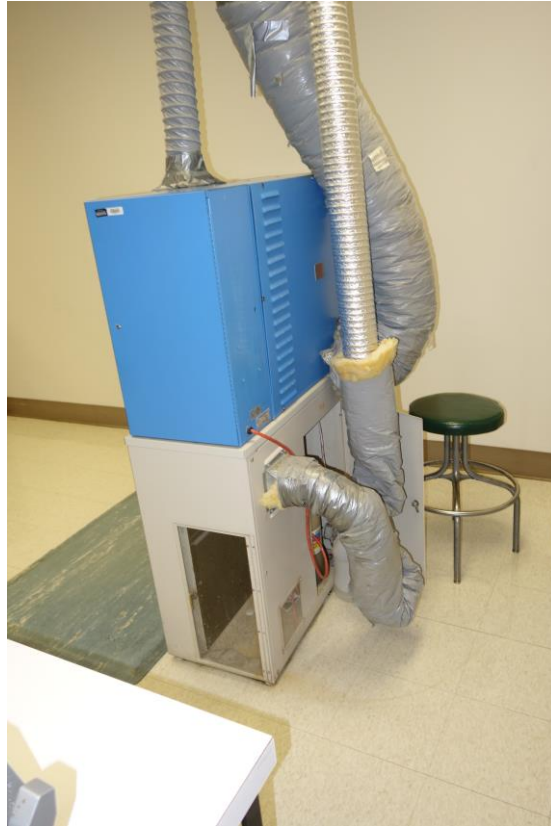
Nevada State Library & Archives - Building #1675
Description: Equipment & Venting Removal Recommended.

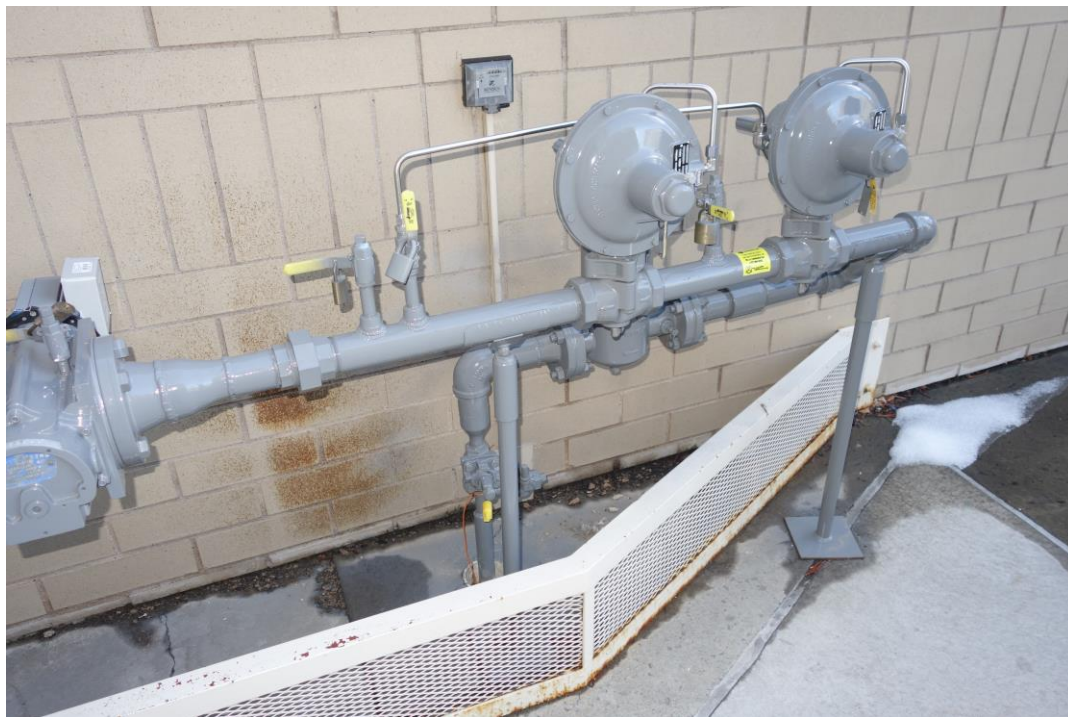
Nevada State Library & Archives - Building #1675
Description: Seismic Gas Valve Installation Needed.

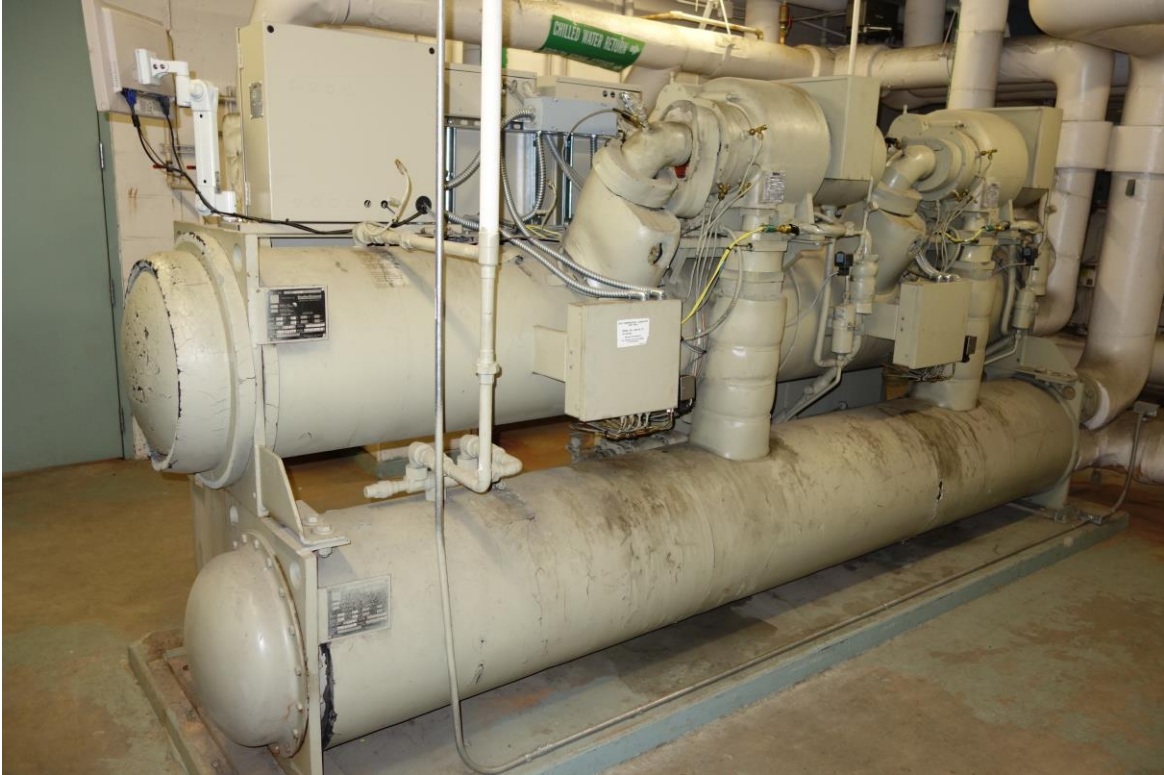
Nevada State Library & Archives - Building #1675
Description: Replacement of Chiller & Central Plant Needed.

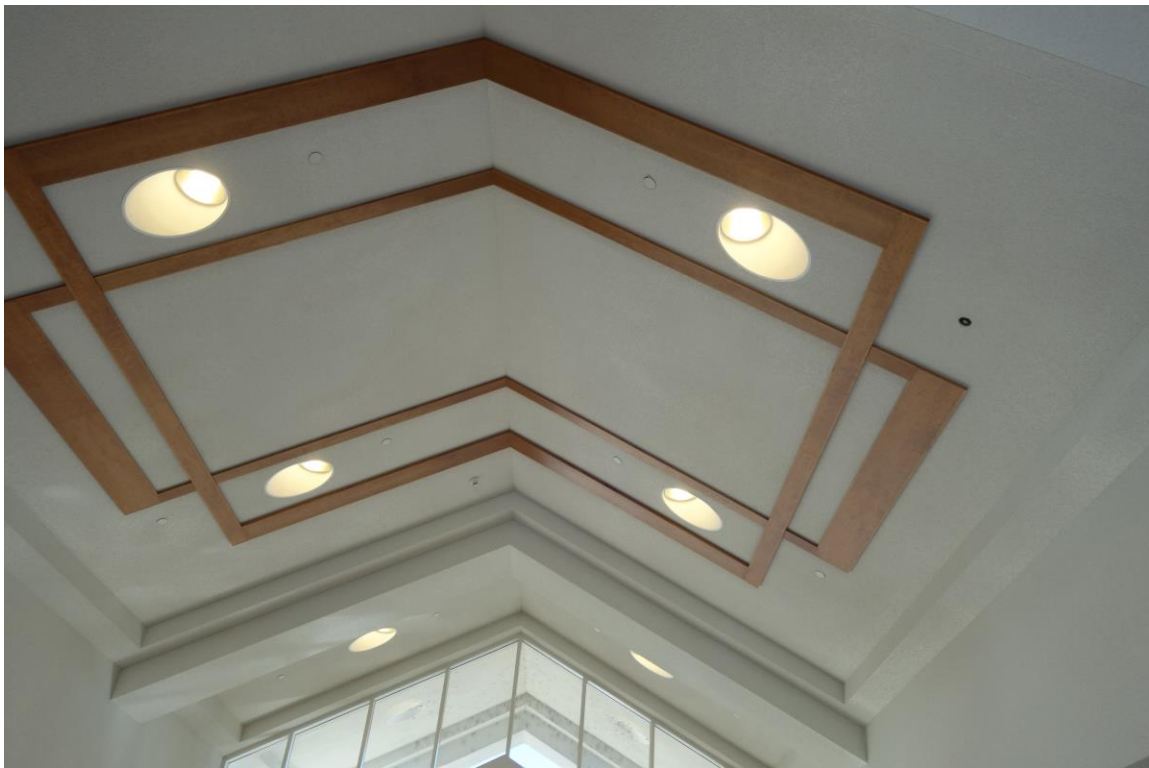
Nevada State Library & Archives - Building #1675
Description: Lighting Upgrade to LED Recommended.
