State of Nevada
Department of Motor Vehicles
Department of Administration - Buildings & Grounds Section
North Decatur DMV Services Center
Facility Condition Analysis

NORTH DECATUR DMV SERVICES CENTER

7170 North Decatur Road
Las Vegas, Nevada 89084

Site Number: 9869
STATE OF NEVADA PUBLIC WORKS DIVISION
FACILITY CONDITION ANALYSIS

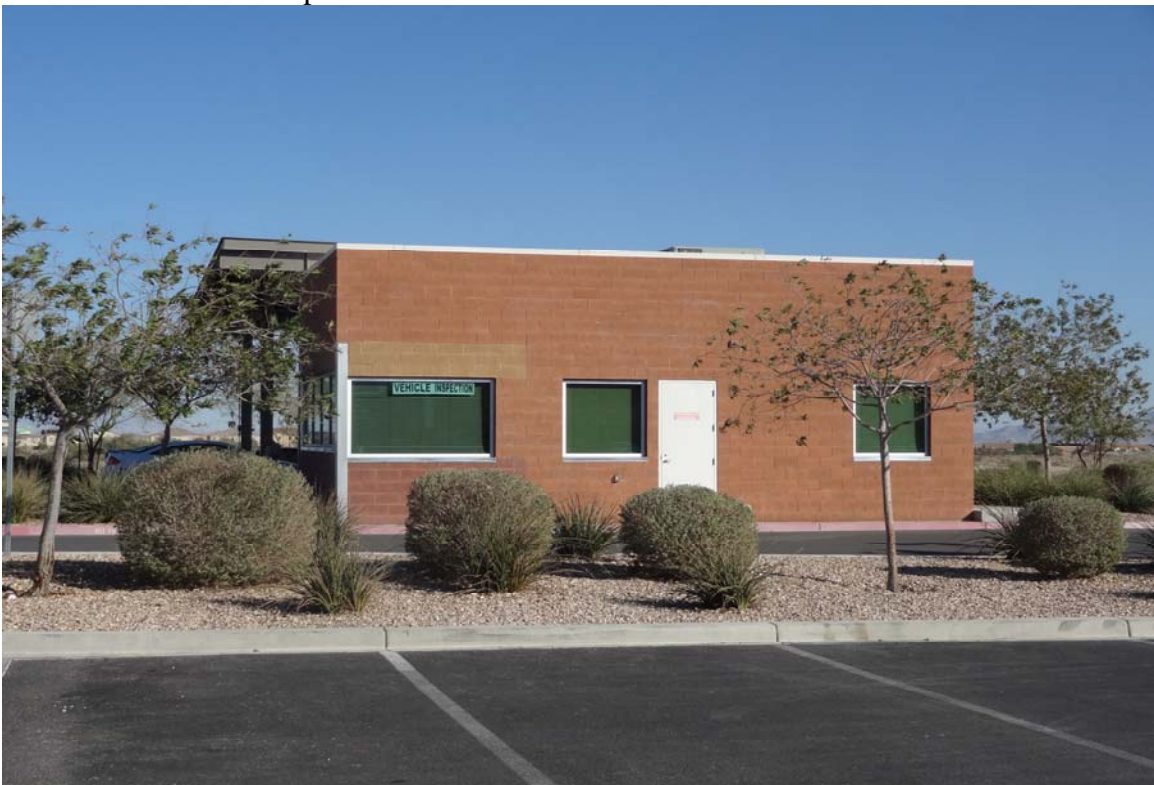
It is important to maintain the finish, weather resistance and appearance of the building. This project would provide funding to protect the exterior of the building excluding the roof. Included in the cost is cleaning and sealing the concrete masonry units and caulking of the windows, flashing, fixtures and all other penetrations. It is recommended that the building finishes are addressed in the next 2-3 years and that this project be scheduled on a cyclical basis to maintain the integrity of the structure.

DMV Inspection Station - Building #2454
Description: Exterior of the building.

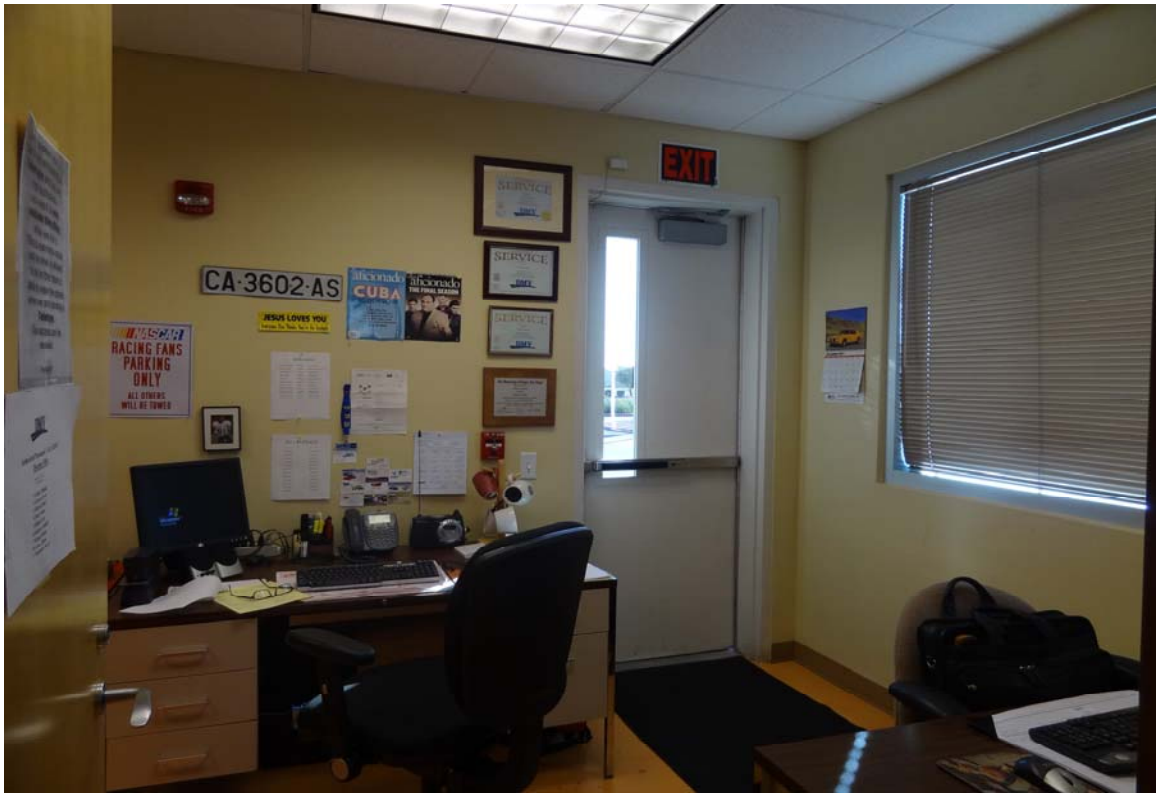
The interior finishes are in fair condition. It is recommended that the interior walls and ceilings be painted at least once in the next 2-3 years and that this project be scheduled on a cyclical basis to maintain the integrity of the structure. Prior to painting, all surfaces should be repaired and prepped. An epoxy-based paint should be utilized in wet areas for durability.

DMV Inspection Station - Building #2454
Description: Interior of the building.

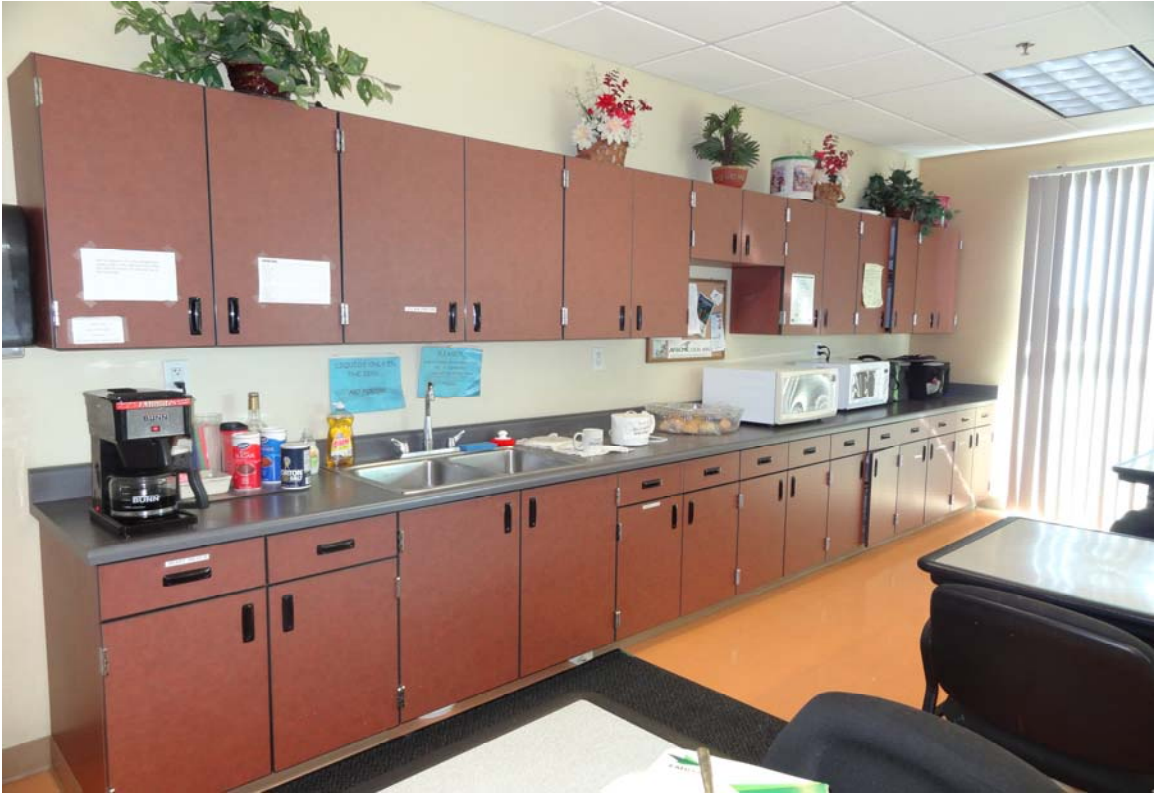
The employee lounge does not meet the Americans with Disabilities Act (ADA) requirements. It is recommended to upgrade some of the features of the room for compliance with accessibility standards for employees. This project would provide funding for construction of an accessible sink and faucet, an accessible space at one of the dining tables and an accessible path of travel throughout the room. NRS 338.180, IBC - 2006, ICC/ANSI A117.1 - 2003 and the most current version of the Americans with Disabilities Act Accessibility Guidelines (ADAAG) were used as a reference for this project.

North Decatur DMV Services Center - Building #2453
Description: View of the kitchen area.

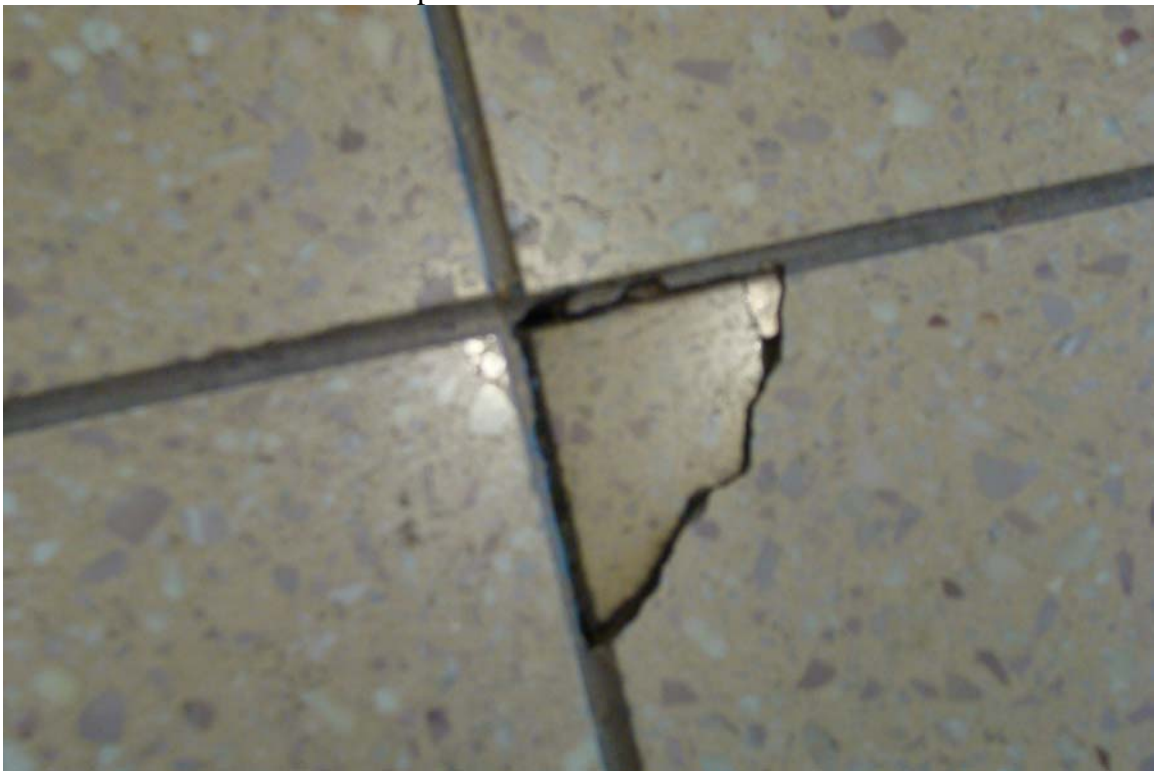
The terrazzo tile flooring in the main Lobby is severely damaged throughout and should be scheduled for replacement. The tiles are breaking at the corners, the grout is failing and there are significant cracks across large sections of tiles. This is a heavily used area and could pose a safety issue with potential tripping hazards to the public and employees. This project would provide for removal and disposal of the existing tile and installation of new tile with a 6" cove base.

North Decatur DMV Services Center - Building #2453
Description: Typical damaged Lobby floor tile.

Project Index #: 2453INT3
Construction Cost \$135,000
