State of Nevada
Department of Public Safety
Highway Patrol Division
Moapa/Mesquite NHP Substation
Facility Condition Analysis

MOAPA/MESQUITE NHP SUBSTATION

1501 State Hwy 169
Moapa, Nevada

Site Number: 9873
STATE OF NEVADA PUBLIC WORKS BOARD
FACILITY CONDITION ANALYSIS

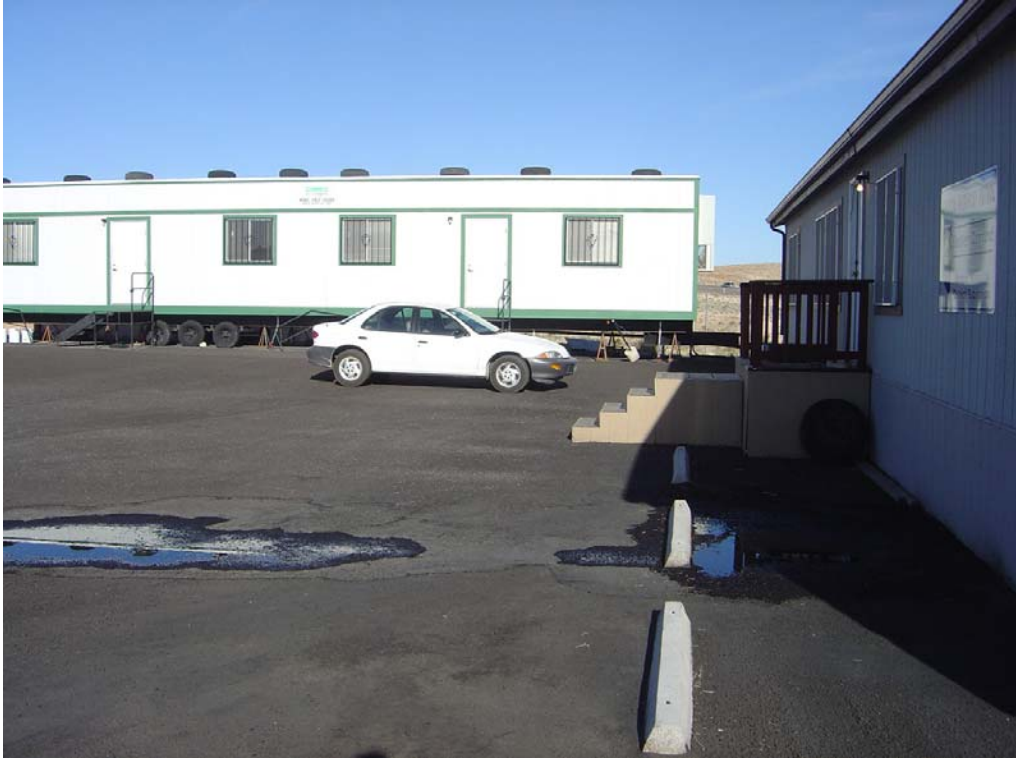
The Moapa/Mesquite NHP Substation is located 50 miles west of Las Vegas on US 15 and north on exit 169. The site is shared with the Nevada Department of Transportation. There are two module units belonging to the NHP and asphalt paving for parking, but lacks ADA signage and parking stalls as described in the ADA Accessibility Guidelines.

Moapa/Mesquite NHP Substation – Site # 9873
Description: Site looking east.

This project would provide for one parking space, including an adjacent accessible loading zone in the existing gravel parking area. The project includes required soil preparation, an asphalt parking area for one vehicle, signage, and striping and marking an accessible route of travel to the building.

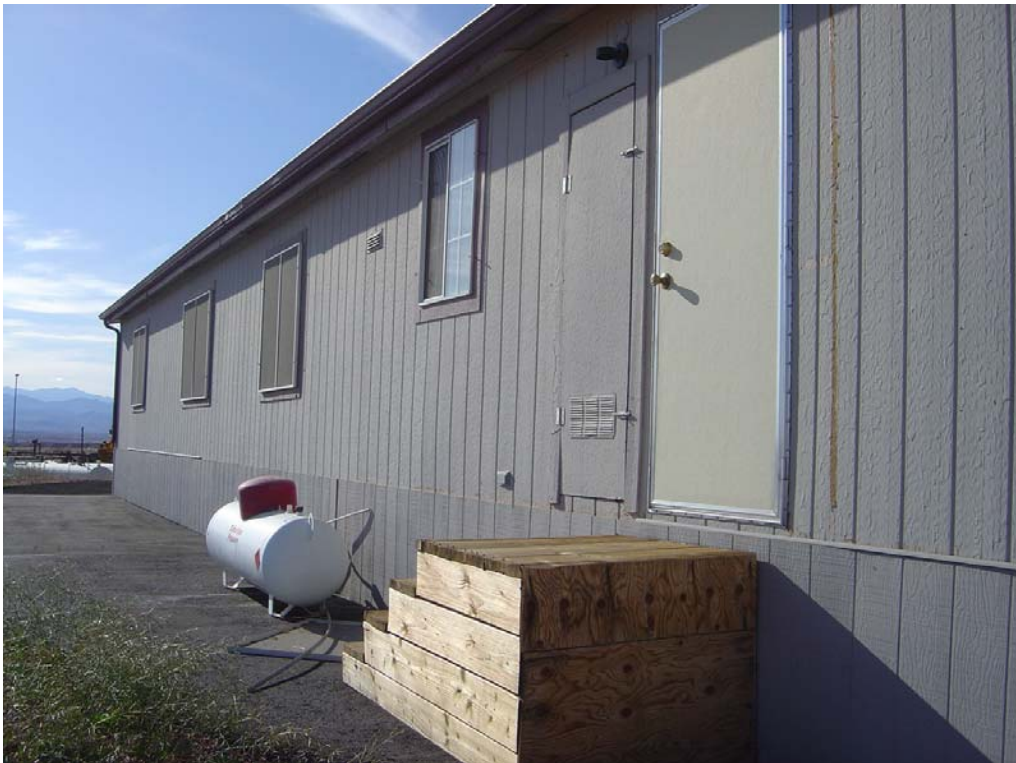
HANDRAIL INSTALLATION **Project cost: \$5,000**
 The 2003 International Building Code 1009.11 requires handrails on each side and adequate in strength and attachment. The building has two sets of stairs which does not have handrails. This project would provide funding for the purchase and installation of handrails on each set of stairs.

Moapa/Mesquite NHP Substation – Building #2463
Description: Stairs on south side of residence.

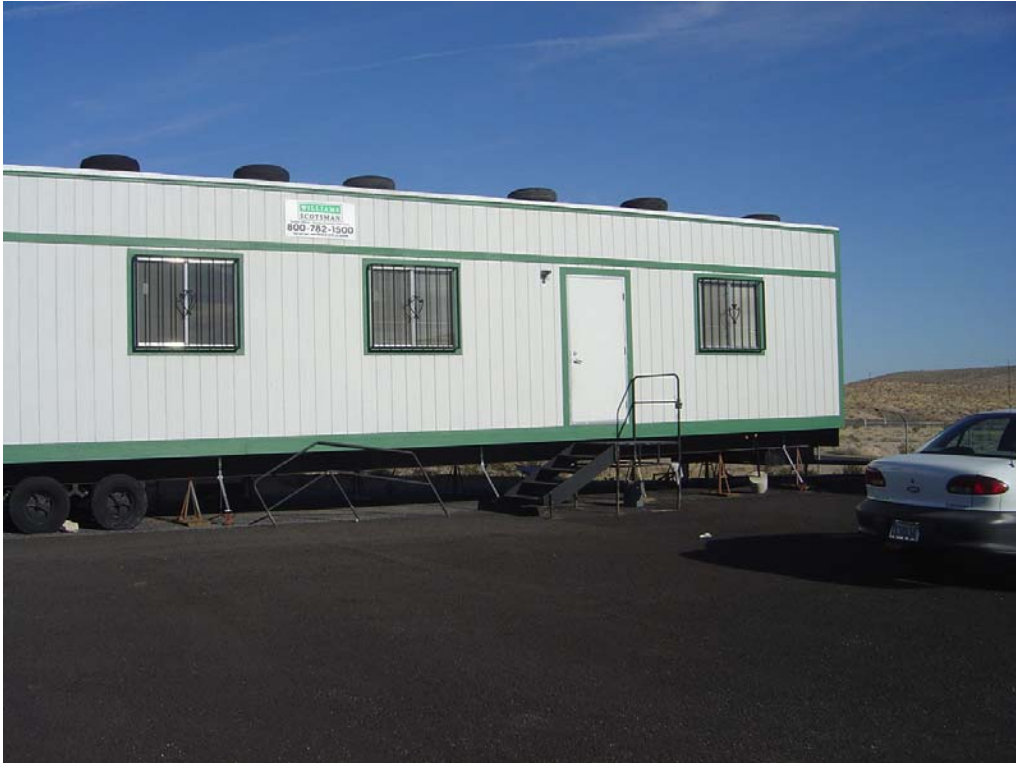
The Moapa/Mesquite NHP Substation is a single wide mobile home structure on an 8 point foundation. The building is used for Nevada Highway Patrol as an office. The facility is in good condition but lacks accessibility as described in the ADA Accessibility Guild lines

The building has steps leading into the main entrance. The entrance does not meet the requirements for ADA Accessibility ICC/ANSI A117.1-1998 404.2.4.1. The entry door has a threshold and hardware that does not meet the requirements for ADA accessibility, ICC/ANSI A117.1-1998 404.2.5.

The skirting around the module building protects the pipes and fixtures from the elements, reduces updrafts, helps controls moisture and reduces energy cost. The building does not have skirting. This project would provide funding for the purchase and installation of a skirting around the module unit.

Moapa/Mesquite NHP Substation – Building #2566
Description: Exterior of modular office.

This project would provide funding for an accessible ramp, including upper and lower landing areas, handrails, curbing, and replacement of the door hardware and threshold to meet the ADA Accessibility Guidelines.

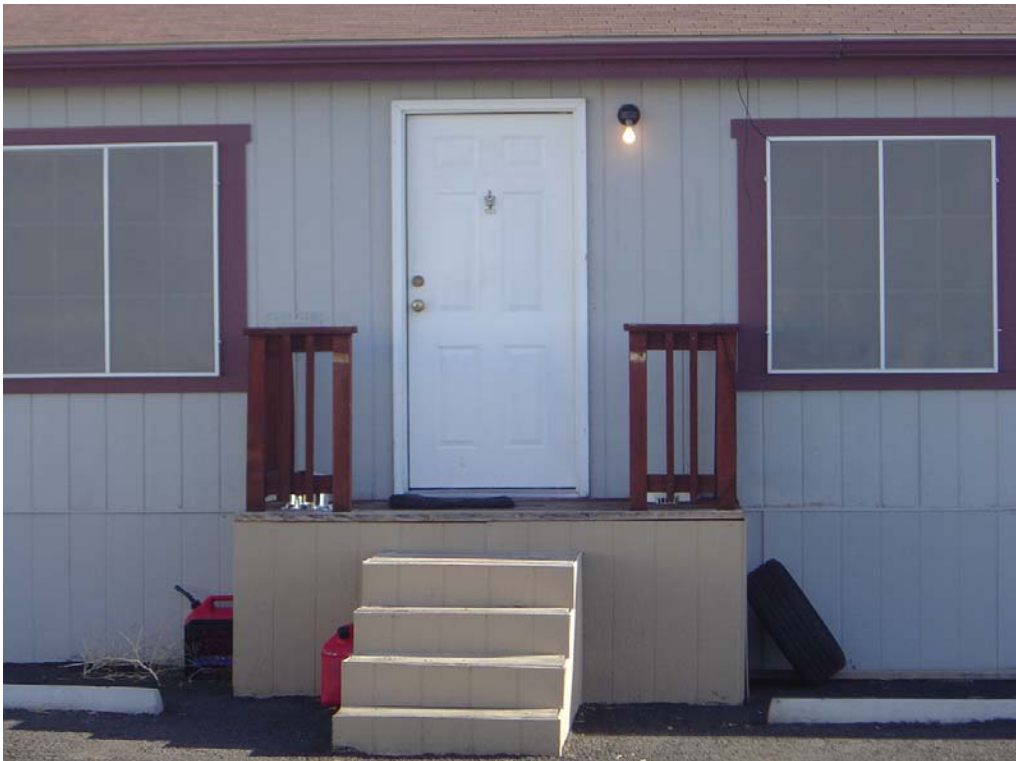
ACCESSIBLE BUILDING ENTRANCE **Project cost: \$30,000**
 The building has steps leading into the main entrance. The entrance does not meet the requirements for ADA Accessibility ICC/ANSI A117.1-1998 404.2.4.1. The entry door has a threshold and hardware that does not meet the requirements for ADA accessibility, ICC/ANSI A117.1-1998 404.2.5.
 This project would provide funding for an accessible ramp, including upper and lower landing areas, handrails, curbing, and replacement of the door hardware and threshold to meet the ADA Accessibility Guidelines.

Moapa/Mesquite NHP Substation – Building #2463
Description: View of main entrance to residence trailer.
