# **CASA GRANDE TRANSITIONAL CENTER**

3955 West Russell Road  
Las Vegas, Nevada 89118

**Site Number: 9875**  
**STATE OF NEVADA PUBLIC WORKS DIVISION**  
**FACILITY CONDITION ANALYSIS**

Report distributed in December 2022

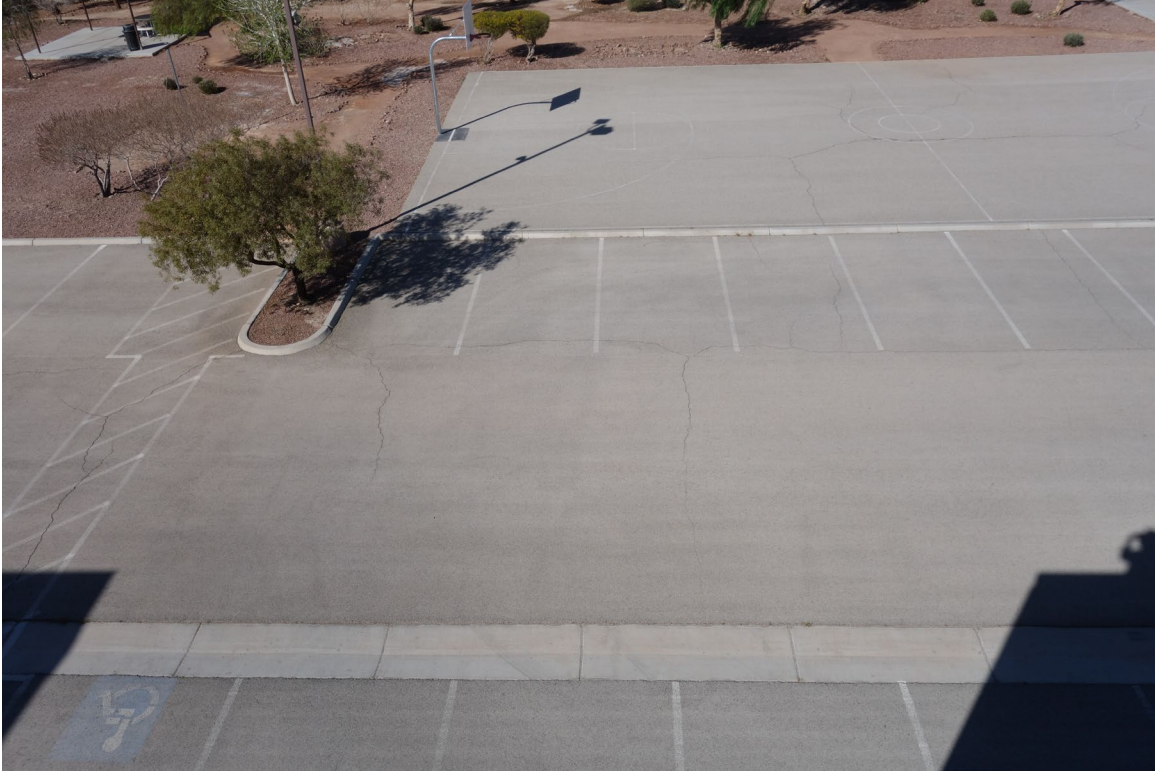
The existing asphalt concrete paving on site is in fair condition. This project would provide for crack filling as needed and sealing and striping the pavement in the next three to four years including striping all loading zones and ADA accessible parking spaces and route of travel. This project should be completed on a cyclical basis based on environmental conditions and use.

Casa Grande Transitional Center Site – FCA Site #9875  
Description: Crack fill / Seal Asphalt Paving Needed.

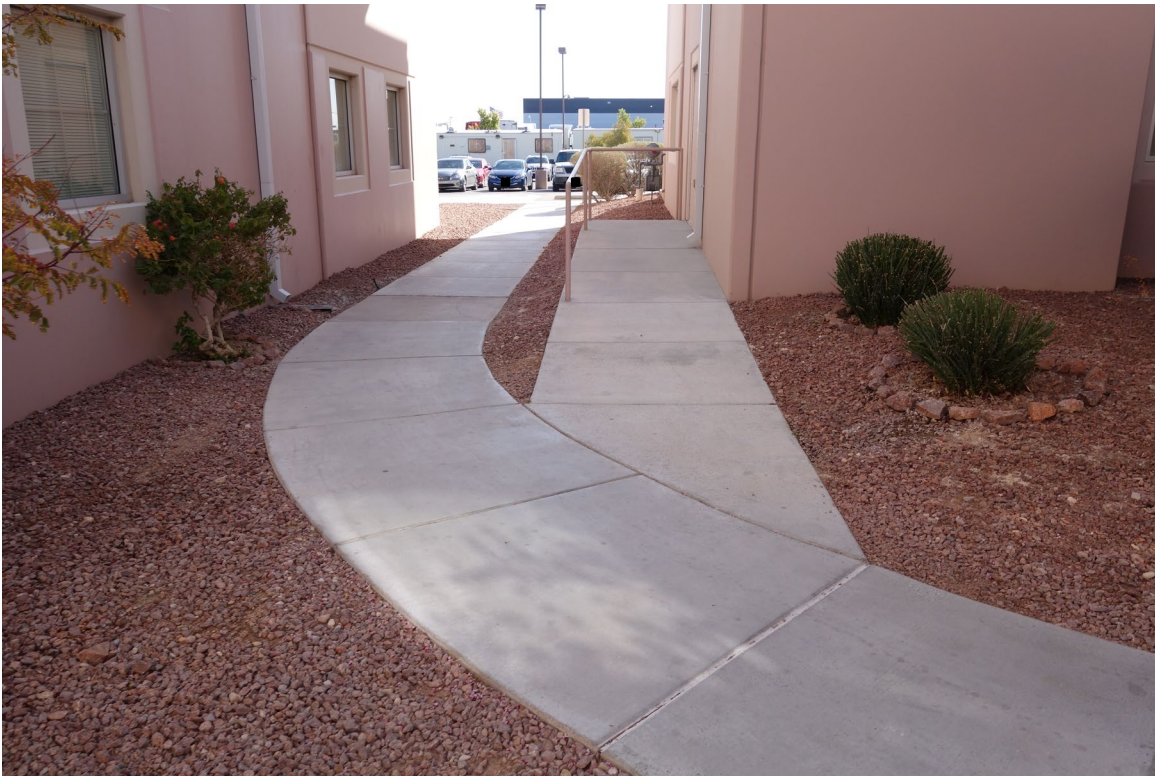
Casa Grande Transitional Center Site – FCA Site #9875  
Description: Accessible Path of Travel between Residential Units.

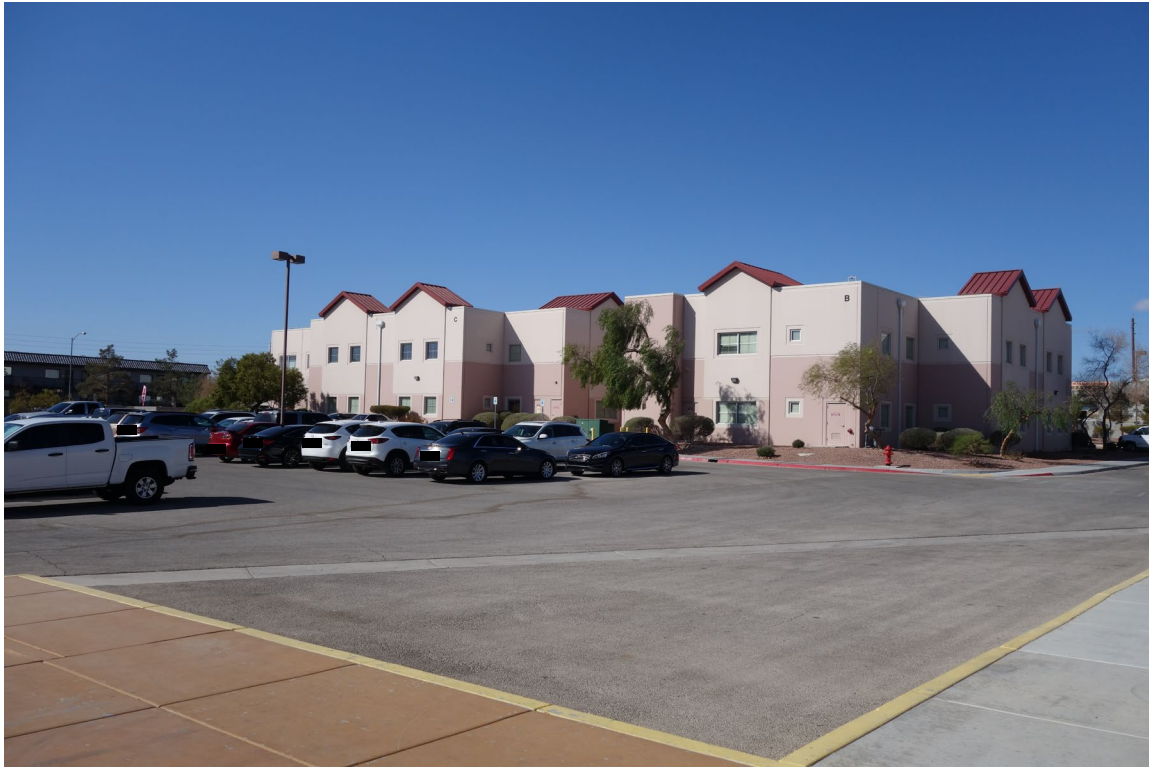
The exterior finishes were in fair condition. It is important to maintain the finish, weather resistance, and appearance of the building. This project would provide funding to protect the exterior of the building excluding the roof. Included in the cost is painting the concrete walls and caulking of the windows, flashing, fixtures and all other penetrations. It is recommended that the building be painted and caulked in the next 4 - 6 years and that this project be scheduled on a cyclical basis to maintain the integrity of the structure.

Residential Units 1 & 2 – FCA Building #2560 & 2561  
Description: Exterior of the Buildings.

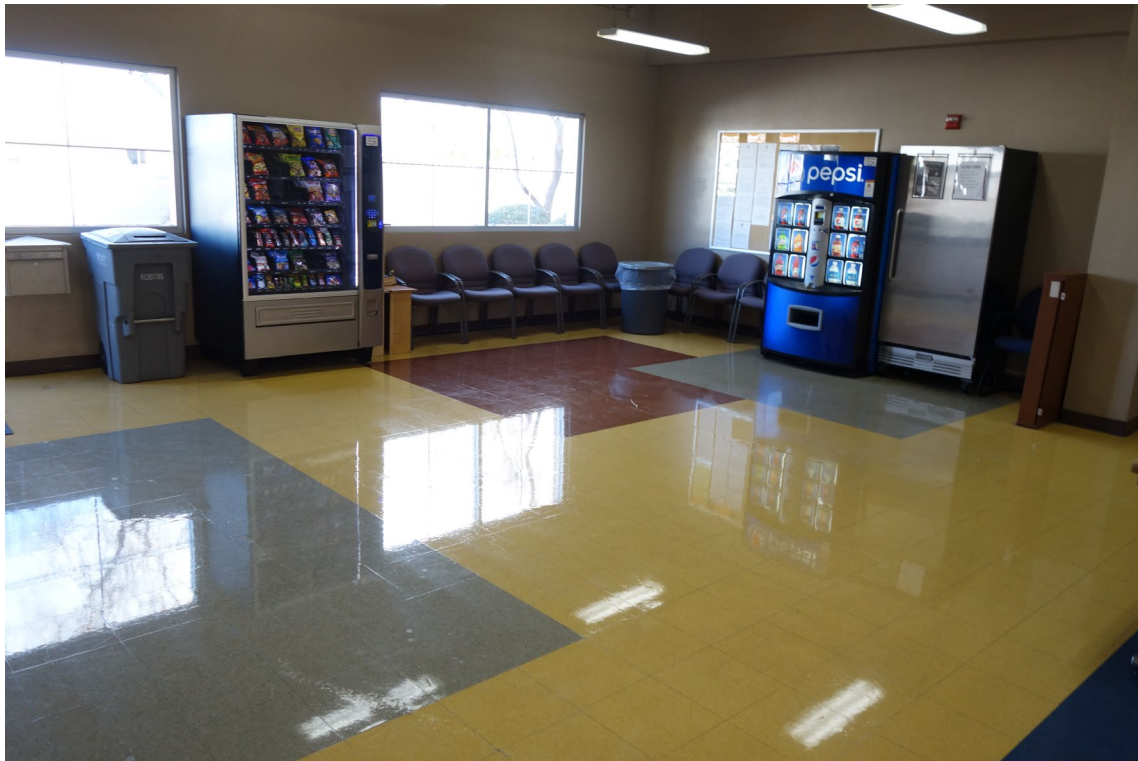
The interior finishes are in good condition. It is recommended that the interior walls, ceilings, doors, frames, steel stairs and exposed steel framing be painted at least once in the next 6 - 8 years. Prior to painting, all surfaces should be repaired and prepped. An epoxy-based paint should be utilized in wet areas for durability.

Residential Unit #2 – FCA Building #2561  
Description: Interior of the Building.

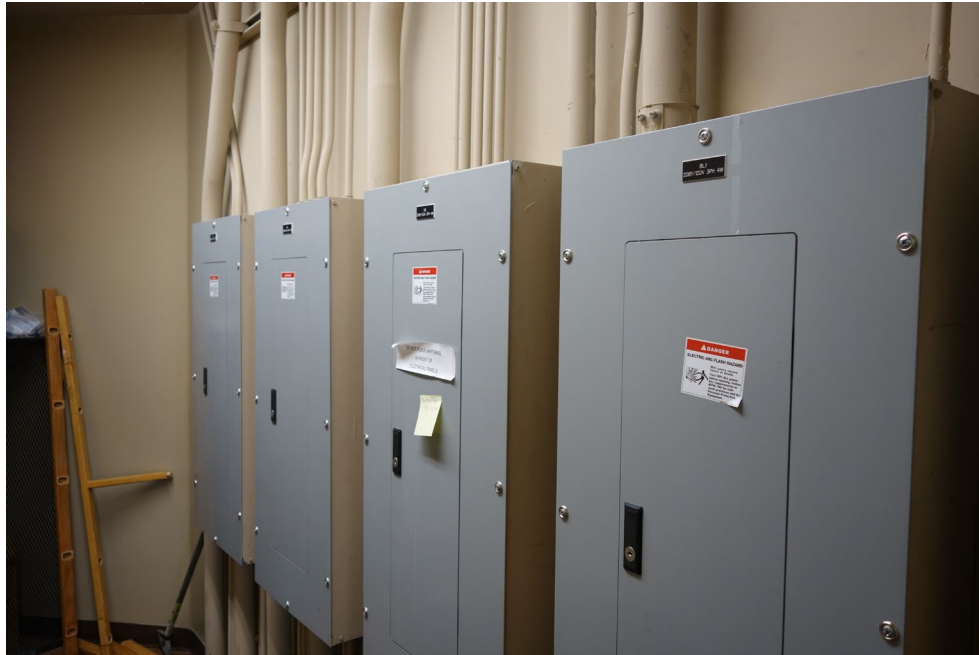
Arc flash and electrical breaker coordination studies have not been performed or it has been more than 5 years since the last coordination study. Safety requirements for maintenance personnel and the latest electrical code require coordination studies to be verified and performed every 5 years, along with arc flash labeling on all electrical panels. This project will perform the required coordination study, evaluation, adjustments and labeling for the building's electrical distribution system.

Residential Unit #1 – FCA Building #2560  
Description: Arc Flash & Breaker Coordination Study Needed.

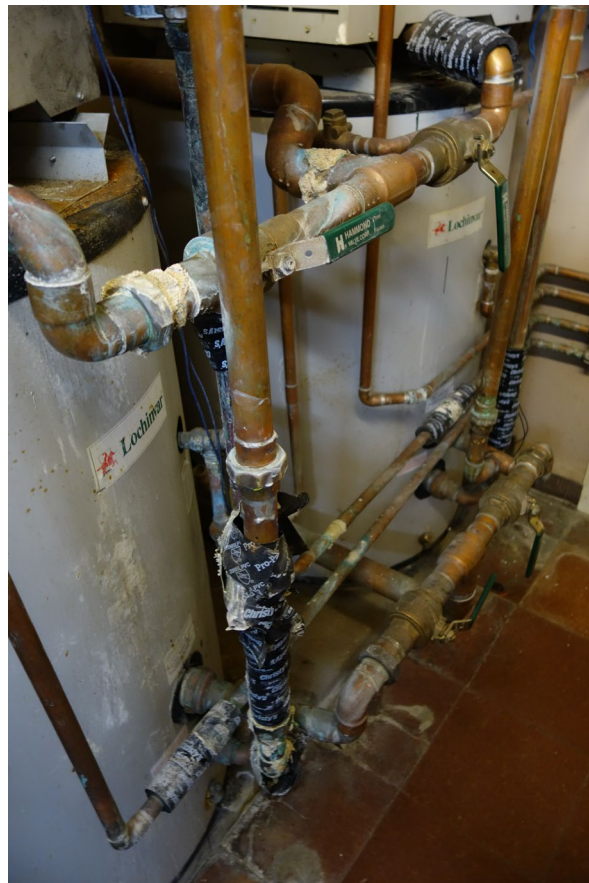
There are two gas fired water boilers on each floor supplying the domestic hot water to the building. Some of the boilers are inoperable and the others have reached the end of their useful life. This project would provide for the purchase and installation of four gas fired water boilers, pumps, controls and include required connections to existing utilities.

The building is lacking a water softener. The hot water boilers are showing catastrophic signs of failure due to lack of water treatment. The laundry and restrooms are also showing signs of severe scaling. This project will fund the installation of a water softening system including the necessary plumbing and electrical modifications.

Residential Unit #1 – FCA Building #2560  
Description: Boiler Replacement & Water Treatment Needed.

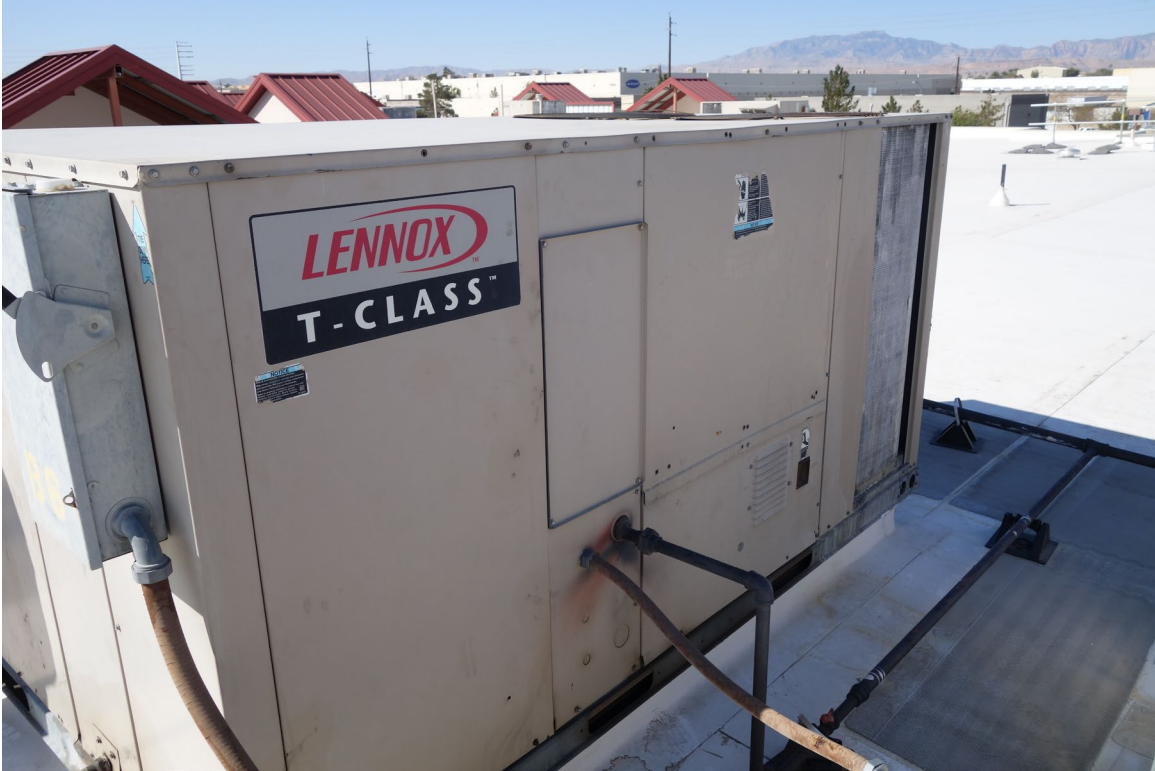
The gas fired rooftop unit HVAC system is original to the building and should be scheduled for replacement. It is not energy efficient and has reached the end of its expected and useful life. The R-22 refrigerant in the cooling system is no longer EPA compliant and its production was phased out completely January 1, 2020. This project would provide for installation of a new HVAC system and cleaning of the existing duct work and grilles. This project includes removal and disposal of the existing HVAC system and all required connections to utilities.

Residential Unit #1 – FCA Building #2560  
Description: HVAC Rooftop Equipment Replacement Recommended.

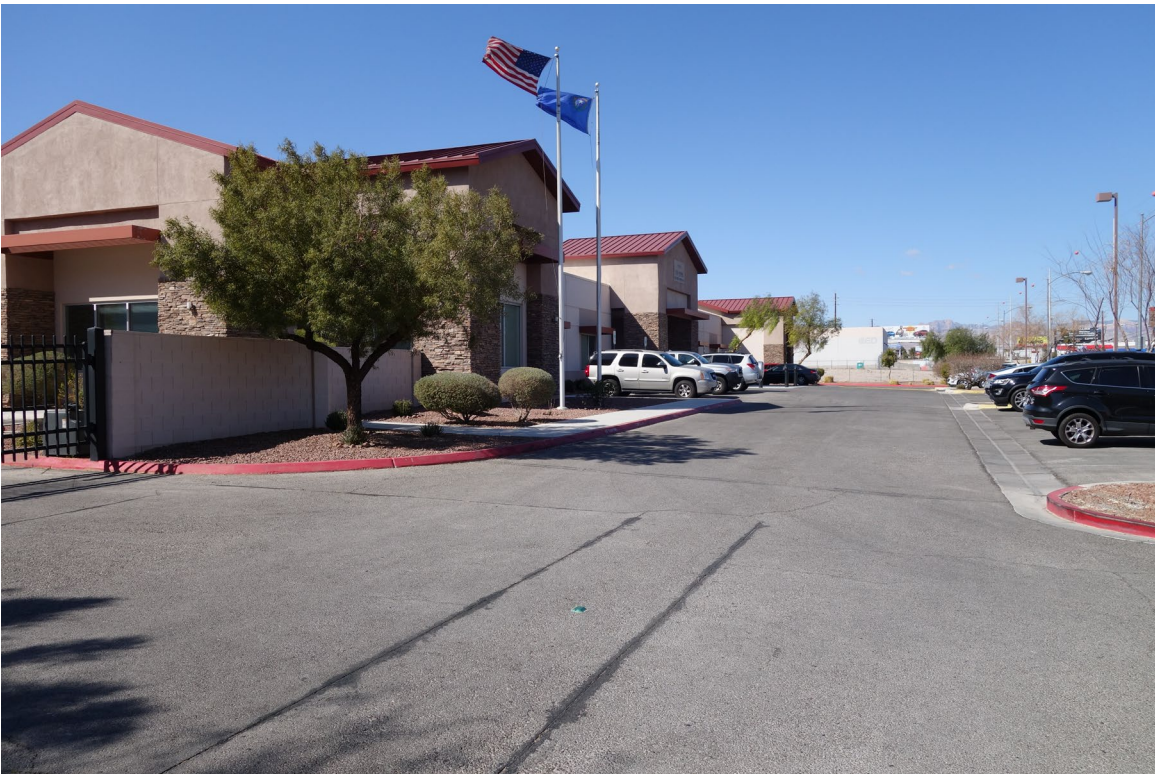
Administration Building – FCA Building #2559  
Description: Exterior of the Building at the Public Entrance.

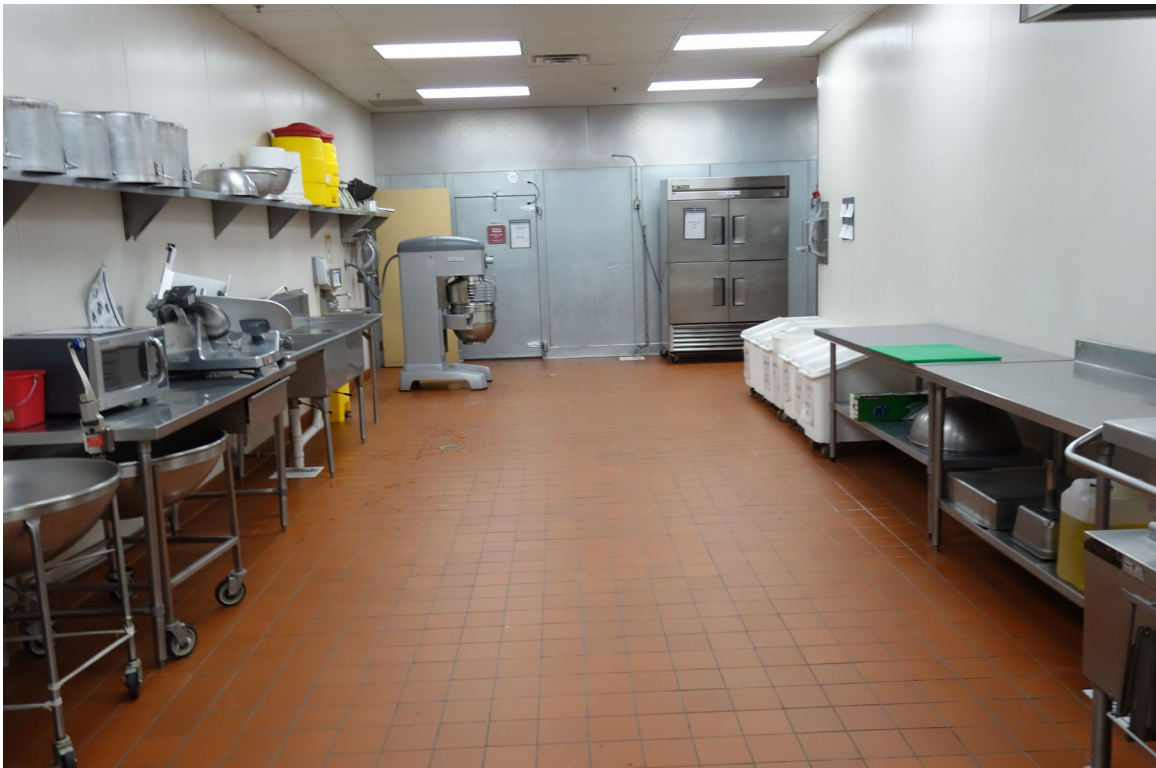
The kitchen has 2 walk-in coolers and 1 freezer. The equipment is approximately 18 years old and has reached the end of its service life due to refrigerant compressor failures. The R-22 refrigerant in the cooling system is no longer EPA compliant and its production was phased out completely January 1, 2020. This project will replace the refrigeration components of the walk-in freezer and the two coolers.

Administration Building – FCA Building #2559  
Description: View of Culinary Area & Walk-In Coolers / Freezer.

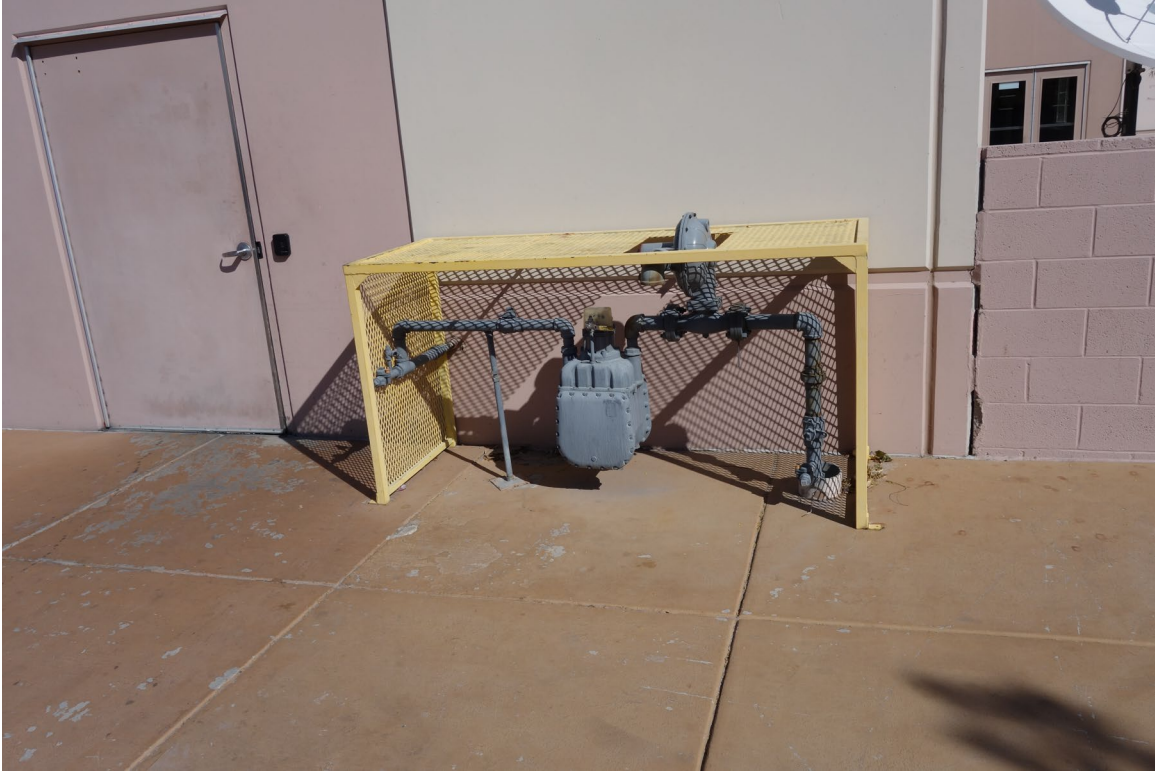
Administration Building – FCA Building #2559  
Description: Seismic Gas Shut-Off Valve Needed.

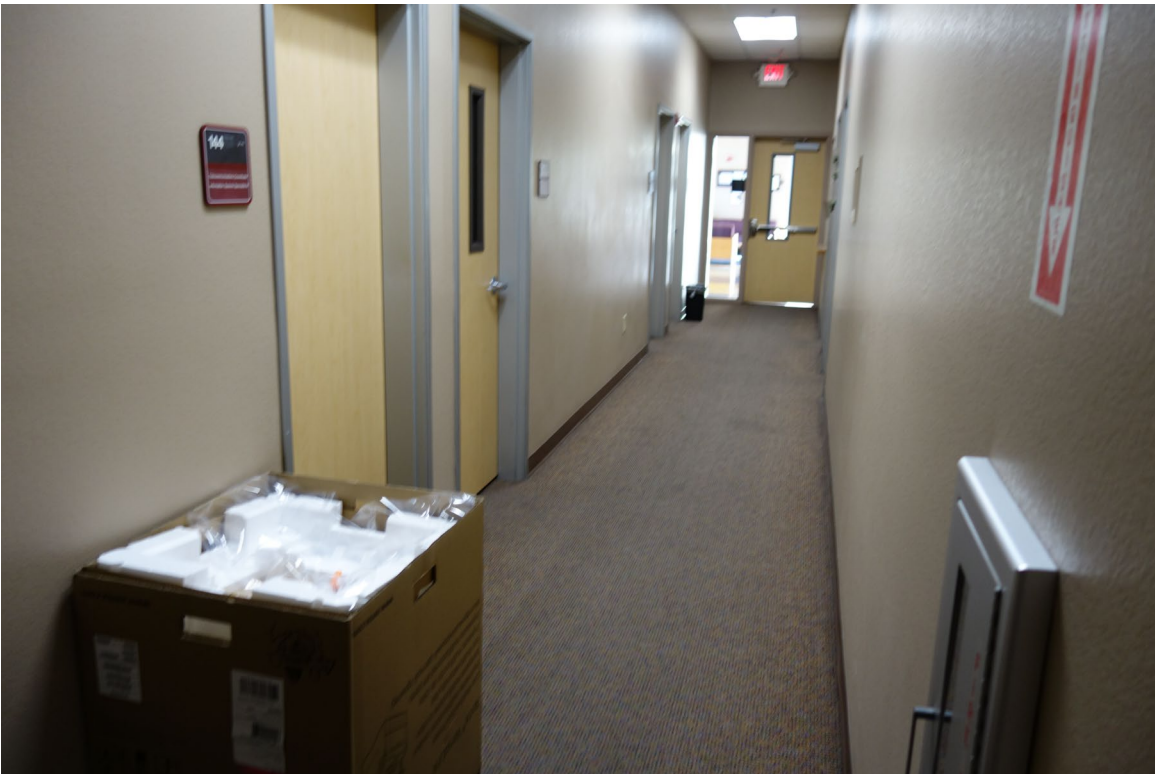
Casa Grande Site – Site Building #9875  
Description: Replacement Planning for Worn Carpet Recommended.
