State of Nevada
Department of Wildlife
Las Vegas Wildlife Offices
Facility Condition Analysis

LAS VEGAS WILDLIFE OFFICES

4747 West Vegas Drive
Las Vegas, Nevada 89108

Site Number: 9878
STATE OF NEVADA PUBLIC WORKS BOARD
FACILITY CONDITION ANALYSIS

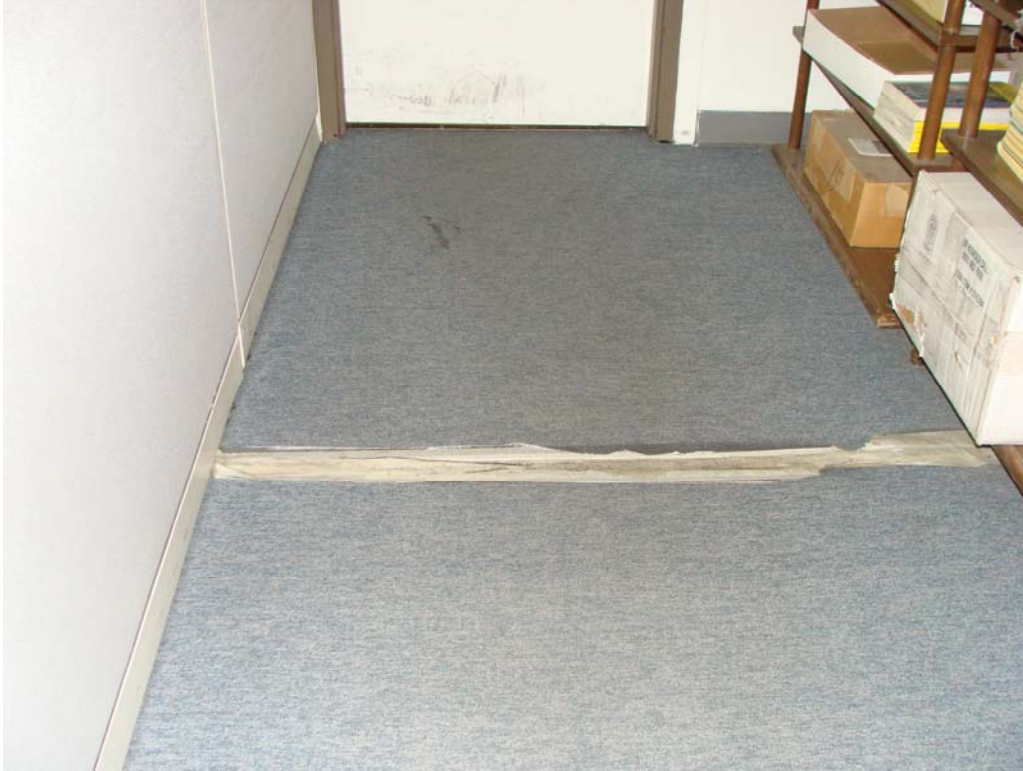
The VCT (vinyl composite tile), sheet vinyl and carpet in the building are damaged and reaching the end of their useful life. It is recommended that the flooring be replaced. This project would provide for removal and disposal of the existing flooring and installation of new 12x12 VCT with a 6" base and heavy duty commercial grade carpet in the next two to three years. It is likely that the mastic used for the VCT and linoleum has asbestos in it. This estimate includes additional funds for proper asbestos abatement including removal, disposal and monitoring.

NDOW Regional Office - Building #0260
Description: Carpet in need of replacement.

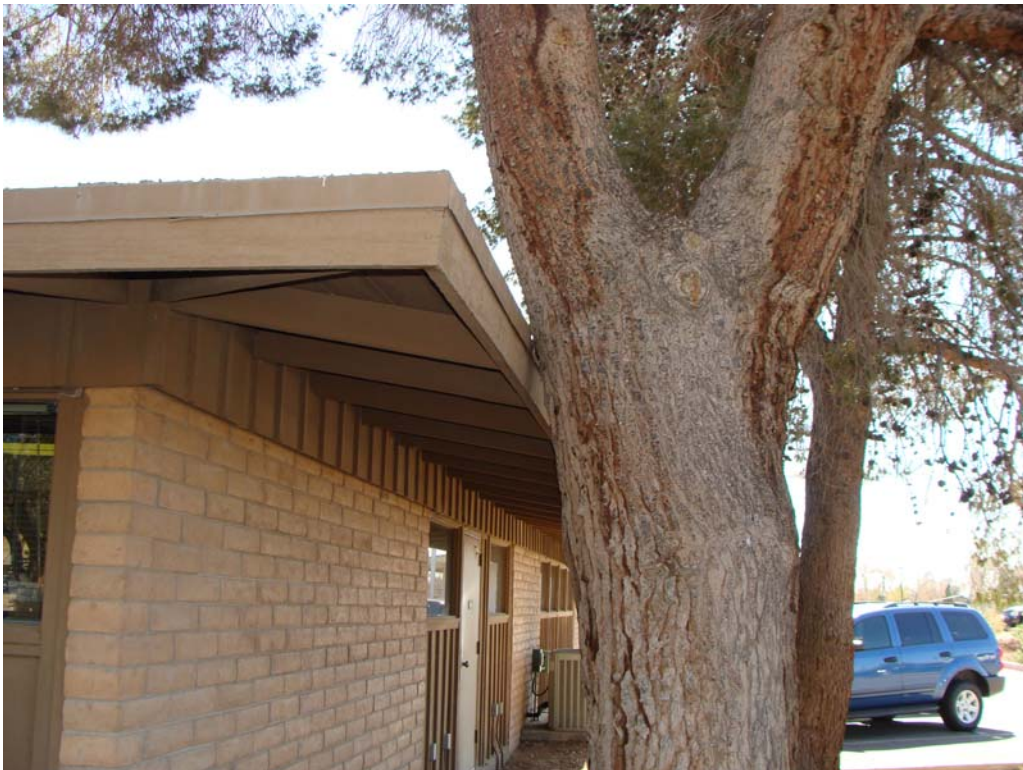
NDOW Regional Office - Building #0260
Description: Area of proposed roof modifications.

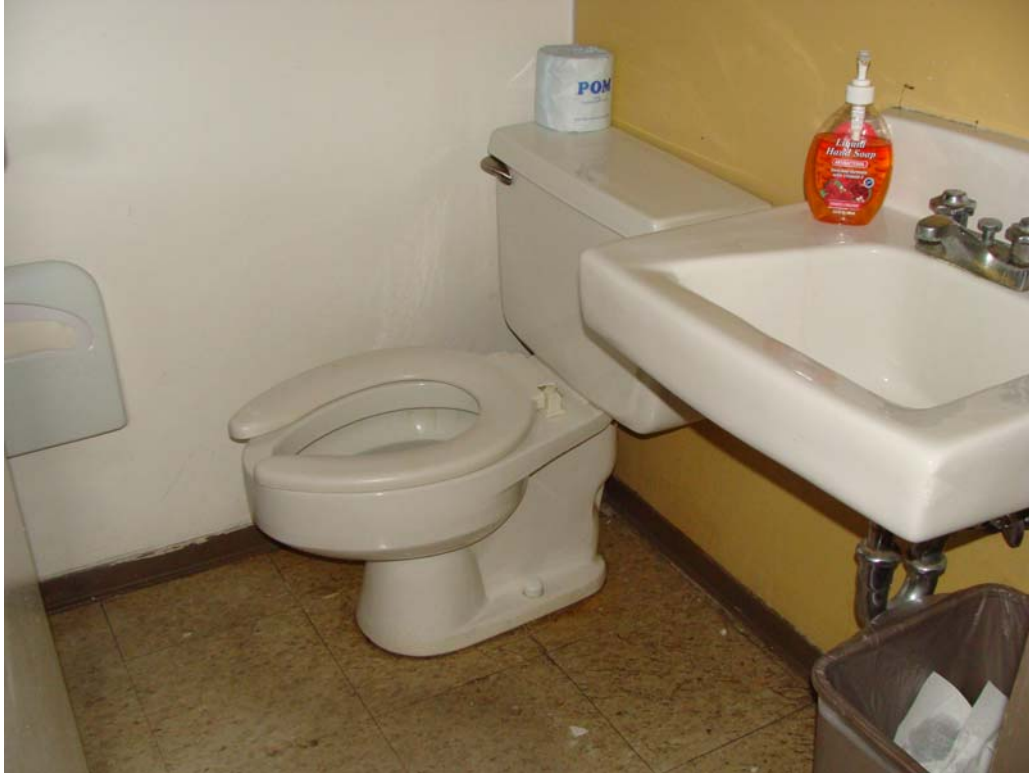
The restroom fixtures in the four restrooms other than the ADA restroom are older and in overall poor condition. The finishes, fixtures, cabinets, sinks, toilets, mirrors and exhaust fans are showing signs of wear and deterioration. This project would provide for a complete remodel of the restrooms. The removal and disposal of the existing fixtures and finishes is included in this estimate.

NDOW Regional Office - Building #0260
Description: Restroom in need of upgrading.

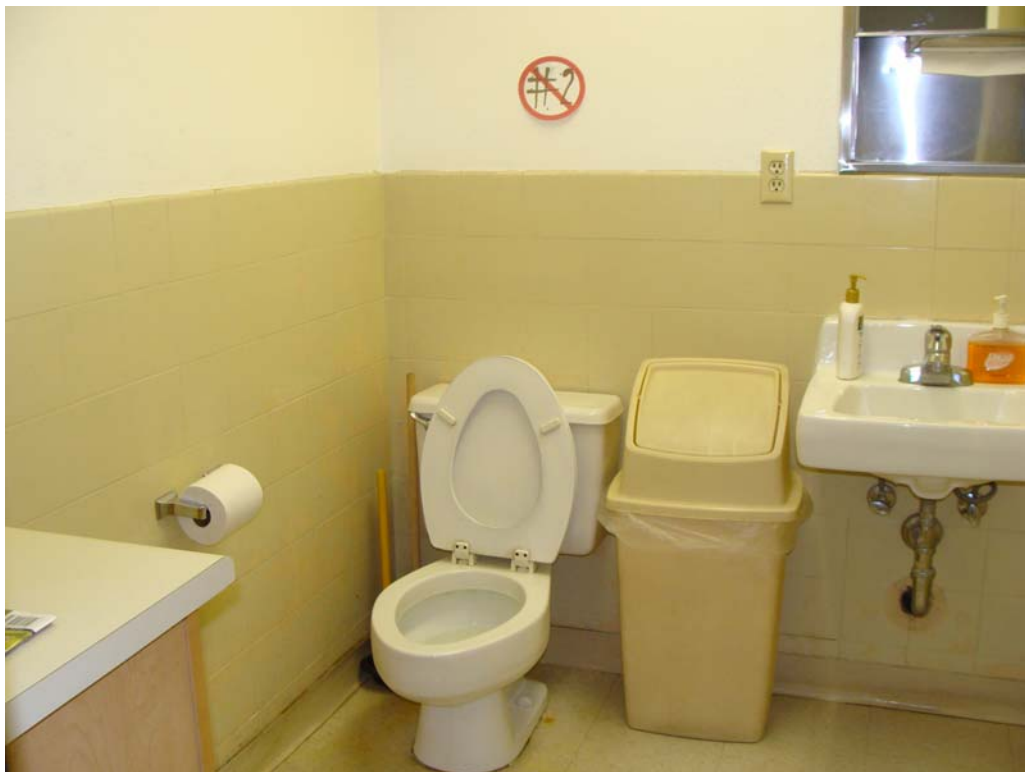
Wildlife Office Annex - Building #0704
Description: Restroom in need of an upgrade.
