State of Nevada
Department of Wildlife
Eastern Region Office
Facility Condition Analysis

EASTERN REGION OFFICE

60 Youth Center Road
Elko, Nevada 89801

Site Number: 9880
STATE OF NEVADA PUBLIC WORKS BOARD
FACILITY CONDITION ANALYSIS

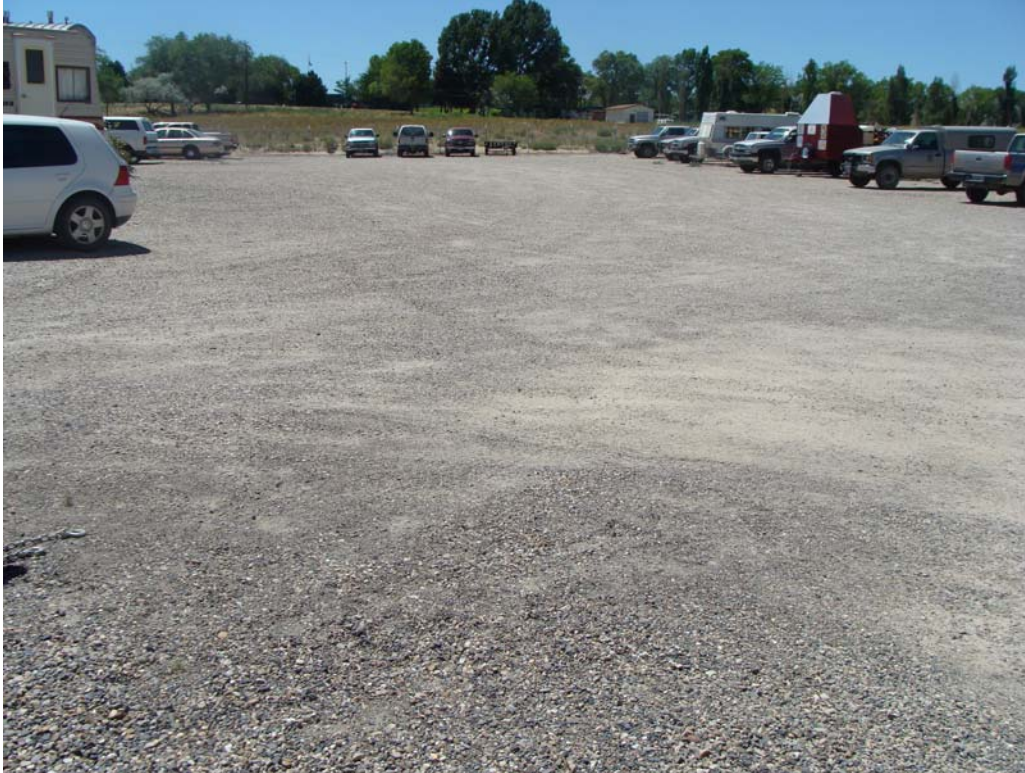
There is approximately 50,000 sq.ft. gravel area between the office and garage. This area is used to park Department of Wildlife vehicles and it is recommended that this area be paved and that a storm drain system be installed. The paving and storm drain will improve drainage in the area, create a safer surface for employees and provide a cleaner surface for the vehicles. This project would provide asphalt cement paving and a storm drain system for the parking area. The estimate includes grading, 6" base, compaction and installation of 4" thick asphalt cement paving. CIP 09-M29 is currently approved and will include this project.

Eastern Regional Office Site - Site #9880
Description: Area of proposed A. C. paving installation.

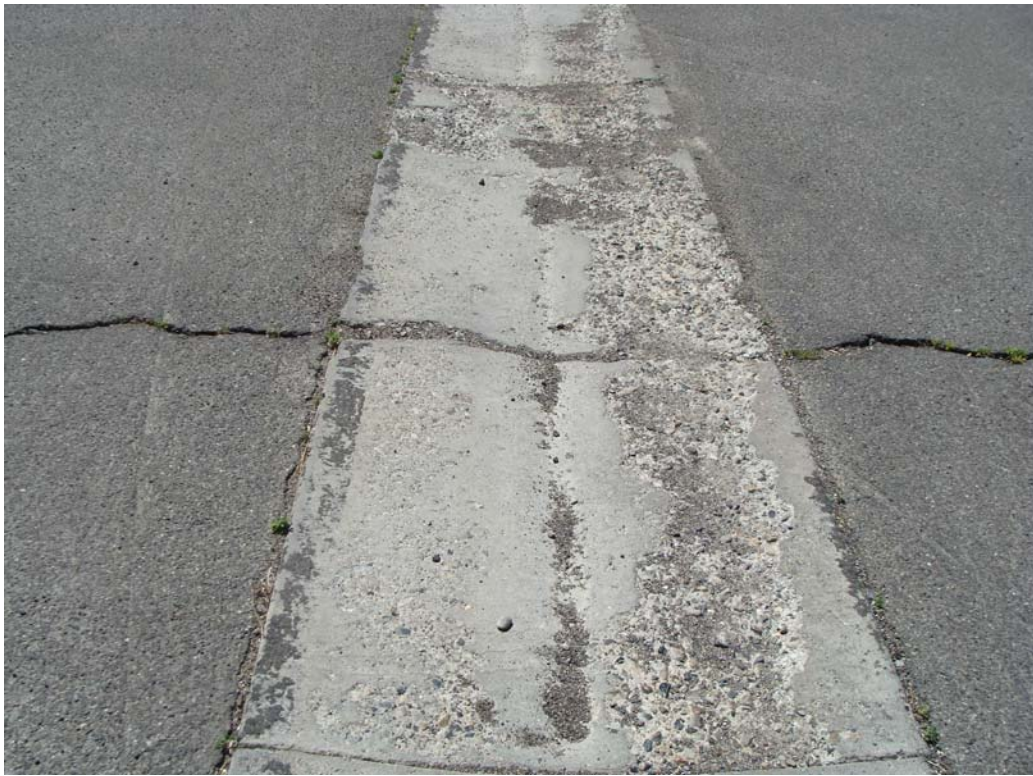
The concrete valley gutter running through the parking lot is deteriorated and failing. There is significant spalling in many areas that will require complete replacement. The rest of the gutter requires patching and sealing. This project addresses removal and replacement of damaged areas and repairs as needed. 350 SF of 4" thick concrete gutter was used for this estimate.

Eastern Regional Office Site - Site #9880
Description: Damaged valley gutter.

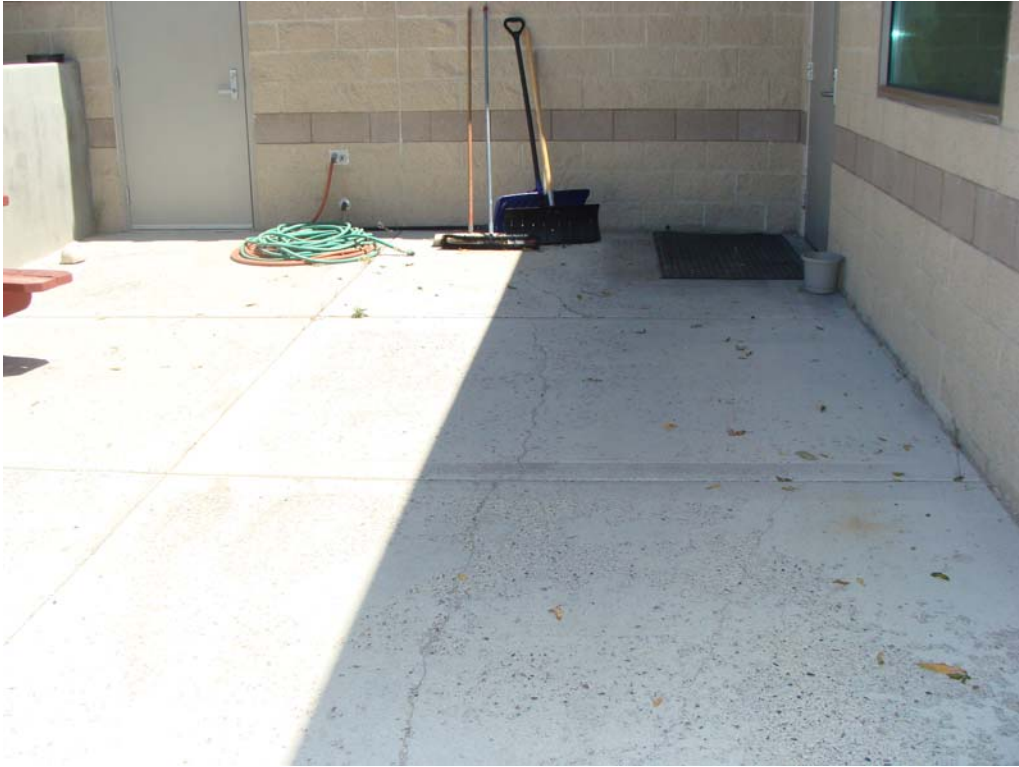
The existing concrete patio is cracked, spalling and deteriorating. Exposure to the weather, especially freezing, has contributed to the damage and deterioration. This project would provide funding for the removal and disposal of the existing concrete and the installation of a 30' wide x 30' long section of concrete patio. Drainage improvements should include sloping the patio away from the building.

Eastern Region NDOW Office - Building #2297
Description: Area of damaged P. C. concrete.

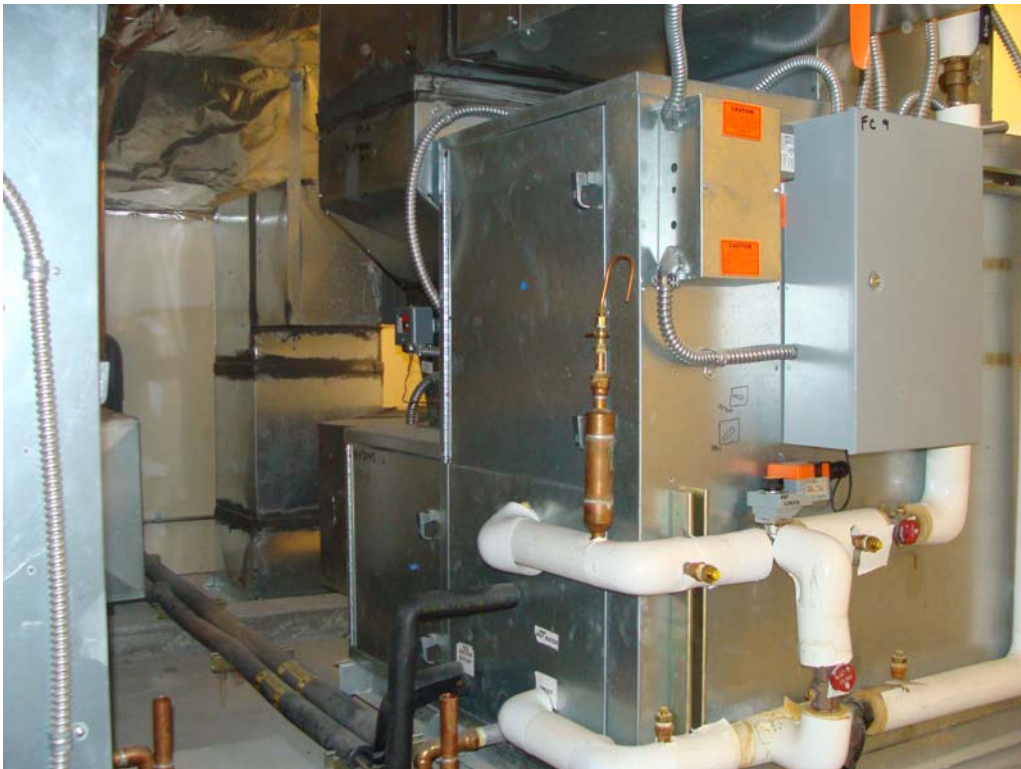
The HVAC system is making a loud humming noise in the office area and small conference room. This project would provide funding for the system to be evaluated and re-balanced. Future projects may be required as a result of this report. This project or a portion thereof was previously recommended in the FCA report dated 09/28/2005. It has been amended accordingly to reflect conditions observed during the most recent survey date of 07/22/2009.

Eastern Region NDOW Office - Building #2297
Description: HVAC equipment in Mezzanine.

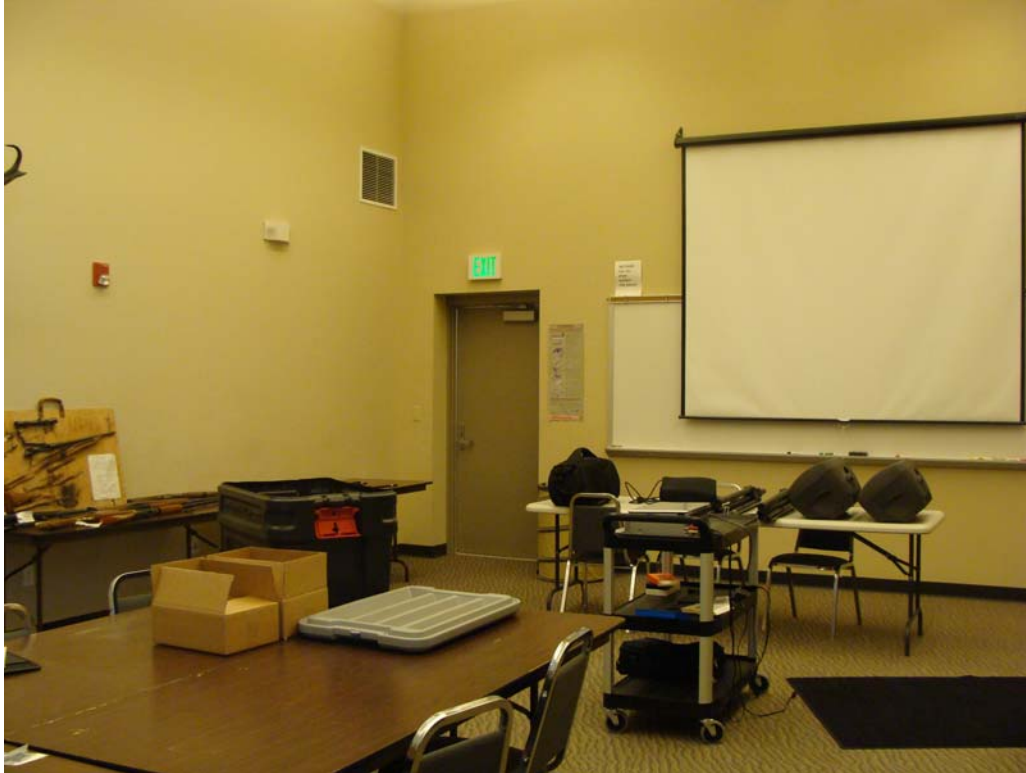
The conference room has an uneven floor due to concrete heaving and an acoustical issue that was not discovered until after construction. The curled concrete floor in the conference room has created ADA accessibility issues and a trip hazard in the middle of the room. Echo in the room created by hard surfaces and the geometry of the walls makes hearing very difficult during public meetings. This project would remedy these safety and accessibility issues. CIP 09-M29 is currently approved and will include this project.

Eastern Region NDOW Office - Building #2297
Description: Interior of the Conference Room.

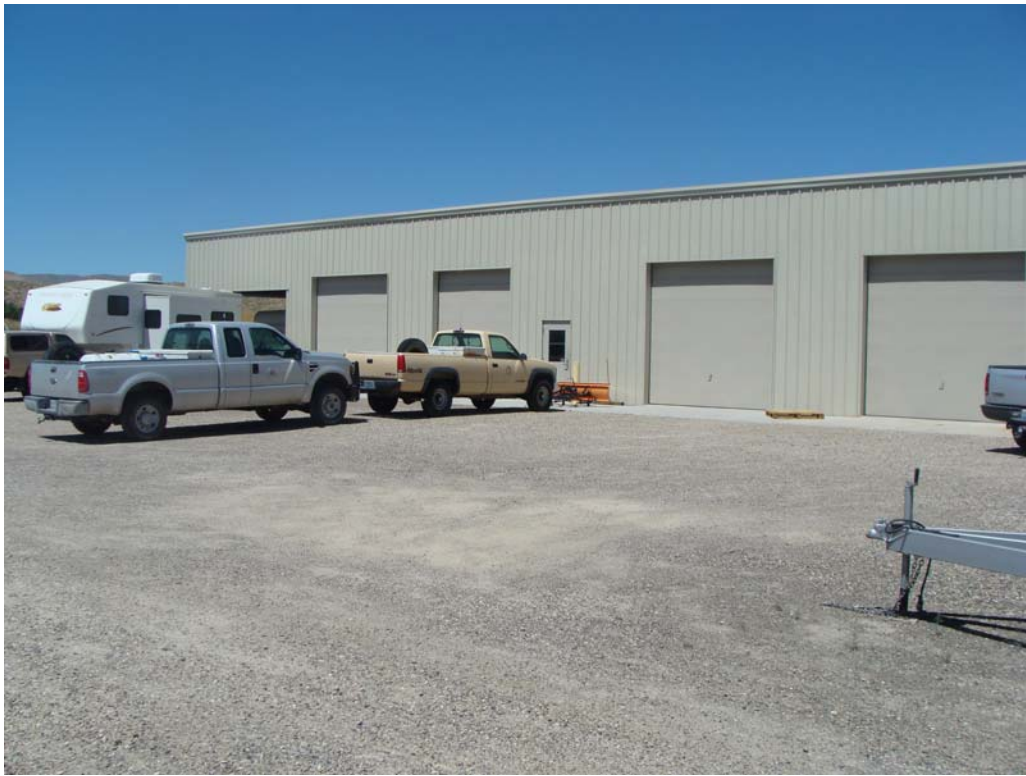
It is important to maintain the finish, weather resistance and appearance of the building. This project would provide funding to protect the exterior of the building. Included in the cost is the caulking and sealing of the flashing, fixtures and all other penetrations. It is recommended that the building be caulked and sealed in the next 3-4 years and that this project be scheduled on a cyclical basis to maintain the integrity of the structure.

Eastern Region NDOW Garage - Building #2298
Description: Exterior of the building.

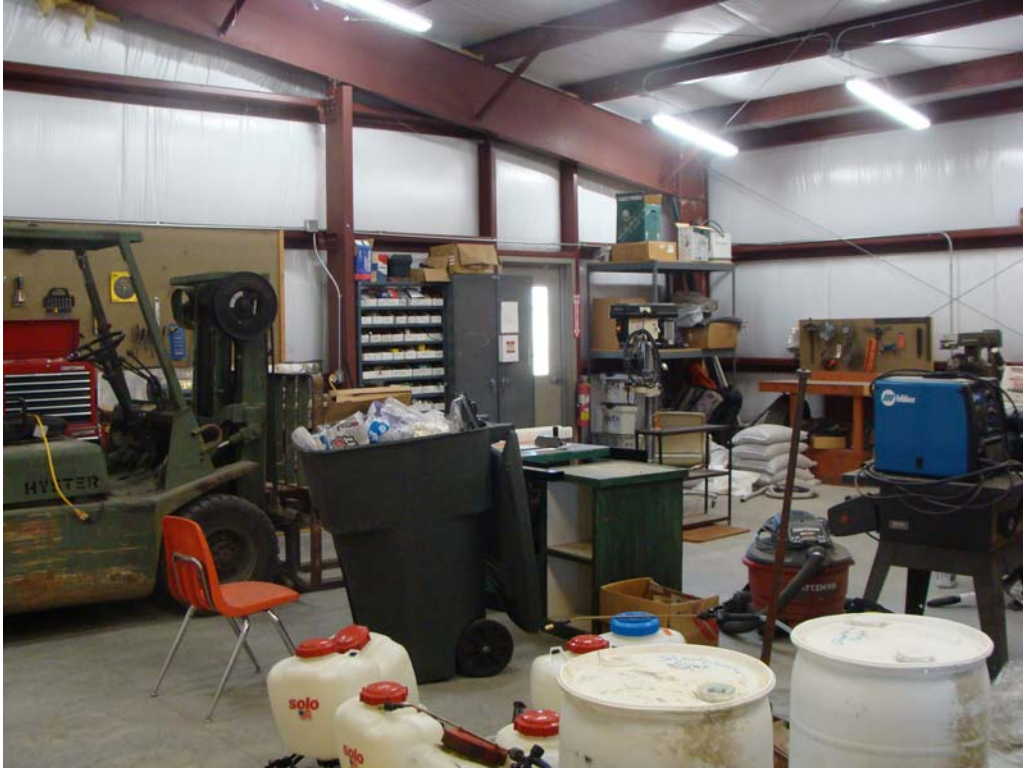
Eastern Region NDOW Garage - Building #2298
Description: Interior of the building.

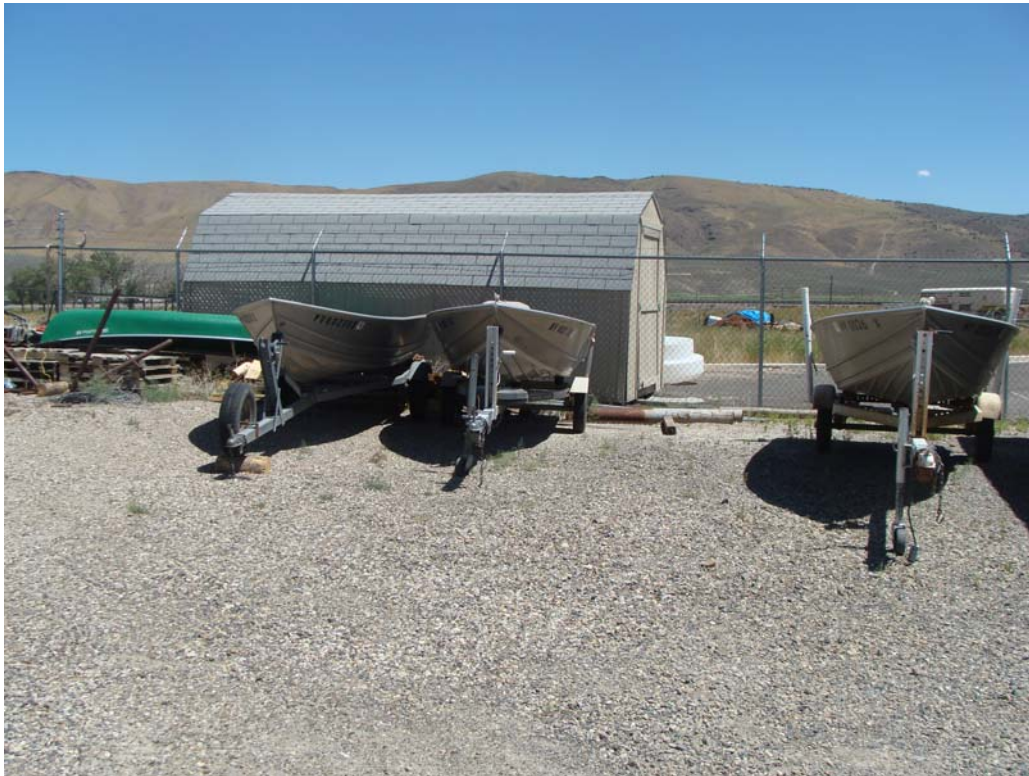
It is important to maintain the finish, weather resistance and appearance of the building. This project would provide funding to protect the exterior of the building. Included in the cost is sanding, priming and painting and caulking of the windows, flashing, fixtures and all other penetrations. It is recommended that the building be painted in the next 2-3 years and that this project be scheduled on a cyclical basis to maintain the integrity of the structure.

NDOW Storage Building - Building #2548
Description: Exterior of the structure.
