State of Nevada  
Department of Motor Vehicles  
Department of Administration - Buildings & Grounds Section  
DMV Office – Henderson  
Facility Condition Analysis

# DEPARTMENT OF MOTOR VEHICLES OFFICE – HENDERSON

1399 American Pacific Road  
Henderson, Nevada 89074

**Site Number: 9888**  
**STATE OF NEVADA PUBLIC WORKS DIVISION**  
**FACILITY CONDITION ANALYSIS**

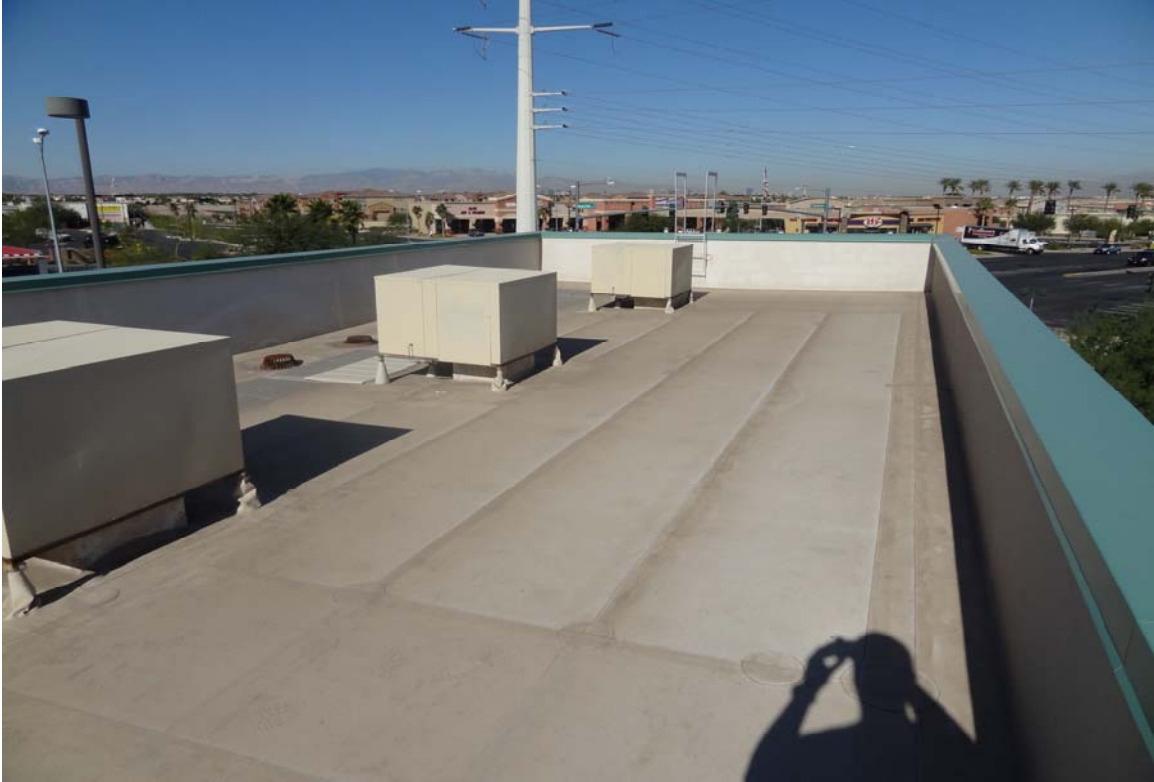
The roof access ladder is a standard fixed steel ladder with the bottom rung 6 feet above the exterior concrete slab-on-grade sidewalk that is attached to the exterior of the building. The ladder currently does not have a ladder guard to prevent the public from using it and gaining access to the roof. This project would provide for a lockable ladder guard to be installed on the existing ladder to prevent unauthorized use by the public.

DMV Inspection Station - Building #2170  
Description: View of the roof.

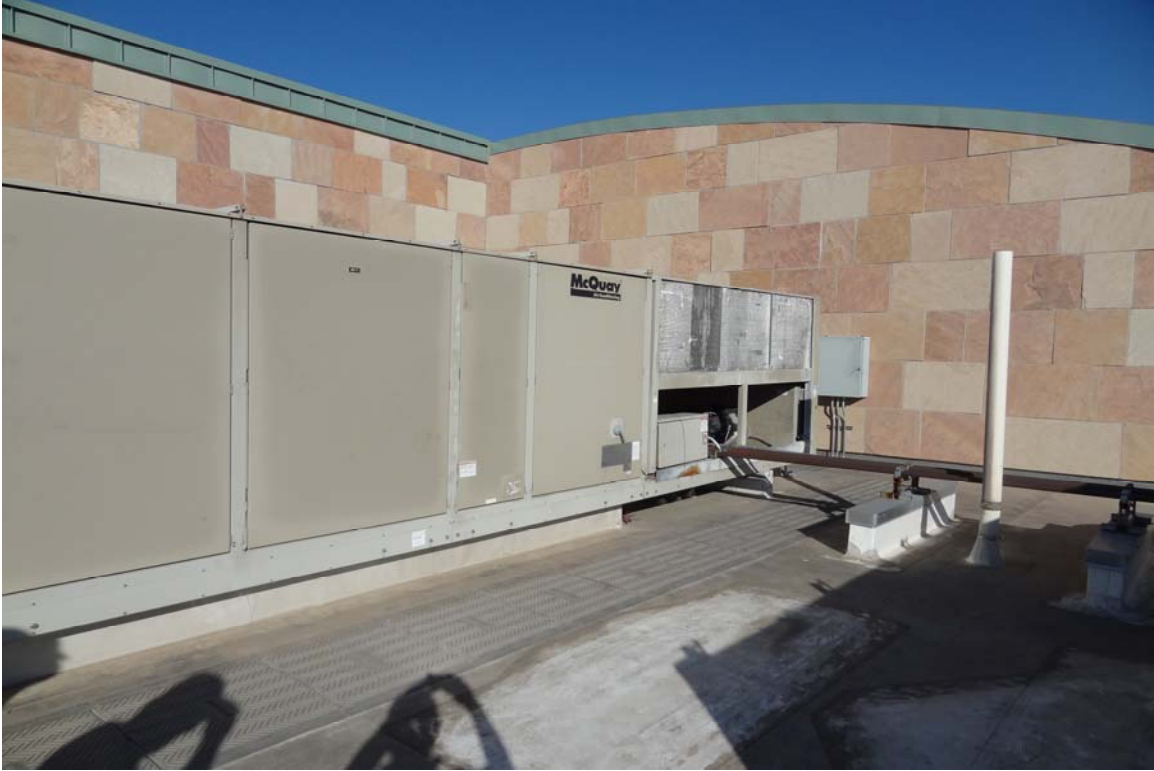
The two hot water boilers and the roof mounted evaporative cooler were installed in 1997. They are not energy efficient and will soon reach the end of their expected and useful life. This project would provide for installation of new HVAC equipment and cleaning of the existing duct work and grilles in the next 6-7 years. This project includes removal and disposal of the existing equipment and all required connections to utilities.

Henderson DMV Office - Building #2000  
Description: Roof mounted HVAC unit.

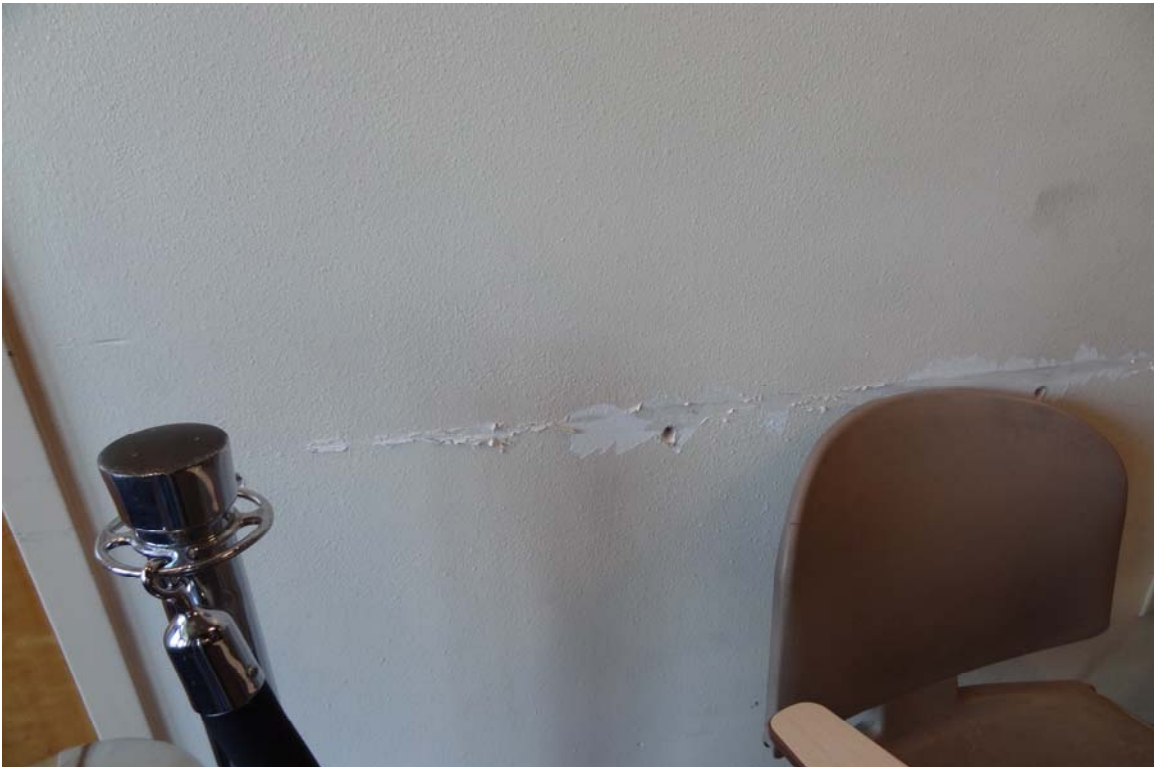
The interior finishes are in fair condition. It is recommended that the interior walls and ceilings be painted at least once in the next 2-3 years and that this project be scheduled on a cyclical basis to maintain the integrity of the structure. Prior to painting, all surfaces should be repaired and prepped. An epoxy-based paint should be utilized in wet areas for durability.

Henderson DMV Office - Building #2000  
Description: Damage to wall surface in public waiting area.
