DEPARTMENT OF MOTOR VEHICLES OFFICE – HENDERSON

1399 American Pacific Drive
Henderson, Nevada 89074

Site Number: 9888
STATE OF NEVADA PUBLIC WORKS DIVISION
FACILITY CONDITION ANALYSIS

Report distributed in December 2021

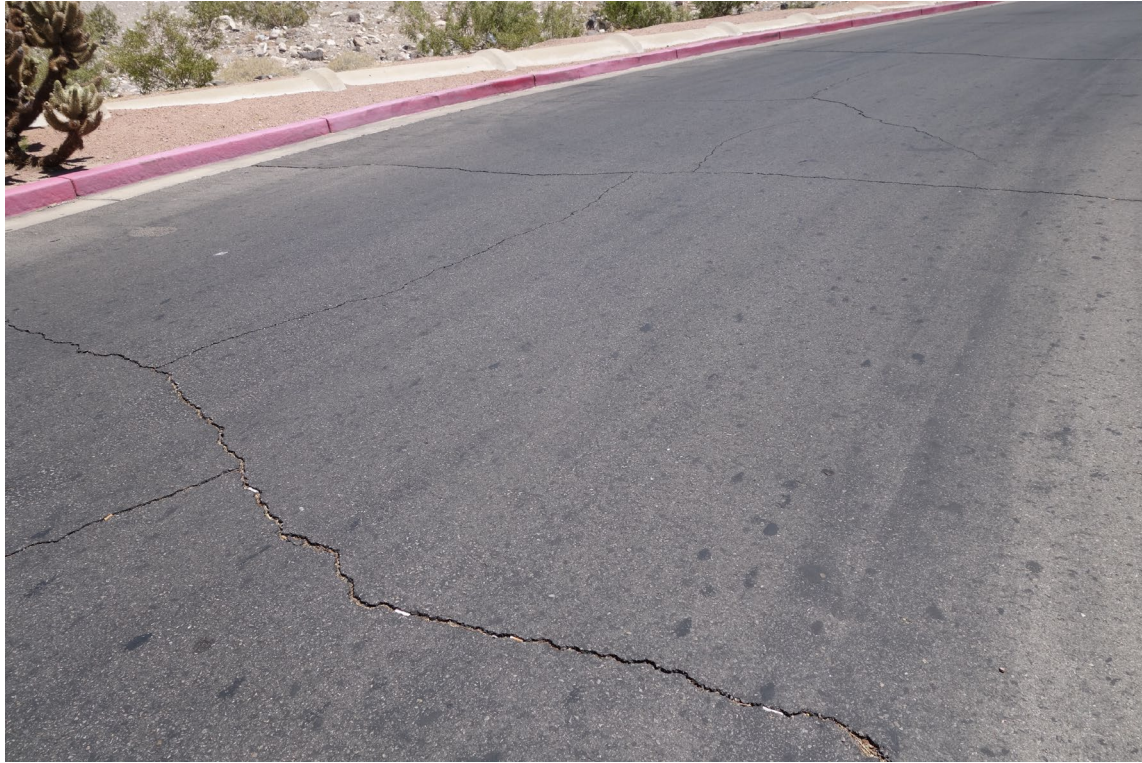
It is important to maintain the asphalt concrete paving on the site. This project would provide for minor crack filling and sealing of the paving site wide including access roads, parking areas and testing courses. Striping is included in this estimate. This project should be scheduled on a 4 year cyclical basis to maintain the integrity of the paving and prevent premature failure. 200,000 square feet of asphalt area was used to generate this estimate.

Henderson DMV Office Site - Site #9888
Description: Crack Fill & Seal Needed.

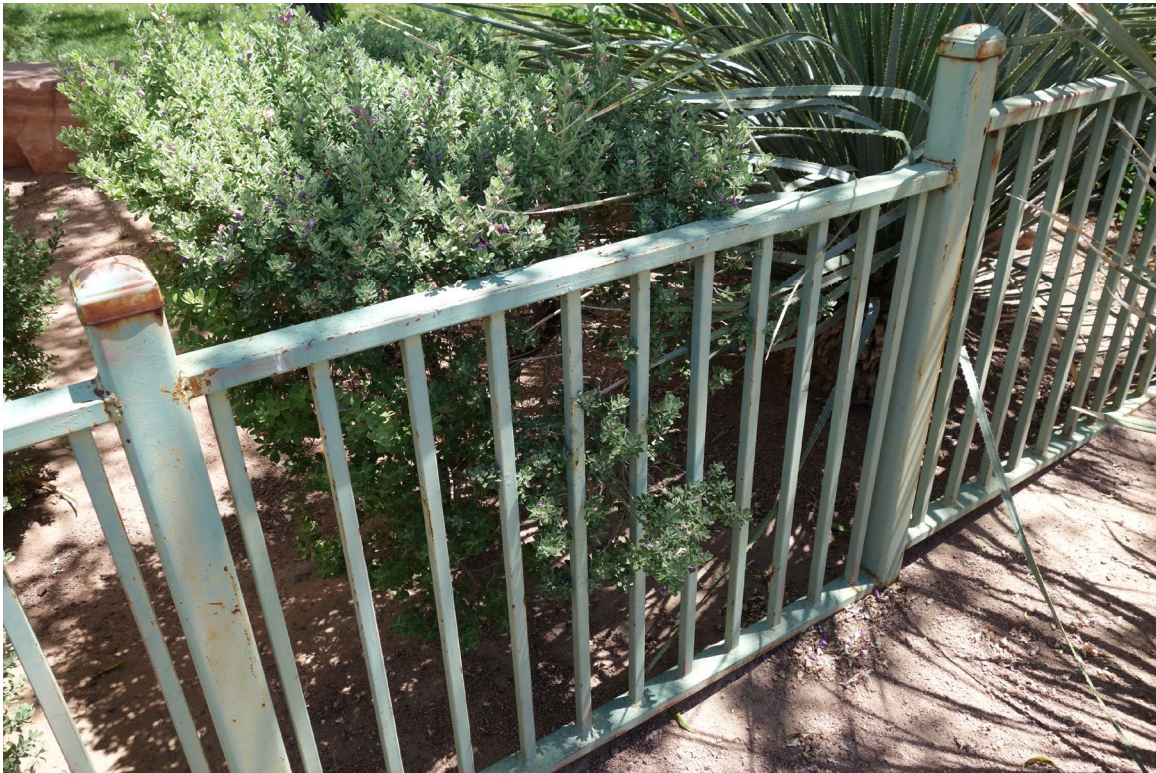
The metal fence separating the staff break area from the public way is corroding and in need of re-finishing. This project would provide for stripping and treating the rusting metal, primer and application of a new coat of paint. 140 feet of fencing was used for this estimate.

Henderson DMV Office Site - Site #9888
Description: Refinish Metal Fencing Needed.

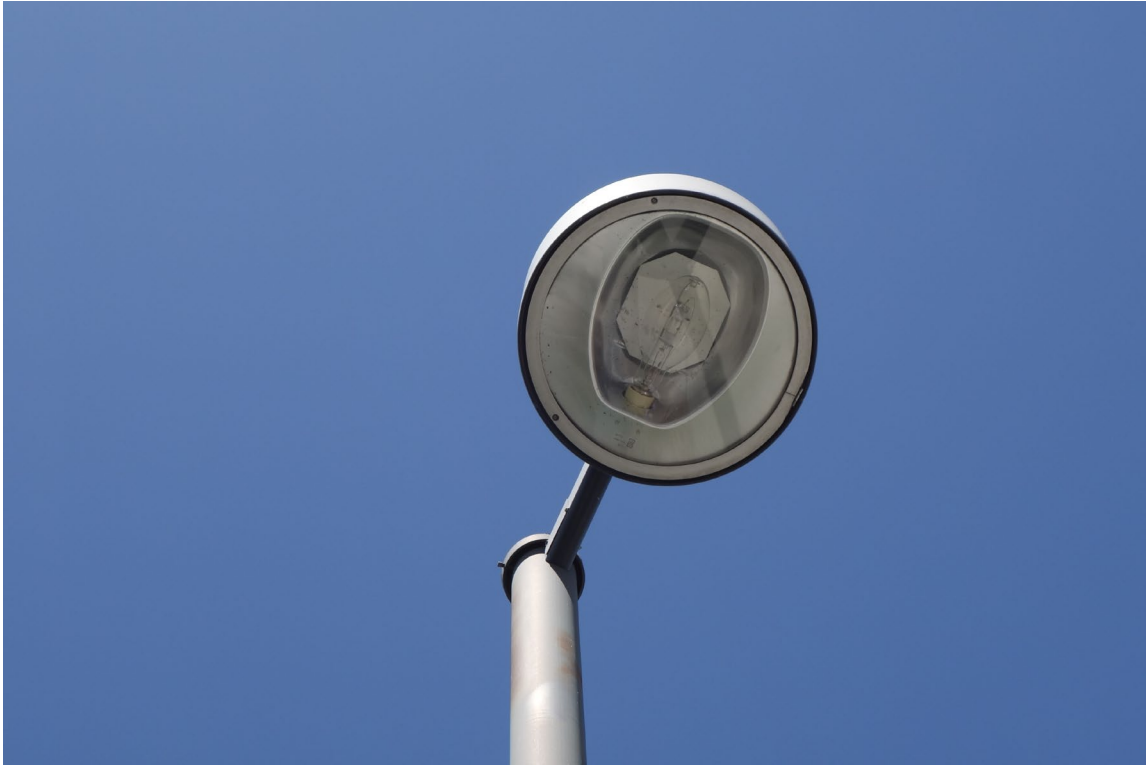
The approximately fifteen light poles around the site. These fixtures have High Pressure Sodium (HPS) lamps and are less efficient. This project would provide for the replacement of the existing light fixtures with LED fixtures using the existing wiring and poles.

Henderson DMV Office Site - Site #9888
Description: Exterior Site Lighting Recommended.

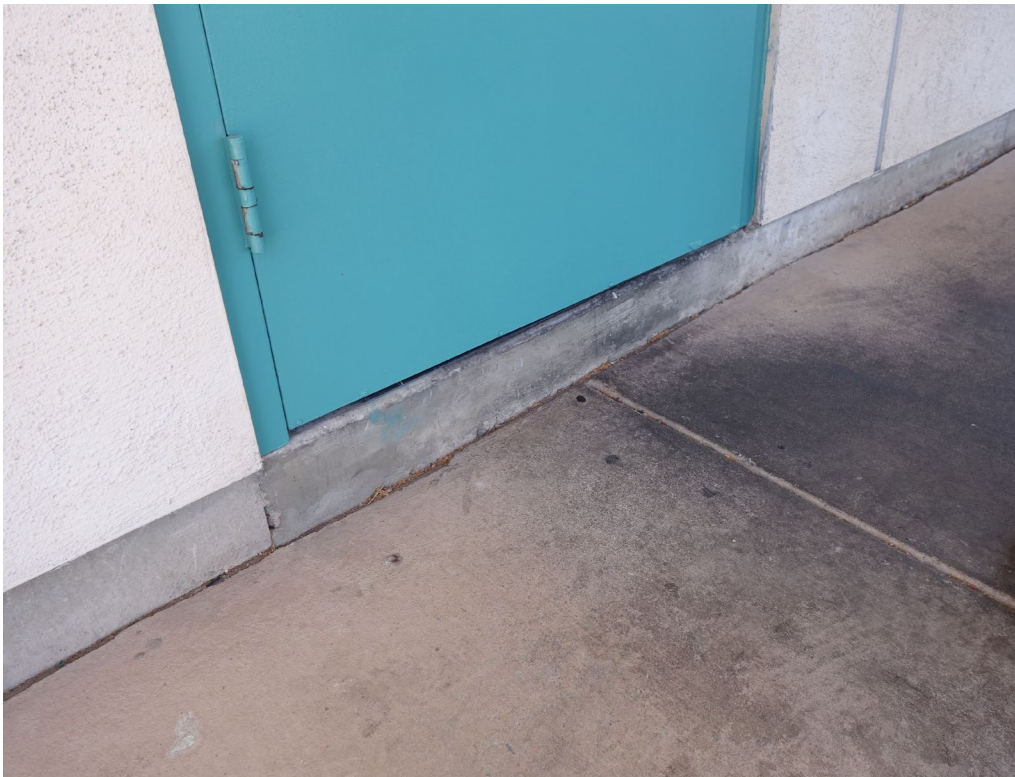
There is an out-swinging exterior door from the building which swings out over a step and does not have a landing that complies with IBC 2018. IBC Section 1008 requires a landing to be not more than 1/2" below the threshold. This project would provide for the installation of a compliant landing for the door.

DMV Inspection Station - Building #2170
Description: Egress Door Landing Needed.

This project should be implemented concurrently with the ACCESSIBLE ENTRANCE RAMP installation project.

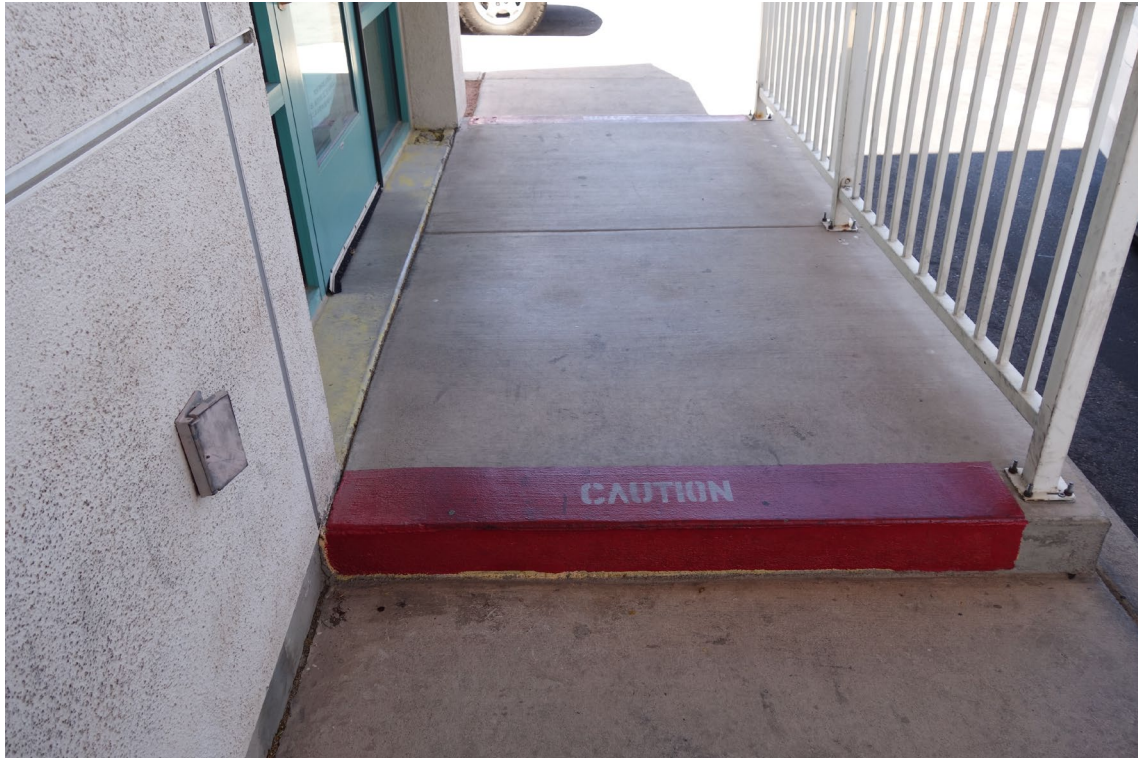
The Inspection Station is lacking an accessible entrance into the building. This project would provide for an accessible ramp to access the building. The 2018 IBC, ICC/ANSI A117.1, NRS 338.180 and the most current version of the ADA Standards for Accessible Design were used as a reference for this project.

DMV Inspection Station - Building #2170
Description: Accessible Entrance Ramp.

This project should be implemented concurrently with the EGRESS DOOR LANDING installation project.

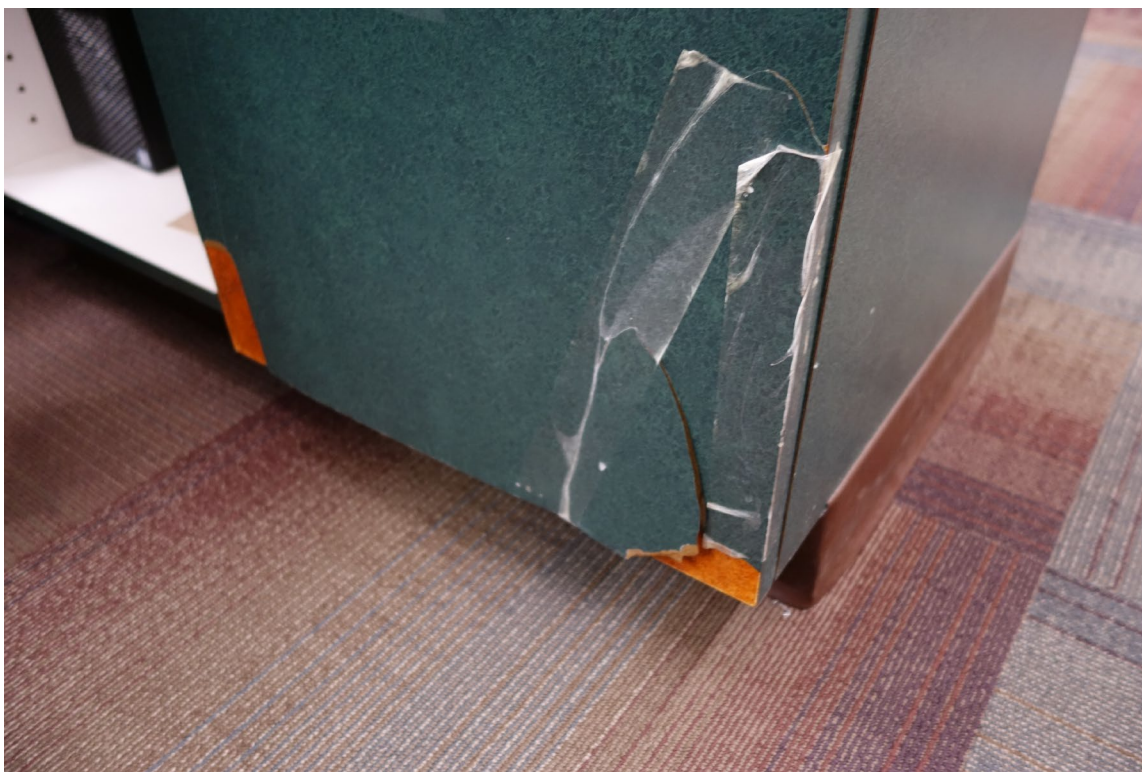
The built-in Customer Service counters and cabinetry are original to the building. The quality of construction and installation was inadequate for the high usage at this facility, and the cabinets and countertops are delaminating and failing. This project recommends the replacement of the existing countertops, cabinets, and associated equipment with heavy duty, quality components. The cabinets should be finished inside and outside with a melamine or similar finish which encapsulates the door, frame, and shelving. ADA compliance according to NRS 338.180, IBC - 2018, ICC/ANSI A117.1 and the most current version of the ADA Standards for Accessible Design should be incorporated into the design such as providing an accessible sink. 100 linear feet of casework was used for this estimate. This estimate includes removal and disposal of the existing materials.

Henderson DMV Office - Building #2000
Description: Customer Service Counters and Casework Replacement Needed.

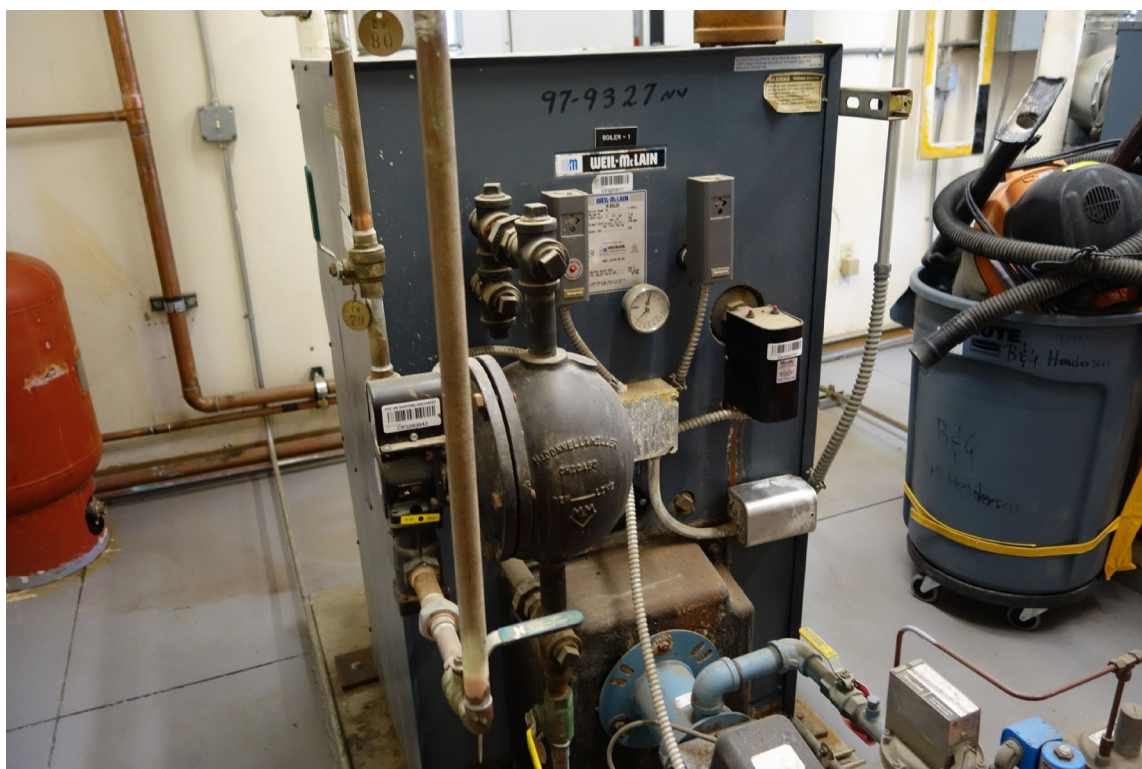
The two hot water boilers and the roof mounted evaporative cooler were installed in 1997. They are not energy efficient and will soon reach the end of their expected and useful life. This project would provide for installation of new HVAC equipment and cleaning of the existing duct work and grilles in the next 4 - 5 years. This project includes removal and disposal of the existing equipment and all required connections to utilities.

Henderson DMV Office - Building #2000
Description: Boilers Needing Replacement.
