State of Nevada
Nevada Office of Veterans Services
Southern Nevada Veterans Home
Facility Condition Analysis

SOUTHERN NEVADA VETERANS HOME

100 Veterans Memorial Drive
Boulder City, Nevada 89005

Site Number: 9889
STATE OF NEVADA PUBLIC WORKS DIVISION
FACILITY CONDITION ANALYSIS

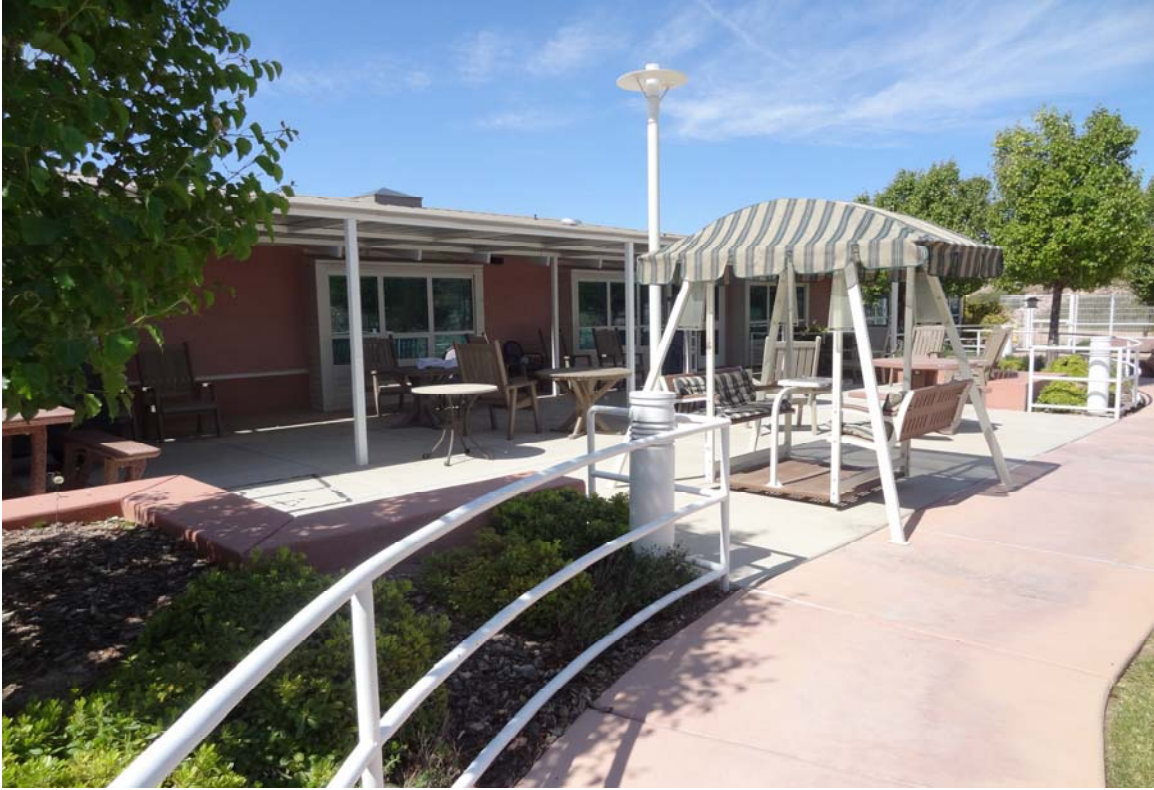
Southern Nevada Veterans Home Site - Site #9889
Description: Typical residence patio area.

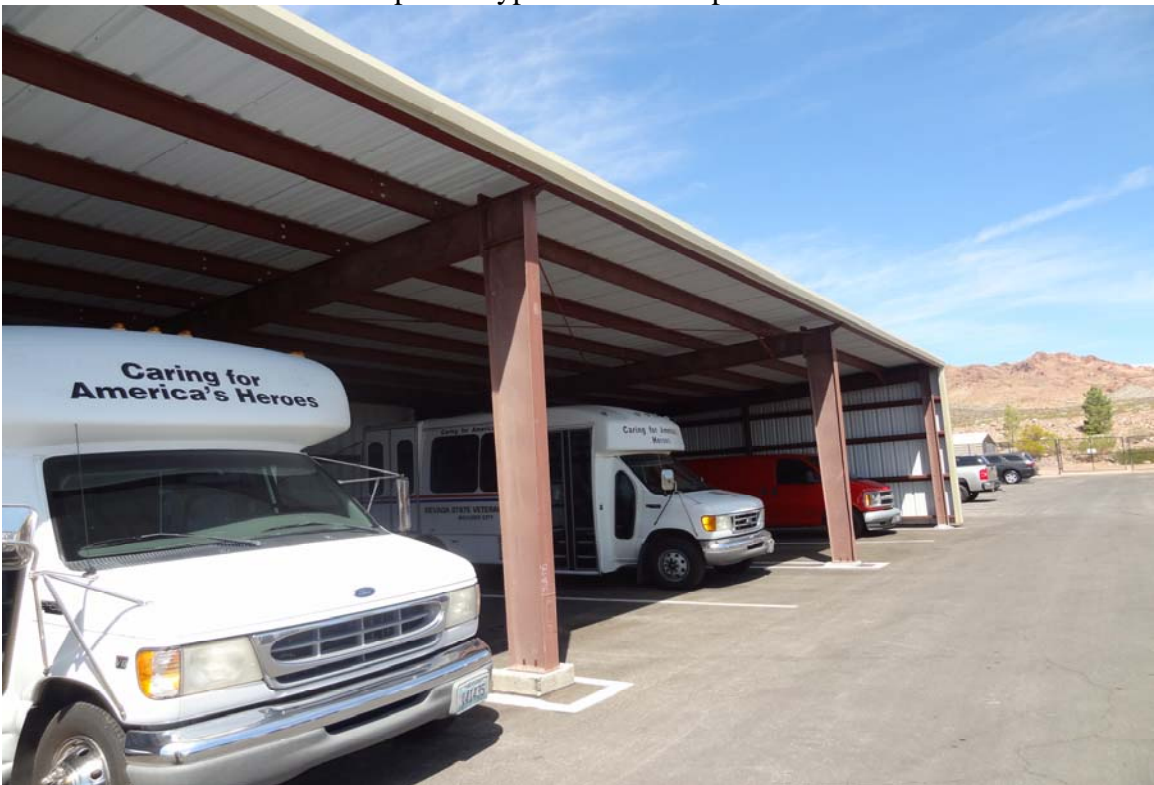
Vehicle Shade Structure - Building #3112
Description: Exterior of the structure.

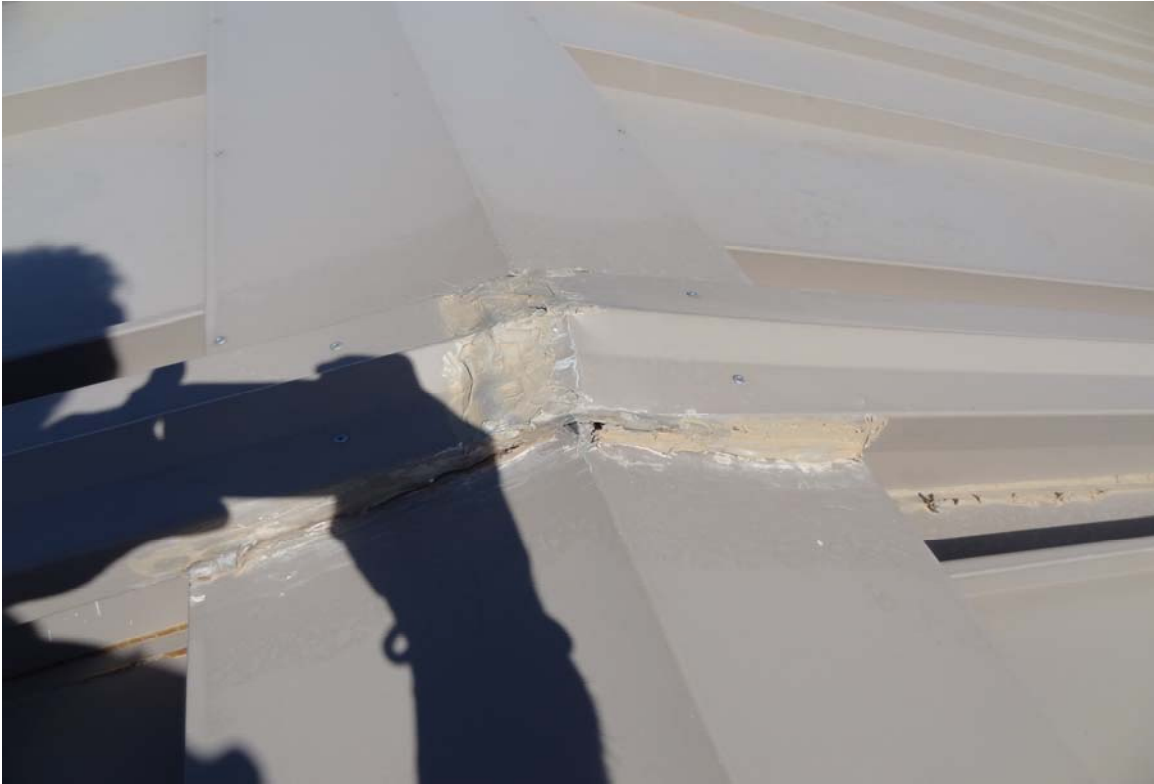
The metal roofing system has leaks in the valleys, at roof penetrations, translucent skylights and other areas where the caulking and sealant has deteriorated. This project would provide for sealing and caulking of these areas particularly the 183 boots around the pipe penetrations.

Southern Nevada Veterans Home - Building #2106
Description: Area of leaking metal roof panels.

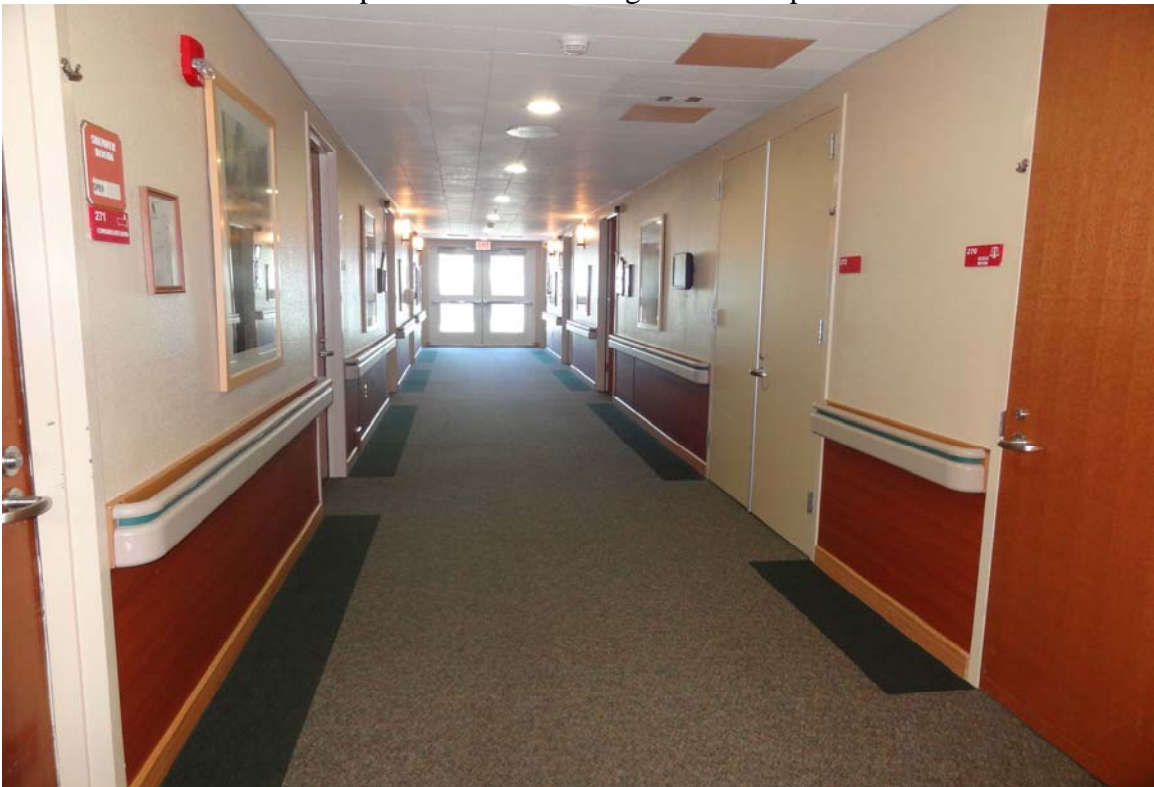
Southern Nevada Veterans Home - Building #2106
Description: Typical corridor.

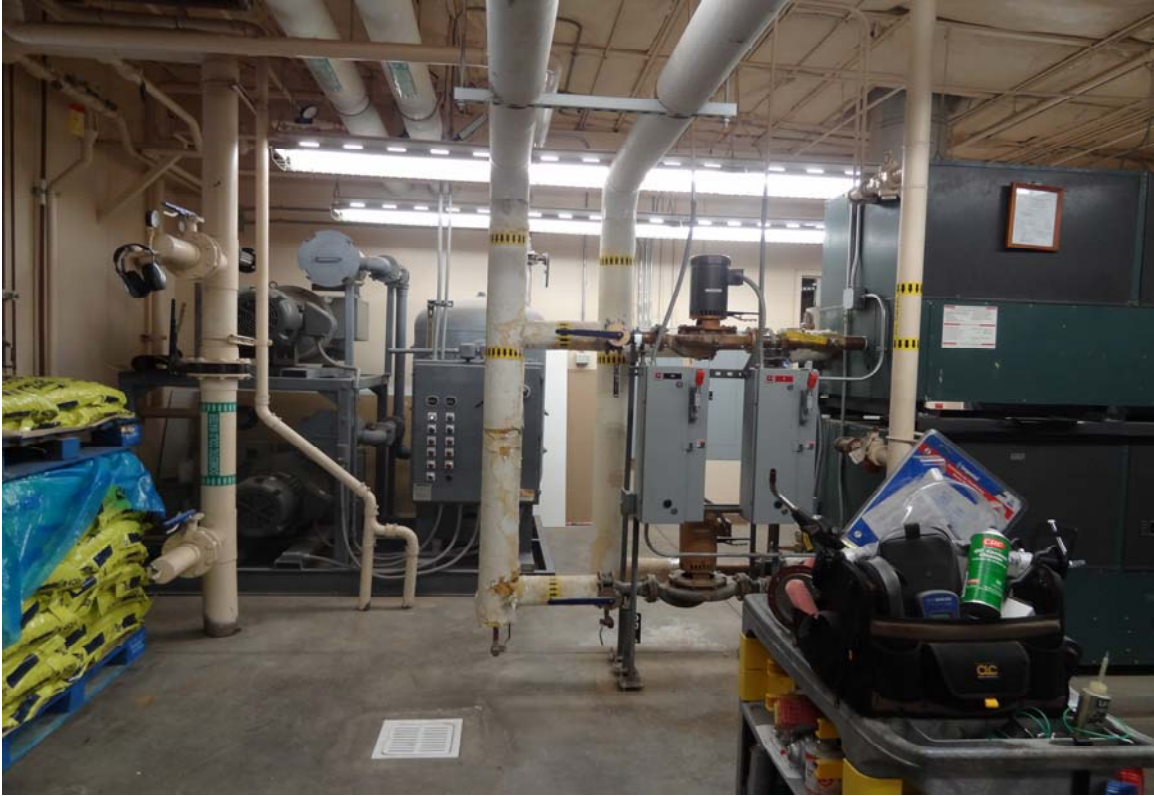
Southern Nevada Veterans Home - Building #2106
Description: View of the mechanical space.

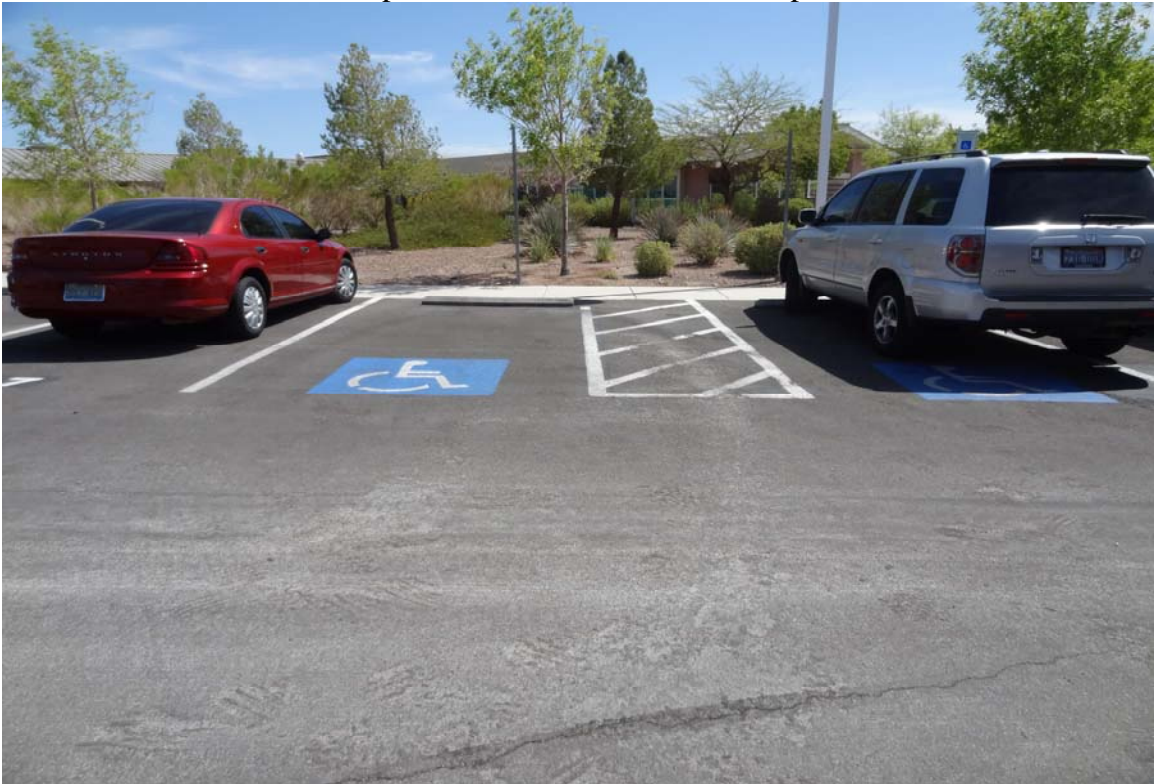
Southern Nevada Veterans Home - Building #2106
Description: ADA compliant Accessible parking.
