State of Nevada
Nevada Office of Veterans Services

SOUTHERN NEVADA VETERANS MEMORIAL CEMETERY

Site Number: 9890
STATE OF NEVADA PUBLIC WORKS DIVISION
FACILITY CONDITION ANALYSIS

Report distributed in March 2022

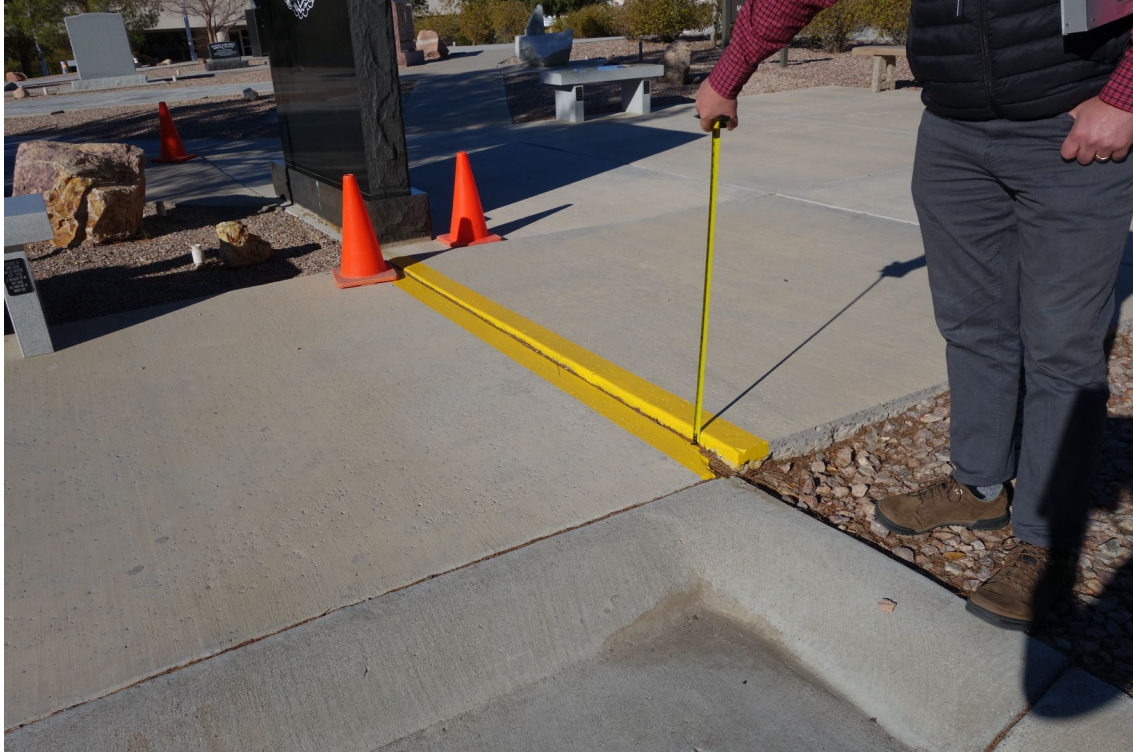
The sidewalks serving the cemetery site are deteriorated and failing. In some areas the concrete has heaved and there is settling in other locations. At one location, the tripping hazard exceeds 1 1/2" in height. This project addresses removal and replacement of existing sidewalks as needed. 1000 square feet of 4" thick concrete sidewalk was used for this estimate. NRS 338.180, IBC 2018, ICC/ANSI A117.1 and the most current version of the ADAAG were used as a reference for this project.

Southern Nevada Veterans Memorial Cemetery Site – FCA Site #9890
Description: Sidewalk Replacement Needed.

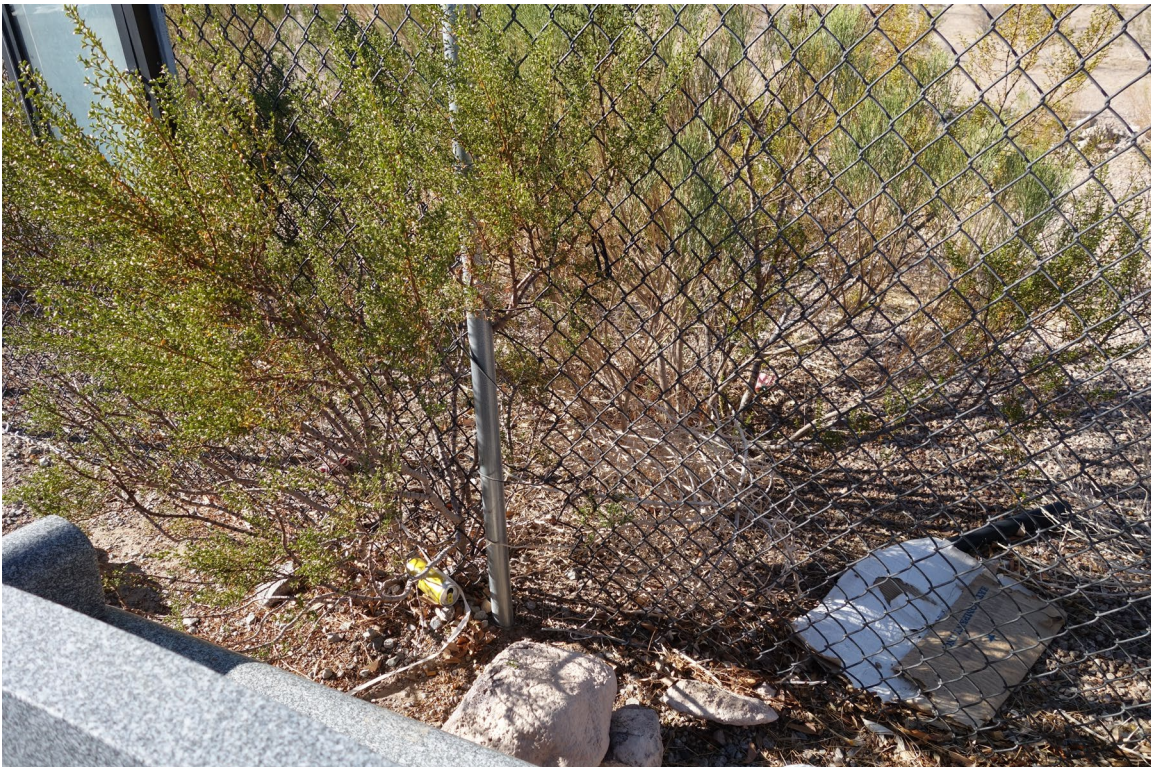
Southern Nevada Veterans Memorial Cemetery Site – FCA Site #9890
Description: Perimeter Fence Damaged During Theft Event.

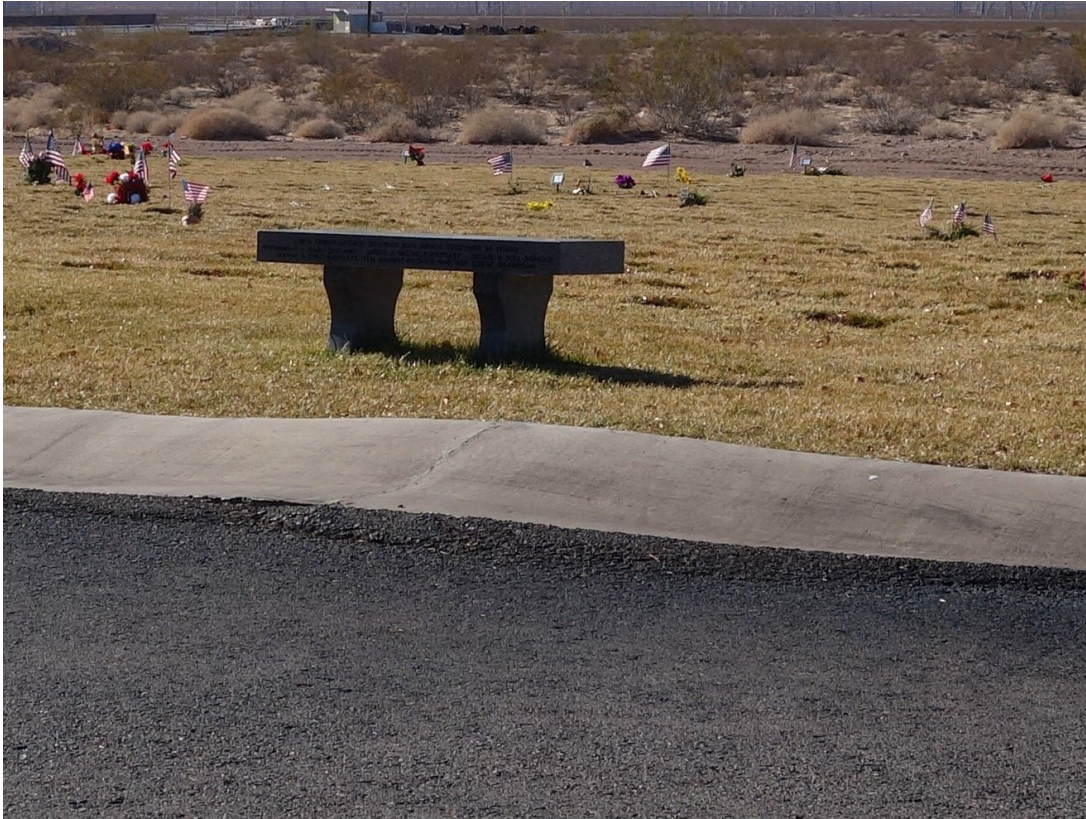
There are several areas of asphalt paving that are damaged and in need of repairs. The asphalt is rolling up on itself as cars push it against the curb creating a thick mass of extra asphalt on the edge of the road. The cause of the problem may be a poor asphalt mix or too much asphalt placed in these areas. This project would provide for removing and replacing the damaged areas of asphalt. Disposal of the existing asphalt is included in this estimate.

Southern Nevada Veterans Memorial Cemetery Site – FCA Site #9890
Description: Asphalt Paving Repairs.

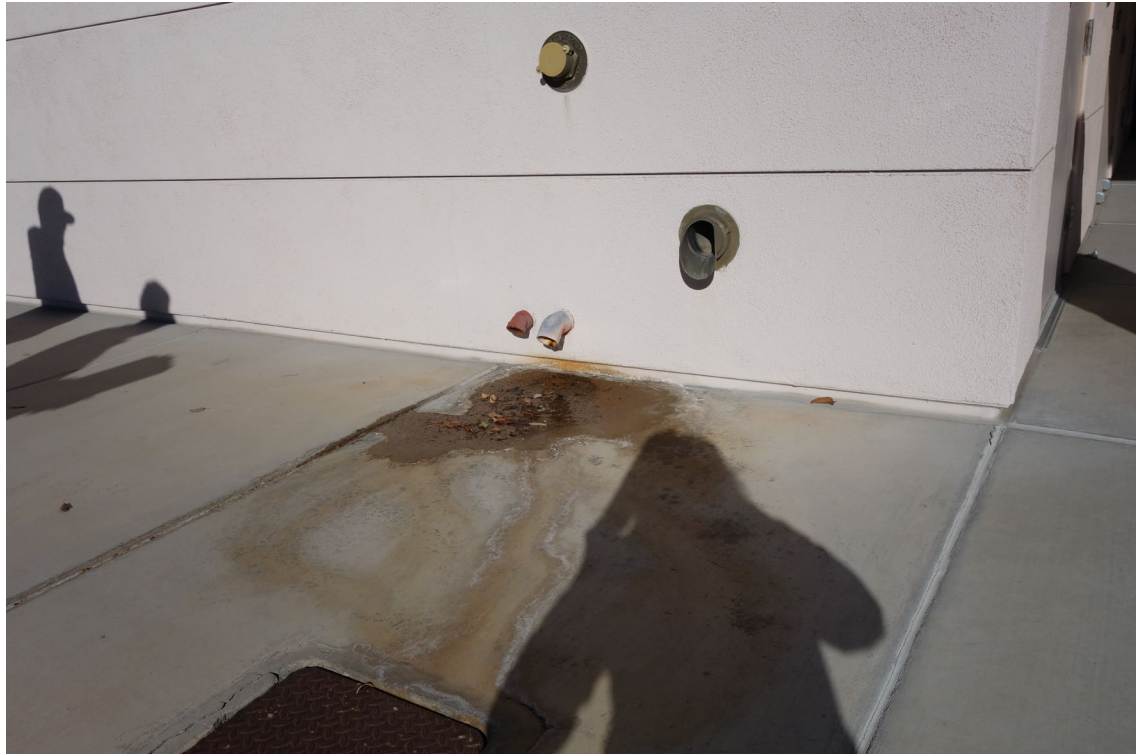
The building roof drain and the fire sprinkler system drain on the south side of the building both discharge directly on the sidewalk. The water sheet flows across the sidewalk and drops into a below grade valve access vault causing the vault to fill with water. This project recommends installing a catch basin at the discharge to capture the water and direct it to the storm drain approximately 30 feet away. This project includes saw cutting the sidewalk, trenching and installation of a small storm water lateral to the new catch basin. Restoration of the sidewalk and landscaping are included in this project.

Administration Building – FCA Building #3147
Description: Drainage Modifications Needed.

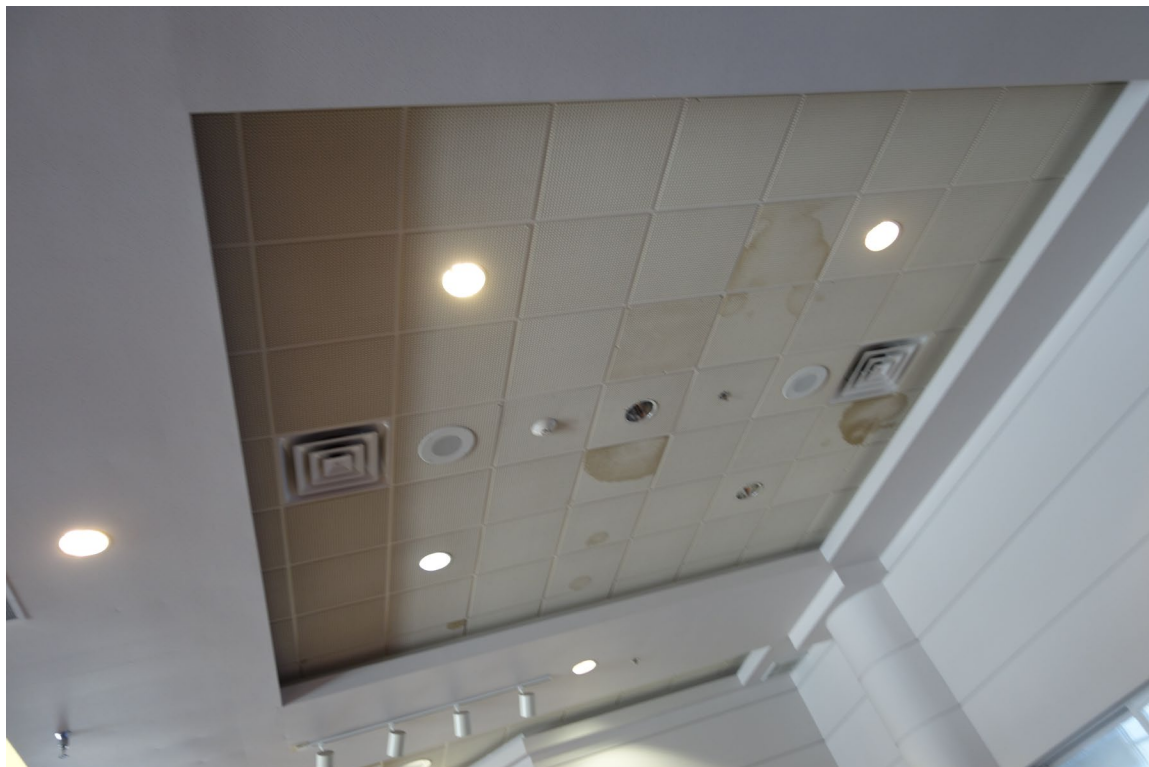
The ceiling in the building is mostly covered with a suspended ceiling system. The ceiling tiles in the system are damaged and stained and some are coming loose from the substrate. This project would provide for the replacement of the ceiling tiles. Removal and disposal of the existing tiles is included in this estimate. This project or a portion thereof was previously recommended in the FCA report dated 06/09/2005 and 04/12/2012. It has been amended accordingly to reflect conditions observed during the most recent survey date of 01/26/2022.

Chapel – FCA Building #2105
Description: Ceiling Tile Replacement Needed.

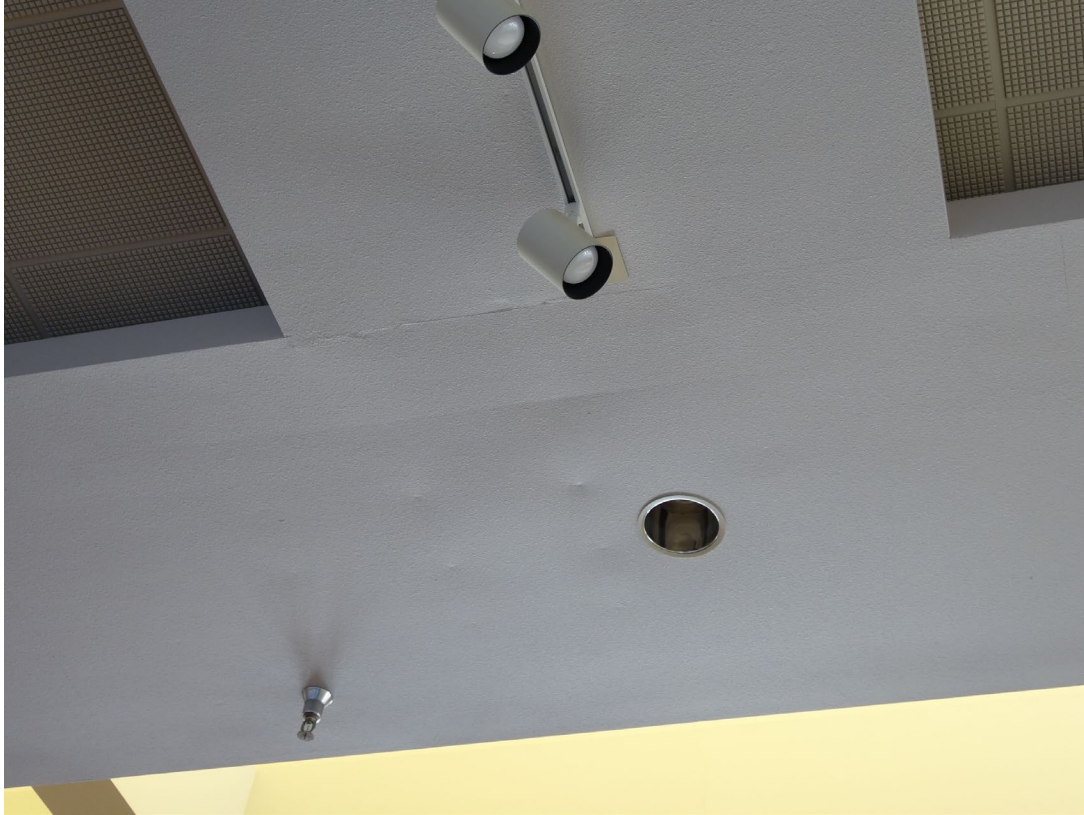
Past water leaks and moisture intrusion have damaged the gypsum board interior ceiling soffits on the north side of the Chapel and the wall above the east entry doors. This project recommends removing and replacing the damaged drywall, refinish and paint. This project should be implemented concurrently with the Interior Finishes project.

Chapel – FCA Building #2105
Description: Gypsum Board Repairs Needed.

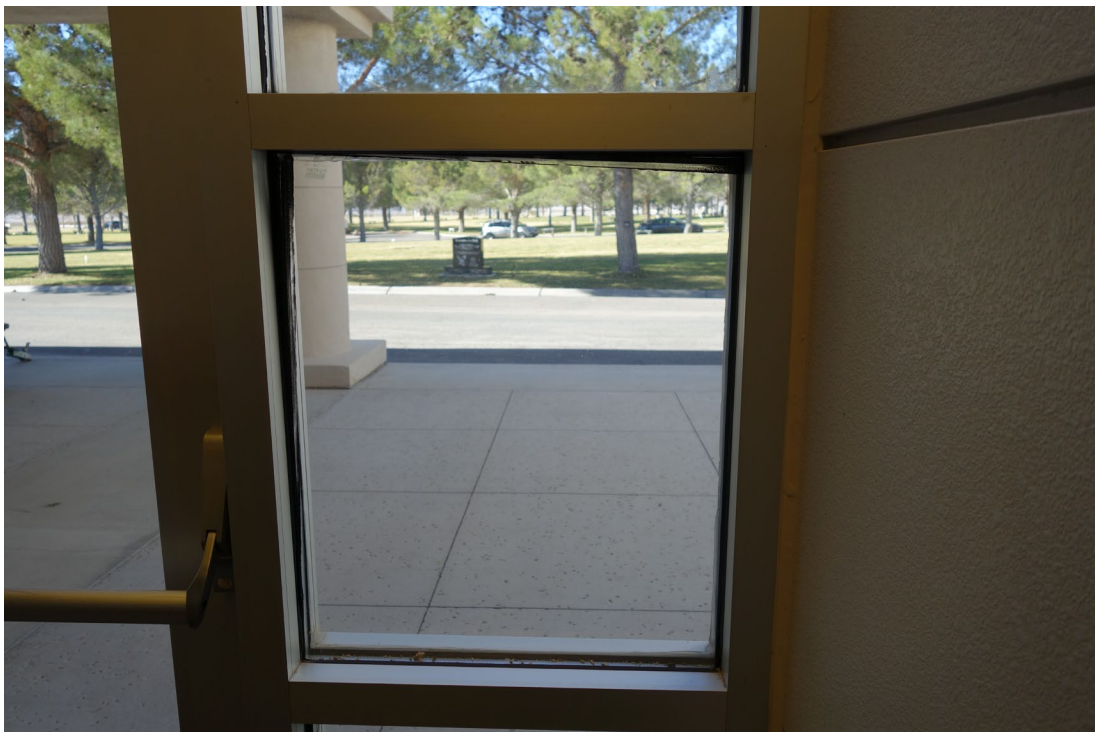
The aluminum storefront window and door framing is in poor condition. Window panes are dropping in the frames and there are locations of water intrusion above the entry doors on the east side of the building. The storefront system requires repairs and some windows and all of the exterior doors need replacement. This project will provide funding to repair the storefront system, replace windows as needed and replace the exterior storefront door systems.

Chapel – FCA Building #2105
Description: Storefront Glazing System Repairs Needed.
