State of Nevada
Nevada Office of Veterans Services
Southern Nevada Veterans Memorial Cemetery
Facility Condition Analysis

SOUTHERN NEVADA VETERANS MEMORIAL CEMETERY

Site Number: 9890
STATE OF NEVADA PUBLIC WORKS DIVISION
FACILITY CONDITION ANALYSIS

Report Printed in December 2012

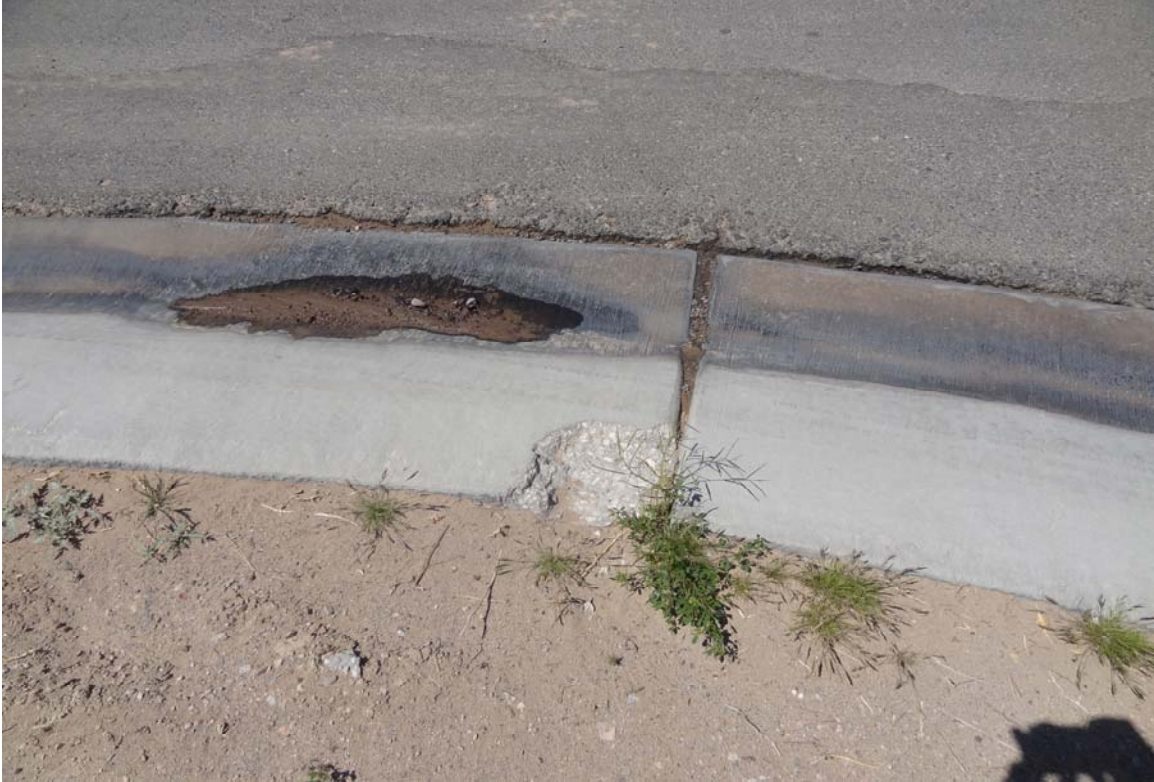
There are several areas of asphalt paving that are damaged and in need of repairs. The asphalt is rolling up on itself as cars push it against the curb creating a thick mass of extra asphalt on the edge of the road. The cause of the problem may be a poor asphalt mix or too much asphalt placed in these areas. This project would provide for removing and replacing the damaged areas of asphalt. Disposal of the existing asphalt is included in this estimate.

Southern Nevada Veterans Memorial Cemetery Site – FCA Site #9890
Description: Damaged roll curb and A. C. paving.

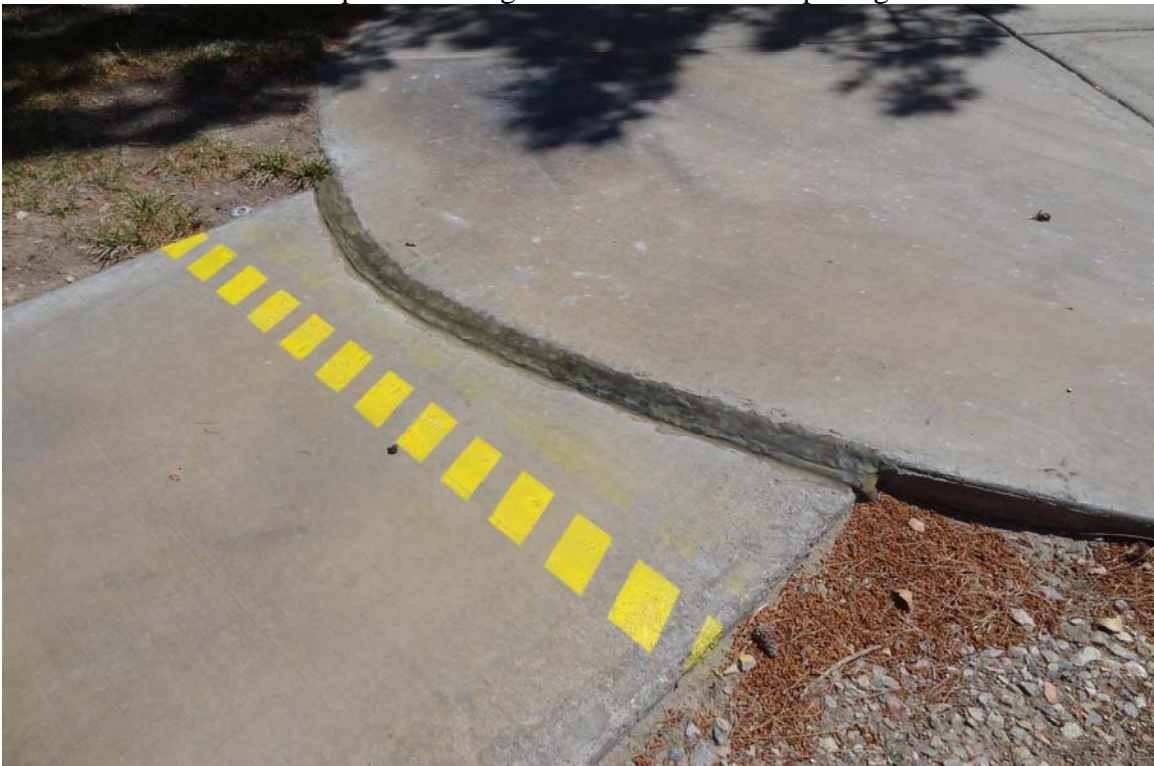
Southern Nevada Veterans Memorial Cemetery Site – FCA Site #9890
Description: Concrete step in need of grinding.

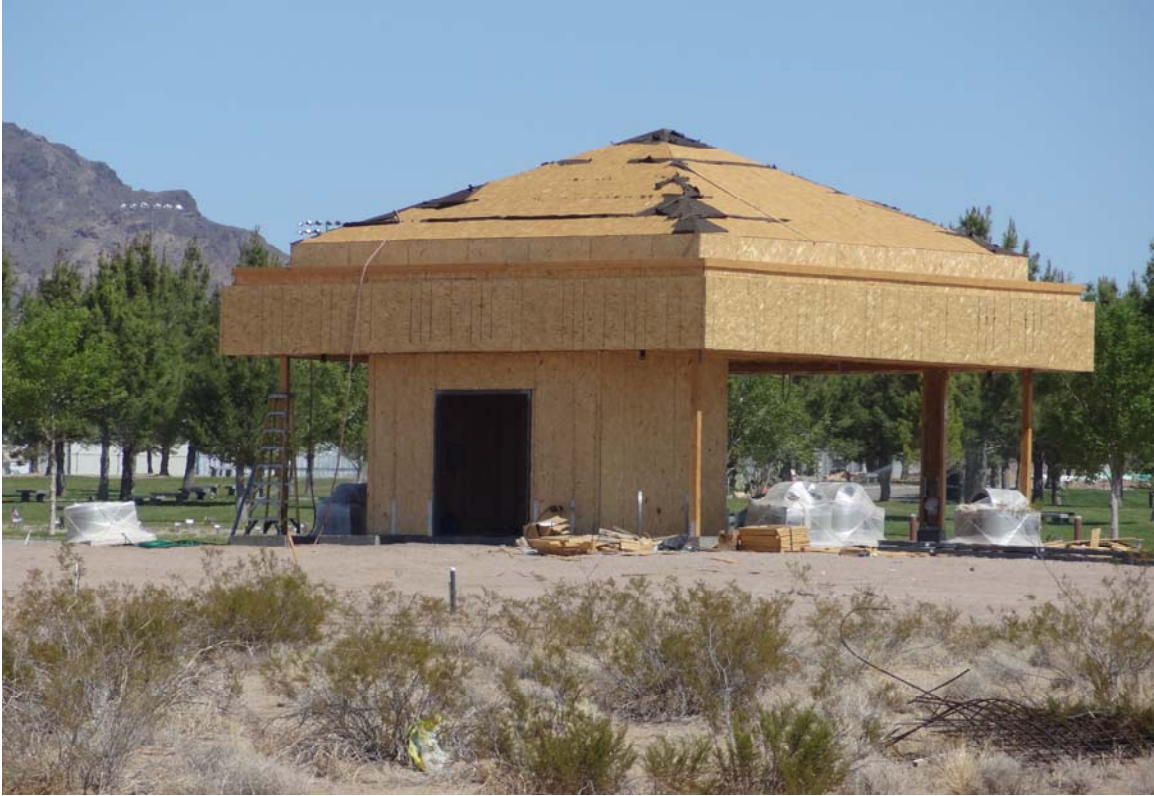
Outdoor Committal Building – FCA Building #3150
Description: Under construction.

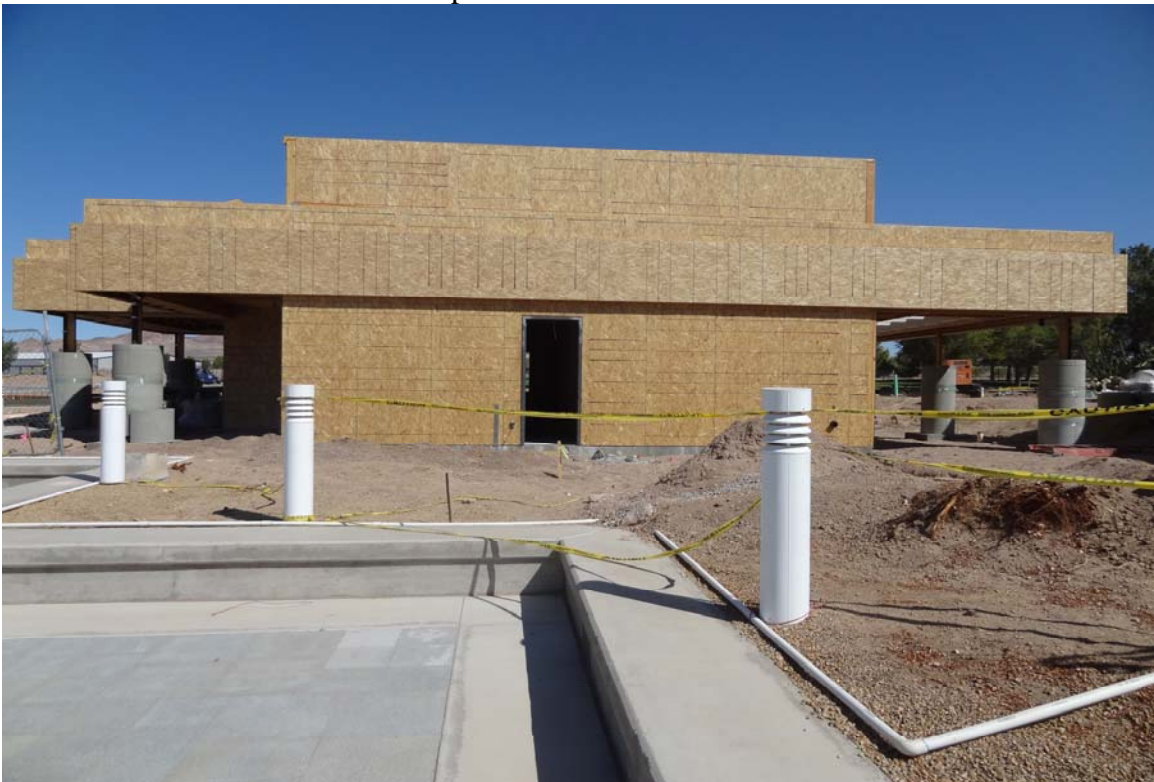
Administration Building – FCA Building #3147
Description: Under construction.

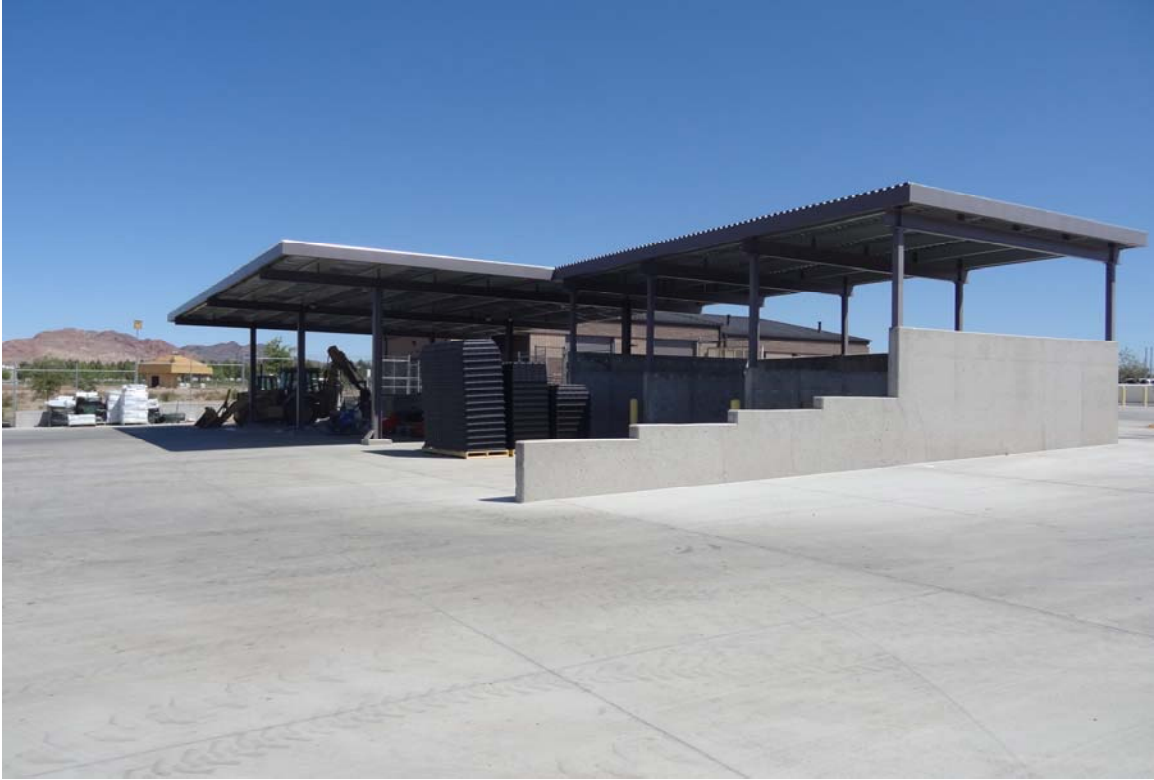
Open Metal Canopy – FCA Building #2998
Description: Exterior of the structure.

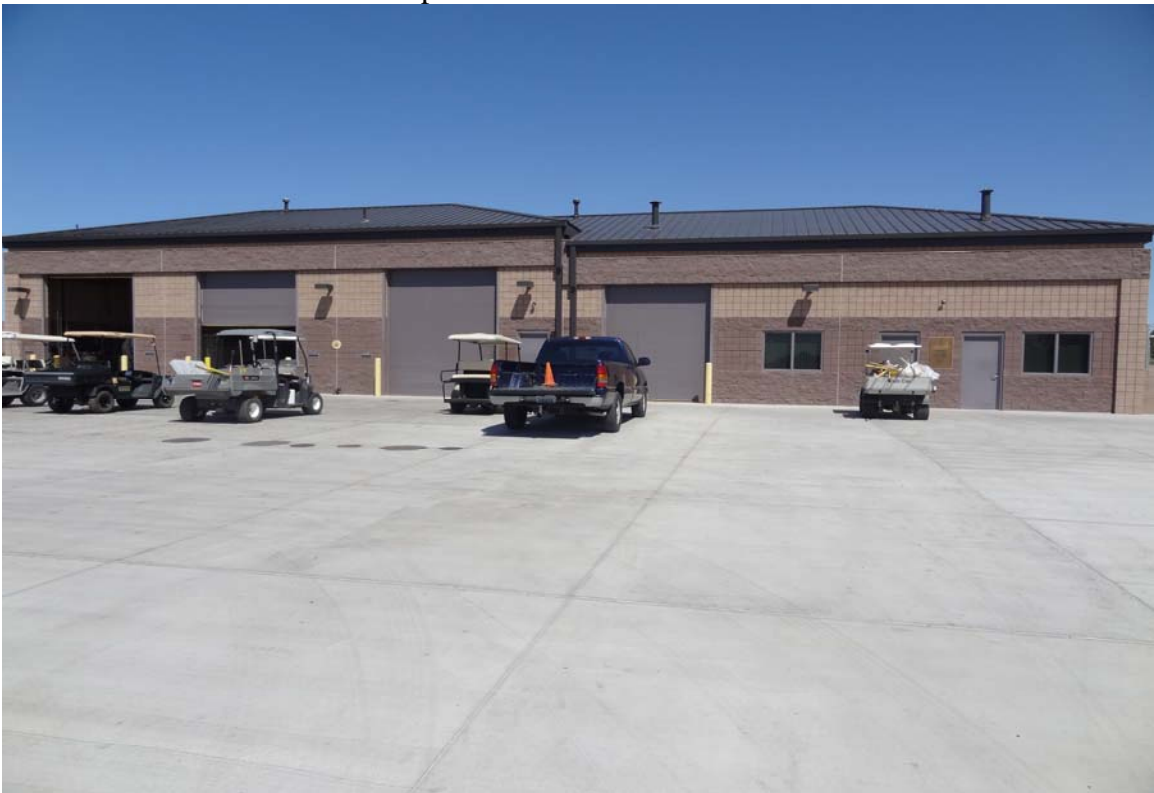
Maintenance / Office Building – FCA Building #2997
Description: Exterior of the building.

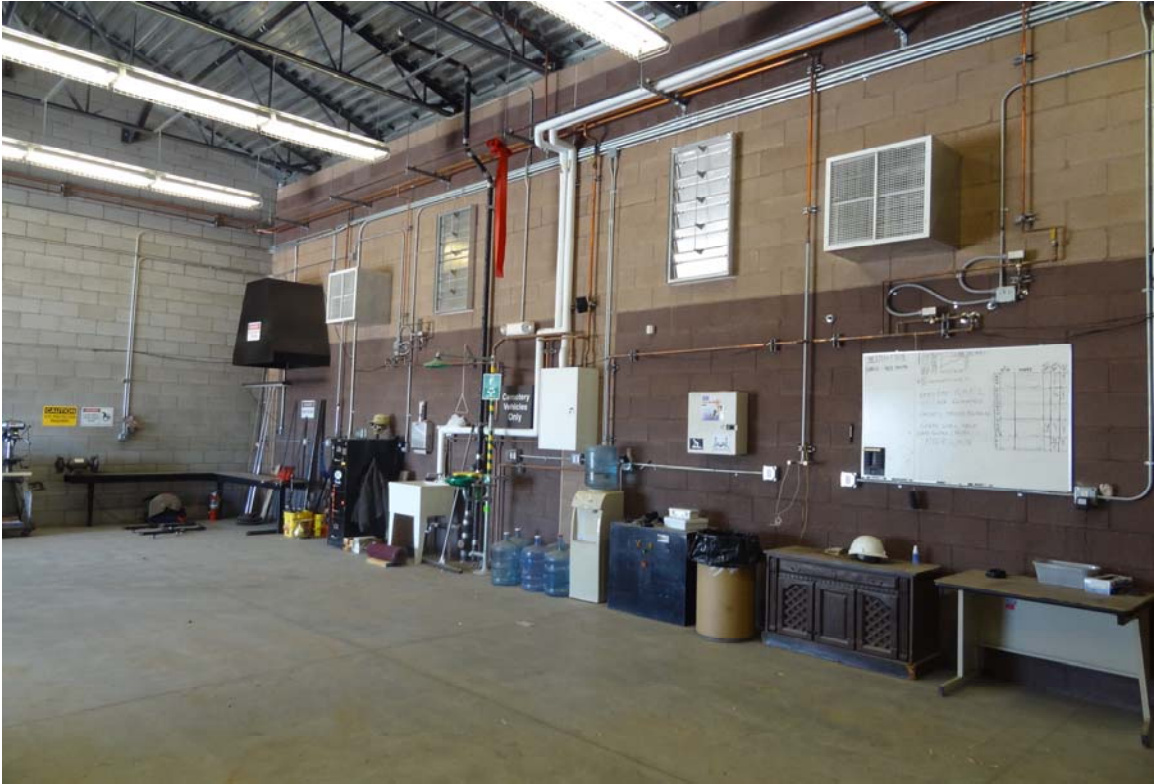
Maintenance / Office Building – FCA Building #2997
Description: Interior of the building.

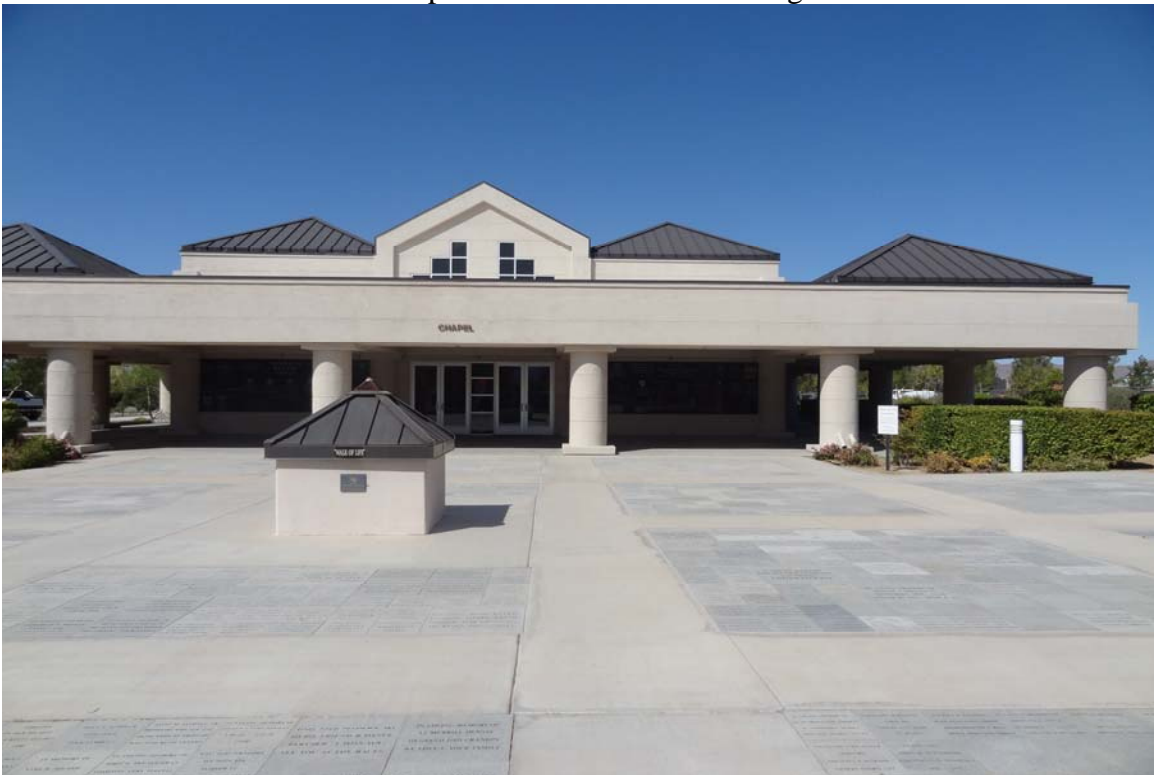
Chapel – FCA Building #2105
Description: Exterior of the building.
