NEVADA NATIONAL GUARD CARSON CITY SITE

2460 Fairview Drive
Carson City, Nevada 89701

Site Number: 9891
STATE OF NEVADA PUBLIC WORKS DIVISION
FACILITY CONDITION ANALYSIS

Report distributed in January 2022

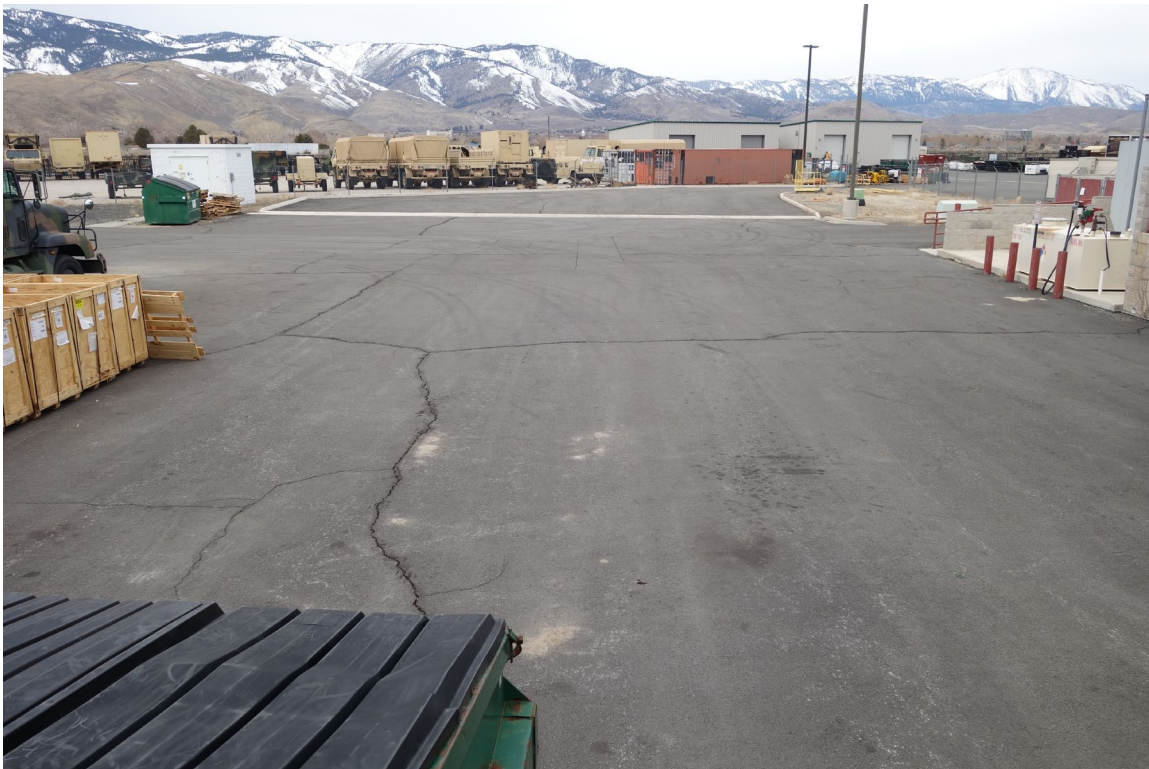
Nevada National Guard Carson City Site - Site #9891
Description: Site Paving Patch, Crack Fill & Slurry Seal Needed.

It is important to maintain the asphalt concrete paving on the site. This project would provide for minor replacement of deteriorated paving, minor crack filling and slurry sealing of the paving site wide. Striping is included in this estimate. This project should be scheduled on a 5 year cyclical basis to maintain the integrity of the paving and prevent premature failure. 130,000 square feet of asphalt area was used to generate this estimate.

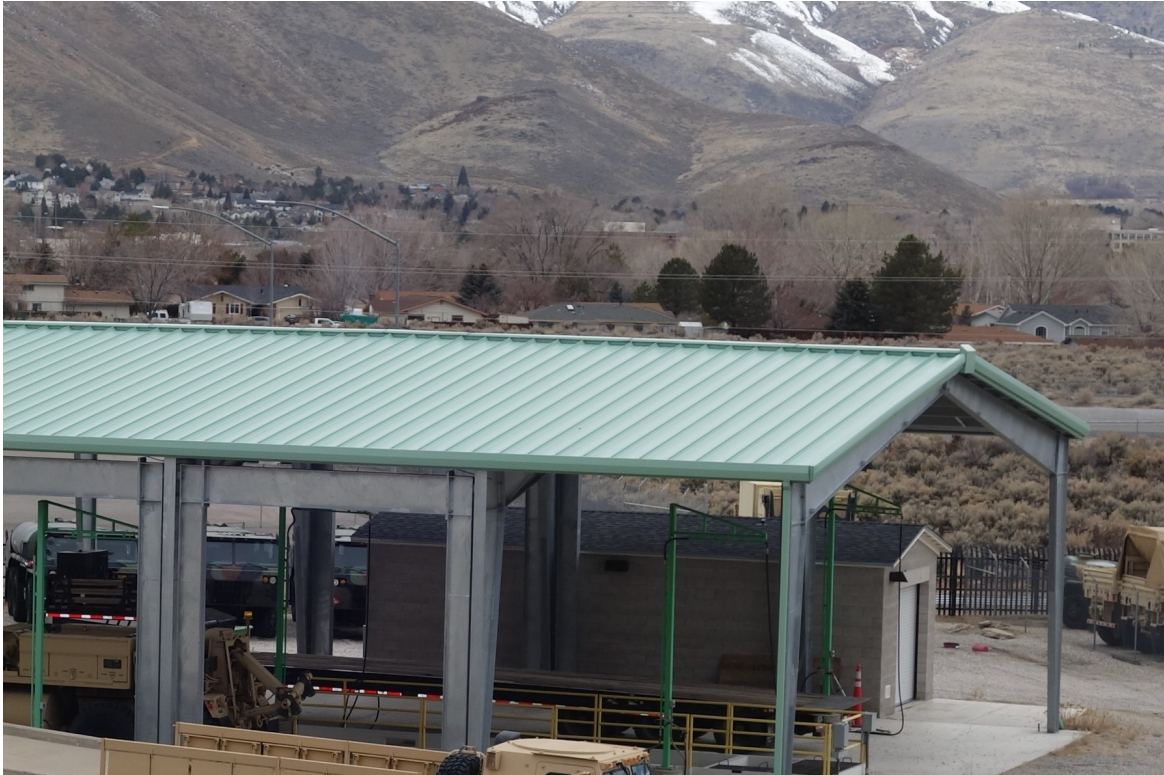
The exterior finishes were in good condition. It is important to maintain the finish, weather resistance and appearance of the building. This project would provide funding to protect the exterior of the building excluding the roof. Included in the cost are cleaning and sealing the concrete masonry units and caulking the flashing, fixtures and all other penetrations. It is recommended that the building be sealed and caulked in the next 7 - 9 years and that this project be scheduled on a cyclical basis to maintain the integrity of the structure.

Wash Station Support Building - Building #4169
Description: Exterior of the Building.

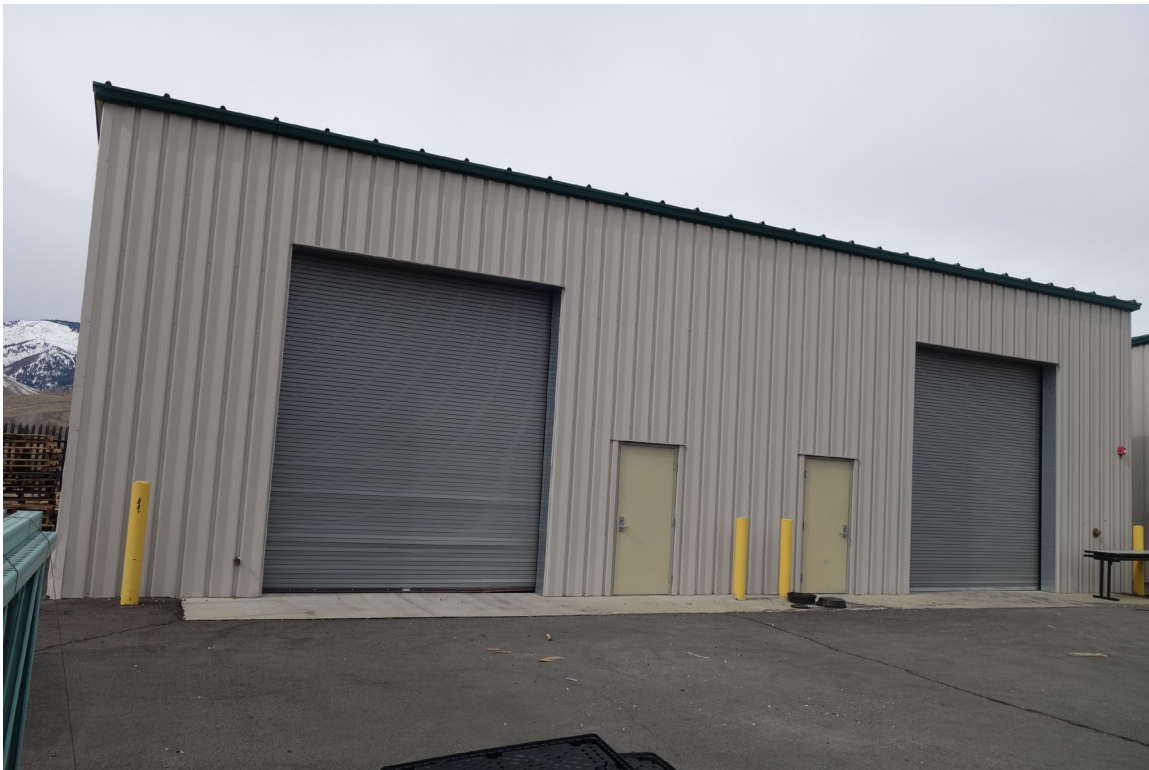
The exterior finishes were in good condition. It is important to maintain the finish, weather resistance and appearance of the building. This project would provide funding to protect the exterior of the building excluding the roof. Included in the cost is caulking and sealing flashings, fixtures and all other penetrations. It is recommended that the building be caulked and sealed in the next 7 - 9 years and that this project be scheduled on a cyclical basis to maintain the integrity of the structure.

USPFO South – Warehouse #1 - Building #3646
Description: Exterior of the Building.

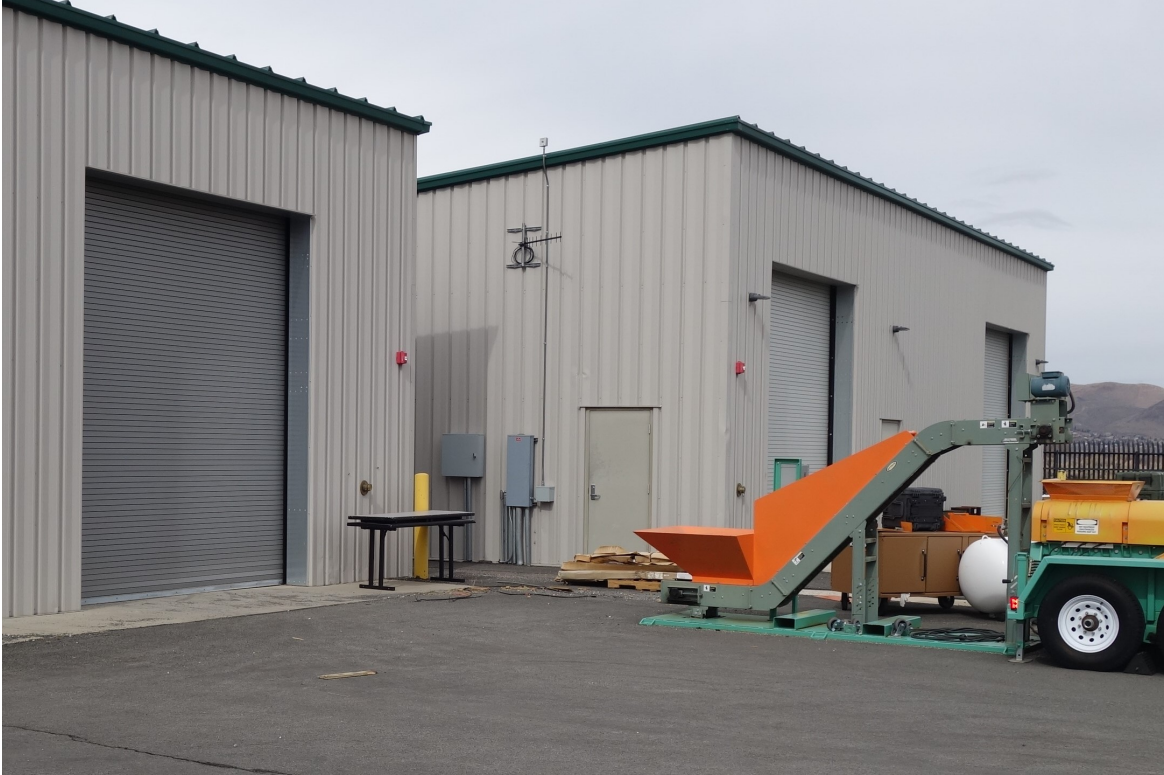
The exterior finishes were in good condition. It is important to maintain the finish, weather resistance and appearance of the building. This project would provide funding to protect the exterior of the building excluding the roof. Included in the cost is caulking and sealing the flashing, fixtures and all other penetrations. It is recommended that the building be caulked and sealed in the next 7 - 9 years and that this project be scheduled on a cyclical basis to maintain the integrity of the structure.

USPFO North – Warehouse #2 - Building #3645
Description: Exterior of the Building.

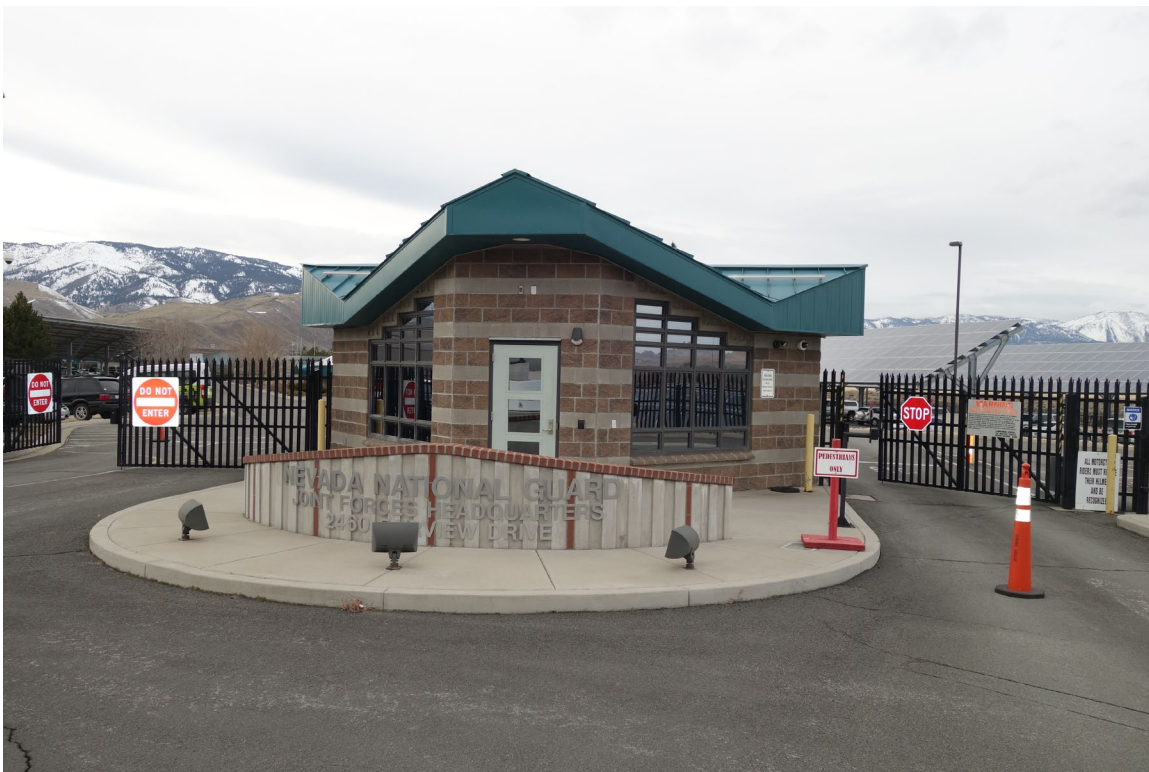
The exterior finishes were in good condition. It is important to maintain the finish, weather resistance, and appearance of the building. This project would provide funding to protect the exterior of the building excluding the roof. Included in the cost are cleaning and sealing the concrete masonry units (CMU) walls and caulking the windows, flashing, fixtures and all other penetrations. It is recommended that the building be sealed and caulked in the next 7 - 9 years and that this project be scheduled on a cyclical basis to maintain the integrity of the structure.

Entrance Guard Station - Building #2987
Description: Exterior of the Building.

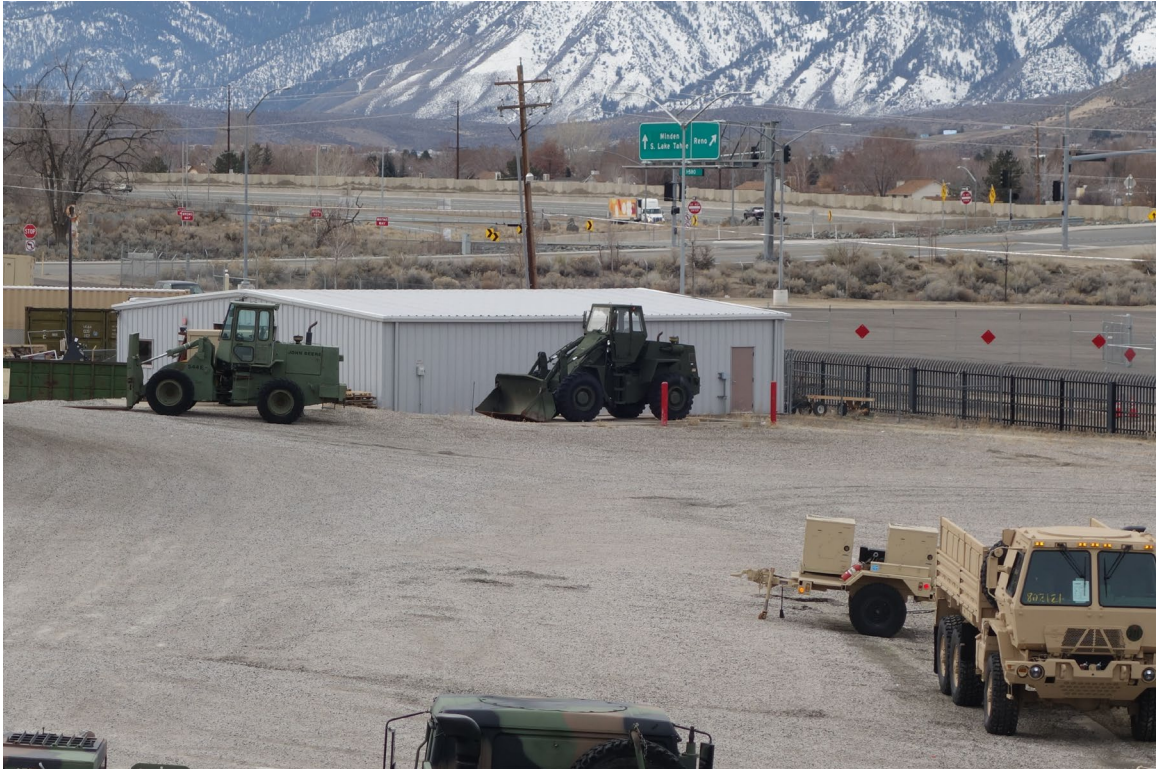
The exterior finishes were in fair condition. It is important to maintain the finish, weather resistance, and appearance of the building. This project would provide funding to protect the exterior of the building excluding the roof. Included in the cost is the caulking and sealing the flashing, fixtures and all other penetrations. It is recommended that the building be caulked and sealed in the next 4 - 6 years and that this project be scheduled on a cyclical basis to maintain the integrity of the structure.

Storage Building - Building #2523
Description: Exterior of the Building.

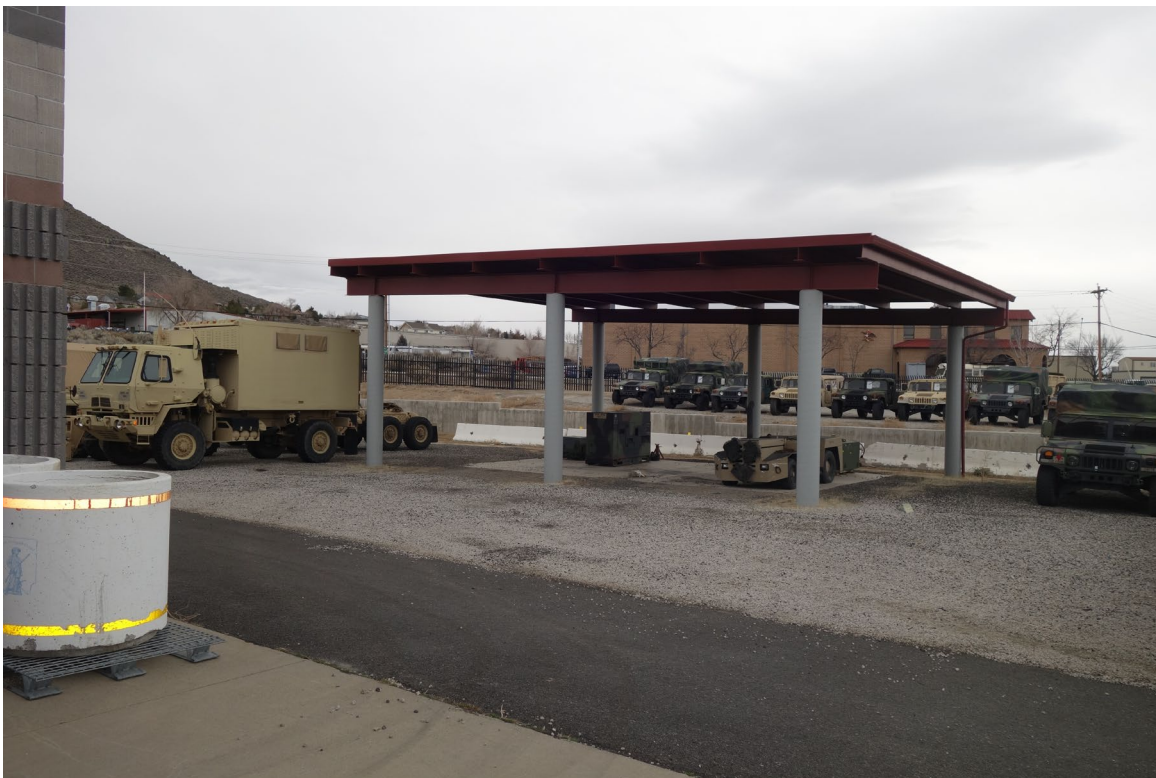
The exterior finishes were in good condition. It is important to maintain the finish, weather resistance, and appearance of the structure. This project would provide for painting of the metal and sealing the concrete and it is recommended that this project be scheduled on a cyclical basis to maintain the integrity of the structure.

Vehicle Ramada #1 - Building #2521
Description: Exterior of the Structure.

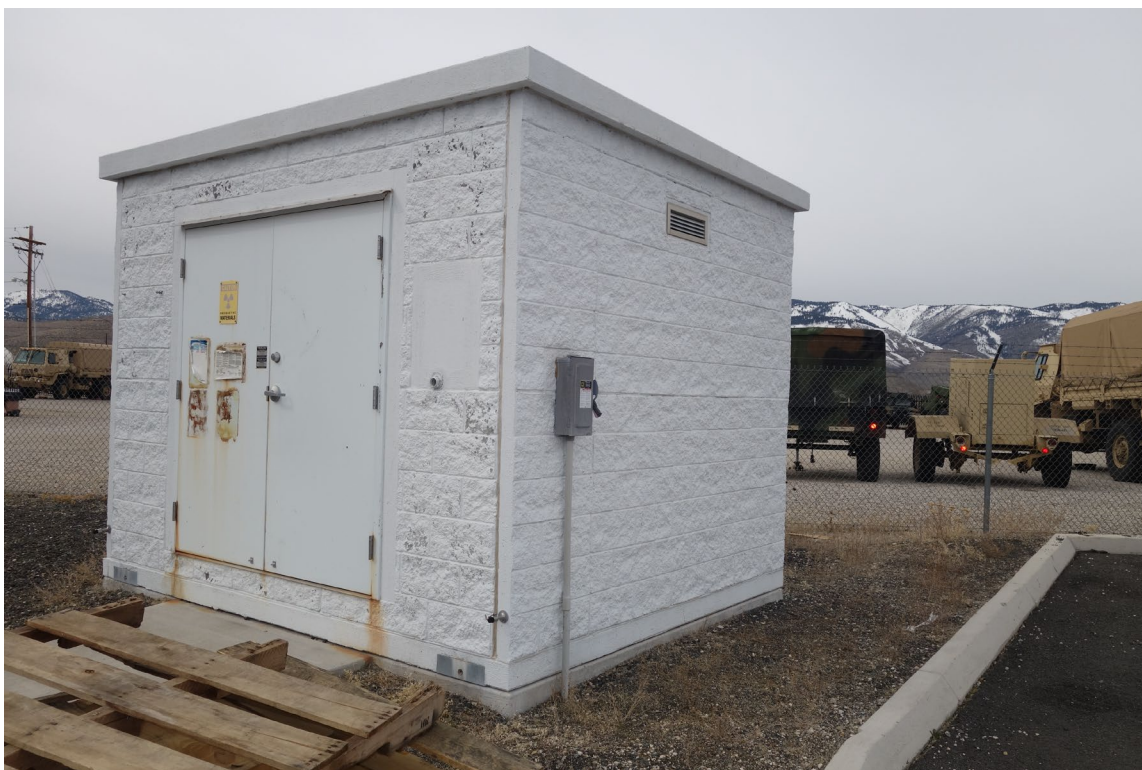
The exterior finishes were in poor condition. It is important to maintain the finish, weather resistance, and appearance of the building. This project would provide funding to protect the exterior of the building excluding the roof. Included in the cost is the caulking and sealing of the flashing, fixtures and all other penetrations. It is recommended that the building be caulked and sealed in the next 2 - 3 years and that this project be scheduled on a cyclical basis to maintain the integrity of the structure.

Haz Material Storage #4 - Building #2520
Description: Exterior of the Building.

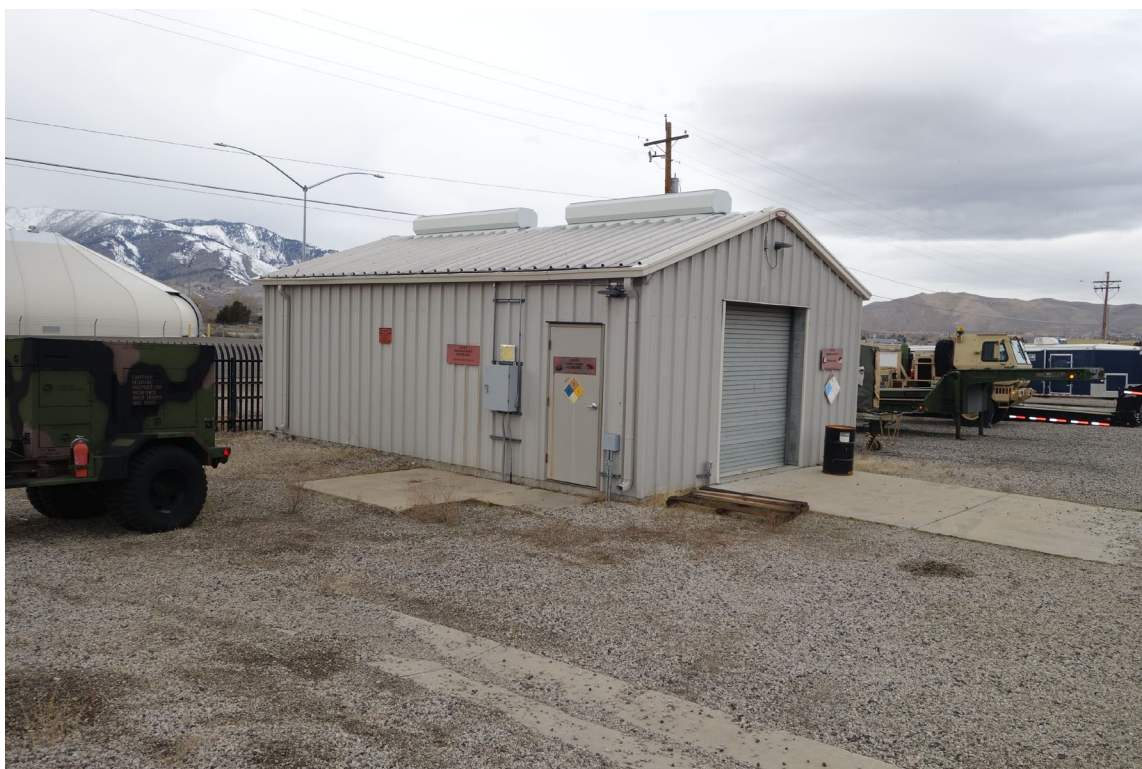
It is important to maintain the finish, weather resistance, and appearance of the building. This project would provide funding to protect the exterior of the building excluding the roof. Included in the cost is painting the concrete walls and caulking of the flashing, fixtures and all other penetrations. It is recommended that the building be painted and caulked in the next 5-7 years and that this project be scheduled on a cyclical basis to maintain the integrity of the structure.

Haz Mat Storage #3 - Building #2518
Description: Exterior of the Building.

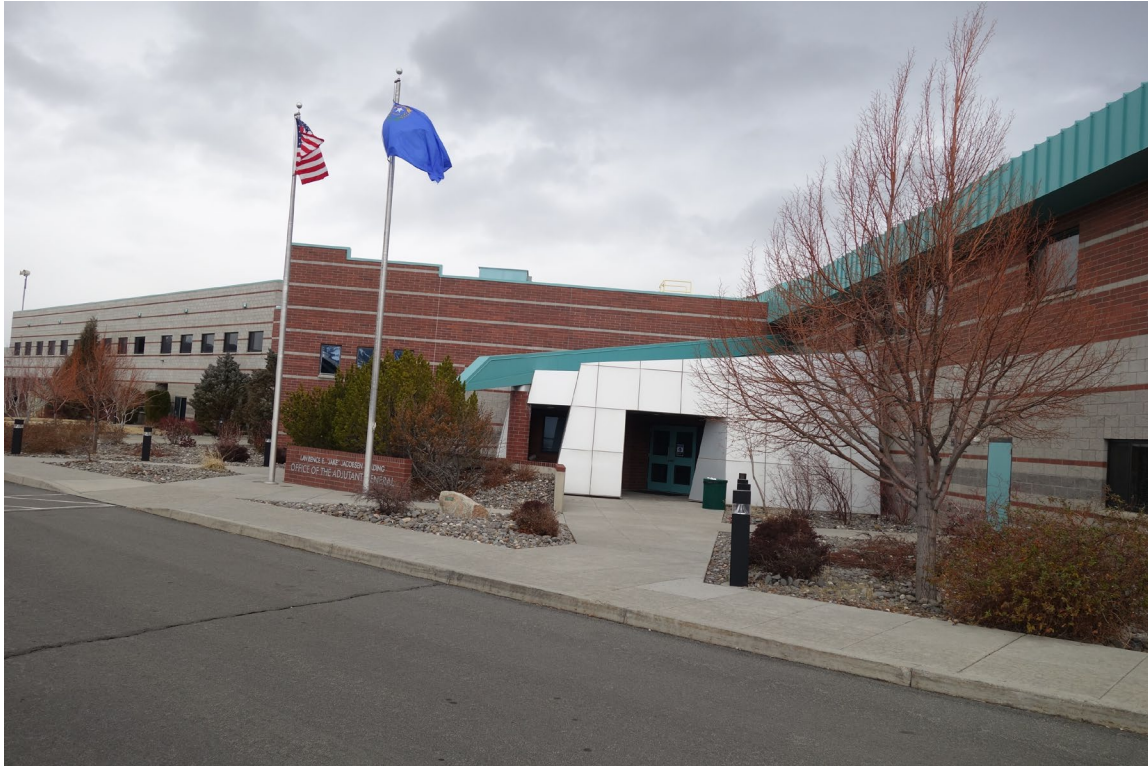
The exterior finishes were in fair condition. It is important to maintain the finish, weather resistance, and appearance of the building. This project would provide funding to protect the exterior of the building excluding the roof. Included in the cost are cleaning and sealing the concrete and brick masonry and caulking of the windows, flashing, fixtures and all other penetrations. It is recommended that the building be sealed and caulked in the next 4 - 6 years and that this project be scheduled on a cyclical basis to maintain the integrity of the structure.

OTAG BLDG / Lawrence E. Jacobsen Center - Building #2199
Description: Exterior of the Building.

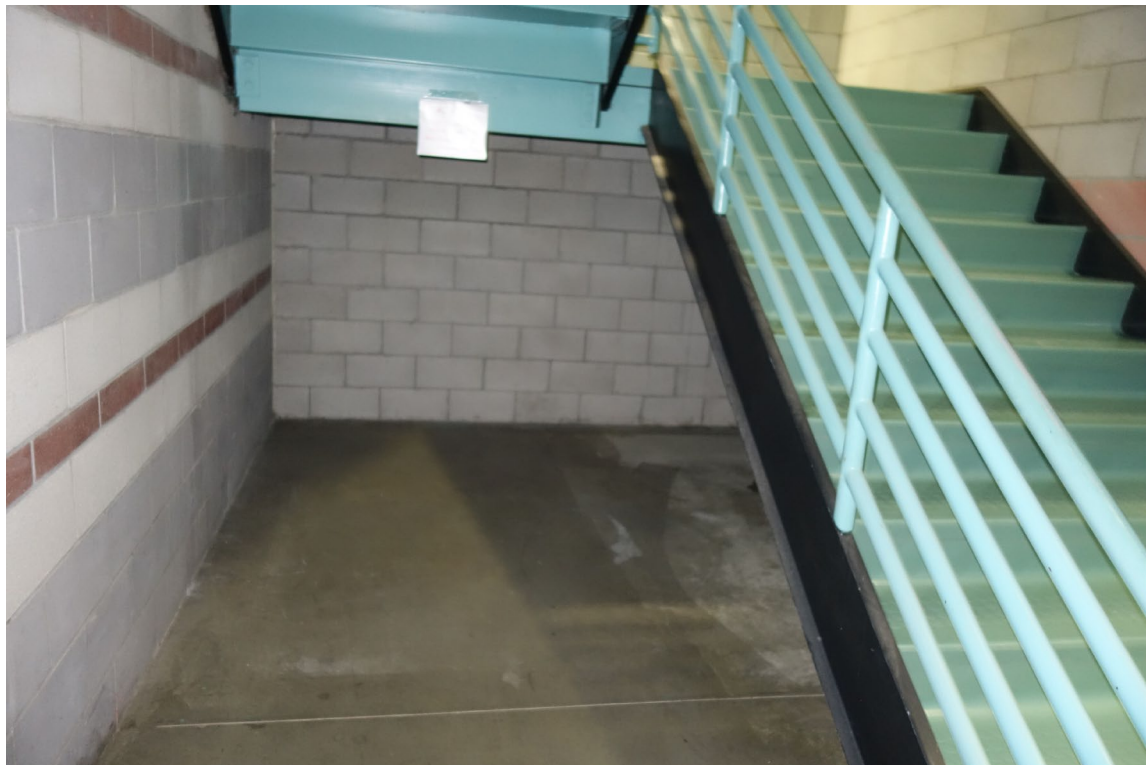
The stairwell in the east corridor does not have 80" of clear head room under the stairs. This project recommends the installation of a permanent barrier under the stairs to warn blind or visually impaired persons of the low head room. NRS 338.180, IBC - 2018 Section 1012 and ADAAG 4.4.2 were referenced for this project.

OTAG BLDG / Lawrence E. Jacobsen Center - Building #2199
Description: ADA Cane Detection Barrier Needed.

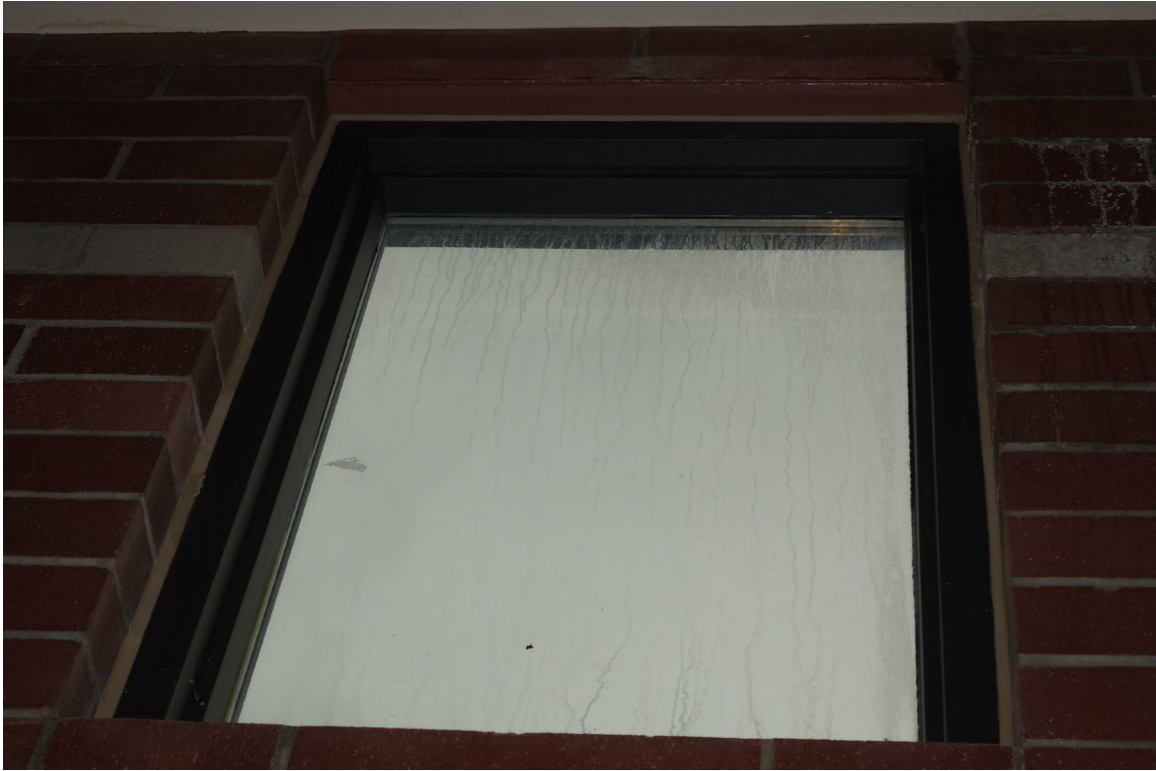
There are several windows around the building that are due for repair or replacement. Two windows have a broken seal and moisture has penetrated between the panes. These will need to be replaced. There may be additional windows throughout the building with the same problem. Also, several windows are showing signs of leaks around the frames and should be repaired to maintain a water proof building envelope. These windows were observed in the fitness room. This project would provide funding to repair or replace windows as needed.

OTAG BLDG / Lawrence E. Jacobsen Center - Building #2199
Description: Window Repair / Replacement Needed.

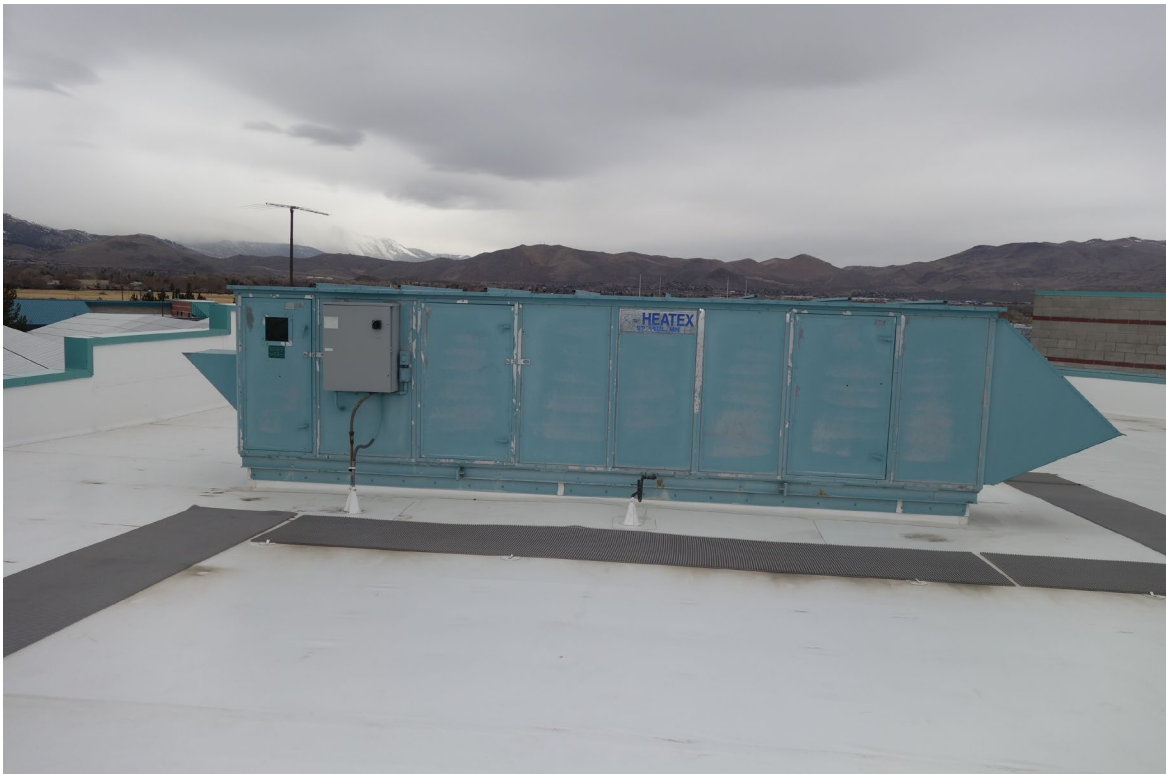
The HVAC equipment in the building is approximately 18 years old and nearing the end of its life. The R-22 refrigerant in the cooling system is no longer EPA compliant and its production is mandated to be phased out completely by January 1, 2020. Temperature stratification has been observed in the Drill Hall and there is a noticeable temperature difference from the lower and upper space. This project will replace the rooftop HVAC equipment, piping, ductwork and related controls.

OTAG BLDG / Lawrence E. Jacobsen Center - Building #2199
Description: HVAC Rooftop Equipment Replacement Needed.

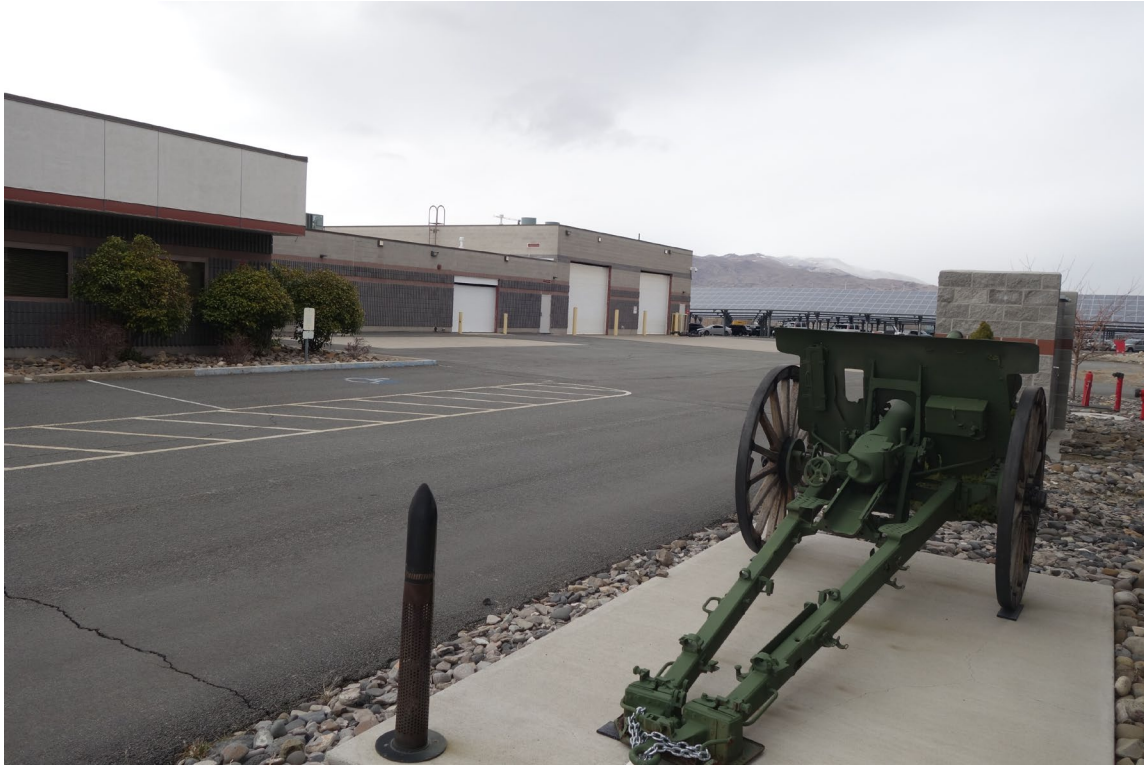
The exterior finishes were in fair condition. It is important to maintain the finish, weather resistance, and appearance of the building. This project would provide funding to protect the exterior of the building excluding the roof. Included in the cost are cleaning and sealing the concrete masonry units and caulking of the windows, flashing, fixtures and all other penetrations. It is recommended that the building be sealed and caulked in the next 4 - 6 years and that this project be scheduled on a cyclical basis to maintain the integrity of the structure.

CSMS Building - Building #1676
Description: Exterior of the Building.

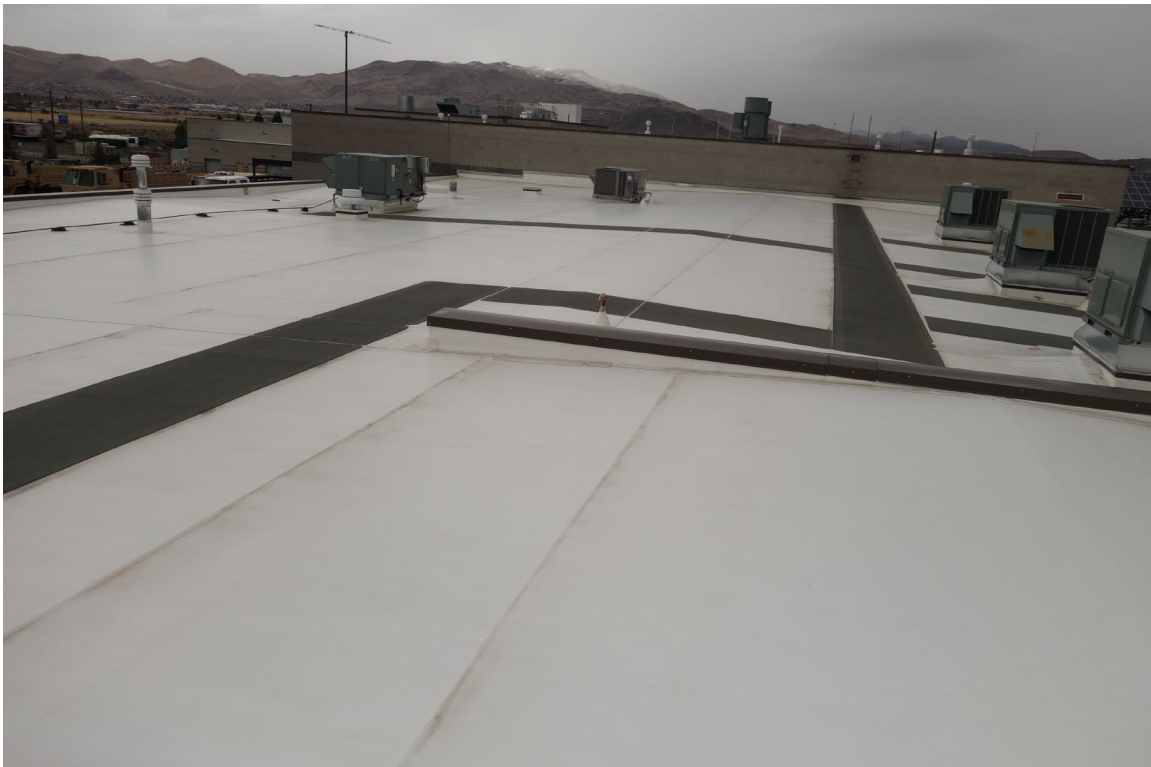
The HVAC system was installed in 1992 and is original to the building. It consists of heating and air conditioning units with ducting to certain areas as well as ceiling mounted unit heaters in the garages and shops. The system is not energy efficient and has reached the end of its expected and useful life. The R-22 refrigerant in the cooling system is no longer EPA compliant and its production was phased out completely January 1, 2020. This project would provide for installation of a new HVAC system and cleaning of the existing duct work and grilles. The new system shall be designed to significantly reduce electrical and natural gas usage in order to comply with ASHRAE 90.1 and to reduce utility costs. This project includes removal and disposal of the existing HVAC units and all required connections to utilities. This project or a portion thereof was previously recommended in the FCA report dated 07/07/2005 and 02/02/2012. It has been amended accordingly to reflect conditions observed during the most recent survey date of 02/18/2021.

CSMS Building - Building #1676
Description: HVAC Replacement Needed.

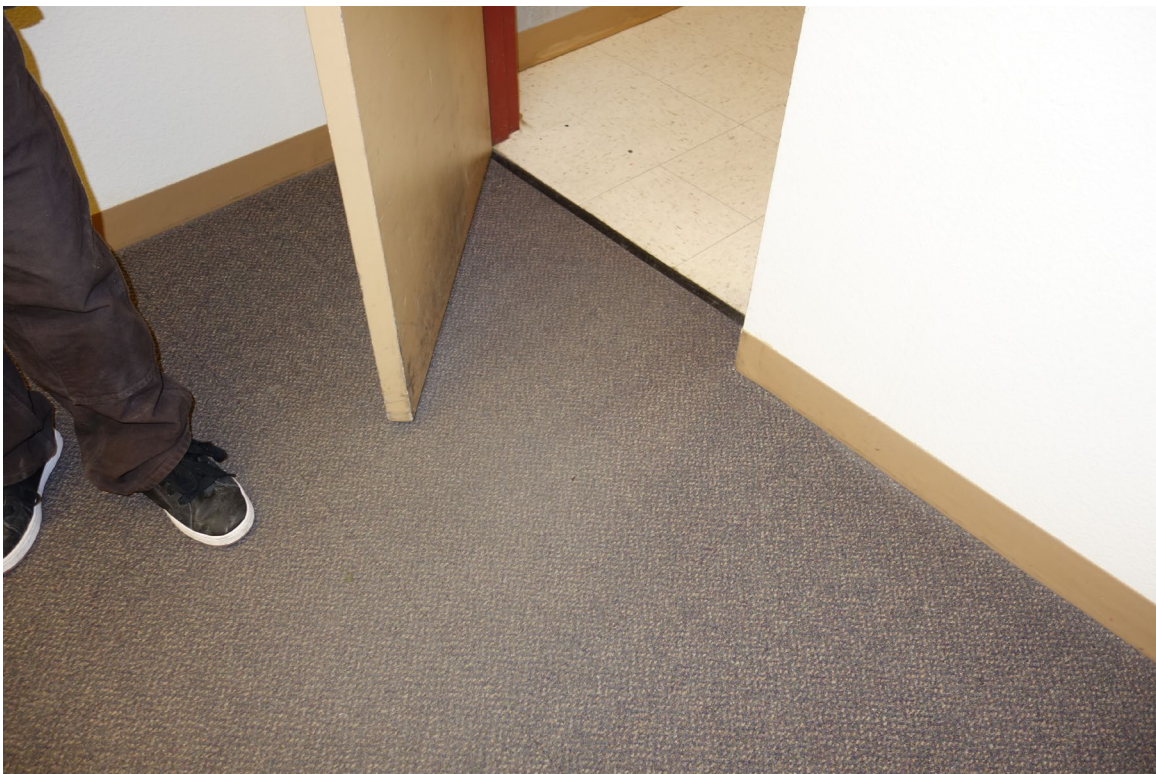
USPFO - Building #0271
Description: Flooring Replacement Needed.

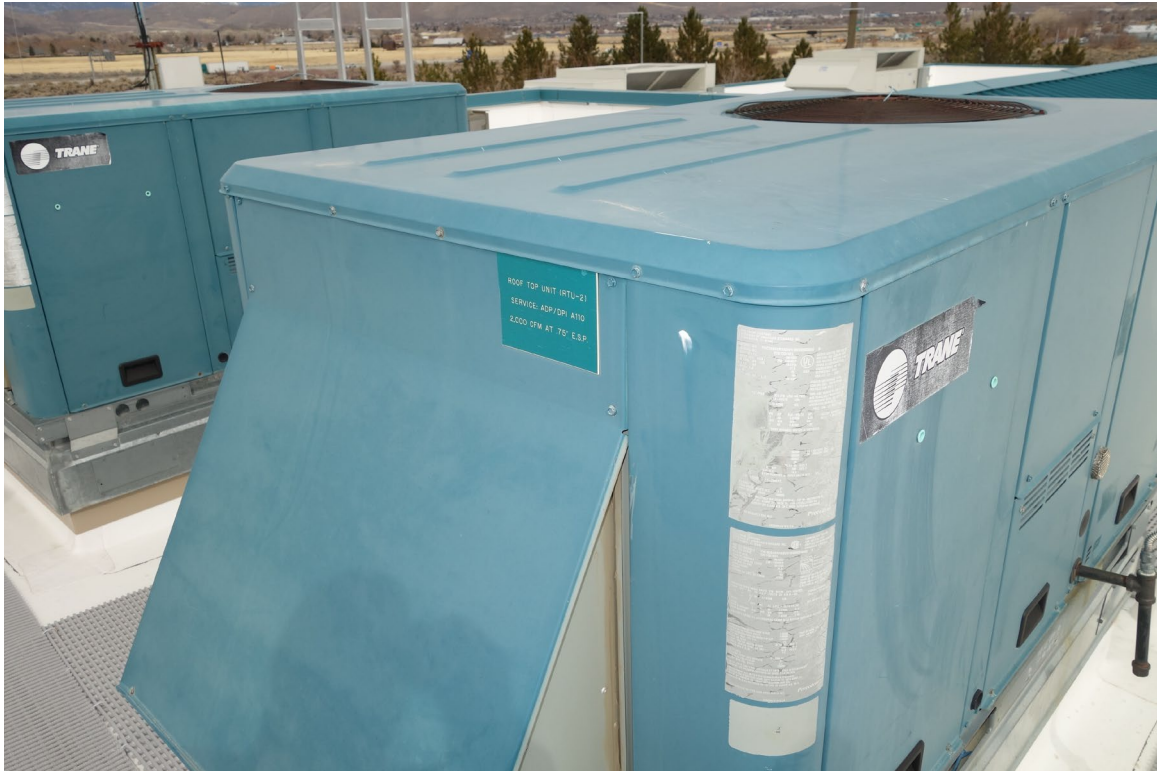
USPFO - Building #0271
Description: HVAC Rooftop Unit Replacement Needed.

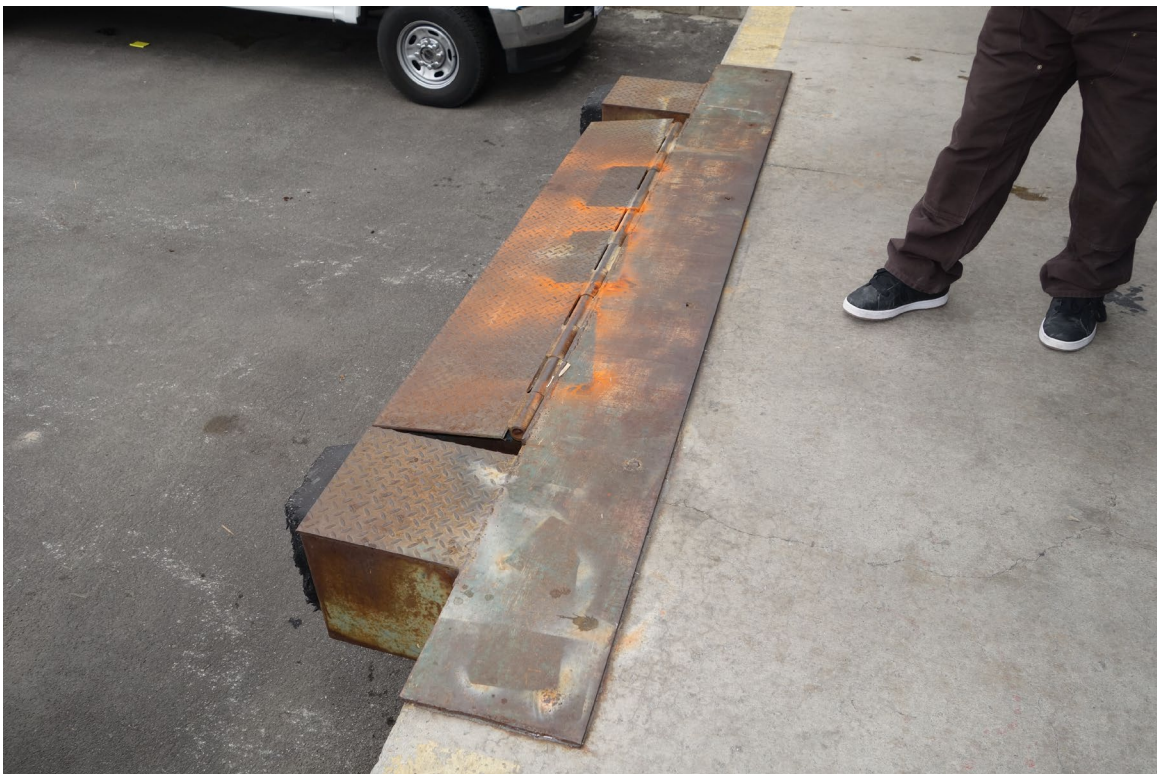
USPFO - Building #0271
Description: Dock Leveler Replacement Needed.
