State of Nevada
Office of Military / Nevada National Guard
Nevada National Guard Headquarters Carson City
Facility Condition Analysis

2460 Fairview Drive
Carson City, Nevada 89701

Site Number: 9891
STATE OF NEVADA PUBLIC WORKS DIVISION
FACILITY CONDITION ANALYSIS

Report Printed in November 2012

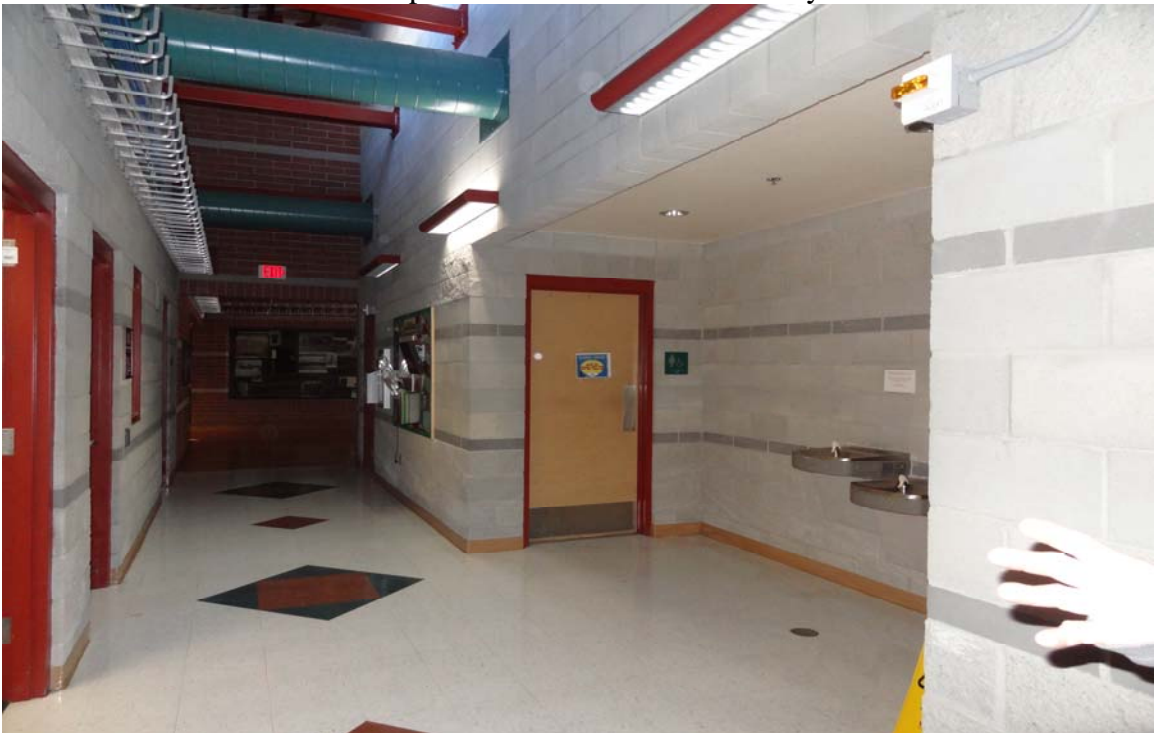
USFPO – FCA Building #0271
Description: Typical interior / restroom area.
