State of Nevada
Department of Administration – State Public Works Division
Buildings and Grounds Section

MARLETTE LAKE WATER SYSTEM OFFICE

Site Number: 9899
STATE OF NEVADA PUBLIC WORKS DIVISION
FACILITY CONDITION ANALYSIS

Report distributed in January 2022

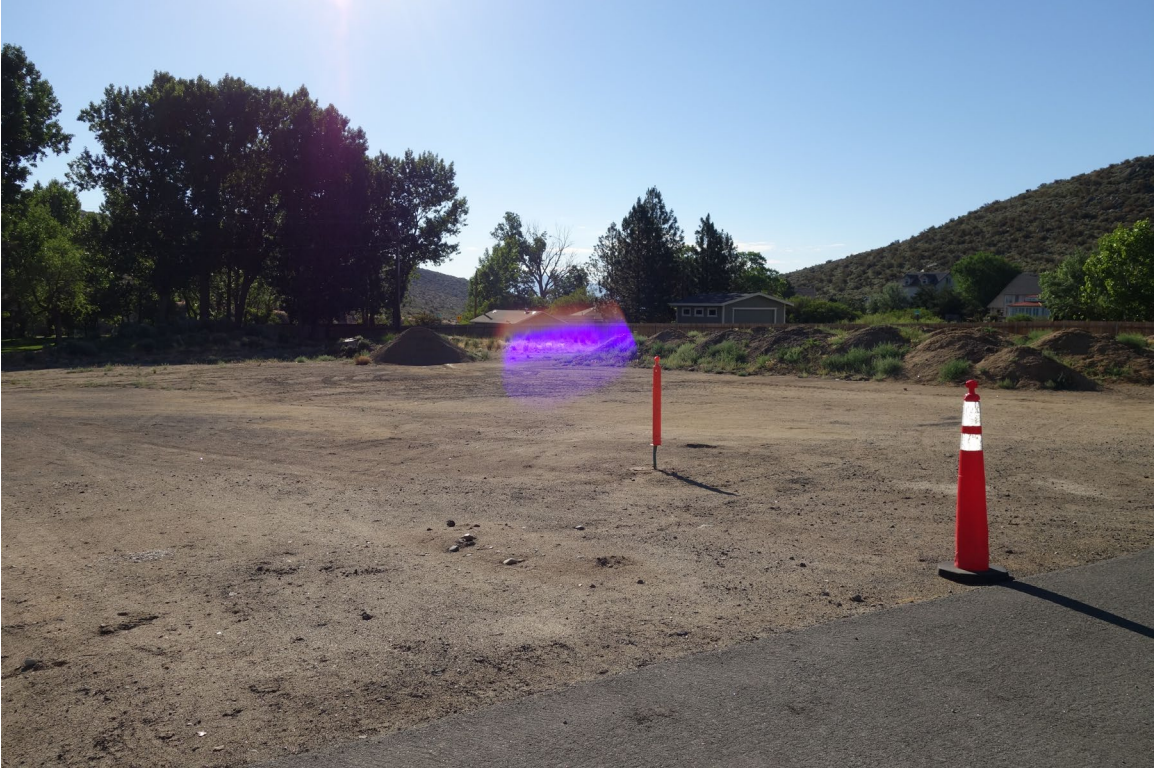
The site has several areas with inadequate drainage due to erosion and clogged drains. A majority of the site is not paved allowing runoff to erode the dirt. Installing asphalt and drainage swales would allow for control of the runoff and prevention of flooding. This project would provide asphalt cement paving for the dirt areas of the site. The estimate includes grading, 6" base, compaction and installation of 4" thick asphalt cement paving.

Marlette Lake Water System Office Site – FCA Site #9899
Description: View of the Unpaved Area of Site.

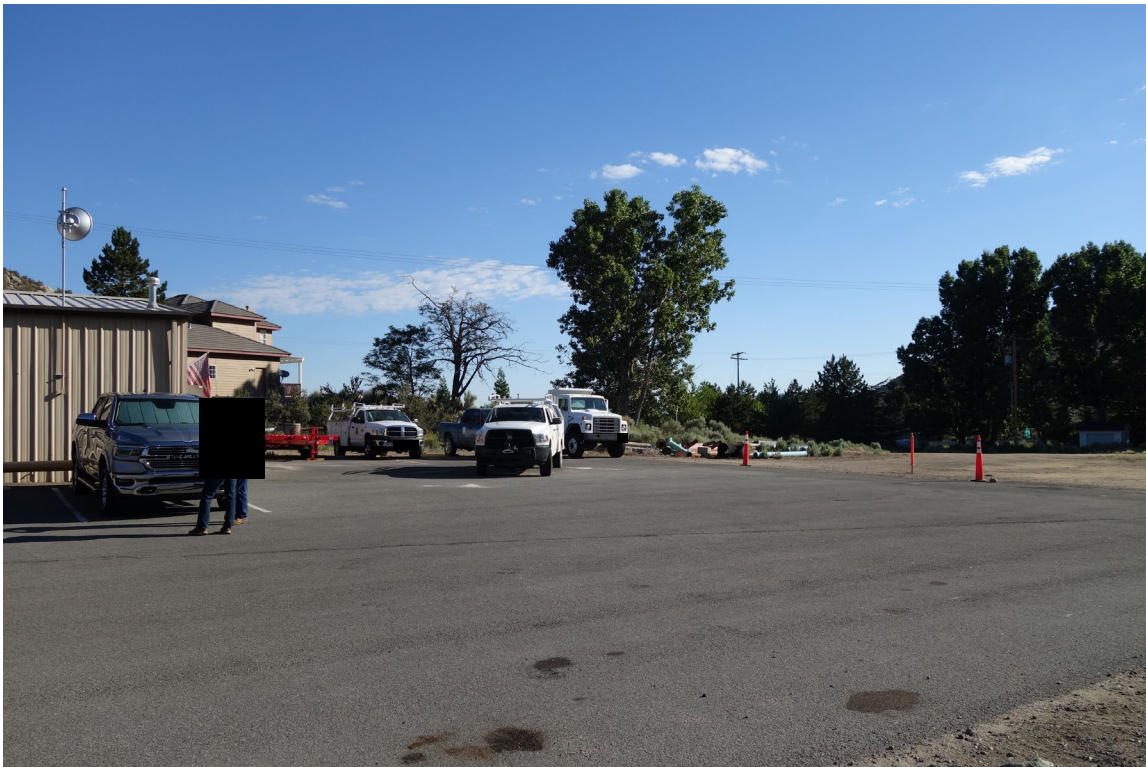
There is no site lighting for the property which is a security and safety concern. This project would provide for the installation of 10 solar powered LED exterior light fixtures, 20 foot tall poles and 30" diameter raised concrete bases.

Marlette Lake Water System Office Site – FCA Site #9899
Description: View of Site Lacking Site Lighting.

This installation will eliminate the need for trenching and electrical connections.

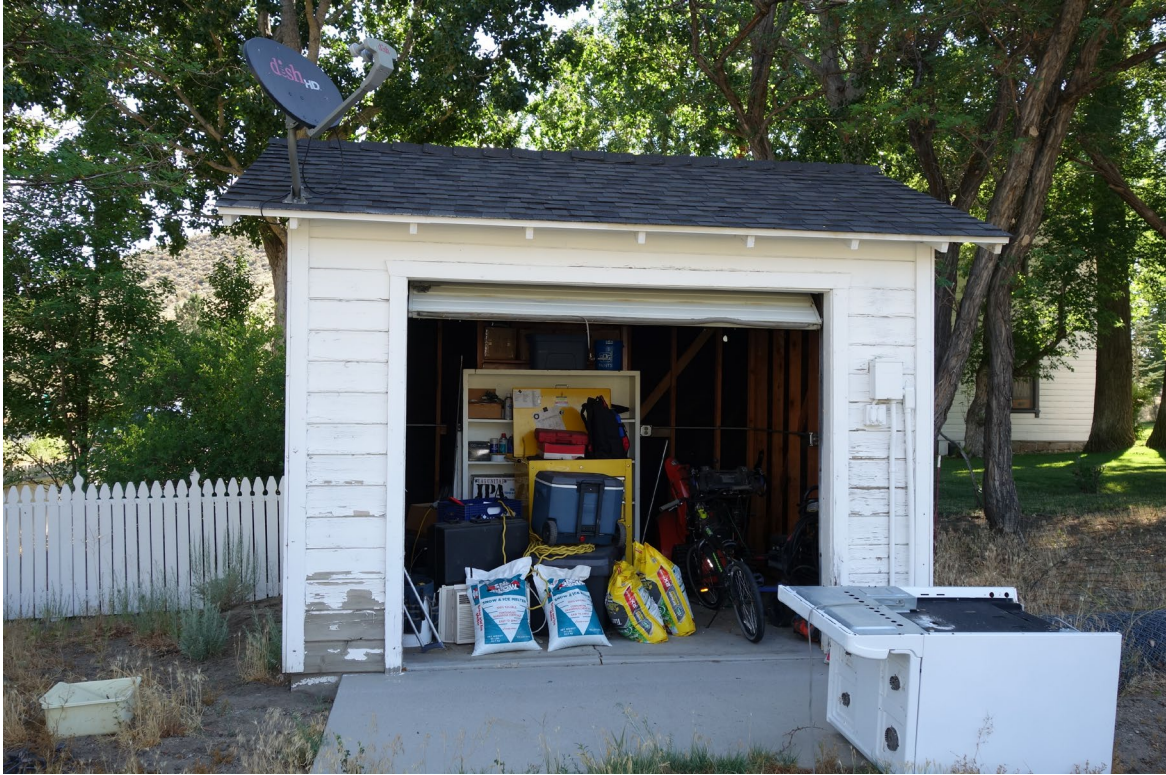
The exterior finishes were in poor condition. It is important to maintain the finish, weather resistance and appearance of the building. This project would provide funding to protect the exterior of the building excluding the roof. Included in the cost is sanding, priming and painting and caulking of the flashing, fixtures and all other penetrations. It is recommended that the building be painted in the next 2 - 3 years and that this project is scheduled on a cyclical basis to maintain the integrity of the structure.

Water Master House Shed – FCA Building #2498
Description: Exterior of the Building.

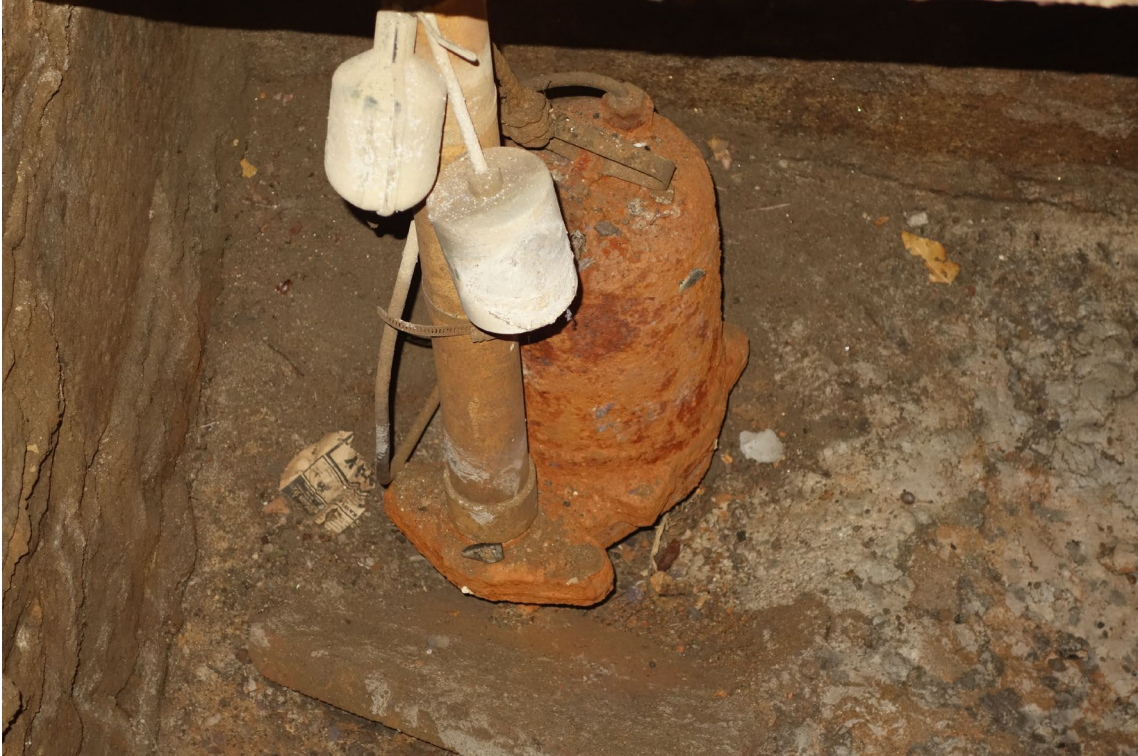
The current sump pump is failing and is in need of replacement. The project will fund the removal of the existing pump and connected plumbing and replace with new.

Lakeview House – FCA Building #2484
Description: Sump Pump Replacement Needed.

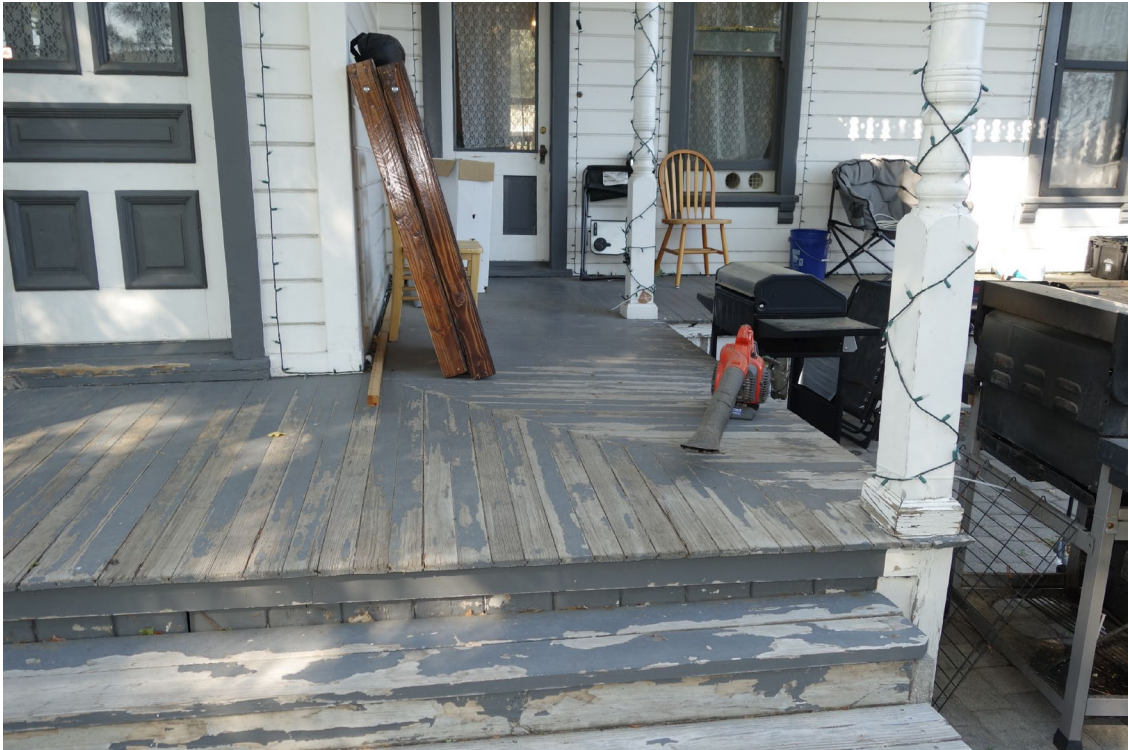
The deck's painted finish was in poor condition. It is important to maintain the finish, weather resistance and appearance of the deck. This project would provide for painting of the deck and it is recommended that this project be scheduled on a cyclical basis to maintain its integrity.

Lakeview House – FCA Building #2484
Description: Deck Refinish Needed.

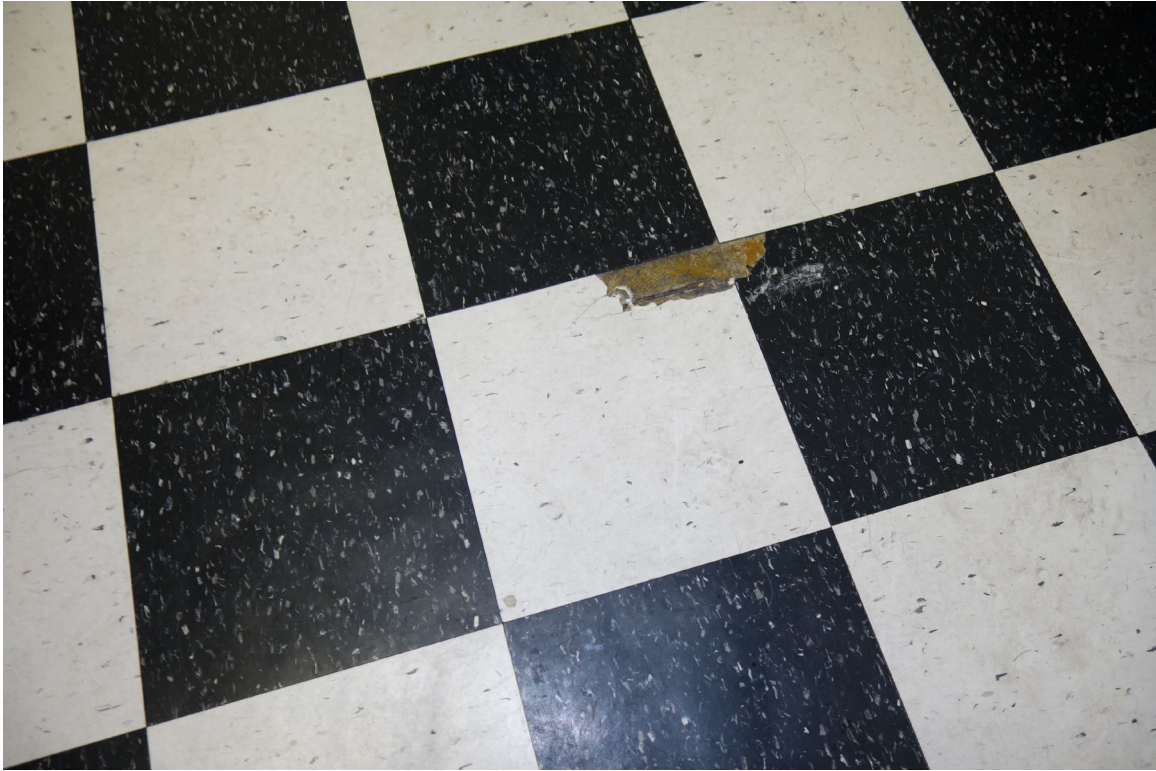
The floor covering in the kitchen are in generally poor condition and have reached the end of their serviceable lives. This project would provide funding to replace the entire floor with non-slip sheet vinyl. Additional costs would be required if there is asbestos in the tiles or adhesive.

Lakeview House – FCA Building #2484
Description: Kitchen Flooring Replacement Needed.

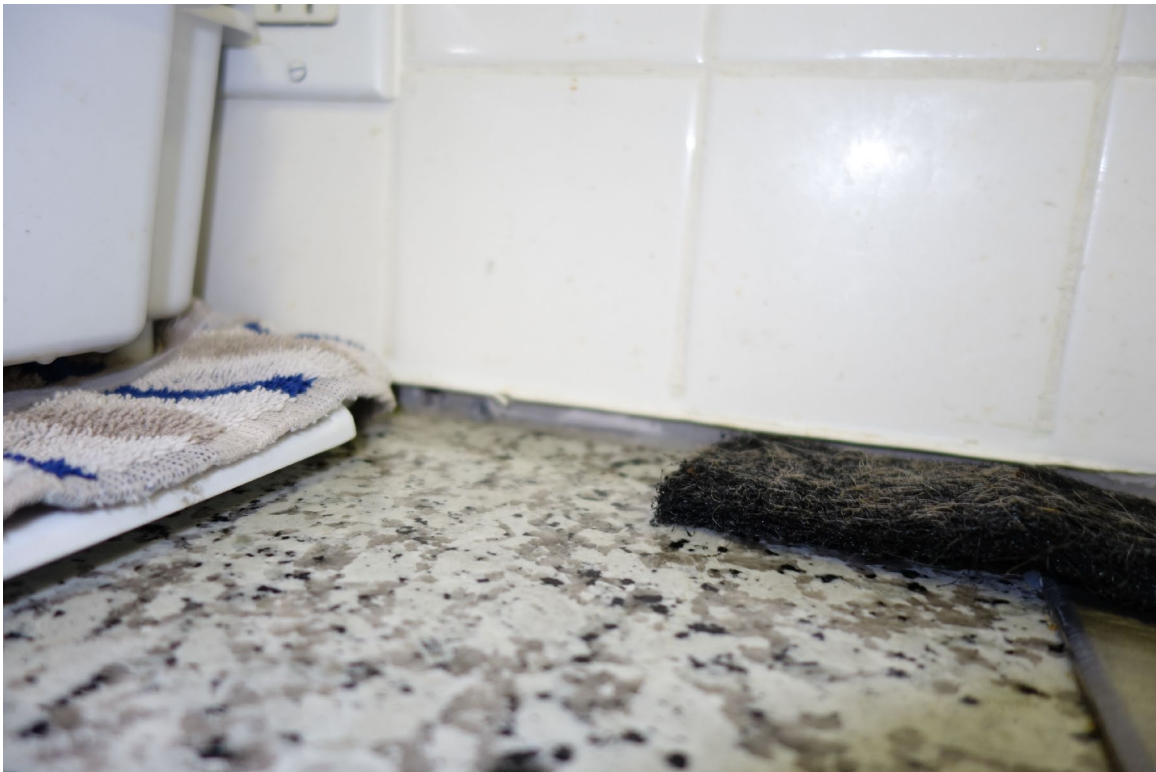
The kitchen countertops were replaced with granite, however the height of the surface dropped approximately 1" creating a gap between the backsplash and the granite countertop. This is a sanitary issue. This project would fund the removal and replacement of the backsplash to create a clean joint that can be sealed.

Lakeview House – FCA Building #2484
Description: Kitchen Backsplash Replacement Needed.
