State of Nevada  
Department of Administration  
Buildings and Grounds  
Marlette Lake Site  
Facility Condition Analysis

# MARLETTE LAKE SITE

**Site Number: 9899**  
FACILITY CONDITION ANALYSIS

Report Printed in May 2005

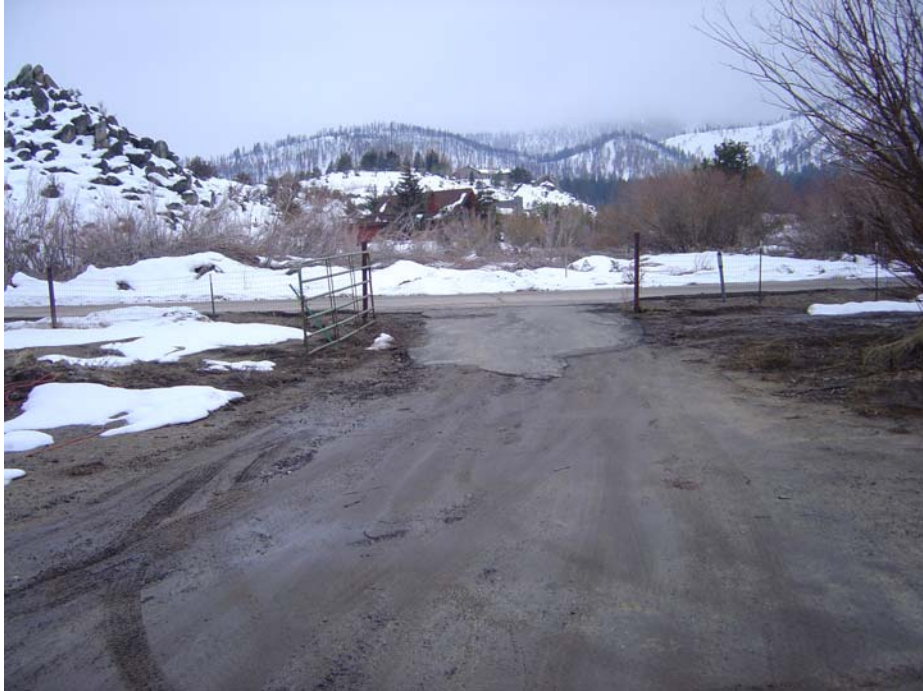
Marlette Lake Site - Site Number 9899  
Description: Main entrance to site.

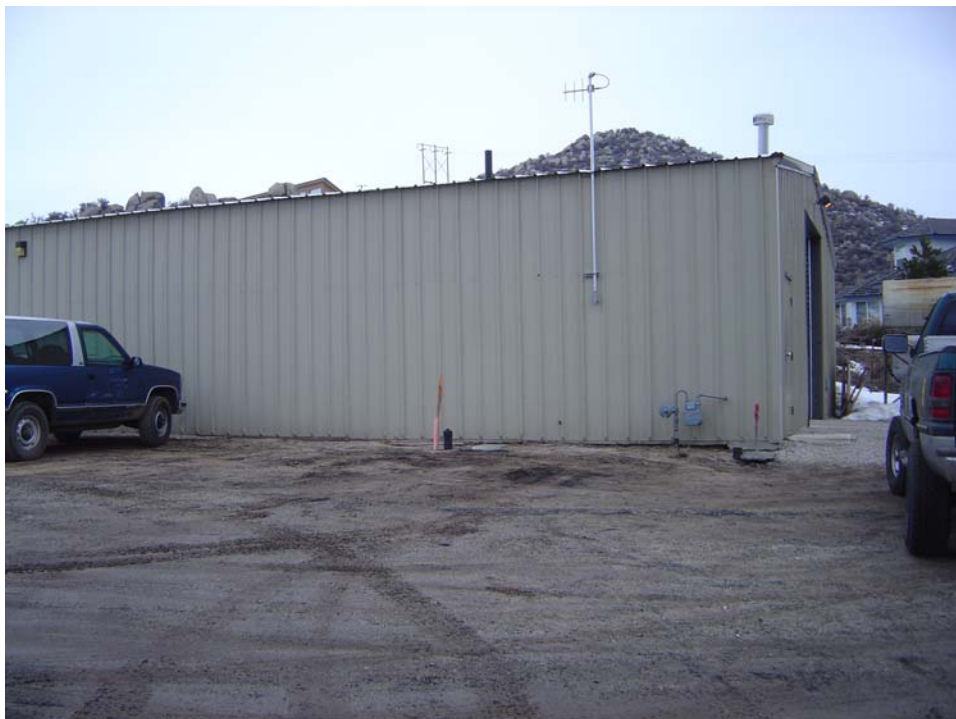
The site currently does not provide any paved parking areas or paved access road to the Marlette office/storage building. Vehicle travel and parking is on loose and compacted soil. This project would add 3" of asphalt concrete paving over 6" of compacted base. Four parking spaces, striping and signage are proposed. A design of the parking area is recommended but is not included in this project. The 5,000 square feet is an estimate based on minimum requirements for ingress, egress and parking.

Marlette Lake Site - Site Number 9899  
Description: Dirt parking area for office/storage.

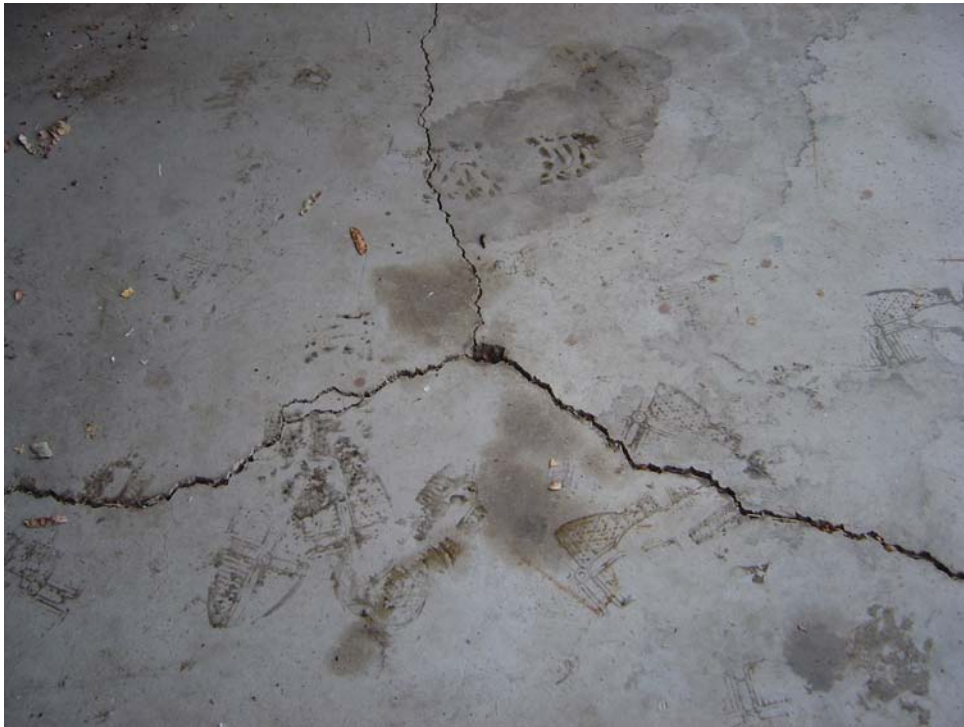
**CONCRETE SLAB-ON-GRADE** **Project cost: \$2,500**  
The concrete slab-on-grade in the shed is deteriorating. Spalling and cracking have occurred. Exposure to the weather is a contributing factor. A replacement is recommended. This project would provide for removal and disposal of the existing concrete slab-on-grade and installation of a 3.5" thick concrete slab-on-grade over a compacted subgrade.

Marlette Lake Site - Building Number 2498  
Description: Concrete spalling and cracking in equipment shed.

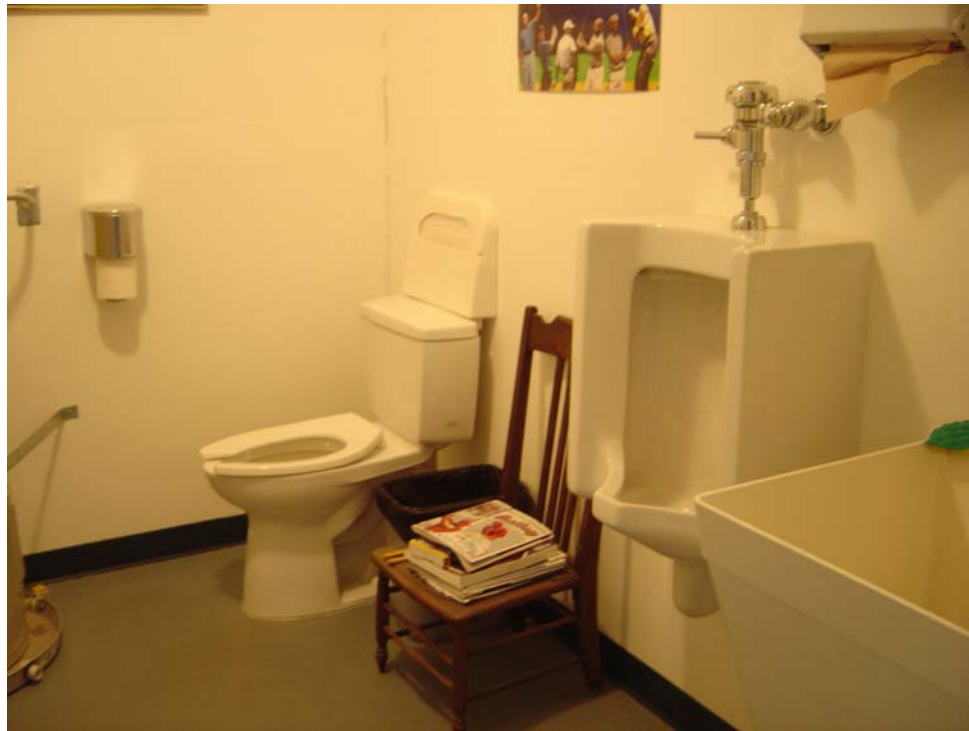
Marlette Lake Site - Building Number 2488  
Description: Non-ADA compliant restroom in office.

We are recommending an ADA survey be performed, to assess specialized needs or adaptations to the building. This project includes a room by room survey, identifying any non-compliant building systems or components by reference, recommendations for remediation, and cost for implementation of recommendations. Project costs include the survey, follow-up communications with the agencies, preparation of the report, and reproducing and distributing the final documents. Future projects will be based on this report.

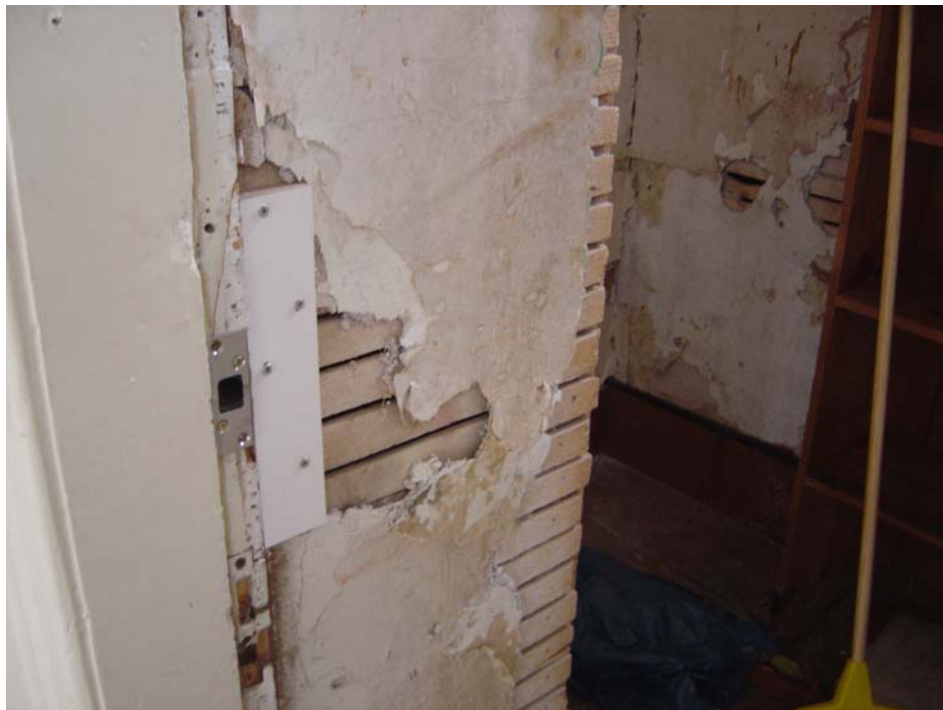
The pantry is in poor condition with areas of the lath and plaster missing or falling from the walls. Prior to any remodeling, we are recommending that an asbestos survey be performed by a licensed professional to verify if asbestos is present. Any future projects will be based on this report.

The walls and floor of the pantry are severely damaged and need to be repaired. This project would provide for repairs to the wall and floor, including gypsum board, plywood sub floor, and painting. This project should be done after an asbestos survey has been completed.

Marlette Lake Site – Building Number 2484  
Description: Damage to wall at interior of pantry.

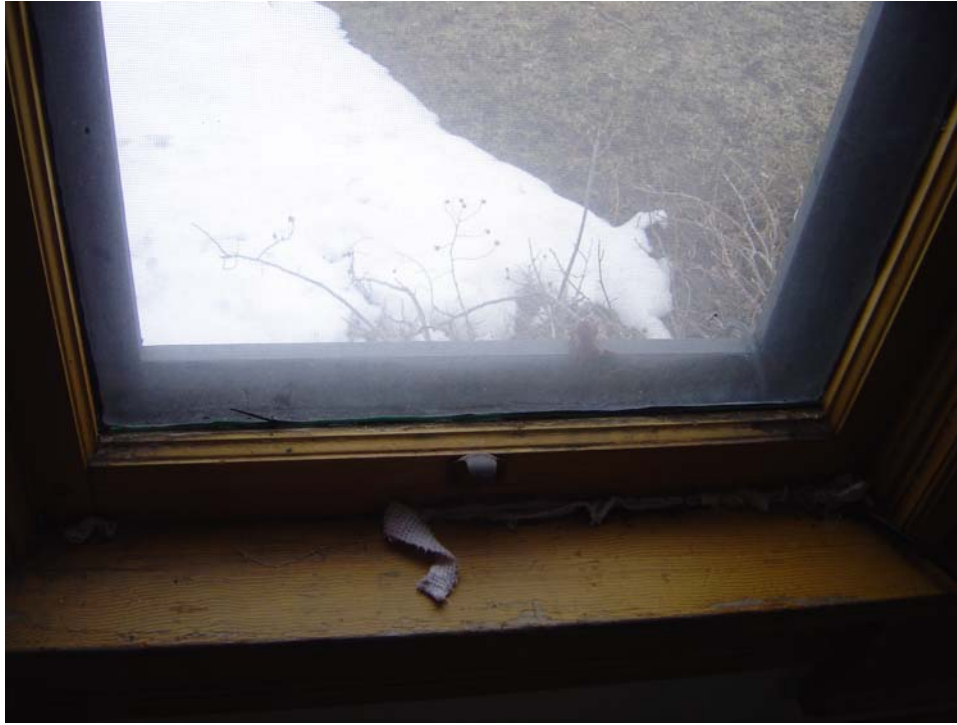
Marlette Lake Site – Building Number 2484  
Description: Typical window sill.

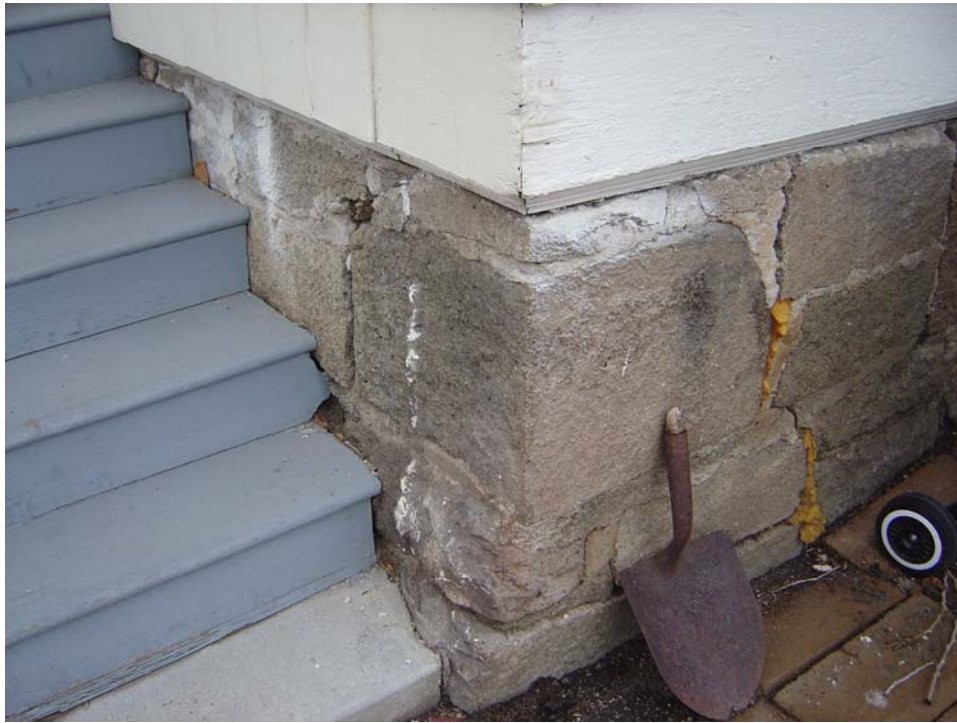
The kitchen floor and the exterior porch have a noticeable slope. The chimney appears to have bricks loose or missing, and the foundation has a large number of mortar joints that have deteriorated and appear to be unreinforced. This project would provide for an investigation and assessment be done by a licensed Structural Engineer to identify deficiencies and problems in the building, and assess remedies. Future recommendations will be based on this report.

Marlette Lake Site – Building Number 2484  
Description: Cracks in the foundation.
