State of Nevada
Department of Motor Vehicles
Buildings & Grounds Division
DMV Office – Flamingo Road
Facility Condition Analysis

DEPARTMENT OF MOTOR VEHICLES OFFICE – FLAMINGO ROAD

8250 West Flamingo Road
Las Vegas, Nevada 89147

Site Number: 9901
STATE OF NEVADA PUBLIC WORKS BOARD
FACILITY CONDITION ANALYSIS

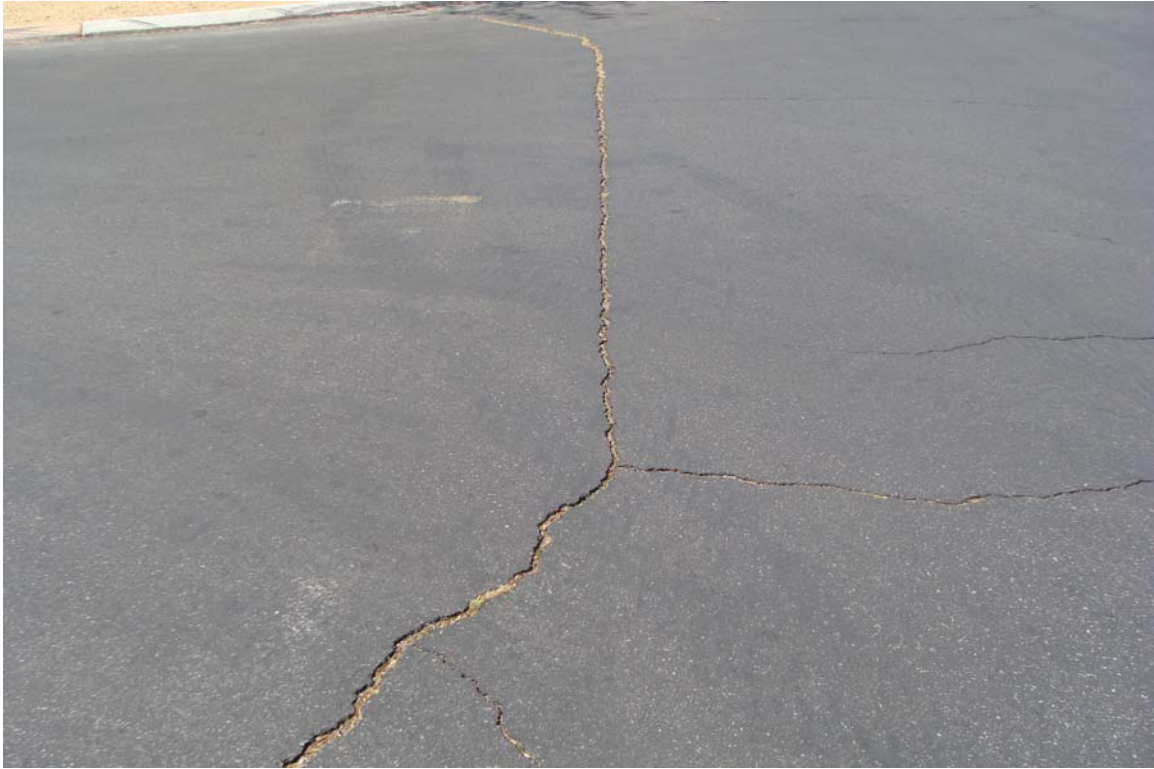
DMV Flamingo Road Site - Site #9901
Description: AC paving in need of crack filling and sealing.

CRACK FILL & SEAL ASPHALT PAVING

It is important to maintain the asphalt concrete paving on the site. This project would provide for minor crack filling and sealing of the paving site wide including access roads, parking areas and driving test areas. Striping is included in this estimate. This project should be scheduled on a 5 year cyclical basis to maintain the integrity of the paving and prevent premature failure. 220,000 square feet of asphalt area was used to generate this estimate. It is recommended that this project coincide with the ADA Site Upgrades project.

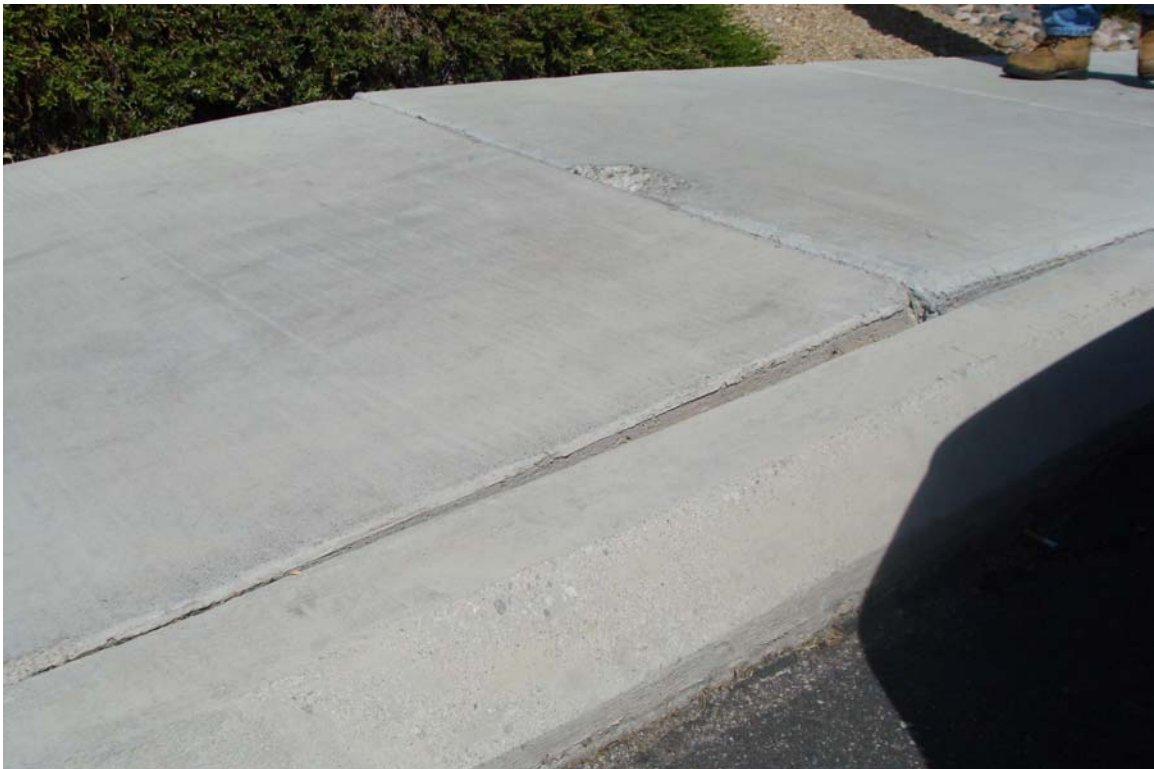
DMV Flamingo Road Site - Site #9901
Description: Heaving concrete at ADA accessible walkway.

ADA SITE UPGRADES

The Americans with Disabilities Act (ADA) provides for accessibility to sites and services for people with physical limitations. There is an accessible path on the east side of the DMV building that is not fully compliant. Starting at the ADA parking space, the path is obstructed by the sloped curb in front of the loading zone. From there, the sidewalk has heaved and caused the concrete to buckle between the loading zone and the ADA ramp. The ramp itself does not have compliant slopes and landings due to sub-grades shifting, settling and heaving. The handrails on the ramp also need to be upgraded. This project would provide for a revision of the parking layout to provide a compliant loading zone, repairing the heaving sidewalk and replacing the concrete and handrails on the ramp. This will require regrading, placement of P.C. concrete, signage, striping, handrails and any other necessary upgrades. The 2006 IBC, ICC/ANSI A117.1 - 2003 and the most current version of the Americans With Disabilities Act Accessible Guidelines (ADAAG) were used as a reference for this project. It is recommended that this project coincide with the Slurry Seal Asphalt Paving project. This project or a portion thereof was previously recommended in the FCA report dated 11/02/2004. It has been amended accordingly to reflect conditions observed during the most recent survey date of 04/25/2011.

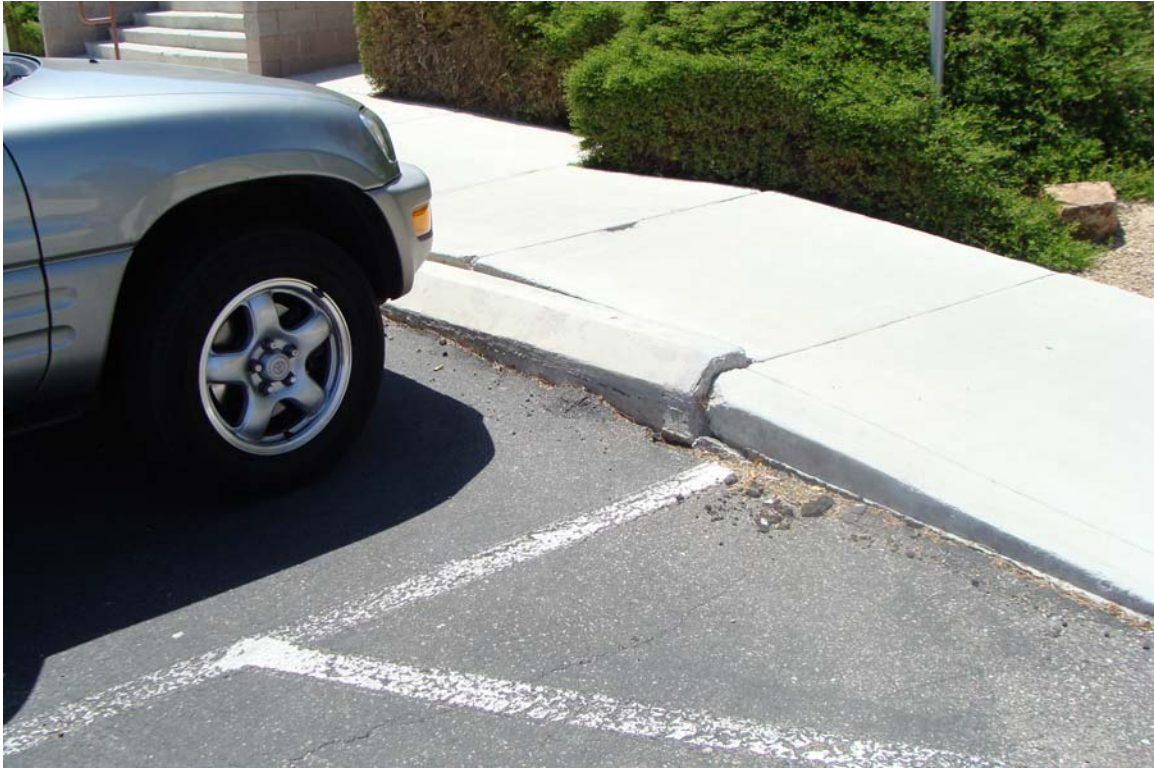
DMV Flamingo Road Site - Site #9901
Description: Damaged ADA accessible concrete walkway.

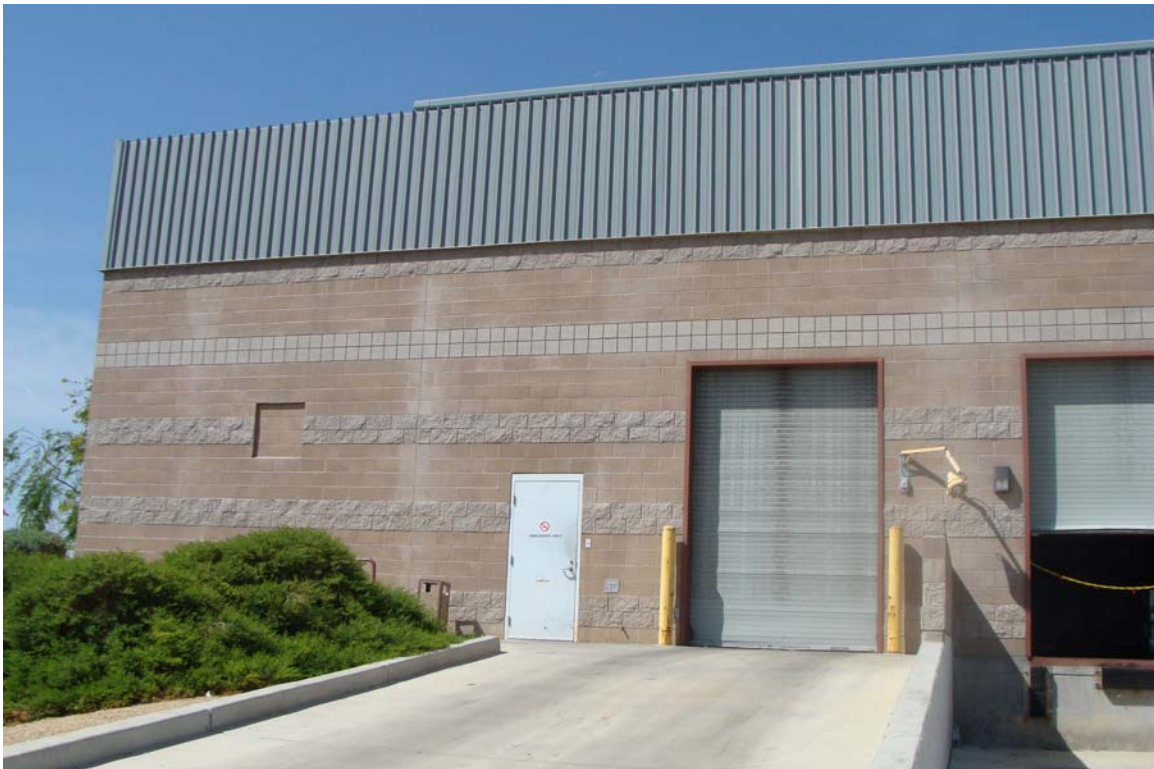
DMV Flamingo Warehouse - Building #0520
Description: View of loading dock area.

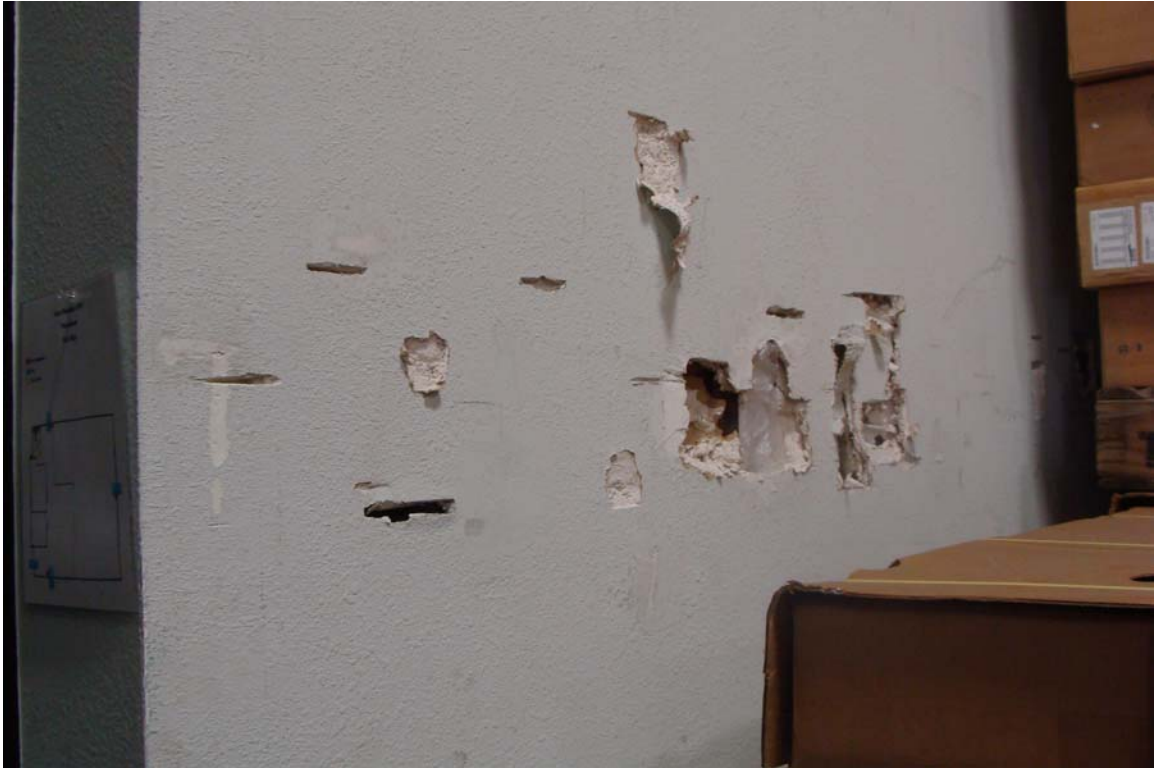
DMV Flamingo Warehouse - Building #0520
Description: Damaged gypsum board in the warehouse.

INTERIOR FINISHES

The interior finishes are in fair condition. It is recommended that the interior gypsum board walls and ceilings be painted at least once in the next 2-3 years and that this project be scheduled on a cyclical basis to maintain the integrity of the structure. There are also damaged areas from forklifts that need repairs. Prior to painting, all surfaces should be repaired and prepped. An epoxy-based paint should be utilized in wet areas for durability.

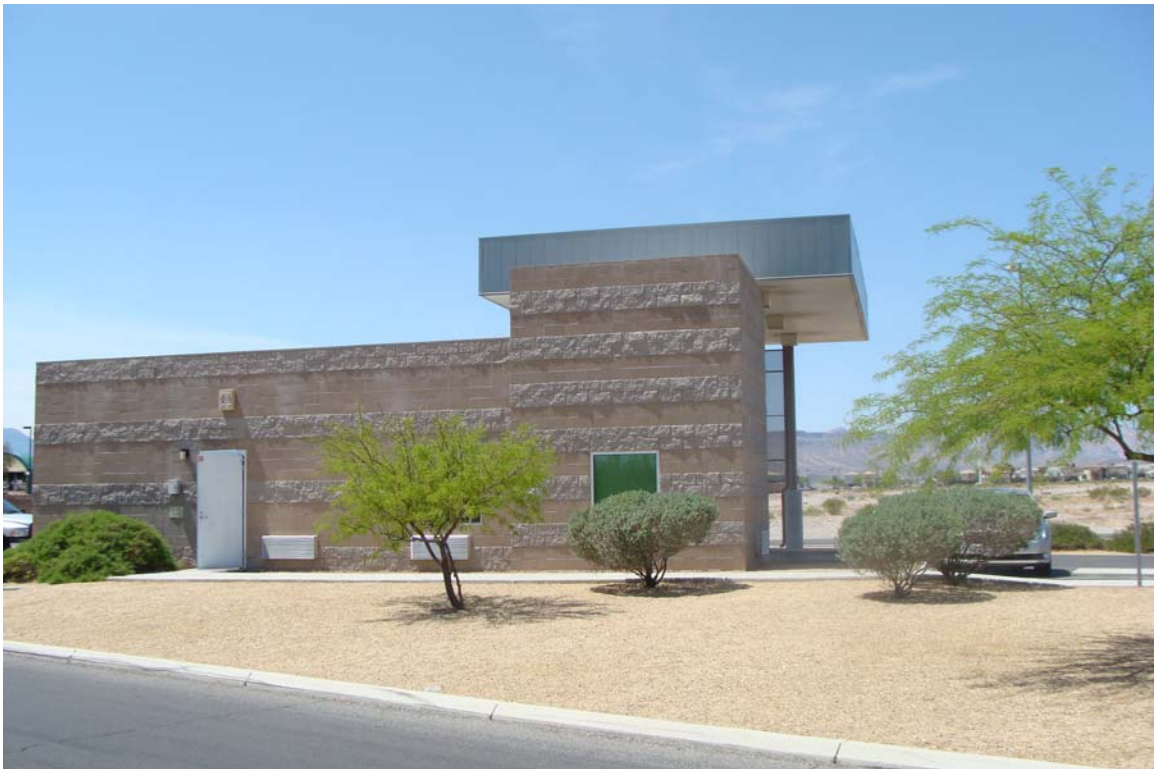
DMV Flamingo Inspection Station - Building #0366
Description: Exterior of the building.

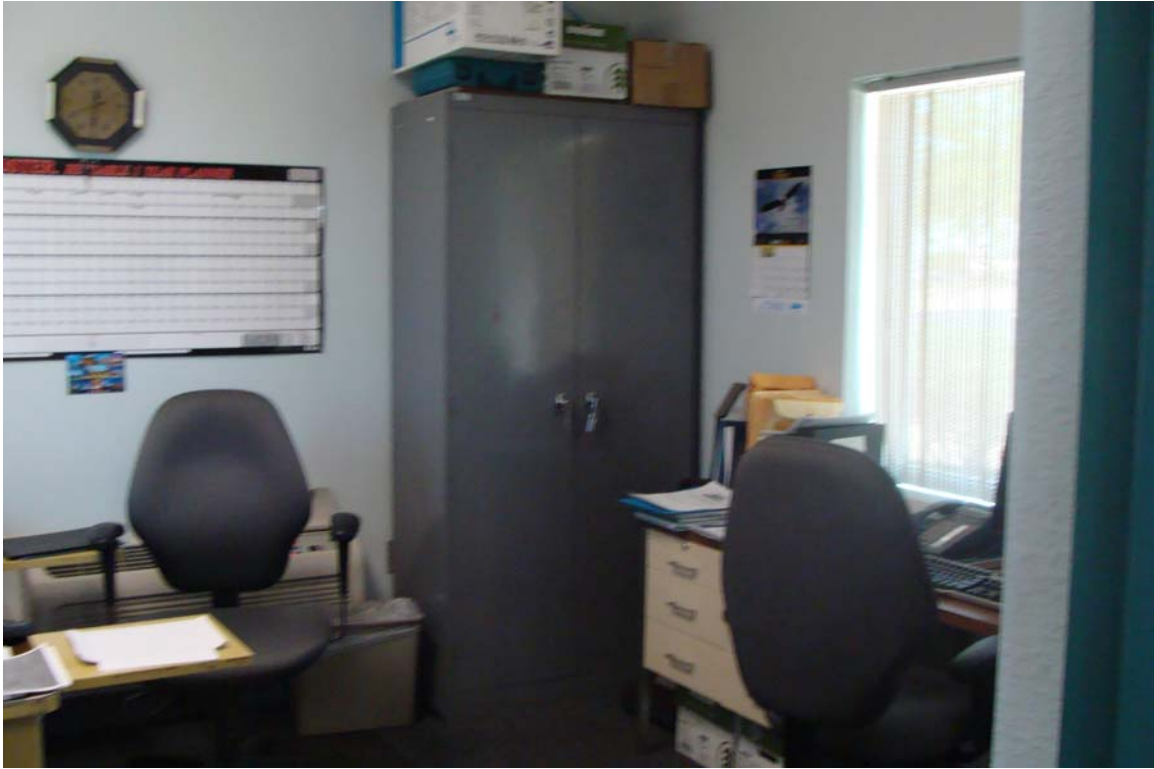
DMV Flamingo Inspection Station - Building #0366
Description: Interior of the building.

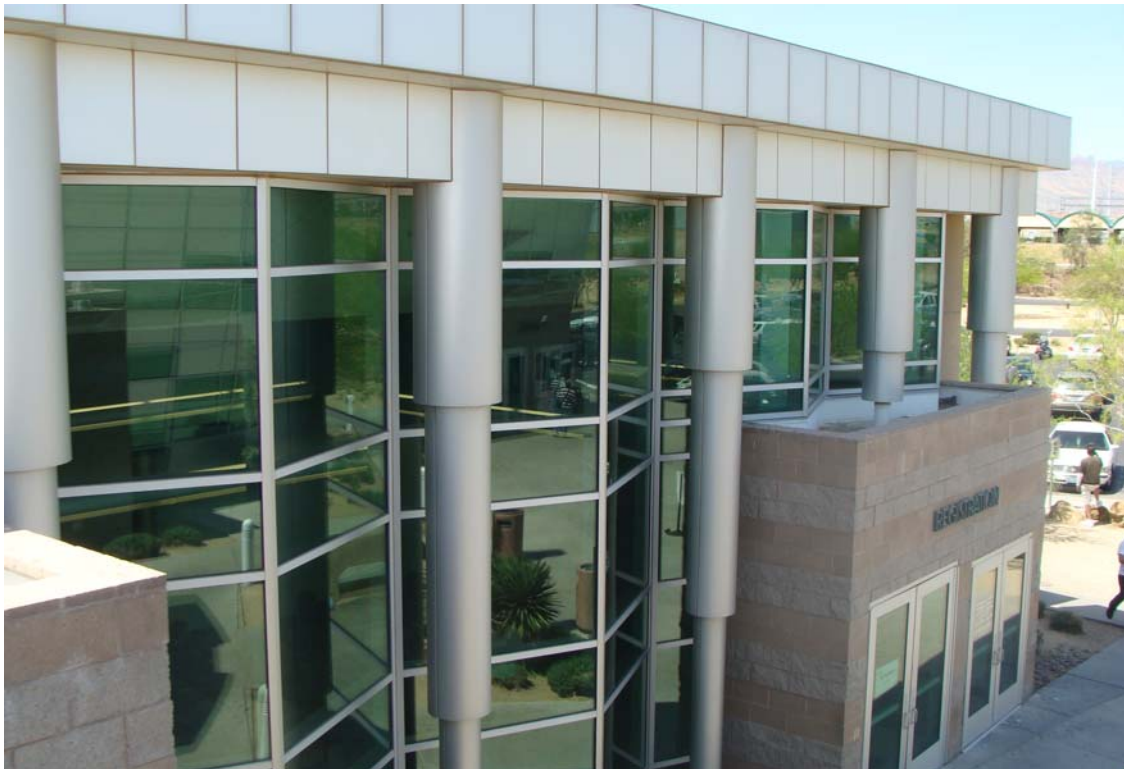
DMV Flamingo Office - Building #0338
Description: Glazed curtain walls.

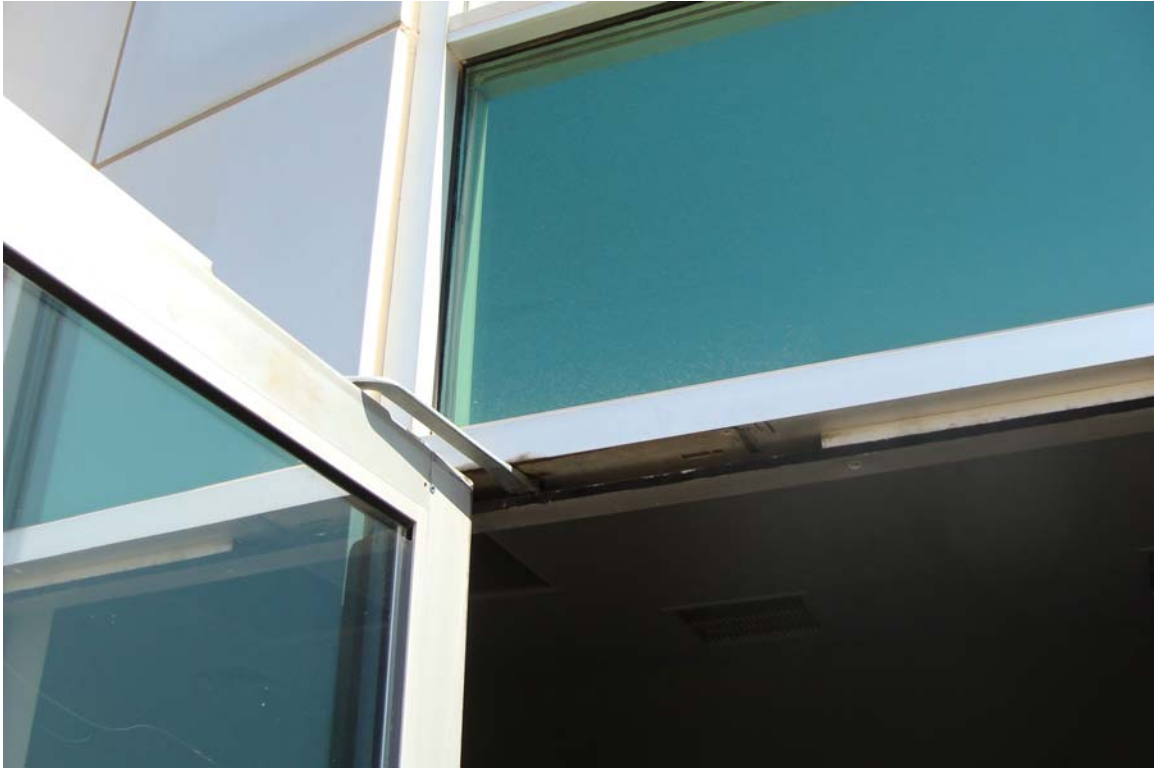
Seven exterior storefront entrance doors to the building are surrounded by an exterior metal curtain wall system. These doors are damaged and do not prevent water from penetrating the building. Age and damage from wear and tear also has led to this failure. This project would provide for the replacement and installation of 7 storefront entrance system doors including hardware. Removal and disposal of the existing doors is included in this estimate.

DMV Flamingo Office - Building #0338
Description: Storefront door that is leaking.

EXTERIOR STOREFRONT ENTRANCE REPLACEMENT

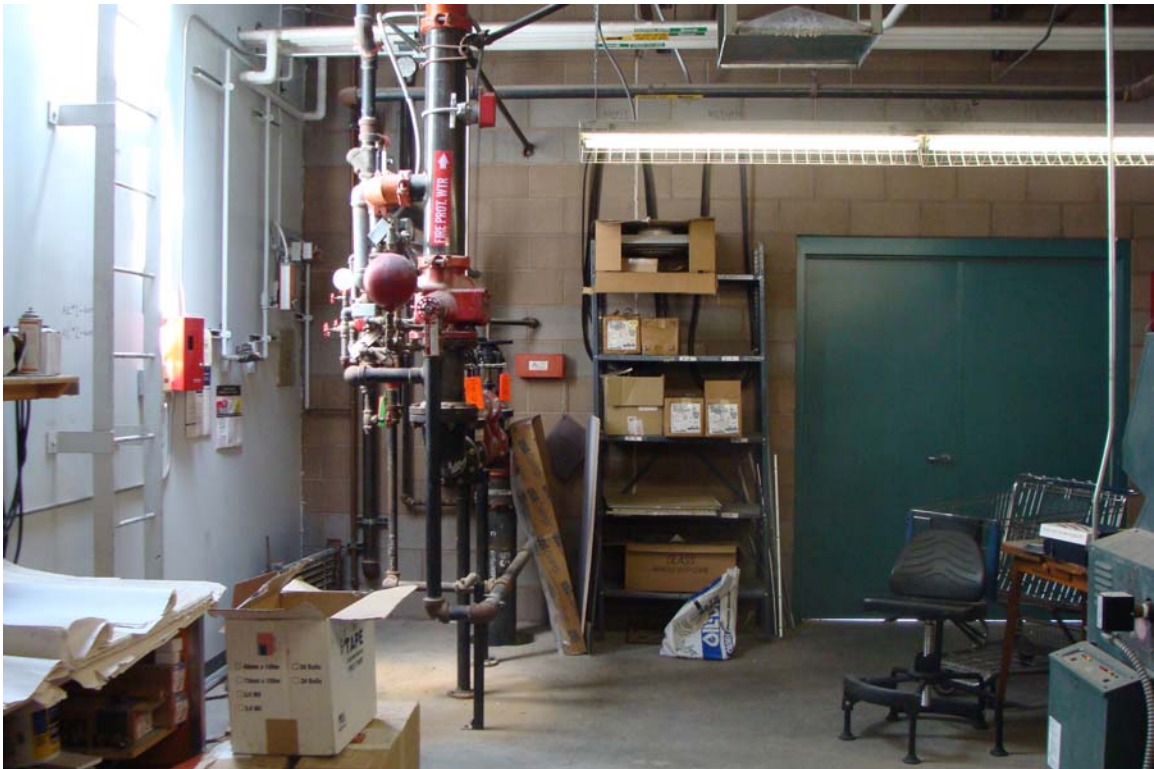
DMV Flamingo Office - Building #0338
Description: Fire sprinkler riser assembly.

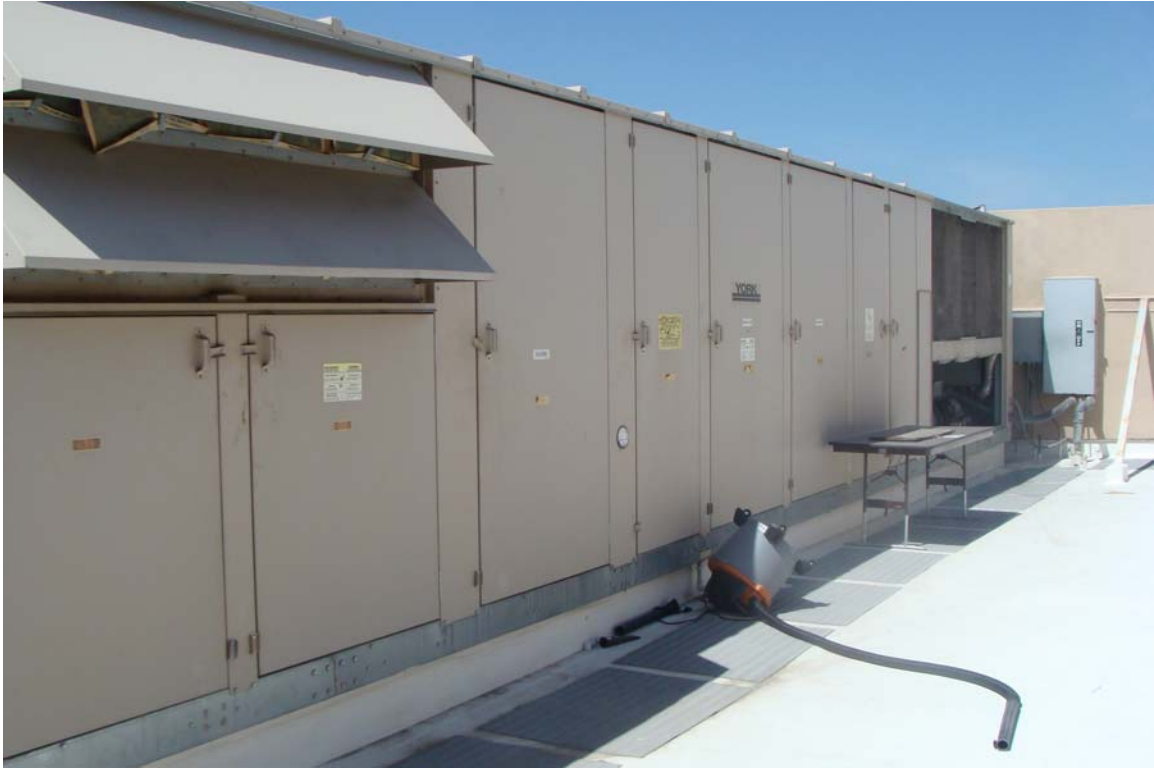
The central HVAC system is original to the building and should be scheduled for replacement. The equipment is not energy efficient, has reached the end of its expected and useful life and replacement parts are no longer available. The existing system consists of two natural gas fired hot water boilers and two large packaged units on the roof along with a digital controls system, a water treatment system and associated valves, pumps and other ancillary parts. This project would provide for installation of all new equipment and cleaning of the existing duct work and grilles. This project includes removal and disposal of the existing HVAC system and all required connections to utilities.

DMV Flamingo Office - Building #0338
Description: View of roof mounted HVAC unit.

HVAC EQUIPMENT REPLACEMENT

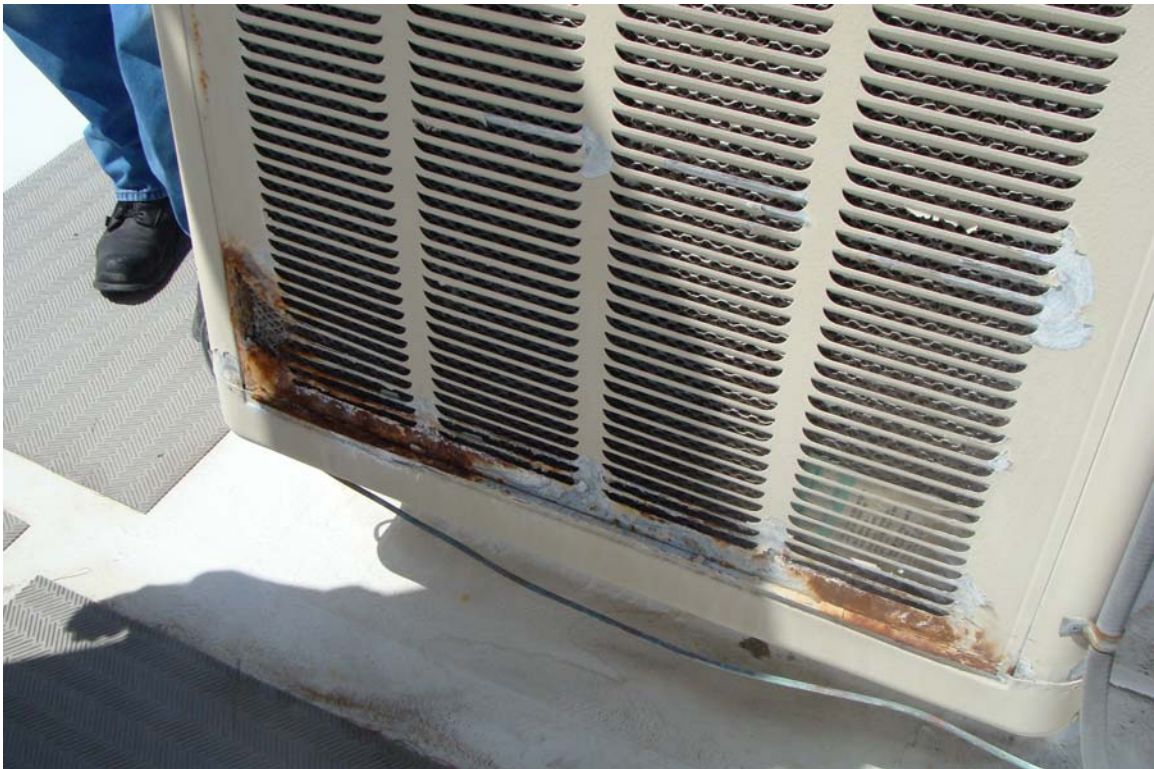
DMV Flamingo Office - Building #0338
Description: Roof mounted evaporative cooler.
