State of Nevada
Department of Wildlife
Western Region Fallon Office
Facility Condition Analysis

DEPARTMENT OF WILDLIFE WESTERN REGION FALLON OFFICE

380 West B Street
Fallon, Nevada 89406

Site Number: 9902
STATE OF NEVADA PUBLIC WORKS BOARD
FACILITY CONDITION ANALYSIS

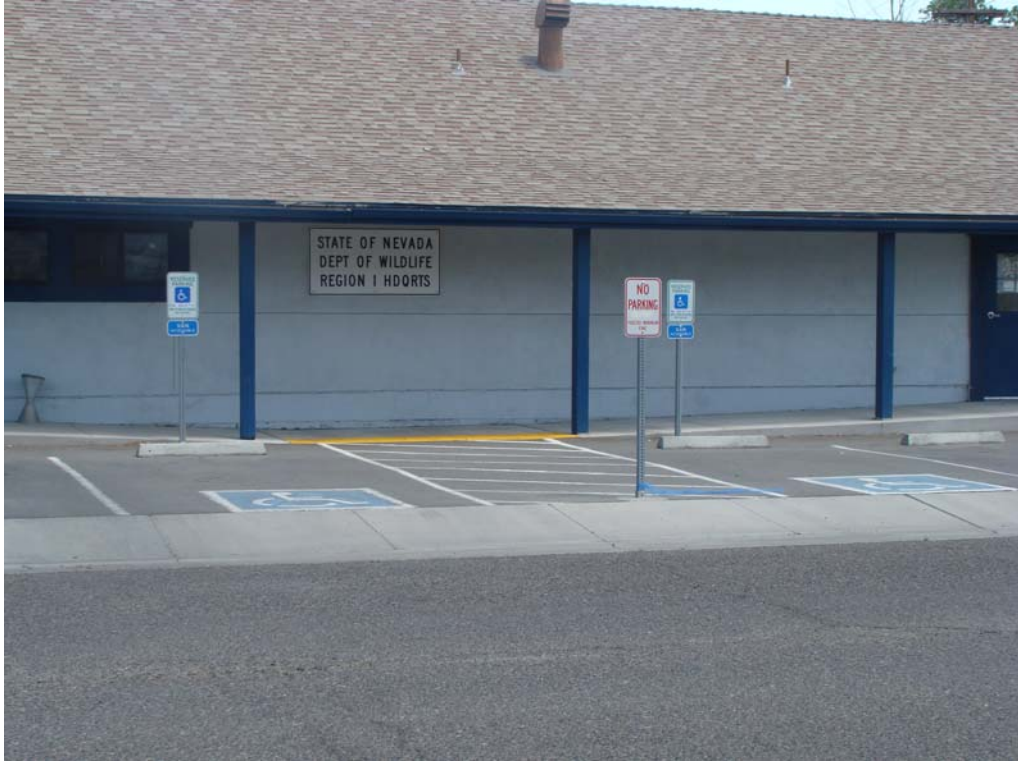
Western Region Fallon Office Site - Site #9902
Description: ADA accessible parking.

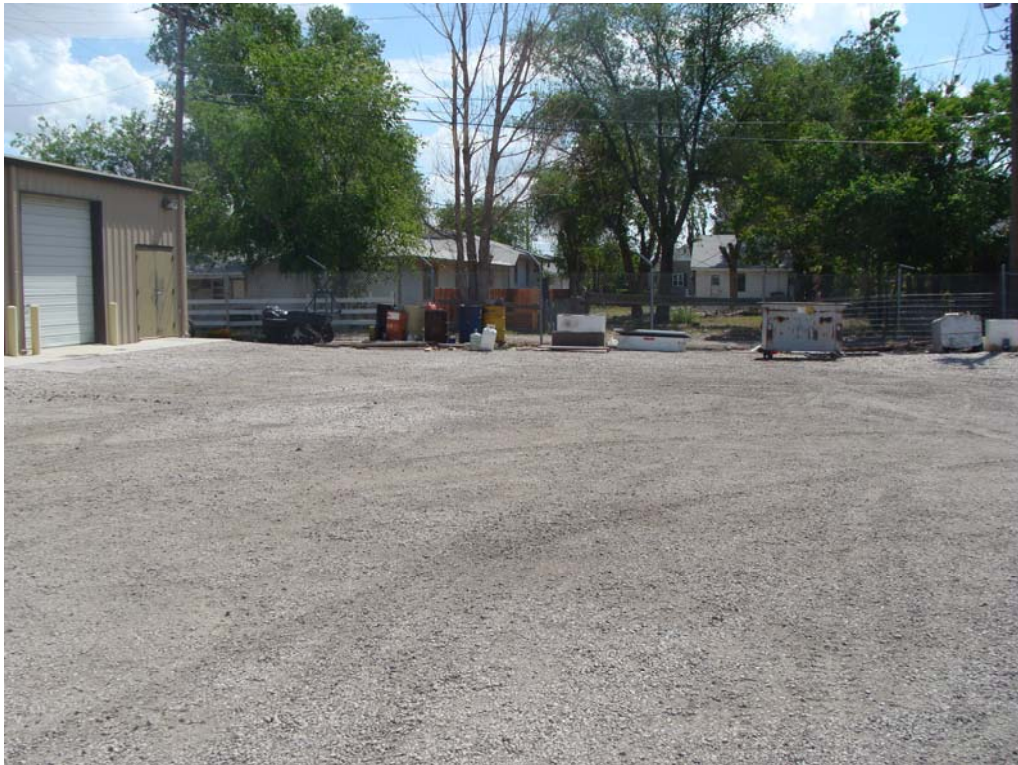
The gravel parking areas on the site should be scheduled for paving. The inclement weather in the area causes deterioration to the grade including potholes and negative drainage areas. This project would provide asphalt concrete paving to replace the gravel areas. The estimate includes grading, 6" base, compaction and installation of 4" thick asphalt concrete paving. 11,500 square feet of gravel area was used to generate this estimate.

Western Region Fallon Office Site - Site #9902
Description: View of the gravel yard area.

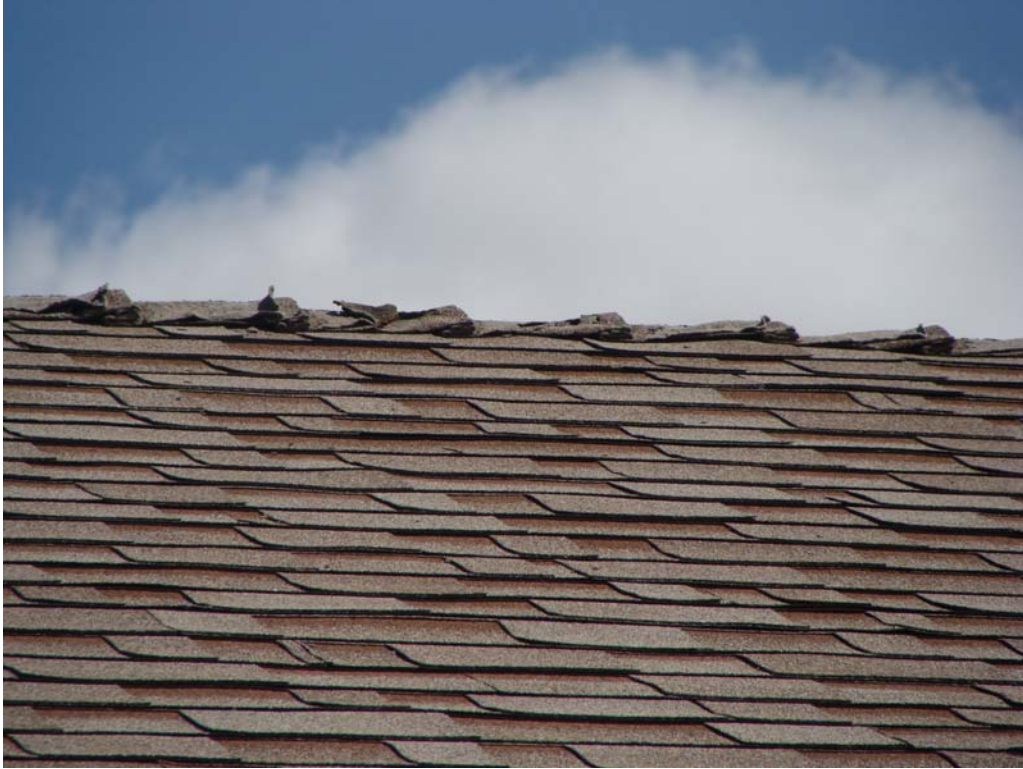
The asphalt composition shingle roof on this building was in poor condition at the time of the survey. It is recommended that this building be re-roofed in the next two to three years with a new 50 year asphalt composition roofing shingle and new underlayments. This estimate includes removal and disposal of the old roofing and underlayments. This project or a portion thereof was previously recommended in the FCA report dated 10/25/2004. It has been amended accordingly to reflect conditions observed during the most recent survey date of 06/11/2009.

Field Office - Building #0633
Description: Damaged roof shingles.

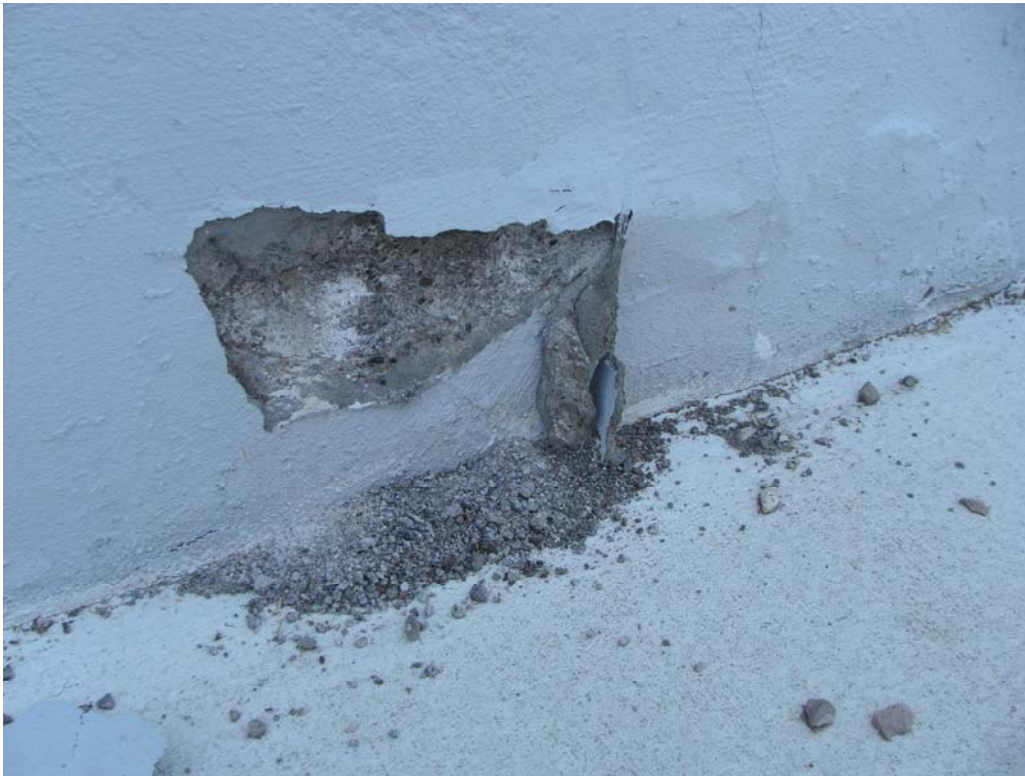
Field Office - Building #0633
Description: Damaged exterior plaster.

It is important to maintain the finish, weather resistance, energy efficiency and appearance of the building. This project would provide funding to protect the exterior of the building. Included in the cost is power washing, priming and painting and caulking of the windows, flashing, fixtures and all other penetrations. It is recommended that the building be painted in the next 4-5 years and that this project be scheduled on a cyclical basis to maintain the integrity of the structure.

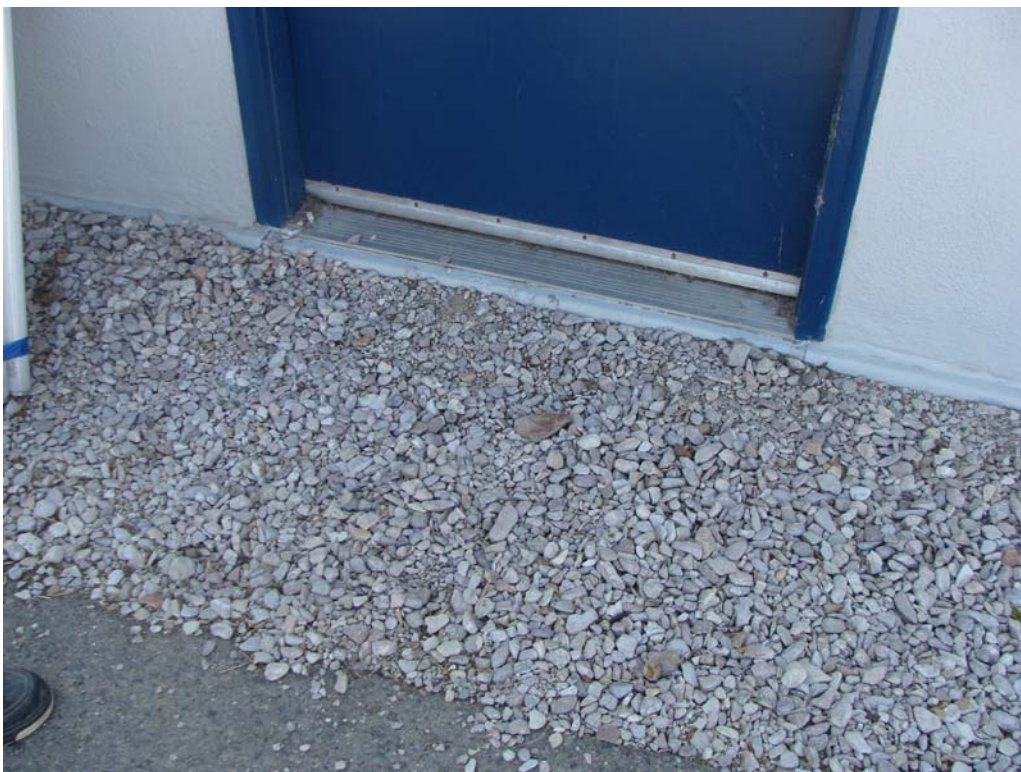
Field Office - Building #0633
Description: Missing exterior door landing.

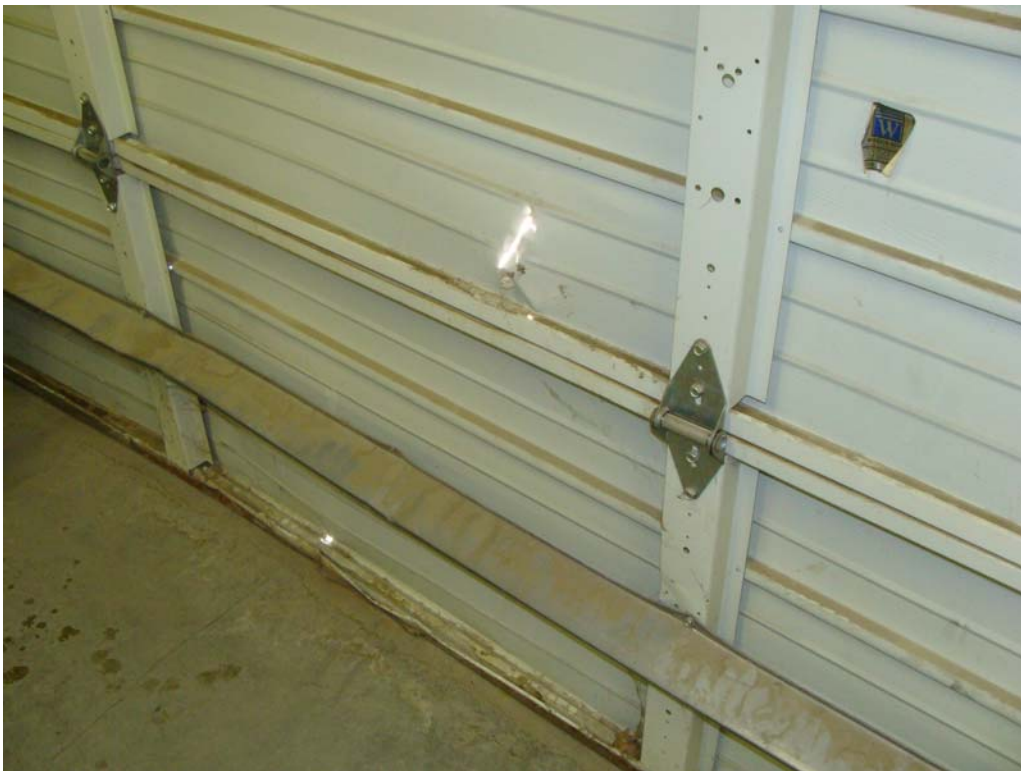
Three of the four 10'x12' overhead coiling doors are damaged and do not function properly. Exposure, wind and vehicle collisions have caused the doors to bend, crack and lose their finish. They are original to the building and should be scheduled for replacement. This project would provide for the removal and disposal of the manually operated overhead coiling doors and replacement with new manually operated overhead coiling doors.

Boat Storage Facility - Building #1438
Description: Damaged overhead door.
