State of Nevada
Department of Wildlife
Mason Valley Wildlife Management Area
Facility Condition Analysis

MASON VALLEY WILDLIFE MANAGEMENT AREA

Site Number: 9904
STATE OF NEVADA PUBLIC WORKS BOARD
FACILITY CONDITION ANALYSIS

Report Printed in June 2009

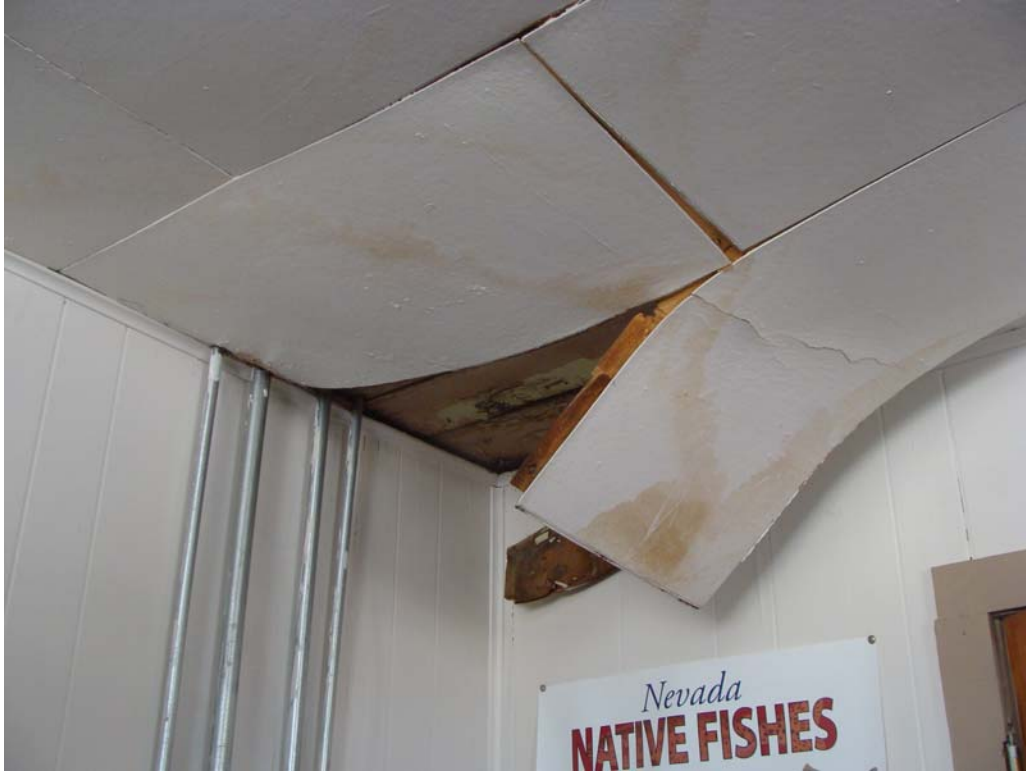
Mason Valley WMA Office / Headquarters - Building #0650
Description: Interior ceiling damage in office.

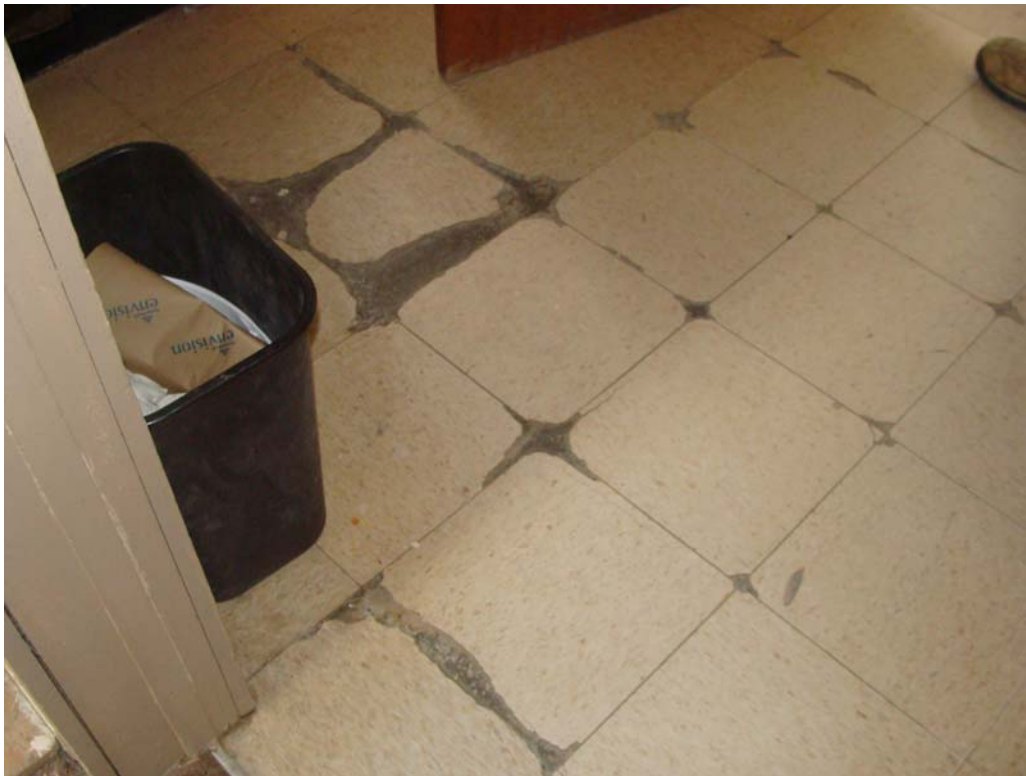
Mason Valley WMA Office / Headquarters - Building #0650
Description: Flooring in need of removal and replacement.

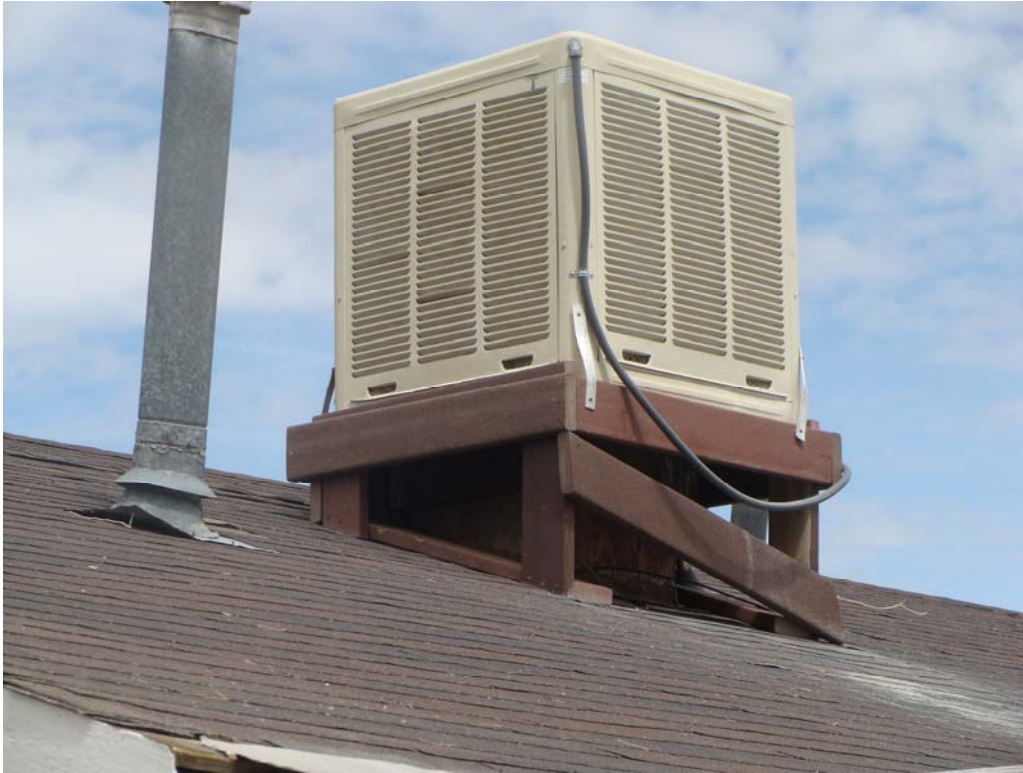
Mason Valley WMA Office / Headquarters - Building #0650
Description: Evaporative cooler and roof damage.

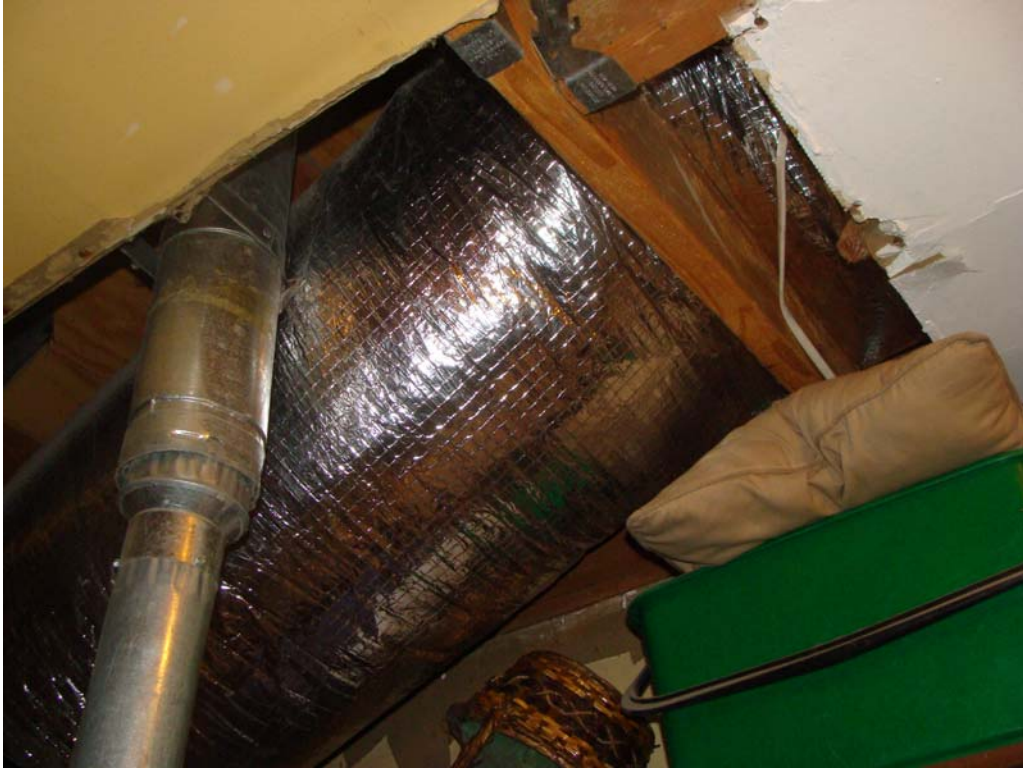
The gypsum board in the closet ceiling is damaged and / or missing at the HVAC duct penetration. This project would provide for the repairs to the ceiling including installing new gypsum board and painting. It is recommended that this project be completed in the next two years.

Mason Valley WMA Residence #4 - Building #0959
Description: Interior ceiling damage in need of repair.

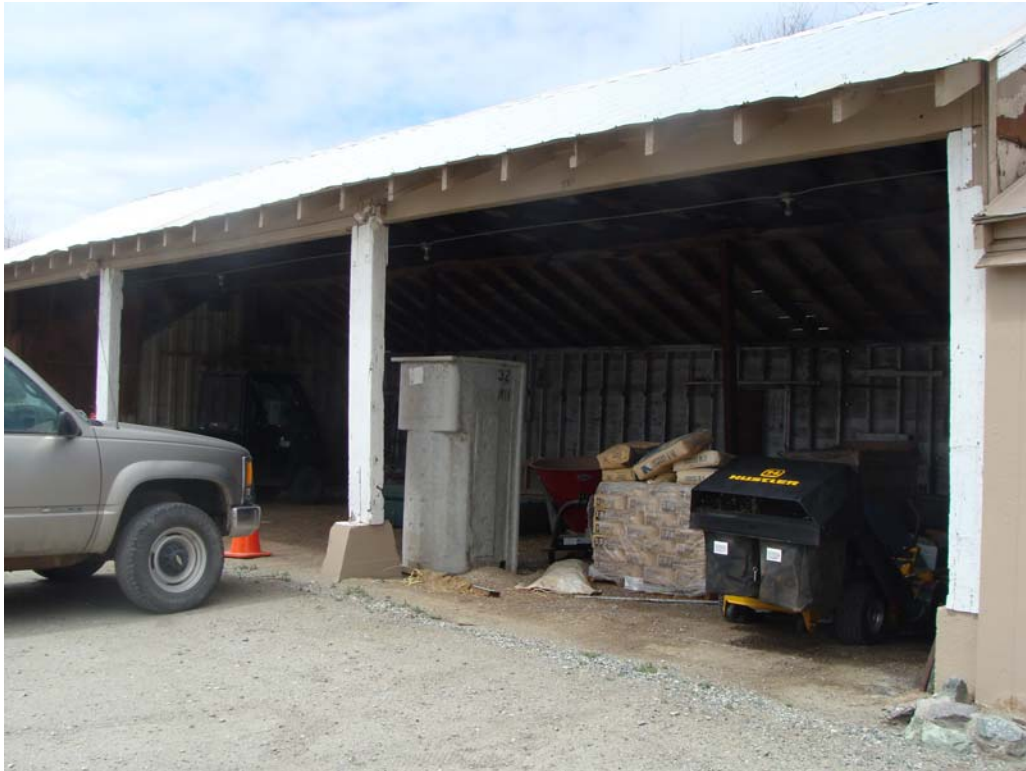
Mason Valley WMA Garage - Building #0961
Description: Exterior of the building.

The Garage is a 3-sided wood framed structure with a dirt floor. It has a corrugated metal roof which is showing signs of leaking and wood siding. The building is adjacent to the HQ office on the west and the Tack Shed on the East. The building is poor to fair condition and is used for storage.

The Garage is dilapidated and deteriorating and has reached the end of its useful life. There is evidence of roof leaks. This project would provide funding for the demolition of the building.

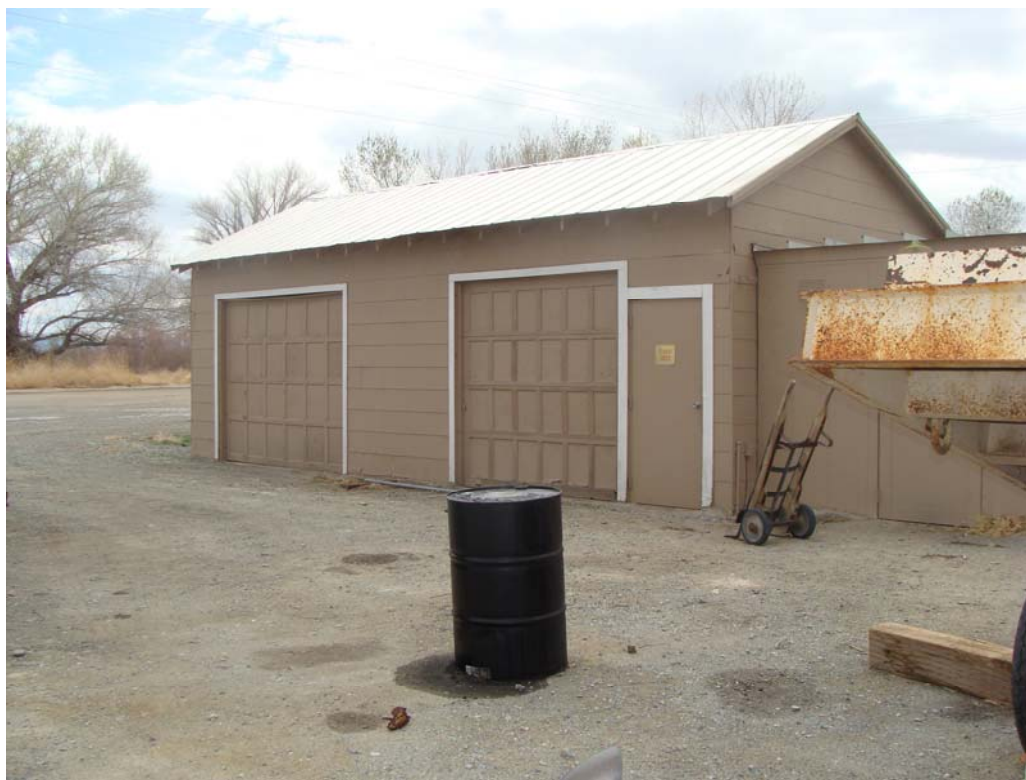
Mason Valley WMA Wood Shop - Building #0962
Description: Exterior of the building.

The Wood Shop is a wood framed structure with a metal roof on a concrete slab-on-grade foundation. It is used by the staff at Mason Valley WMA. There is an old oil fired heater inside and the doors and windows appear to be original. The building is not insulated and is in poor to fair shape.

The Wood Shop contains numerous code and safety issues including but not limited to transite siding, broken windows, broken or missing electrical fixtures, dry rot and possible structural damage due to the age of the building. The building is dilapidated and deteriorating and has reached the end of its useful life. This project would provide funding for the demolition of the building.

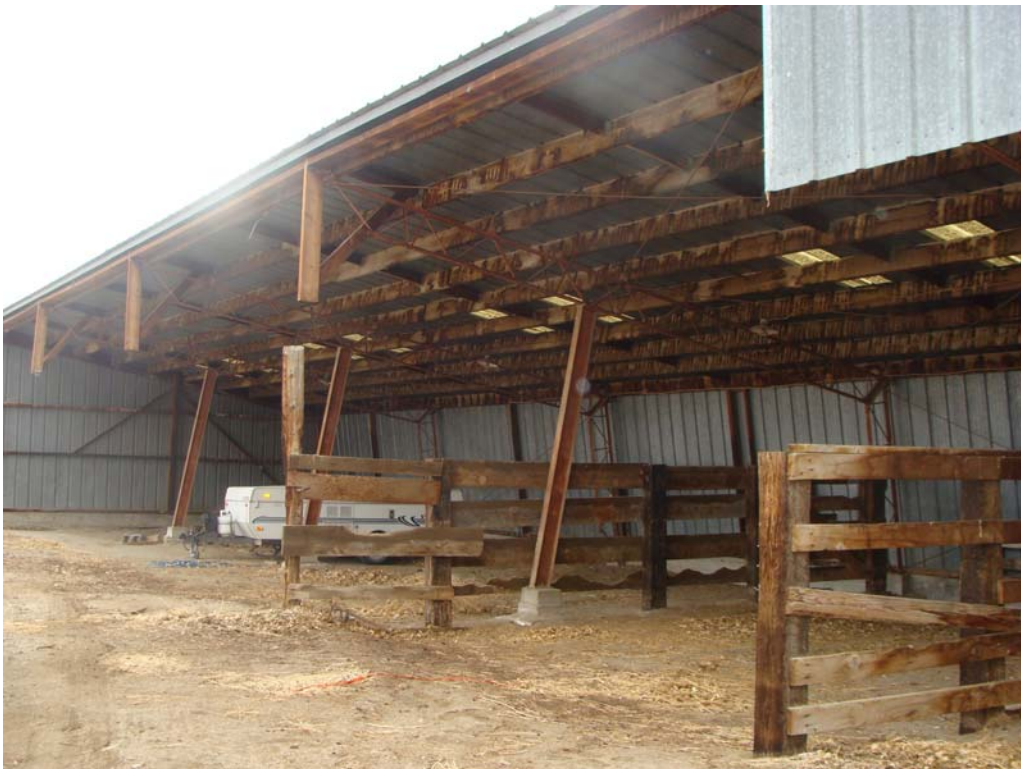
Mason Valley WMA Old Goose Pens - Building #2474
Description: Exterior of the building.

The Old Goose Pens building is dilapidated and deteriorating and has reached the end of its useful life. This project would provide funding for the demolition of the building.

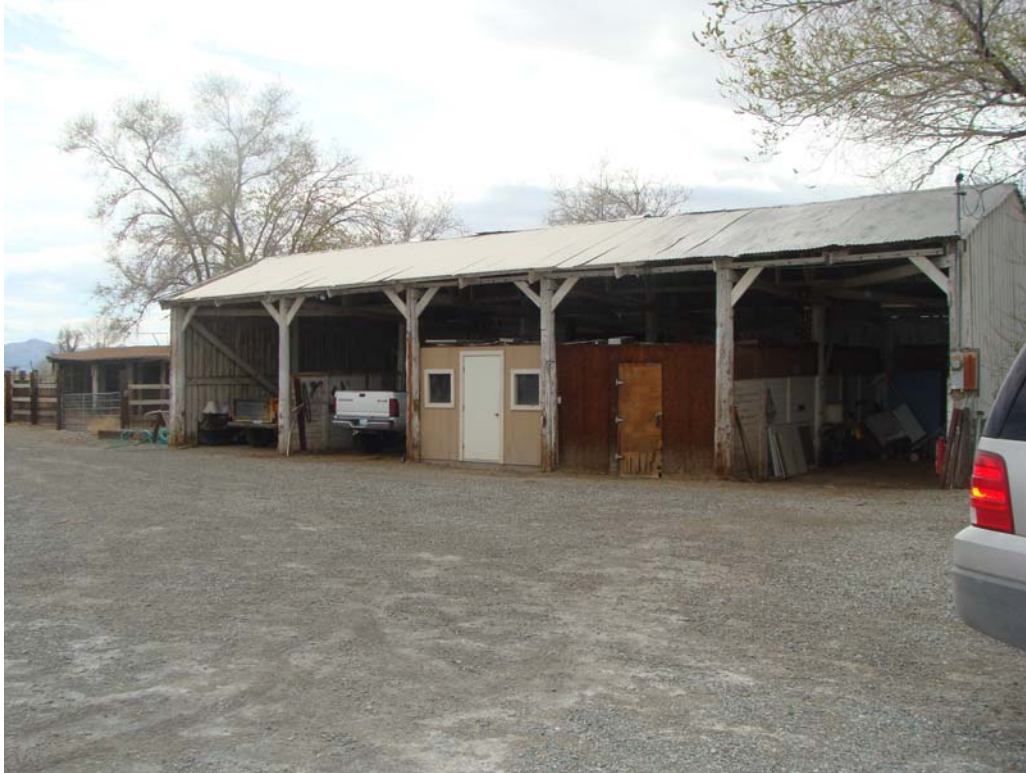
Mason Valley WMA Residence 4 Storage Shed- Building #2475
Description: Exterior of the building.

The Residence 4 Storage Shed is dilapidated and deteriorating and has reached the end of its useful life. This project would provide funding for the demolition of the building.

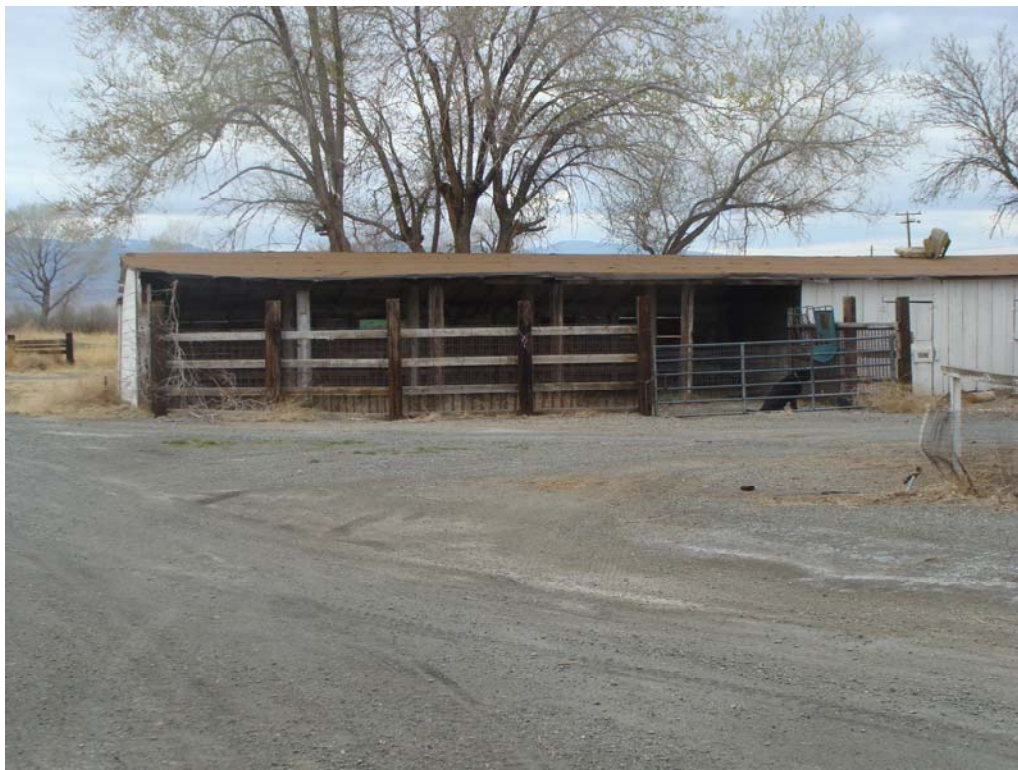
Mason Valley WMA Barn / Box Stalls - Building #2476
Description: Exterior of the building.

The Barn/ Box Stalls building is dilapidated and deteriorating and has reached the end of its useful life. This project would provide funding for the demolition of the building.

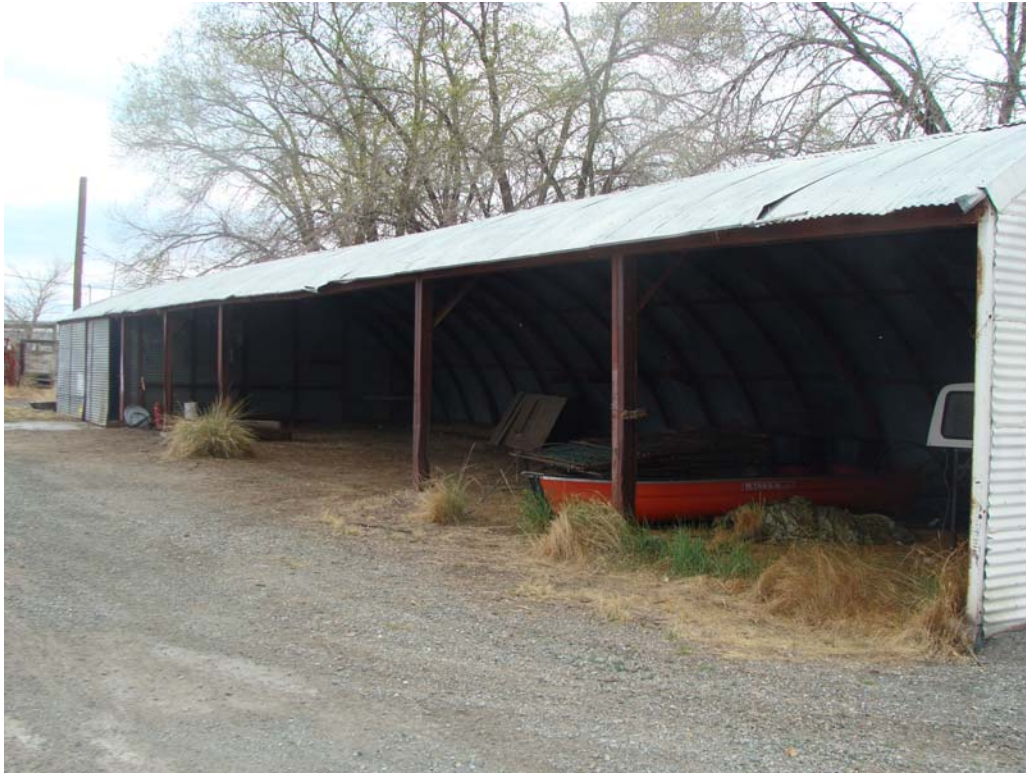
Mason Valley WMA Quonset Hut - Building #2477
Description: Exterior of the building.

The Quonset Hut is dilapidated and deteriorating and has reached the end of its useful life. This project would provide funding for the demolition of the building.

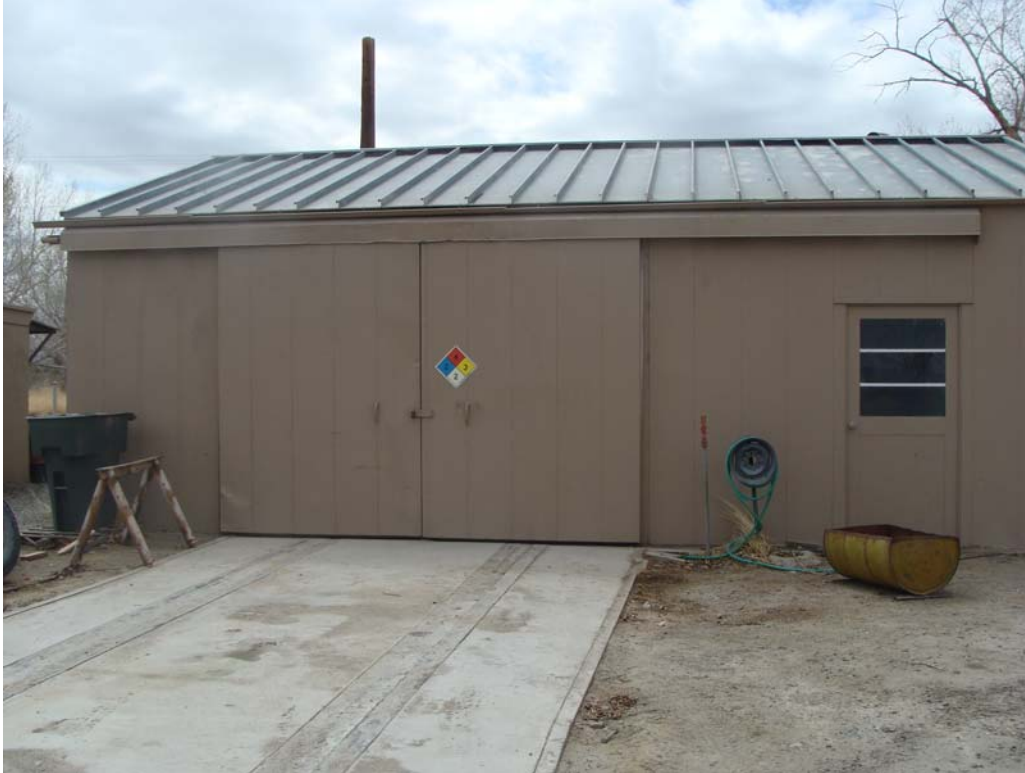
Mason Valley WMA Mechanics Shop - Building #2981
Description: Exterior of the building.

The existing exterior wood door is approaching the end of its expected life. It is damaged from age and general wear and tear. This project would provide for the replacement of the wood door with a new metal door, frame and hardware. Also, a 3'x3'x4" thick concrete landing is included in this project. Removal and disposal of the existing door and painting of the new door is included in this estimate.

The windows are original, single pane construction in a metal frame. These older windows are drafty and not energy efficient. This project recommends replacing the windows with dual pane, higher efficiency units. This estimate is for the replacement of 6 units. Removal and disposal of the existing windows is included in this estimate.

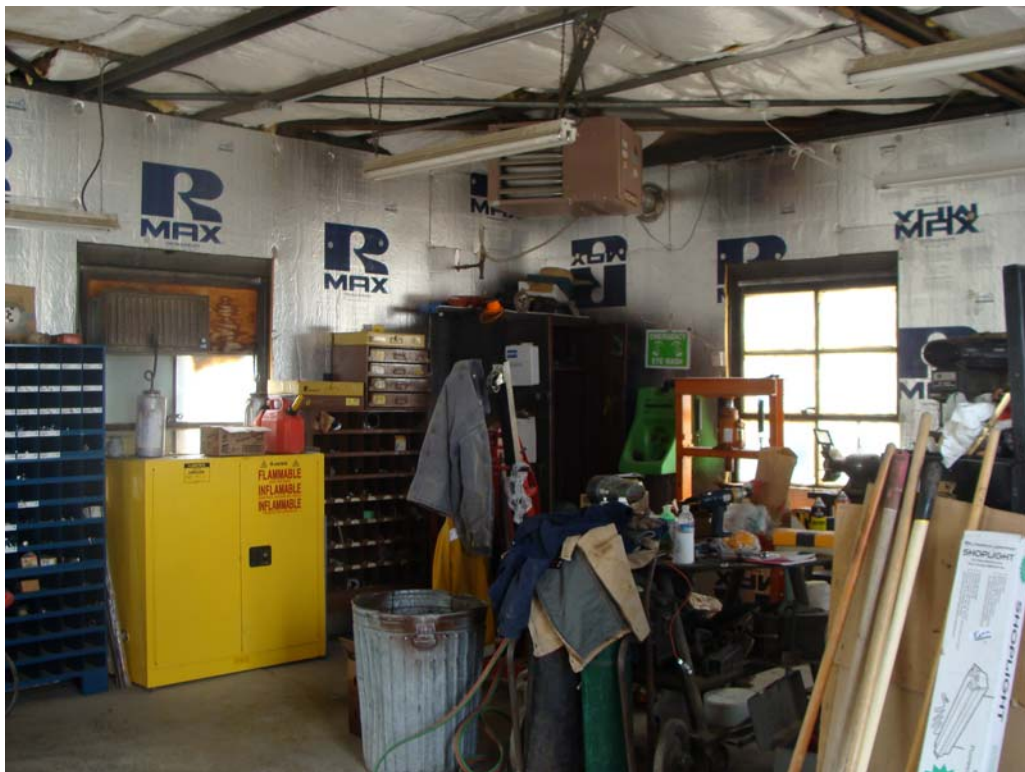
Mason Valley WMA Mechanics Shop - Building #2981
Description: Interior of the building.

Additionally, the heater in the Mechanic's Shop is installed with a flexible gas line penetrating the heater metal cabinet. This is a Plumbing Code Violation. This project will install a solid pipe nipple to project beyond the heater case for connection.

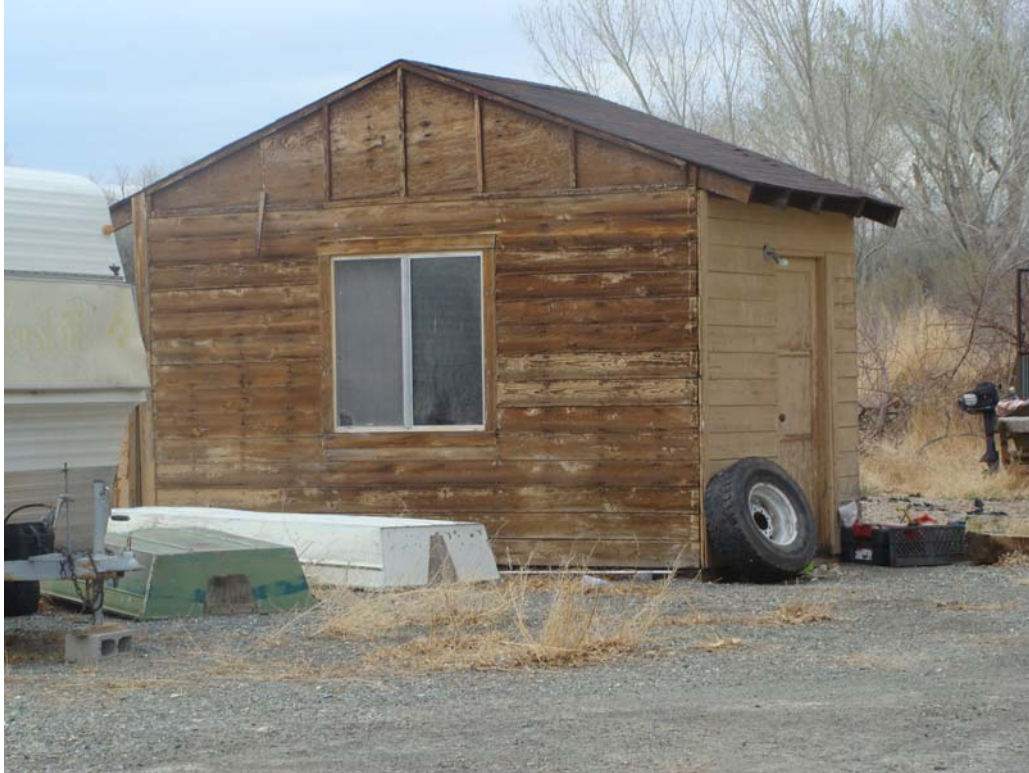
Mason Valley WMA Storage Building - Building #2982
Description: Exterior of the building.

The Storage Building contains numerous code and safety issues including but not limited to damaged windows, broken or missing electrical fixtures, dry rot and possible structural damage due to the age of the building. The building is dilapidated and deteriorating and has reached the end of its useful life. This project would provide funding for the demolition of the building.
