State of Nevada
Department of Health & Human Services
Division of Child & Family Services
Summit View Youth Correctional Center
Facility Condition Analysis

SUMMIT VIEW YOUTH CORRECTIONAL CENTER

Site Number: 9908
STATE OF NEVADA PUBLIC WORKS DIVISION
FACILITY CONDITION ANALYSIS

Report Printed in May 2014

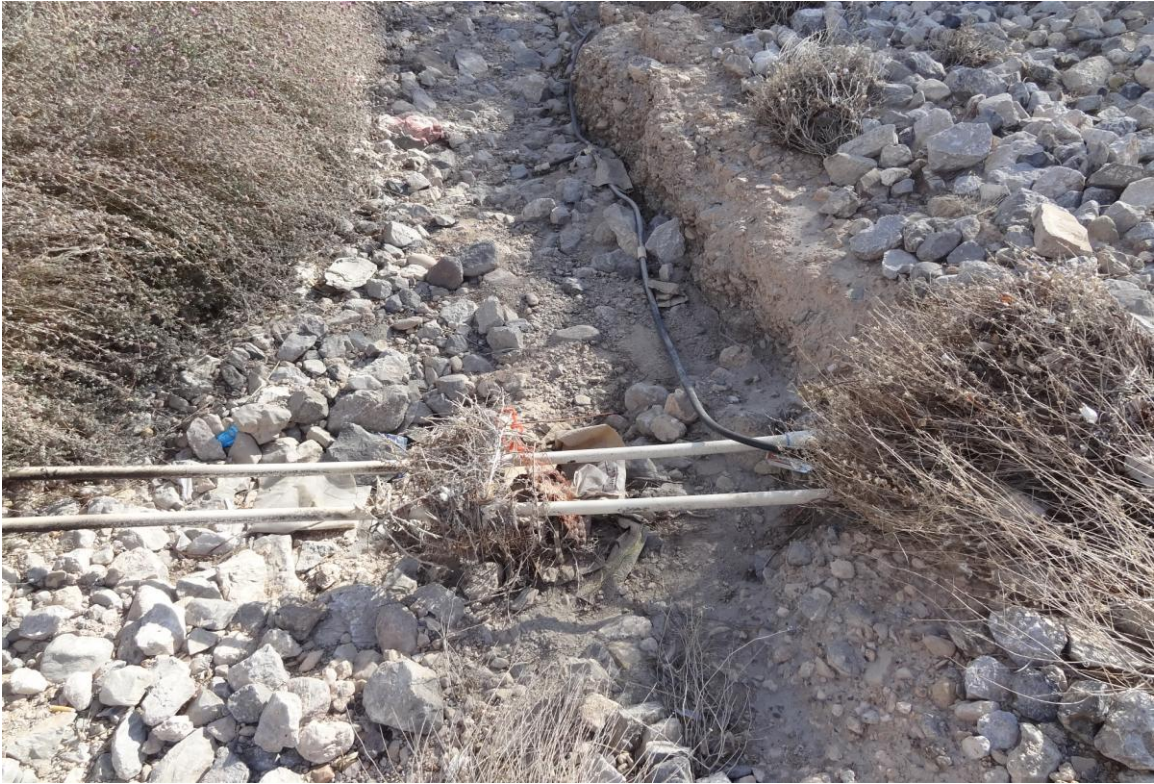
West of the Administration building, storm water runoff does not drain properly and pools up next to the curb and sidewalk. It is recommended to install a dry well to collect and dispose of the water. This project provides for installing a concrete dry well with a silt basin on the west side of the Administration building to mitigate the drainage problem.

Summit View Youth Correctional Center Site – FCA Site #9908
Description: Flood damage, west side of parking area.

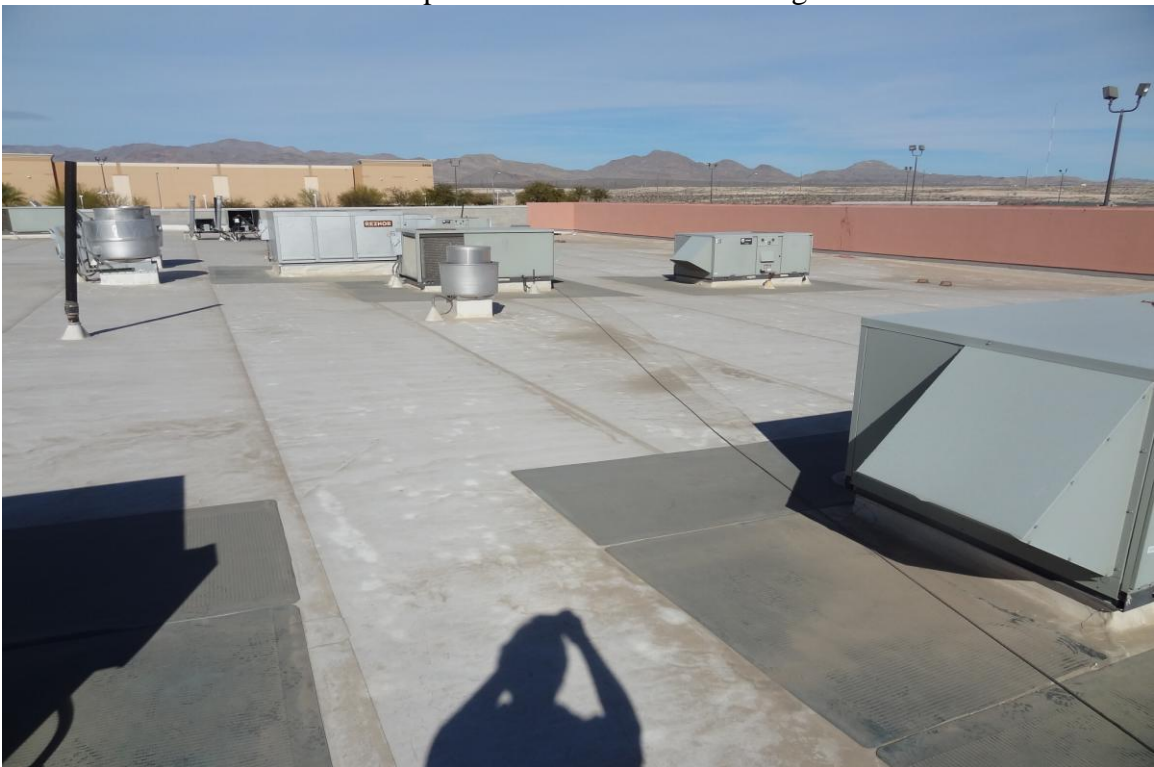
The HVAC system was installed in 2000 and is original to the building. It consists of 21 rooftop packaged units with natural gas-fired furnaces and air conditioners utilizing R-22 coolant. The system is not energy efficient and has reached the end of its expected and useful life. The R-22 coolant is no longer allowable for cooling. This project would provide for installation of a new HVAC system and cleaning of the existing duct work and grilles. The new system shall be designed to significantly reduce electrical and natural gas usage in order to comply with the 2009 IECC and ASHRAE 90.1 and to reduce utility costs. This project includes removal and disposal of the existing HVAC units and all required connections to utilities.

Administration & Education – FCA Building #2428
Description: View of the roof / equipment.
