State of Nevada
Department of Administration
Public Works Division – Building and Grounds Section
Education/State Mail Services Site
Facility Condition Analysis

EDUCATION / STATE MAIL SERVICES SITE

700 East 5th Street
Carson City, Nevada 89701

Site Number: 9916
STATE OF NEVADA PUBLIC WORKS DIVISION
FACILITY CONDITION ANALYSIS

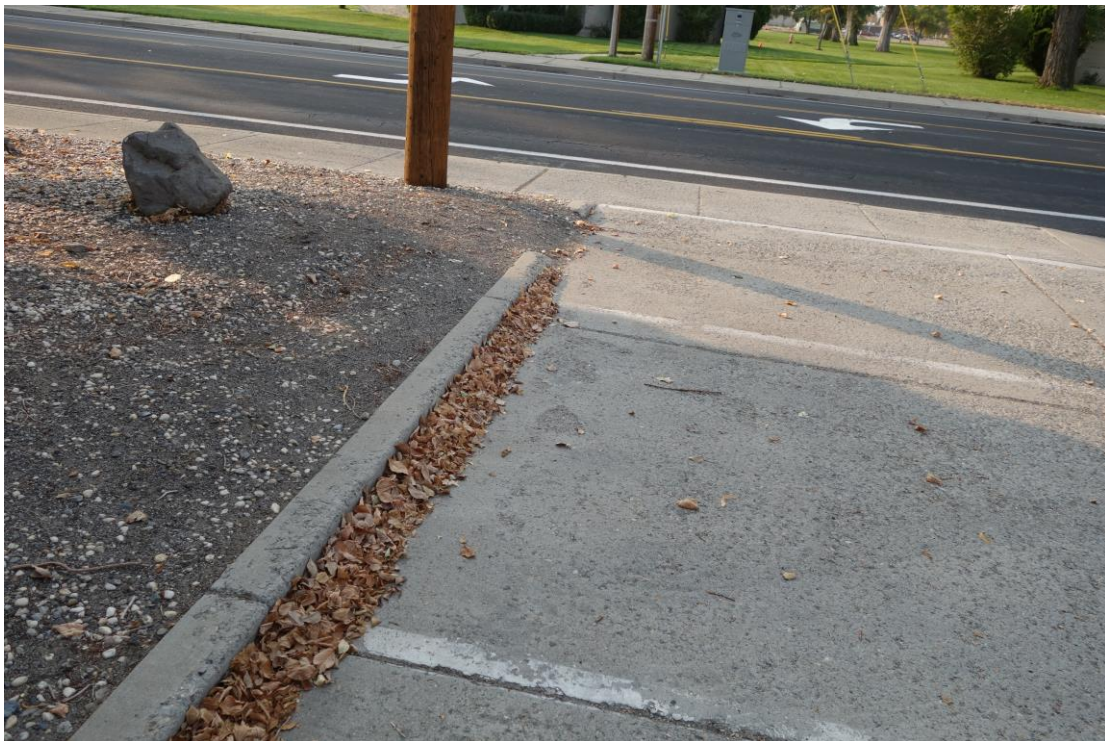
The concrete public parking area, sidewalk and curbs on the south side of the Mail Services Building is failing and in need of replacement. This project provides funding to replace the concrete paving, curbs and the adjacent sidewalk. Striping for safety and parking is included in this estimate.

Education / State Mail Services - Site #9916
Description: Parking Lot Replacement South of Mail Services Building #0395.

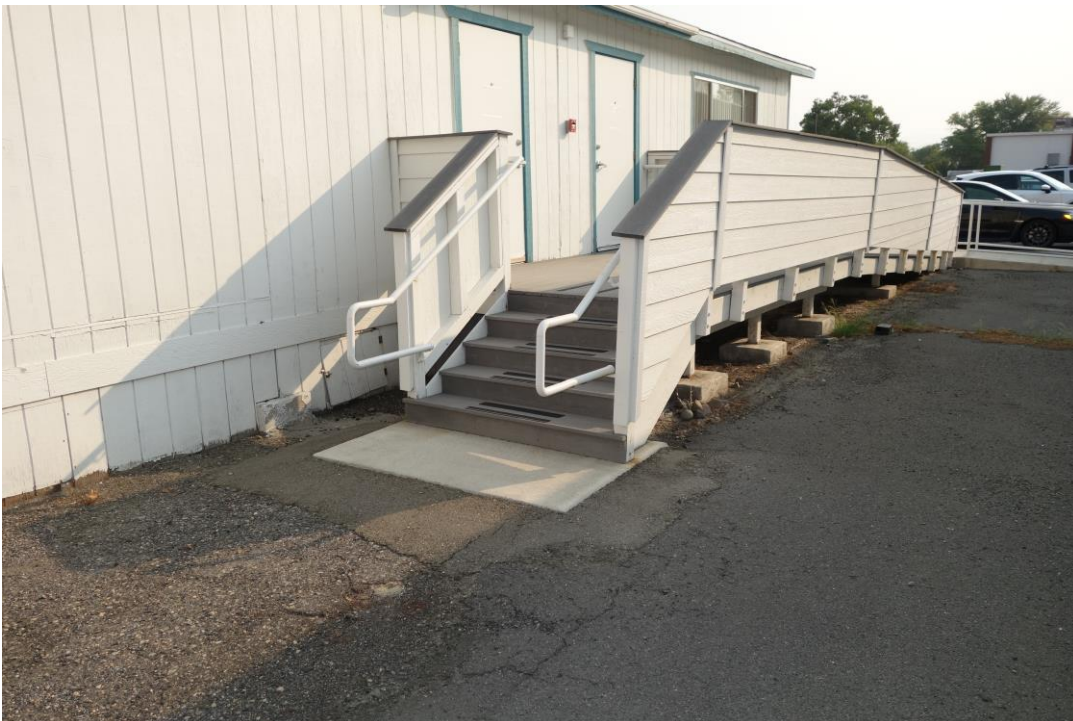
The guardrail supporting the ADA handrails appears to be inadequately supported. The guardrail can be easily moved horizontally perpendicular to the path of travel. It is recommended that the guardrail and handrail be strengthened to meet 2018 IBC Chapter 1607.8 requirements.

Education Modular Office-West - Building #2308
Description: Strengthen Guardrail.

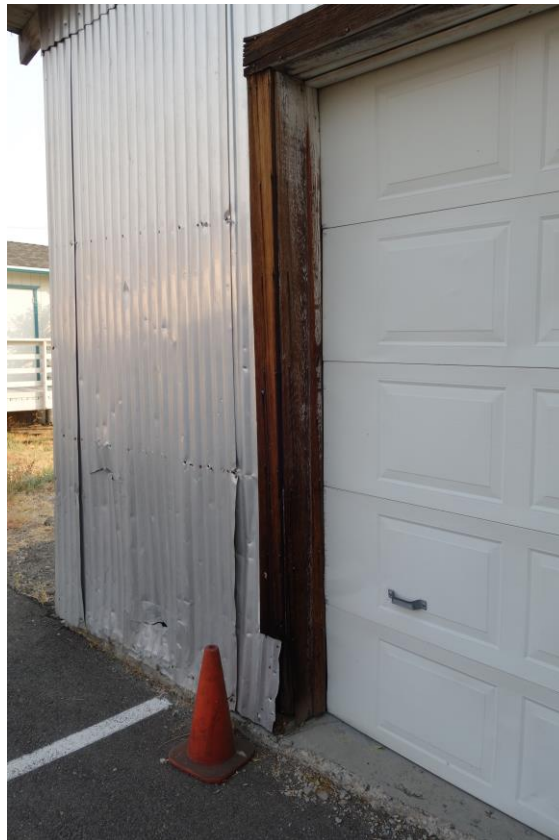
There is damage to the metal siding and the metal roof which is compromising the weather resistance of the building. The siding has been punctured and is exposing the framing of the building. It is recommended to repair the damage immediately in order to protect the framing and the interior of the building.

The exterior painted wood finished portions are in poor condition. It is important to maintain the finish, weather resistance, and appearance of the building. This project would provide funding to protect the exterior of the building. Included in the cost is the sealing and caulking of the windows, flashing, fixtures and all other penetrations. It is recommended that the building be caulked and sealed in the next 2 - 3 years and that this project be scheduled on a cyclical basis to maintain the integrity of the structure.

Storage #3 - Building #2304
Description: Siding Repairs and Exterior Finishes.

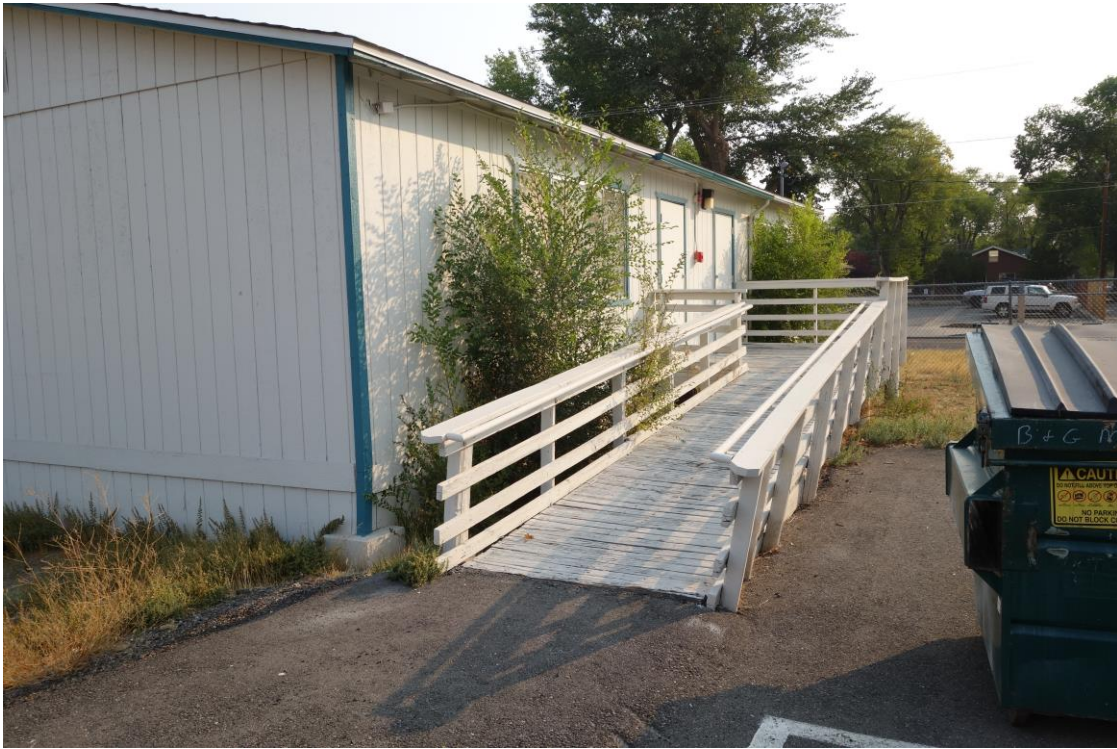
This facility has a wood ramp and entry deck located on the south side of the building. The ramp and deck are deteriorating and do not have proper landings, guardrails or handrails. This project would provide for an upgrade to the ramp to make it fully ADA compliant including new decking, handrails, guardrails, signage, and landings. The 2018 IBC Chapter 10 and 11, ICC/ANSI A117.1 and the most current version of the Americans With Disabilities Act Accessible Guidelines (ADAAG) was used as a reference for this project.

Modular Storage #2-East - Building #2303
Description: Replace Accessible Ramp / Entry Deck.

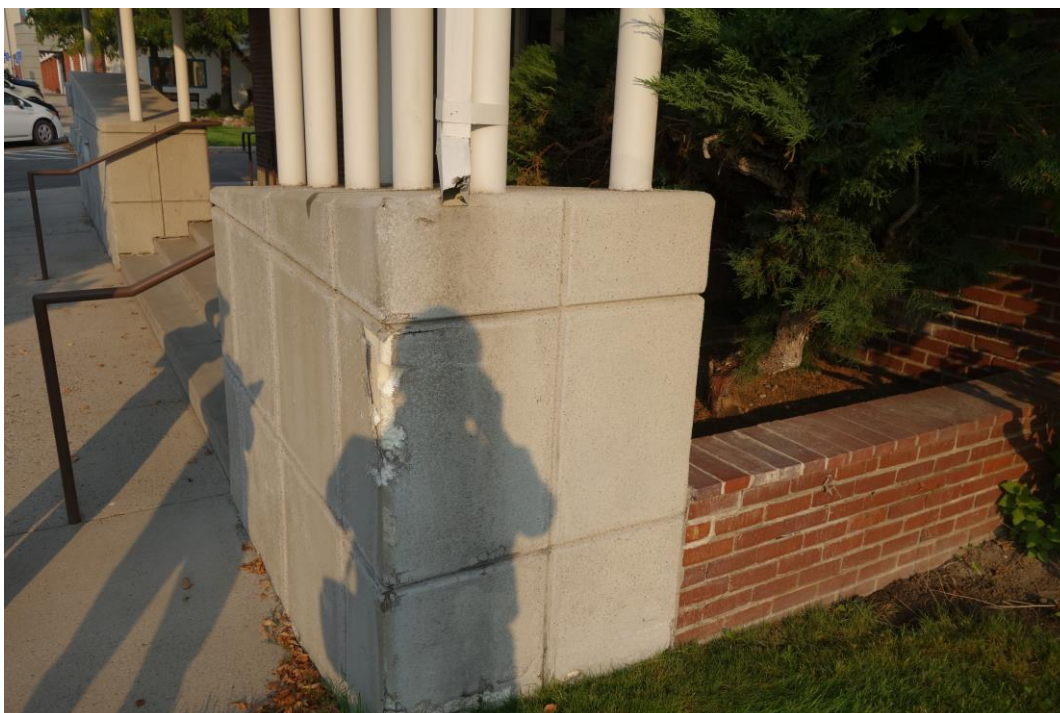
The EIFS (Exterior Insulating Finish System) at the front entry of the building is damaged and in need of repair and the EIFS finish has deteriorated. This project would provide for the repair of the EIFS system and re-coating all of the EIFS surfaces.

State Mail Services Building - Building #0395
Description: EIFS Repairs.

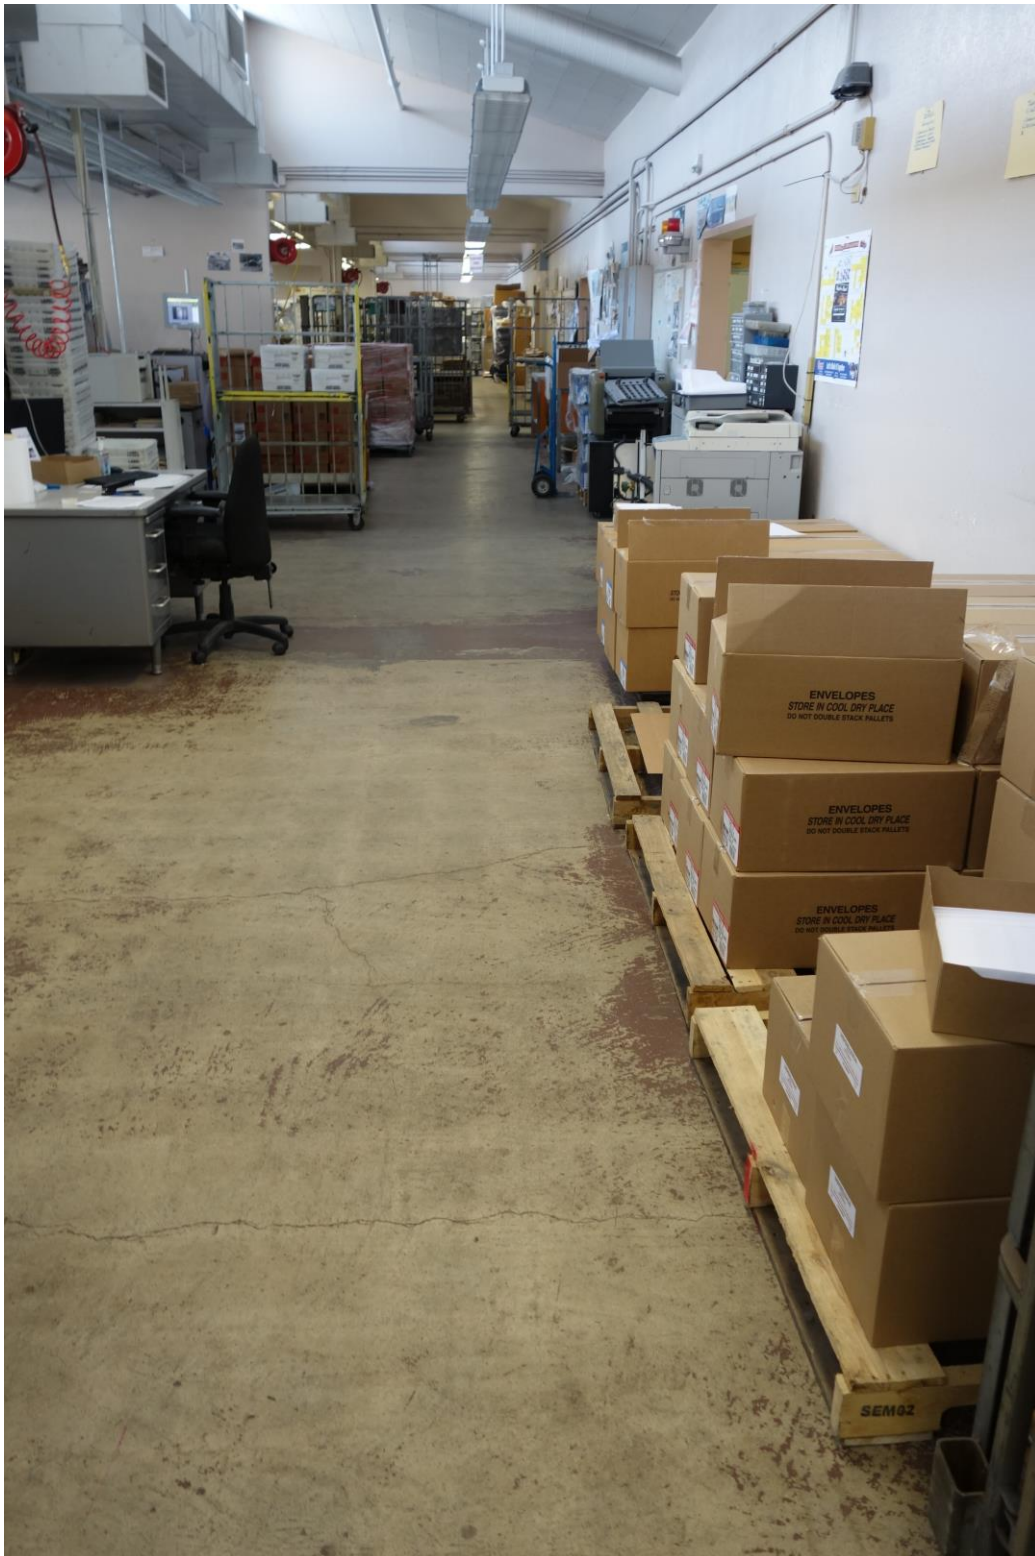
State Mail Services Building - Building #0395
Description: Resurface Concrete Floor.

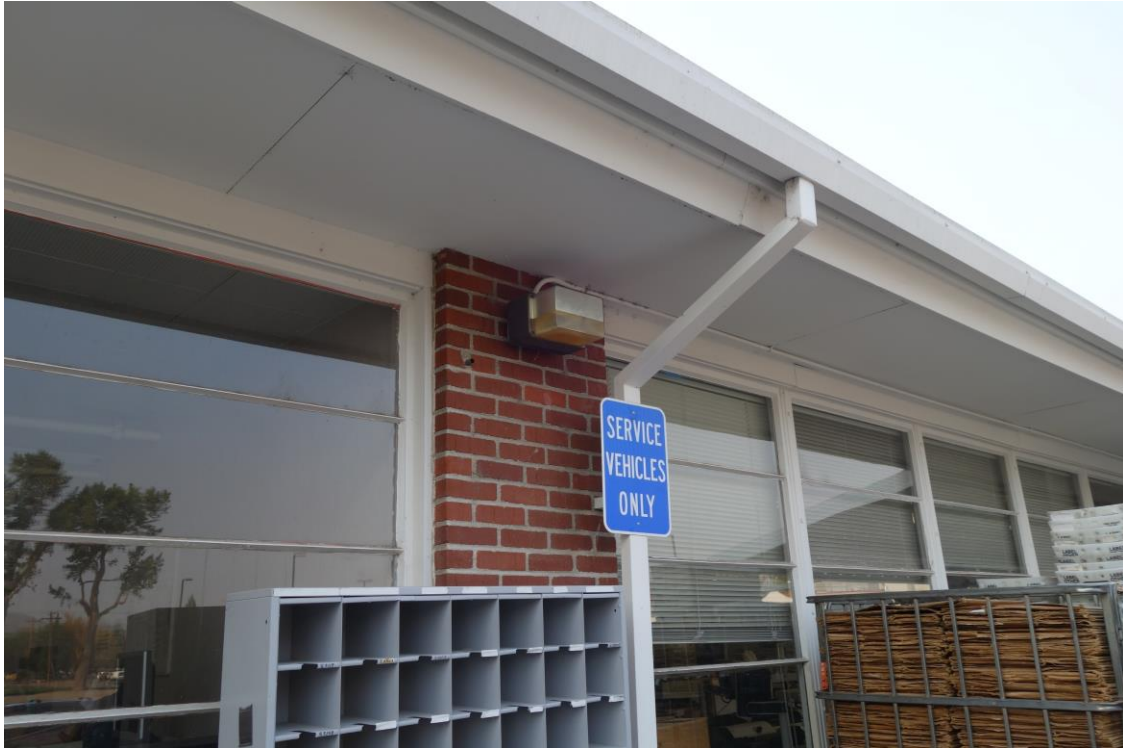
The building has exterior lighting on the north side of the building and the 3 existing light fixtures are old, failing, and not energy efficient. This project would provide for augmenting site lighting on the north side and replacement of the exterior lighting fixtures with new LED light fixtures using existing wiring circuits.

State Mail Services Building - Building #0395
Description: Exterior Lighting Upgrade.

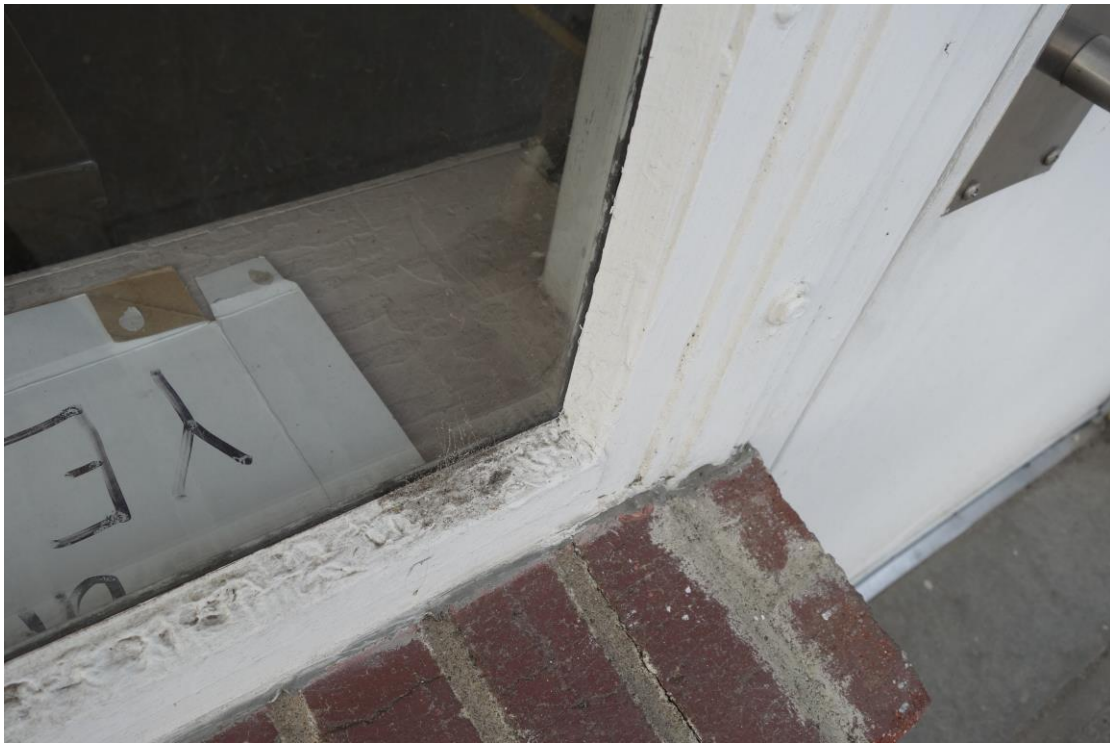
State Mail Services Building - Building #0395
Description: Replace Windows.

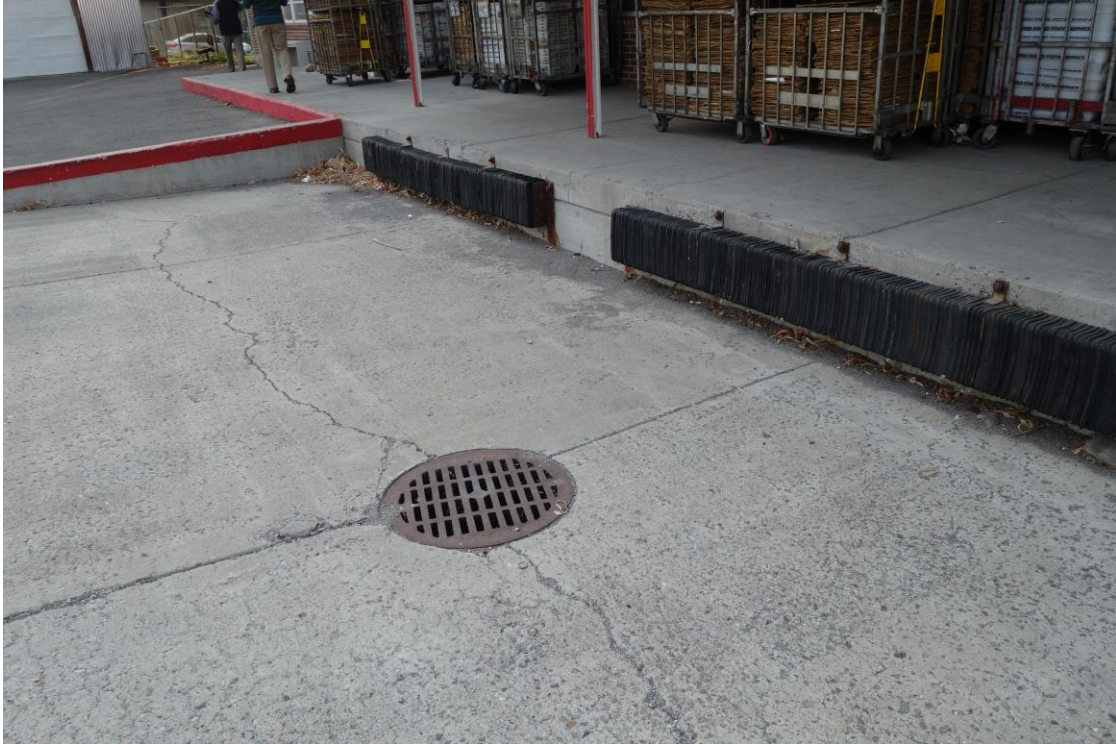
State Mail Services Building - Building #0395
Description: Loading Dock Refurbishment.

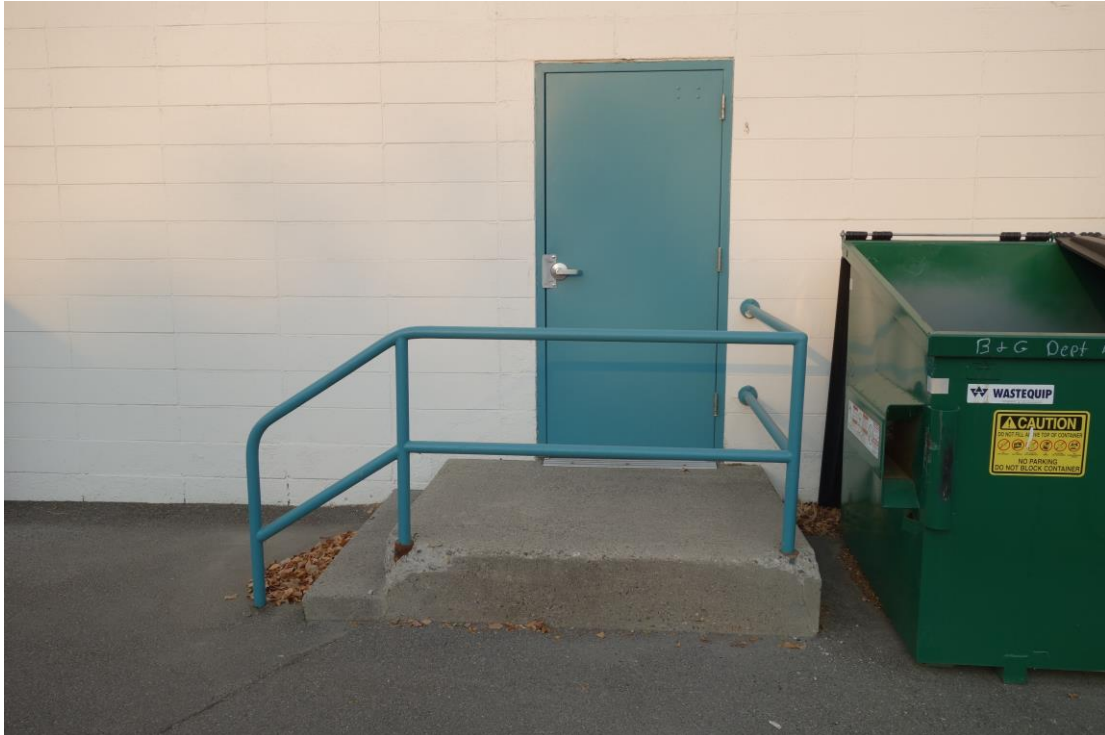
Department of Education Office - Building #0202
Description: Concrete Stair Replacement.

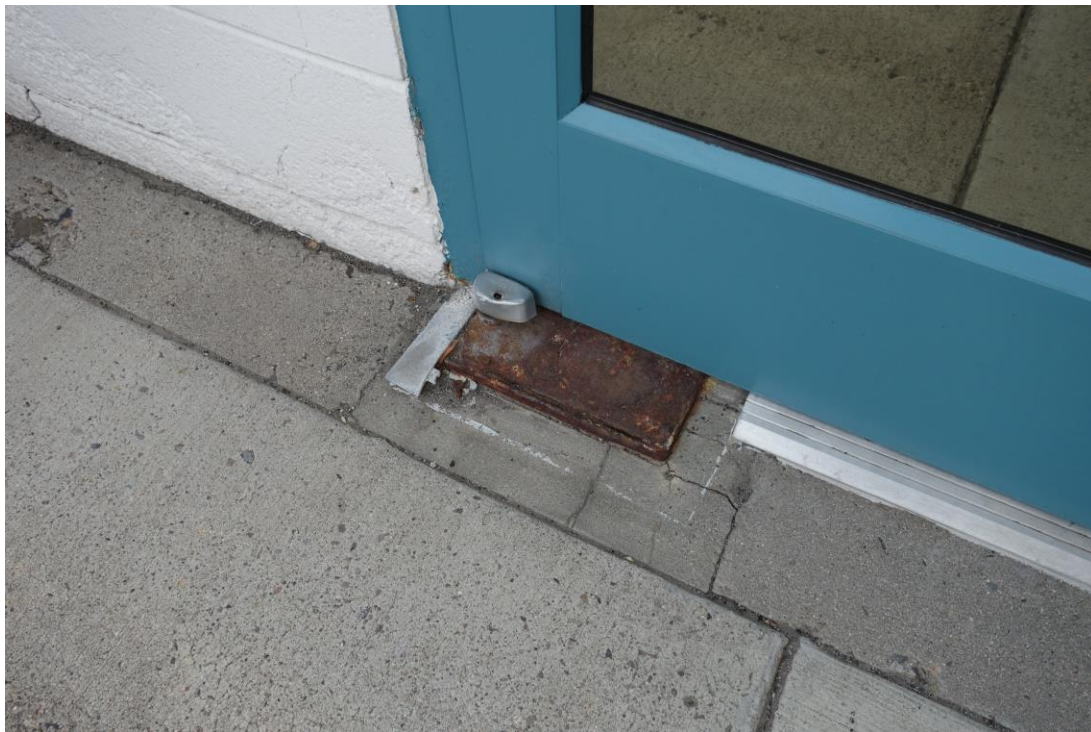
Department of Education Office - Building #0202
Description: Exterior Door Replacement.

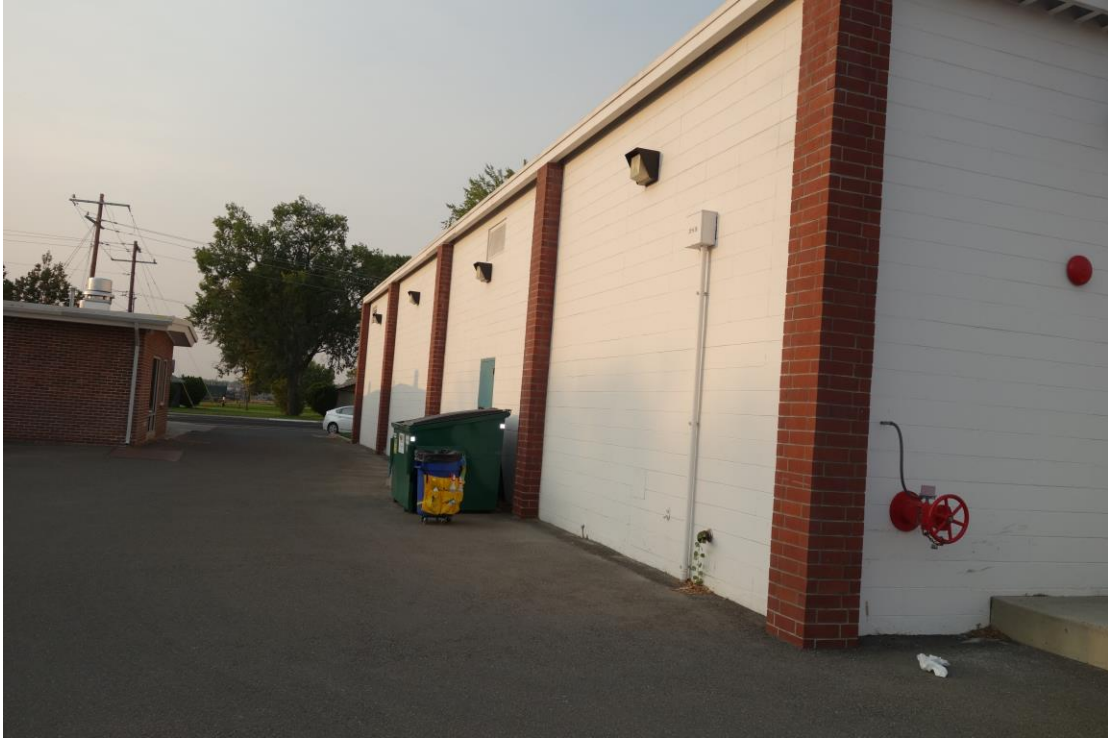
Department of Education Office - Building #0202
Description: Exterior Lighting Replacement.
