State of Nevada
Department of Administration
Buildings and Grounds Division
Nevada State Capitol
Facility Condition Analysis

NEVADA STATE CAPITOL

101 North Carson Street
Carson City, Nevada 89701

Site Number: 9918
STATE OF NEVADA PUBLIC WORKS BOARD
FACILITY CONDITION ANALYSIS

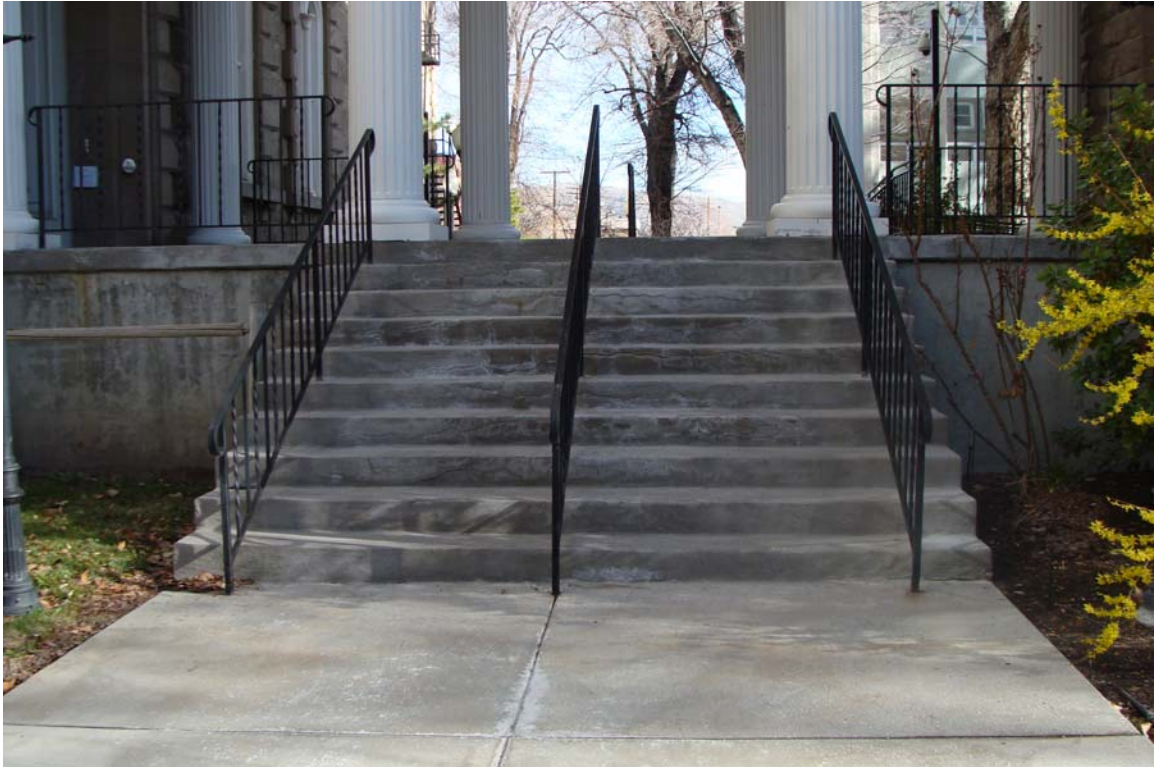
The south side concrete stairs and landing at the breezeway between the Annex and Capitol are severely deteriorated. Spalling and cracking have occurred to the extent that the stairs need to be replaced and the landing resurfaced. It is currently a tripping hazard especially during inclement weather. This project addresses removal and replacement of the entire stair structure and resurfacing the concrete landing. The existing handrails do not meet current building codes and may need to be replaced in kind or altered to bring them into compliance. Due to the historical nature of the building, this project is subject to review and approval from the State Historical Preservation Office. Section 1012 of the 2006 IBC was referenced for this project.

Nevada State Capitol - Site #9918
Description: Stairs / rails in need of replacement.

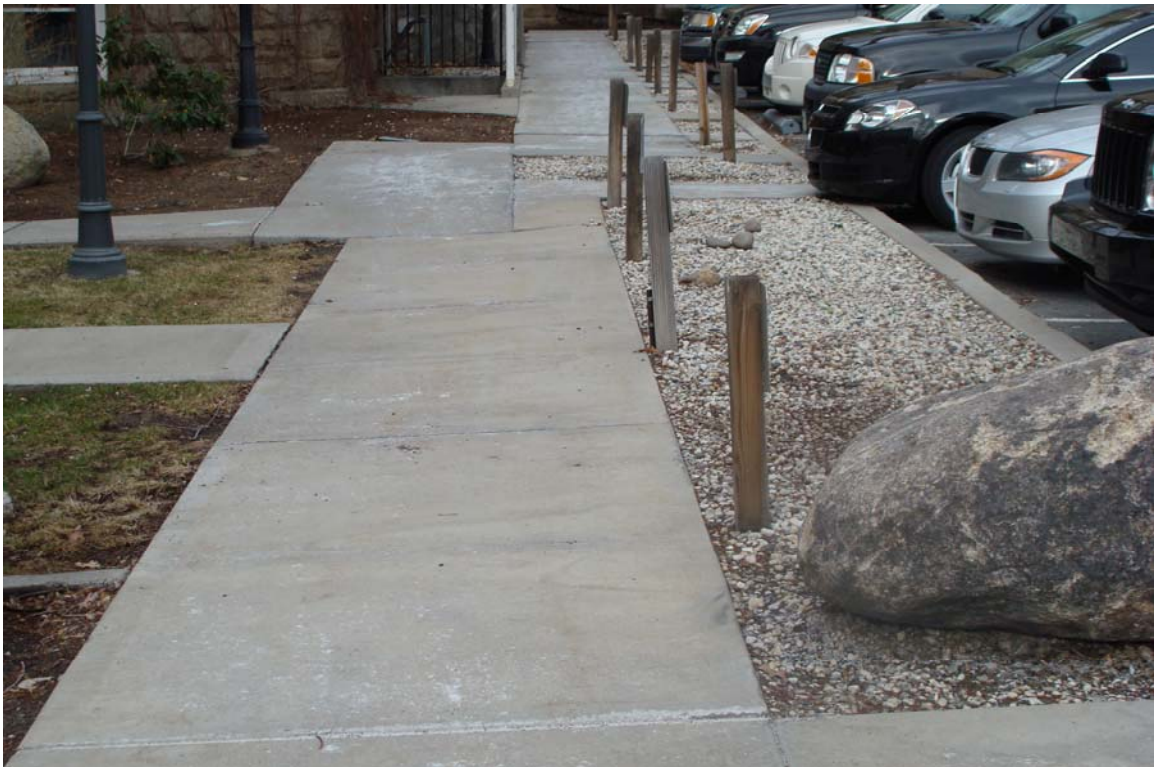
Some of the sidewalks around the building are deteriorated and failing and some do not meet ADA requirements. In some areas there is extensive cracking, heaving and settling. The concrete landings at the bottom of the three steel exterior exit stairs are too small and one is missing. This project addresses removal and replacement of existing sidewalks as needed particularly for the ADA path of travel on the east side of the site and installing new landings for the exit stairs. NRS 338.180, IBC - 2006, ICC/ANSI A117.1 - 2003 and the most current version of the Americans with Disabilities Act Accessible Guidelines (ADAAG) were used as a reference for this project.

Nevada State Capitol - Site #9918
Description: ADA accessible route with cross slope exceeding 2%.

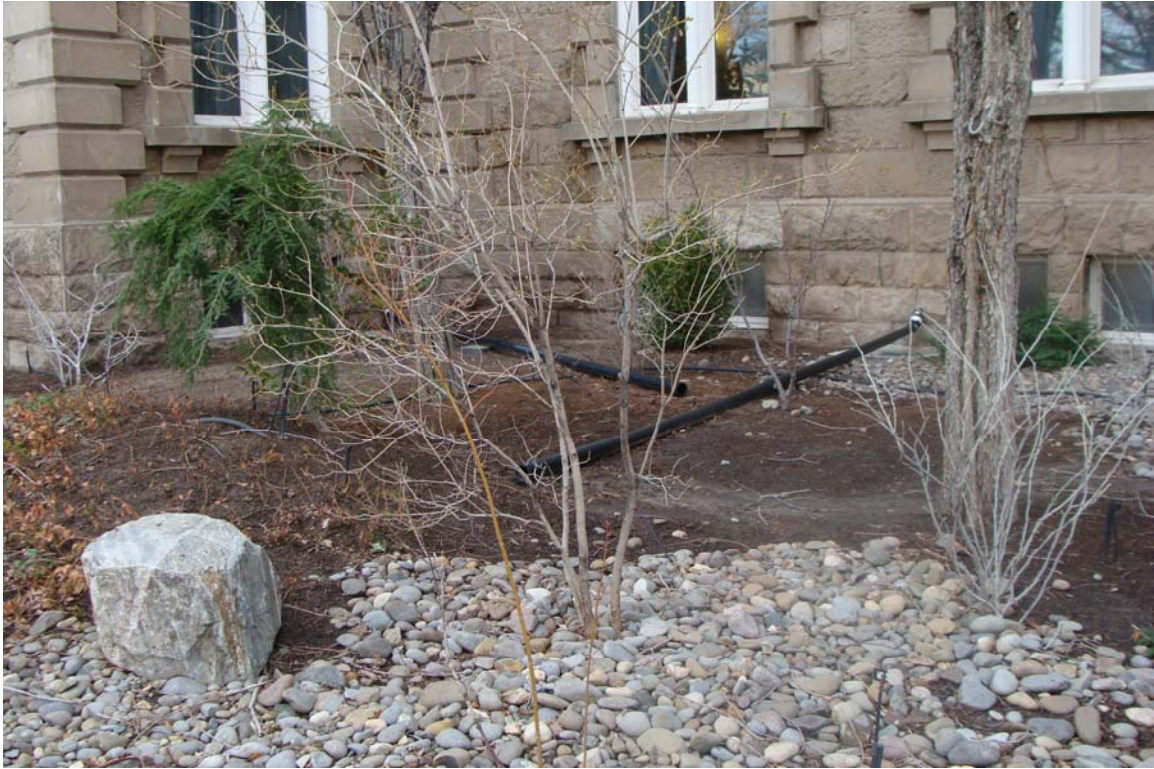
There is a drainage problem on the west side of the Capitol building resulting in water leaking into the basement. Two roof drain downspouts and landscaping are just outside of the subject area and it is suspected that the water is pooling up in this area instead of running off away from the building. It is recommended to extend the downspouts underground to a dry well or similar drainage feature to carry the water away from the building and regrade the landscaped area to provide a positive slope away from the building.

Nevada State Capitol - Site #9918
Description: Area in need of drainage improvements.

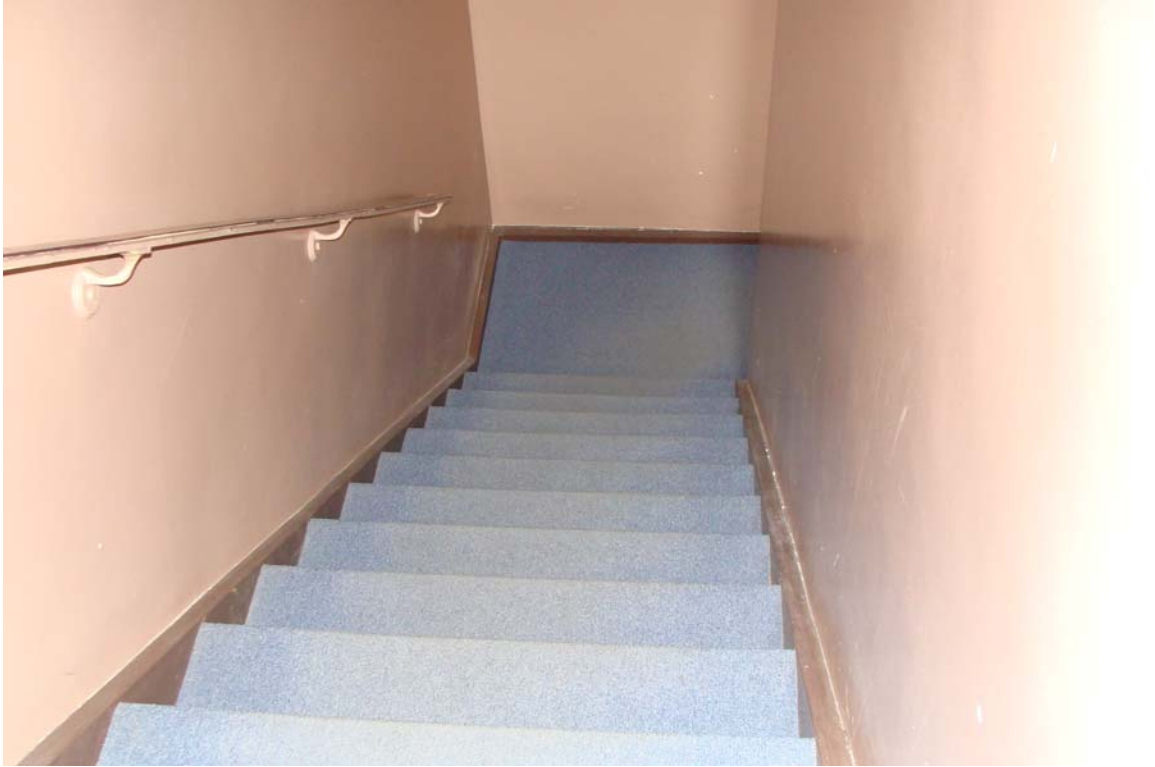
There are two exit stairwells on the west side of the building. The handrails are older and do not meet code for safety or accessibility. The gripping surfaces are incorrect, they do not have proper returns, they are on only one side of the stairway and they are not continuous from the top to bottom landings. This project recommends the installation of handrails on both sides of the stairs, with proper gripping surfaces, returns and supports. Removal and disposal of the existing railing is included. Due to the historical nature of the building, this project is subject to review and approval from the State Historical Preservation Office. NRS 338.180, 2006 IBC Chapter 10, Section 1012, ICC/ANSI A117.1 - 2003 and the most current version of the Americans with Disabilities Act Accessible Guidelines (ADAAG) were used as a reference for this project.

Nevada State Capitol - Building #0235
Description: Interior stairway handrails in need of upgrade.

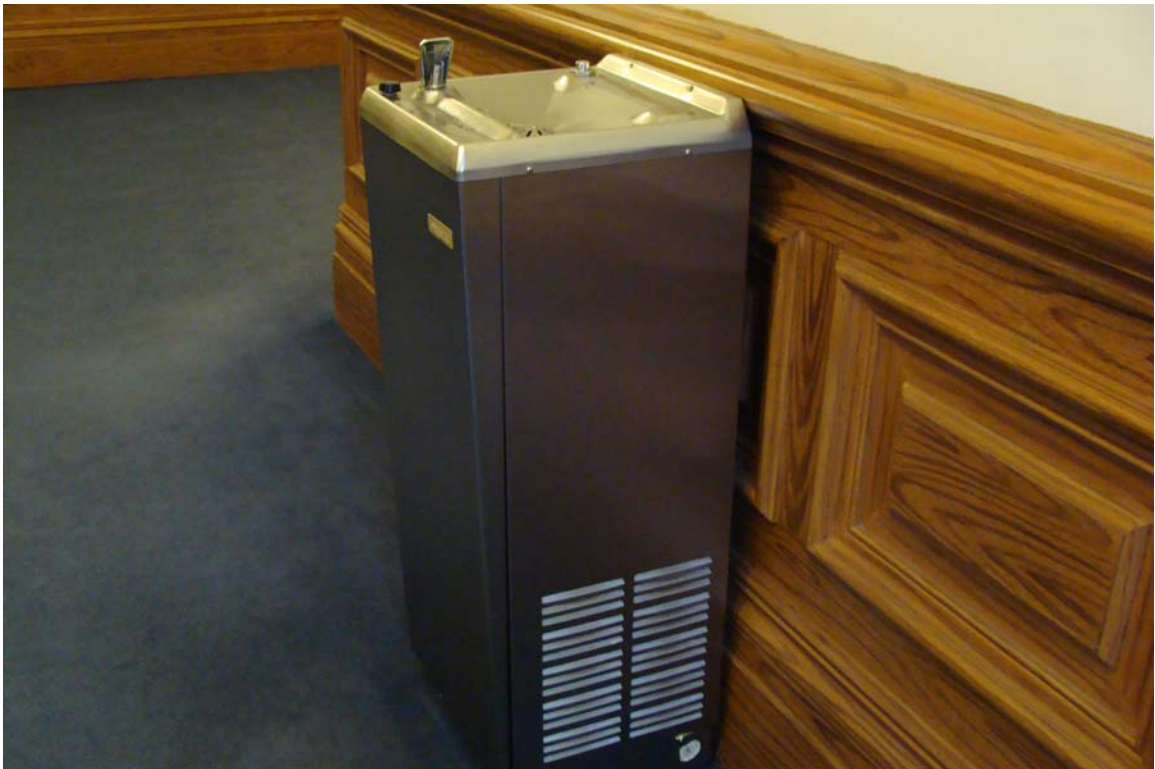
This building contains a water fountain on each floor. The basement floor and 1st floor drinking fountains are not accessible. The 2006 IBC Section 1109.5 states where a water fountain is provided, at least half should be accessible. This project would provide funding for the purchase and installation of two new accessible fixed high/ low ADA drinking fountains for the basement and 1st floor. NRS 338.180, IBC - 2006, ICC/ANSI A117.1 - 2003 and the most current version of the Americans with Disabilities Act Accessible Guidelines (ADAAG) were used as a reference for this project.

Nevada State Capitol - Building #0235
Description: Drinking fountain in need of replacement.
